OLD BEN COAL CO.
MINE # 26

Mine Index No. 879 S-26

COAL MINE—PRODUCTION

ILLINOIS GEOLOGICAL SURVEY, URBANA

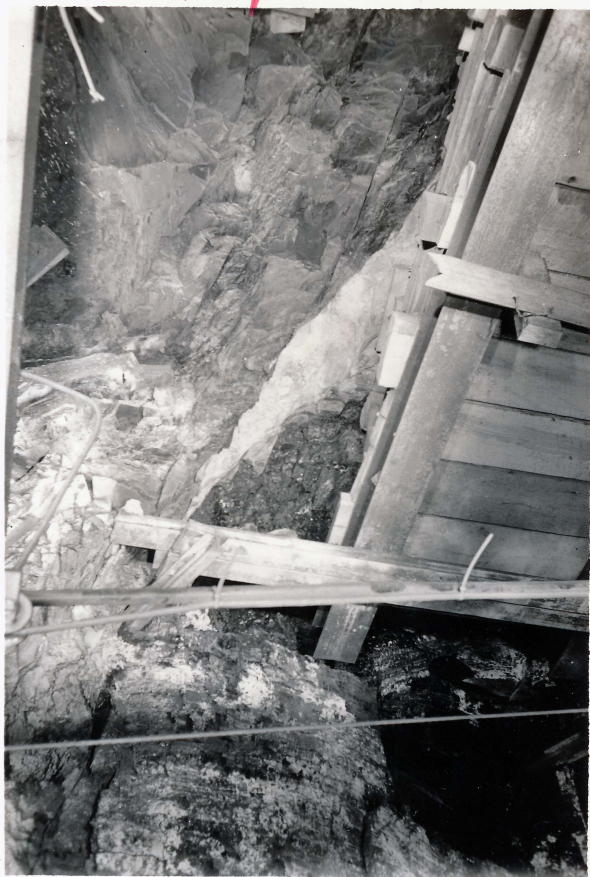
photo 1 mn-03A-042.tif

Photo 1 6th Main E off South. Fault, looking S and up fault: white stuff probably sandstone drawn into fault. Coal in west side of fault downthrown, much fault breccia to E side of main fault plane. Strike 010° , dip $60-70^{\circ}$ east. Barite found in little fault east of main fault.

Photo 1 (2A) to the Main E of S
 fault, looking S and up

fault: whole stuff probably ss
 down into fault. Coal in W
 side of fault, down through
 to E side, much fault

Basite found in little
fault E of main fault

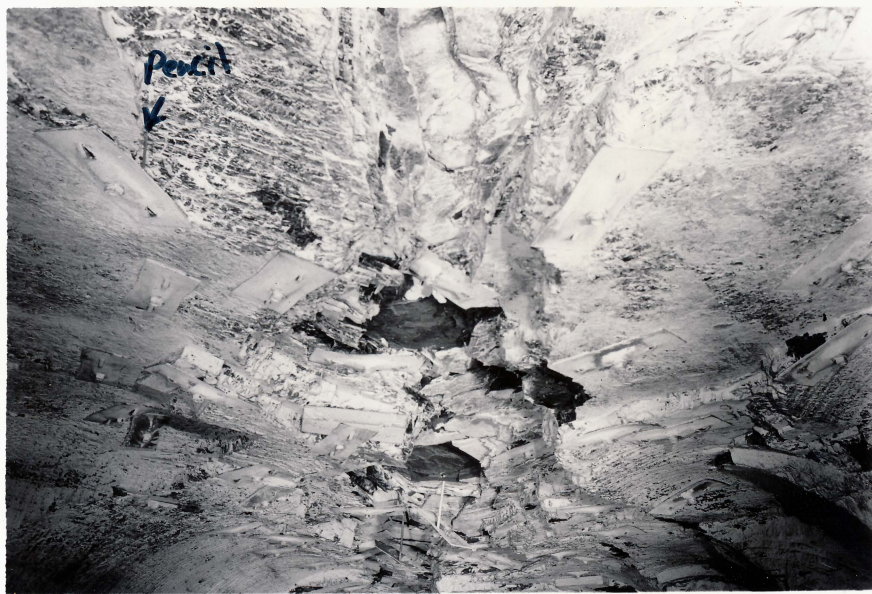
Photo 4 ↓ mn-03A-044

Photo 4 Left side front (pencil) covers same area as photo 3; fracture in roof (incipient fall) trends about $165-170^{\circ}$.

ph. 4: left side front (pencil) (5A)
covers same area as ph. 3
fracture in roof (incipient
fall) trends about 165-70 (H.S.)

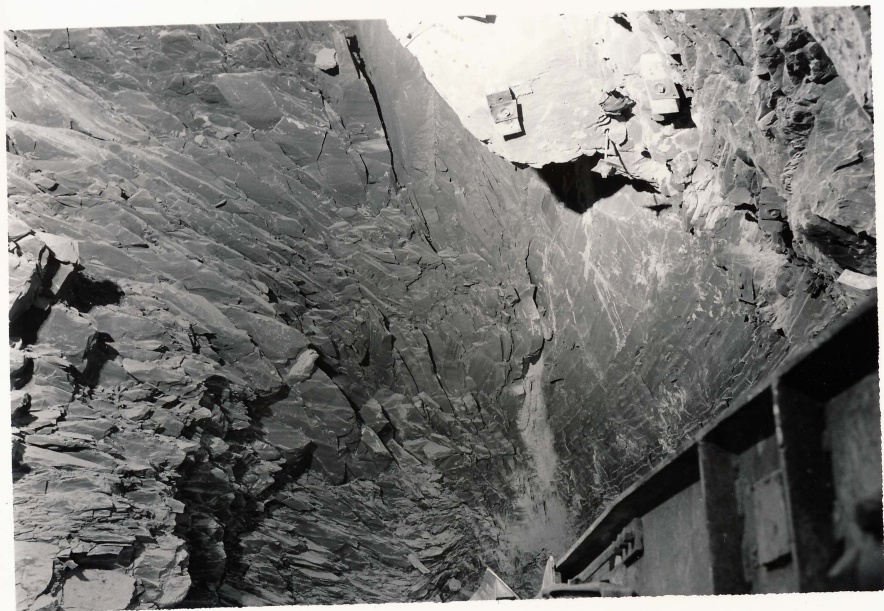
Photo 7 ↑ mn-03A-046

Photos 7-12 Roof fall caused by pillaring. Mining machine trapped by fall.

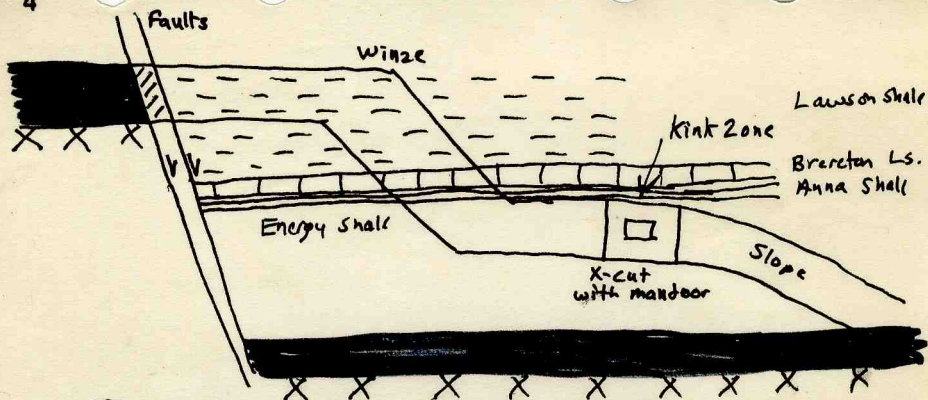
11. Severe cutting as shown, into base of Anna Shale. Contact Anna to medium gray Energy Shale is very sharp. North-south cutting or "kinks" are typical

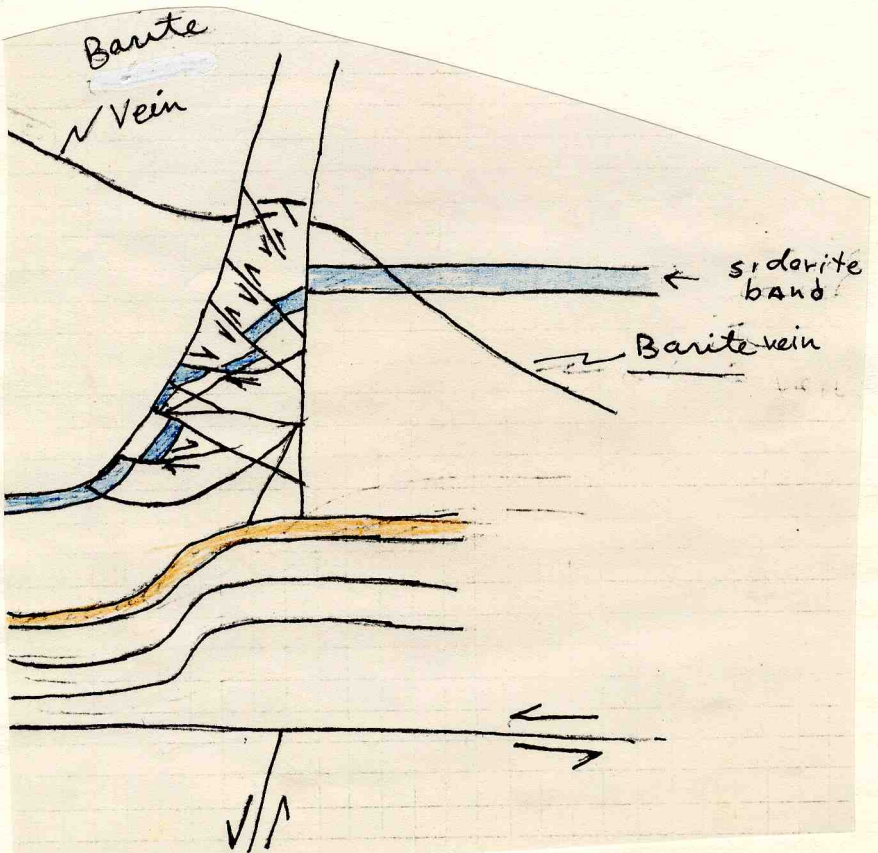
Summary drawing of locations 2+3:

1. Small N-S slip in Lawson shale. Mylonitic and calcite vein. Dips W at 70° .
2. N-S slip - Dips W - offset by horizontal shear. Throw approx. 1'.

3. Highly fractured $\frac{1}{2}$ foot fault/monocline. Down to W.

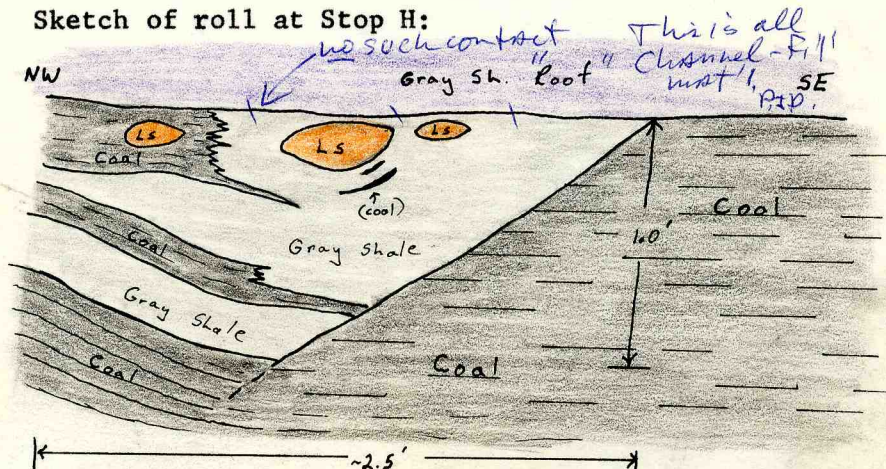
Sketch of roll at Stop H:

Stop H: Exposed roll in rib. We have tracked this NE trending roll across three entries and this is the best exposure. See sketch. The roll is about 3-4' wide and displaces about one foot of coal at its lowest point. The right side of the structure is terminated by a slip fracture about 2.5' in length. The coal along this fault shows no signs of drag, the banding is terminated sharply. The roll materials consist of mostly a gray shale (Energy?), some bright-banded coal, and a bastard limestone. The shale is not very different from the roof rock. The coal in the roll interfingers with the shale, and shows a curving, or bending, of the coal laminations(bands), especially near

the base of the structure. Several thin stringers of coal are isolated within the shale. The bastard limestone is a medium gray to med dark gray micrite containing numerous fossil shell fragments. Although very argillaceous, crystals of sparry calcite are in evidence. There seems to be no preferred orientation to the shell fragments. The blocks of limestone are isolated within the shale or within the rider coal. No bedded ls is visible.

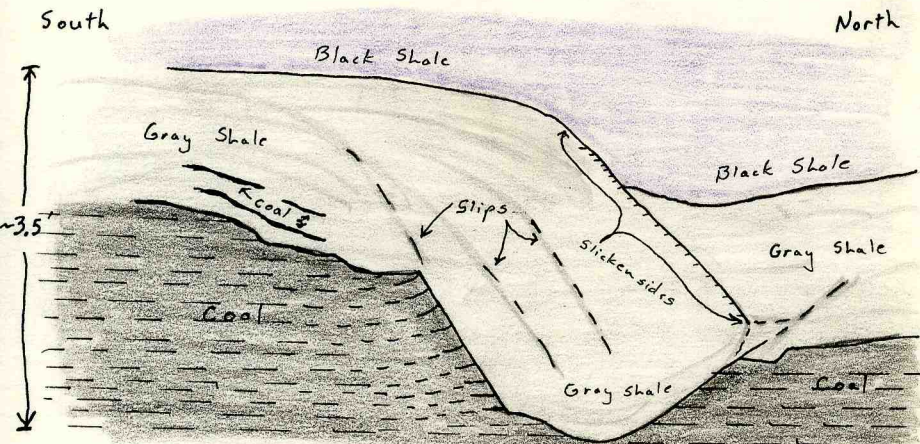
Stop P: (one entry west of Stop Q) Exposed gray shale roll on rib. Conditions are similar to those at Stop Q, black shale roof, eroded coal, and deformed gray shale roll with coal stringers. There is a noticeable bending of the coal lamina (banding) where they encounter the roll. They are nearly horizontal near the bottom of the roll, but tend to curve, or bend upward near the top of the seam. As before, much of the contact between the roll material and the roof rock is slickensided. Much of the gray shale has weathered yellow. A sketch of the structure follows:

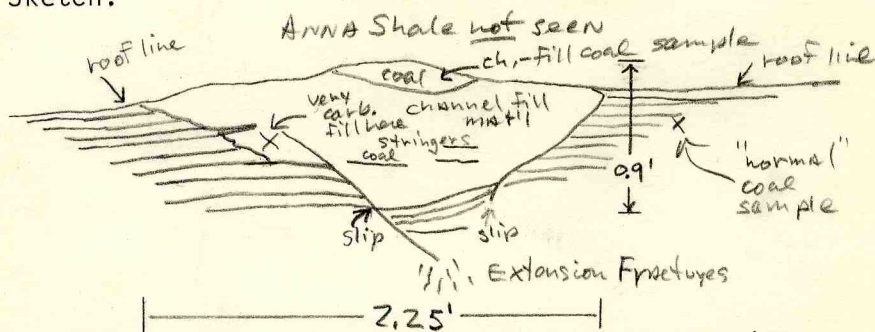
Site C. Erosional channel ("roll") cut 0.9' minimum into Herrin; coal ball under it (O.B. 26-A-4) sampled. Channel-fill material is weak shale (sulfates have weathered out) with coal stringers and probable Allochthonous coal capping the fill. Expected Anna roof not seen and exposure laterally ends in top coal as well. Top coal (-A-2) and coal above fill (-A-3) sampled. Sketch:

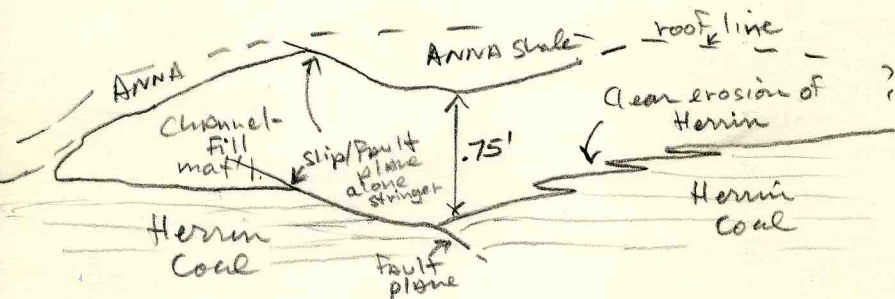
Site D. Deepest point in very wide "roll" (erosional channel) showing clear erosion of Herrin peat

here, but totaling less than a foot. Several low angle (about 20° dips) faults in channel-fill material, several following coal stringers. Sketch from N. rib:

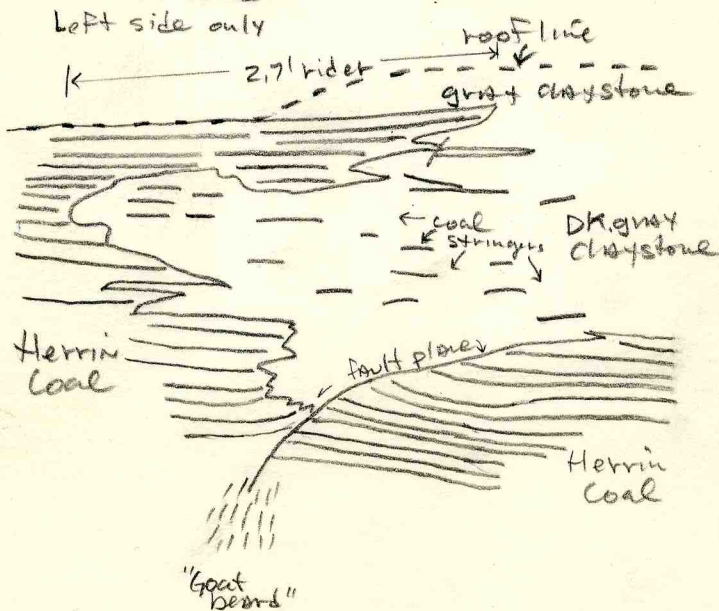
G. Found linear "roll"-thought it might be of deformational origin, but no roof (certain) or tidal material was seen. ~~Subsequent exposures at H (where tidal material was seen).~~ Subsequent exposures at H (where tidal material was found) and at L & R confirm this as an erosional channel. Sketches:
