February 15, 1978

Notes by John Nelson in mapping with John Popp, Bob Bauer, and Roger Nance.

FREEMAN UNITED COAL MINING CO. CROWN MINE II

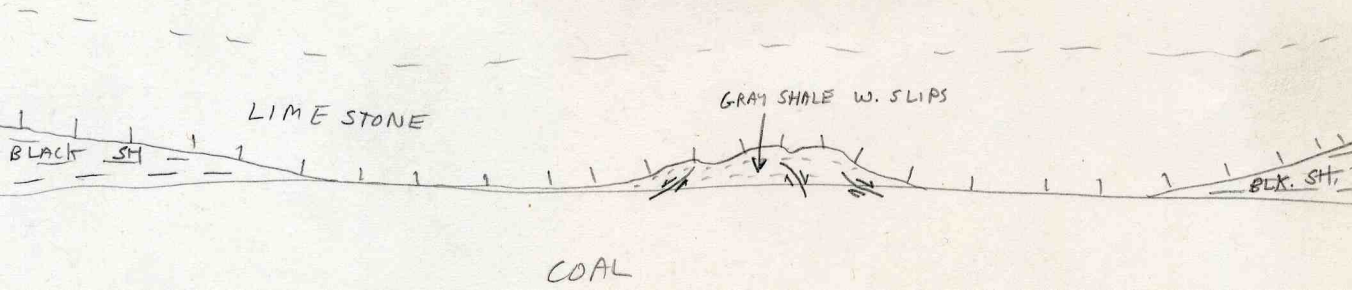
Stop 22
Schematic cross-section

22.) Pod of gray shale about 20 feet in diameter completely surrounded by area of limestone roof about 80 feet in diameter. Gray shale is directly overlain by limestone with nodules; the Anna Shale is absent. A similar pattern was also noted in the 5th-7th Main East near the 1st Panel (see compilation map).

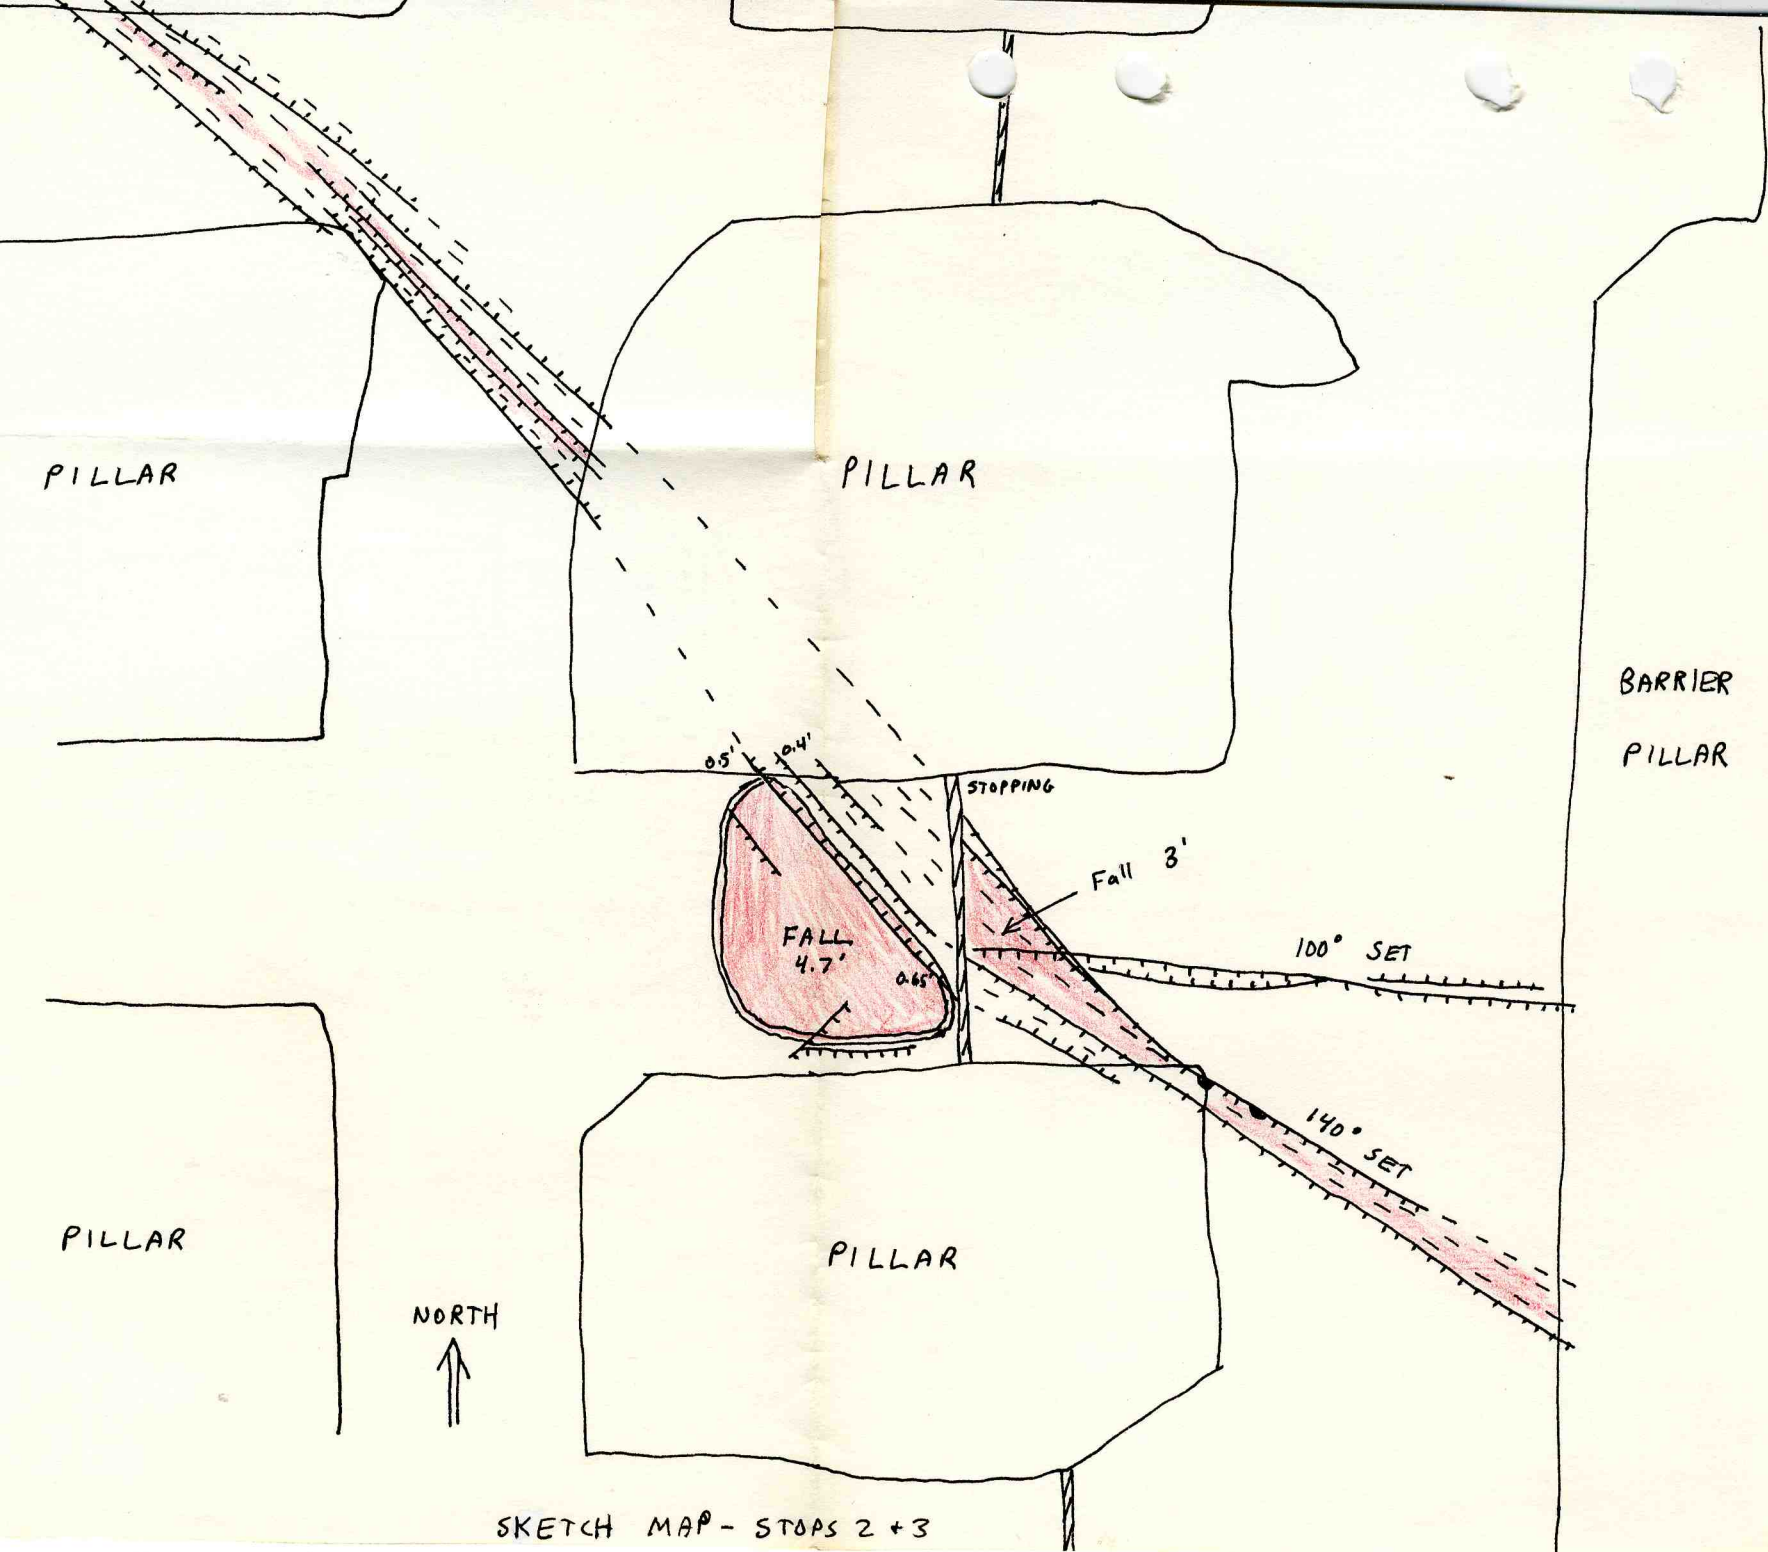
2.) Fractured area. See sketch map (over; also includes Stop 3).

Two sets of fractures are present. The more prominent trends 140° and the other about 100° .

The 140° set consists of multiple closely-spaced high-angle fractures and small faults in a zone about 5 feet wide. Near the crosscut the zone appears to widen as the fractures diverge. Several faults have displacement on the order of several inches, mostly downthrown to the southwest. The fault planes tend to curve in dip direction and have prominent vertical slickensides. There are no indications of horizontal movement.

One prominent fracture, marked with a clay dike symbol on the sketch map, displays "false drag", convergent bedding and steepens downward in typical clay dike fashion. However, no clay filling is present.

There is slight water and gas seepage from the fractured area along the east rib. A small roof fall has occurred along the fracture set.

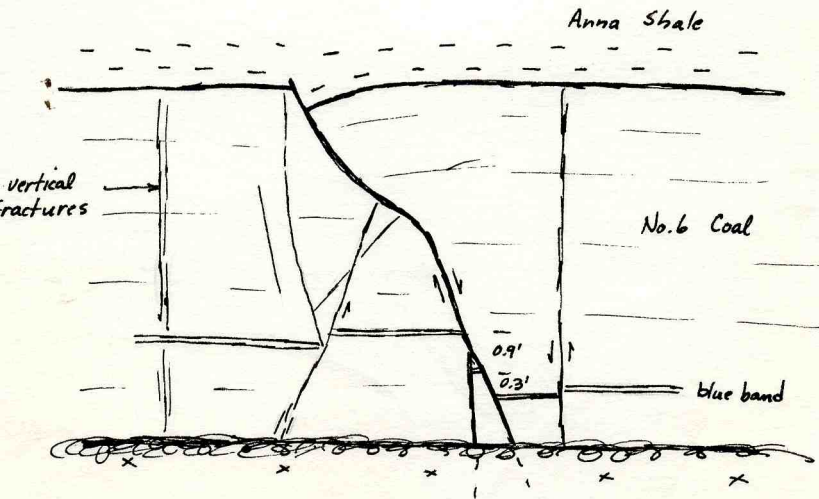
Booknote 3

Northwest facing view of the rib, looking at the corner of the ~~or~~ intersection.

This sketch sort of illustrates the multiple nature of the fault zone; rather than being one fault, this zone appears to have one slightly more prominent fault with one or more adjacent faults. The coal is fractured strongly in the vicinity.

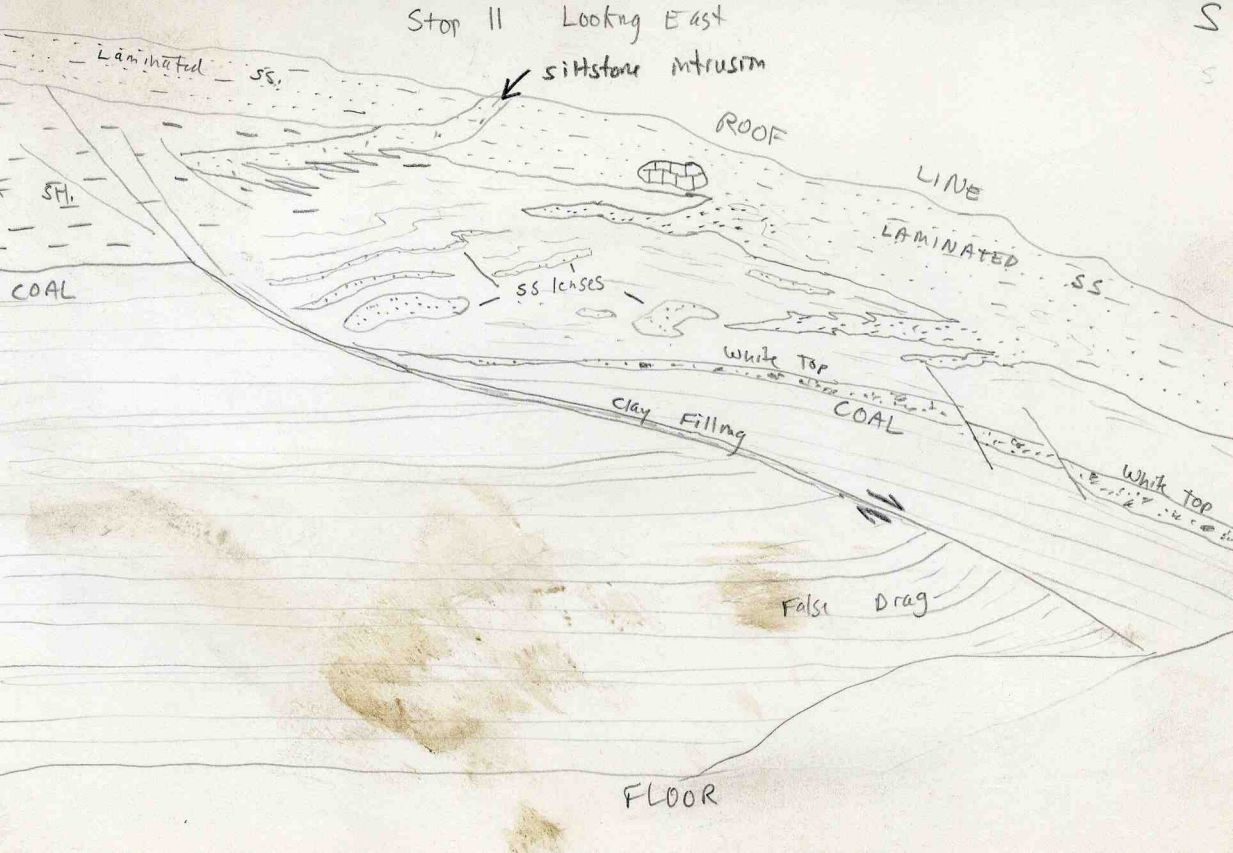
Stop 11 Looking East

I believe the interfingering of shale and sandstone is secondary and was contemporaneous with faulting. The sandstone appears to have been not at all lithified, but the shale must have been laminated and partially indurated. As the hanging wall slid down the fault plane, the sand was squeezed between layers of shale. The picture was later altered by final compaction.

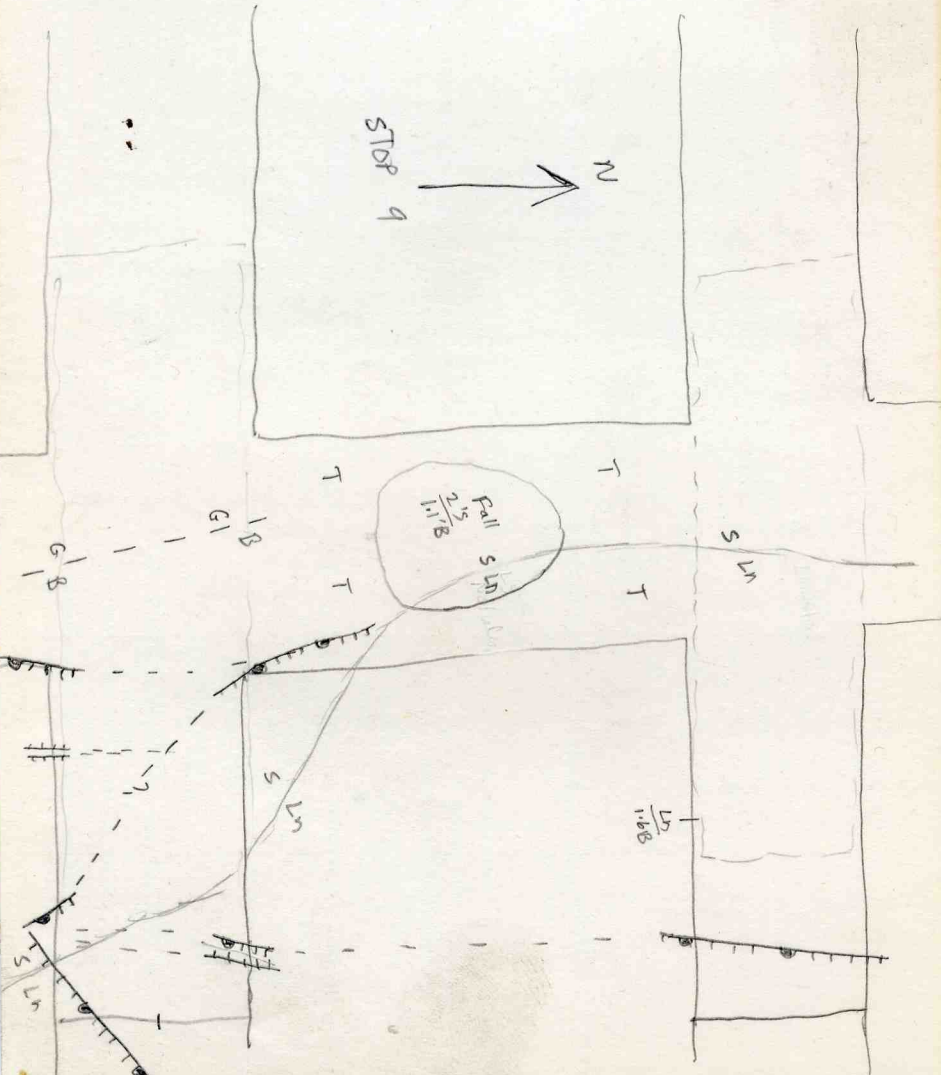
STOP 9

9.) See sketch map (over). Very complicated area; cut down for overcast. Numerous large slips and clay dikes are present. It is very difficult to link them from one side of the entry to the other because the roof has been cut down and it is well known how rapidly the

At the east edge of the cut, near the mandoor, the immedaite roof is a mixture of "white top" and Anna Shale with clay intrusions, overlain by thin nodular limestone. The limestone pinches out to the west and sandstone directly overlies the black shale. The sandstone is shaly and thinly laminated, and does not bear water. Occasional limestone nodules or concretions occur along the lower contact.

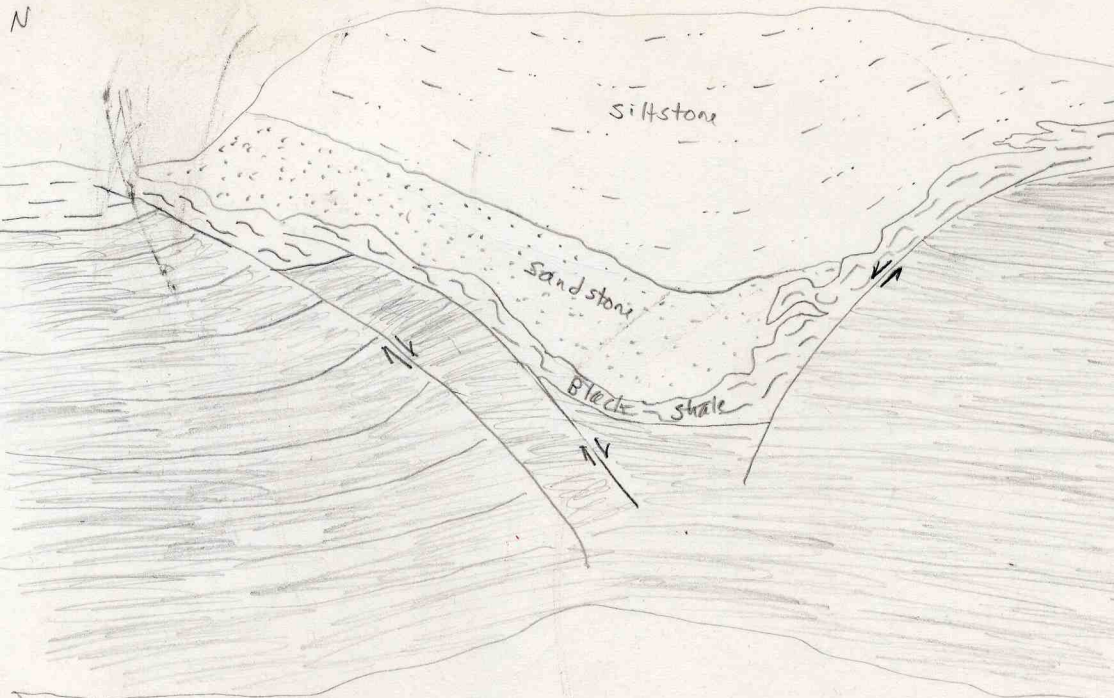
stop 3 - East Rib

to movement or compaction and not to erosion. Small lenses and veinlets of sandstone are found within the Anna Shale.

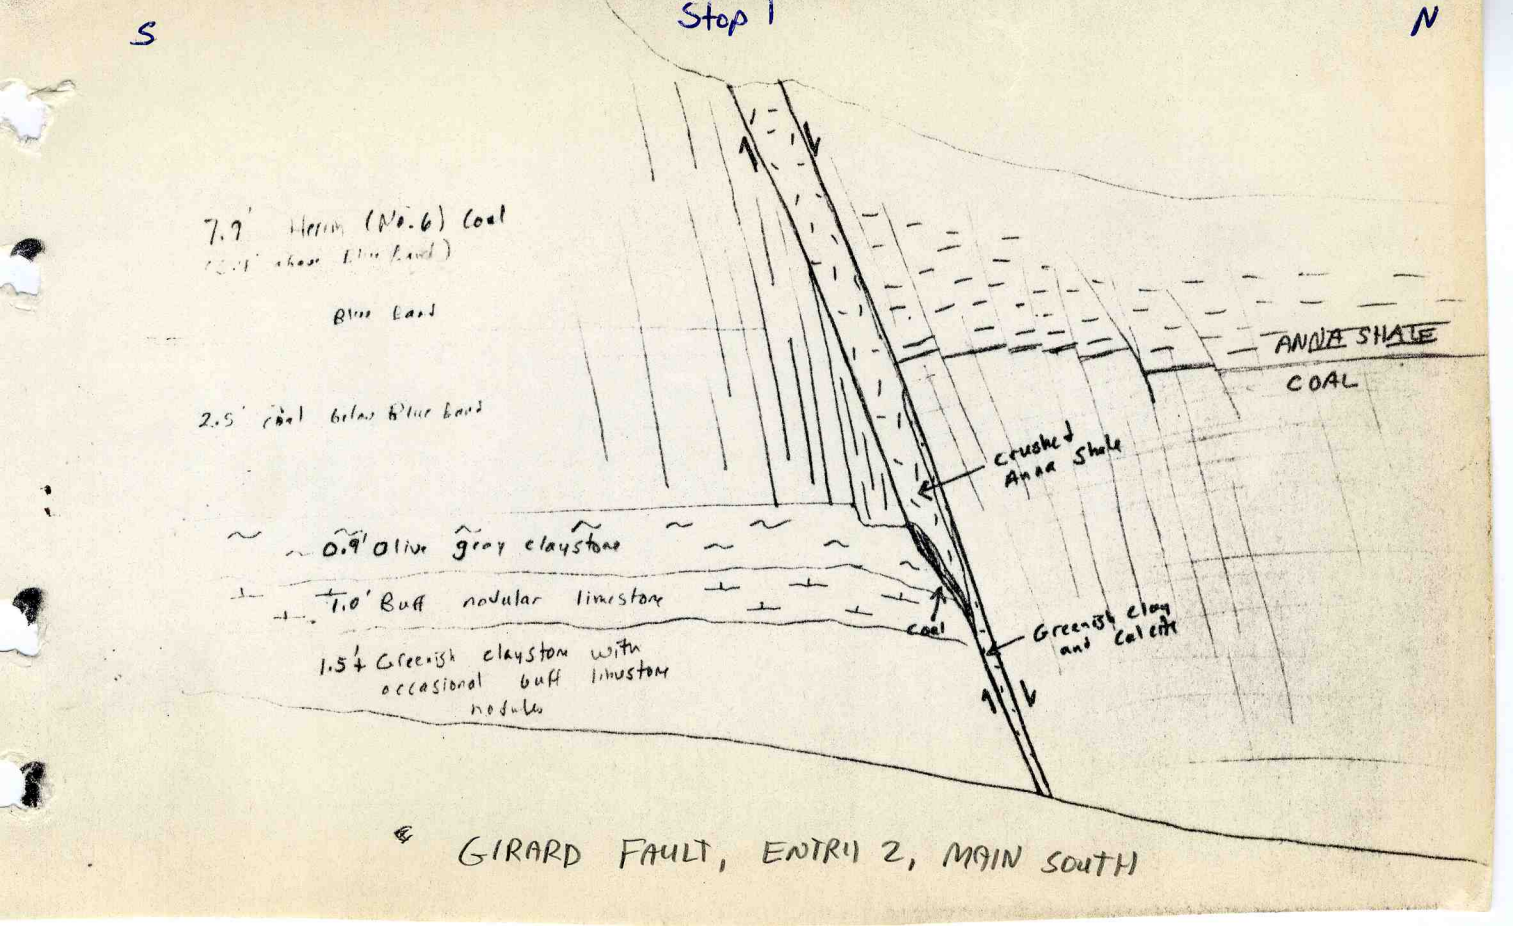
GIRARD FAULT, ENTRY 2, MAIN SOUTH

(B) Reversed movement along the fault. Difficult to explain mechanically. Also there are no good indications such as compressional folds for reverse faulting.

(C) The fault formed by extension and an open void was produced, and Anna Shale dropped along the fault plane by the force of gravity. This seems the most likely explanation.

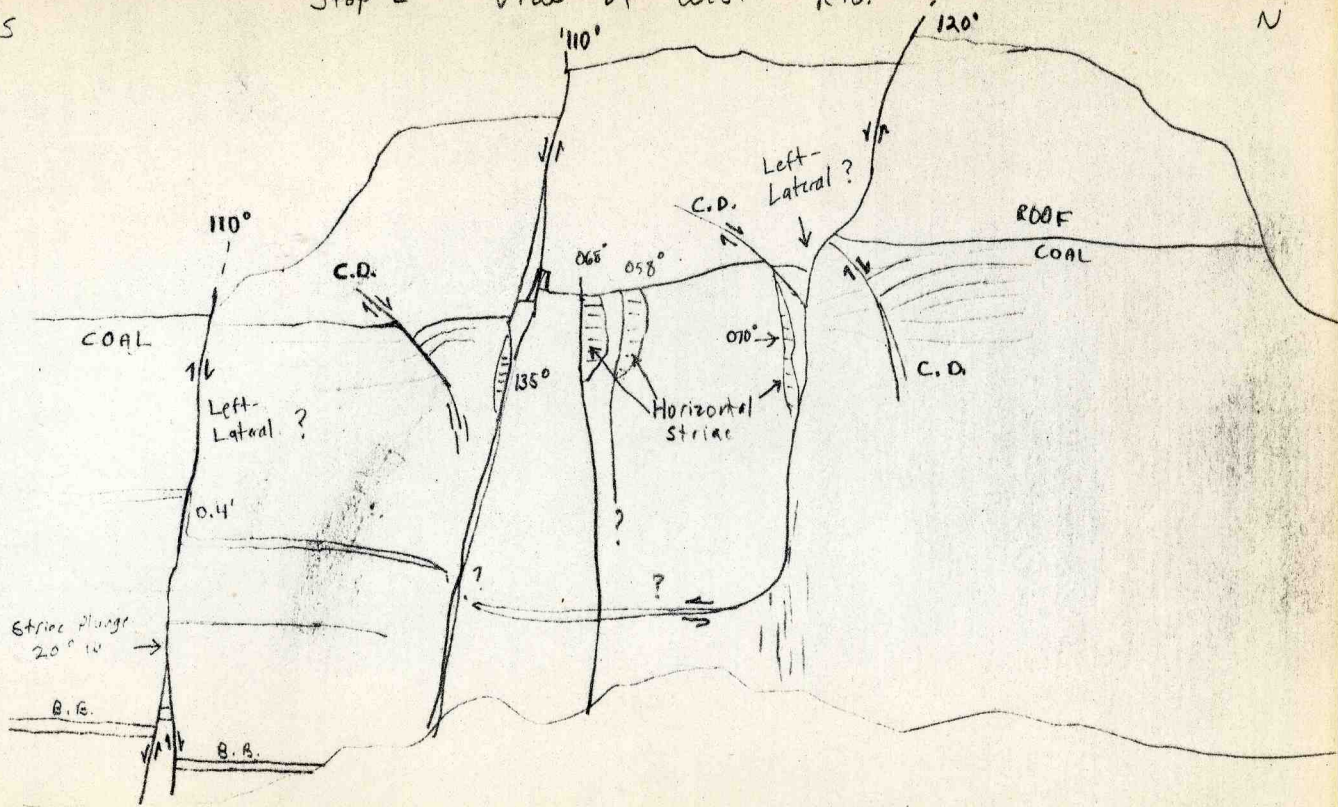
C.D. = Clay Dike-Type Fault
 Directional Trend of Strike Slip Faults Indicated

The east rib has heavy rock dust and is very high; therefore I did not attempt to sketch it. Three main fault planes are present. As noted on Jan. 10, a clay dike-type fault appears to have been displaced about 5 feet in a left-lateral direction across the entire fault zone.

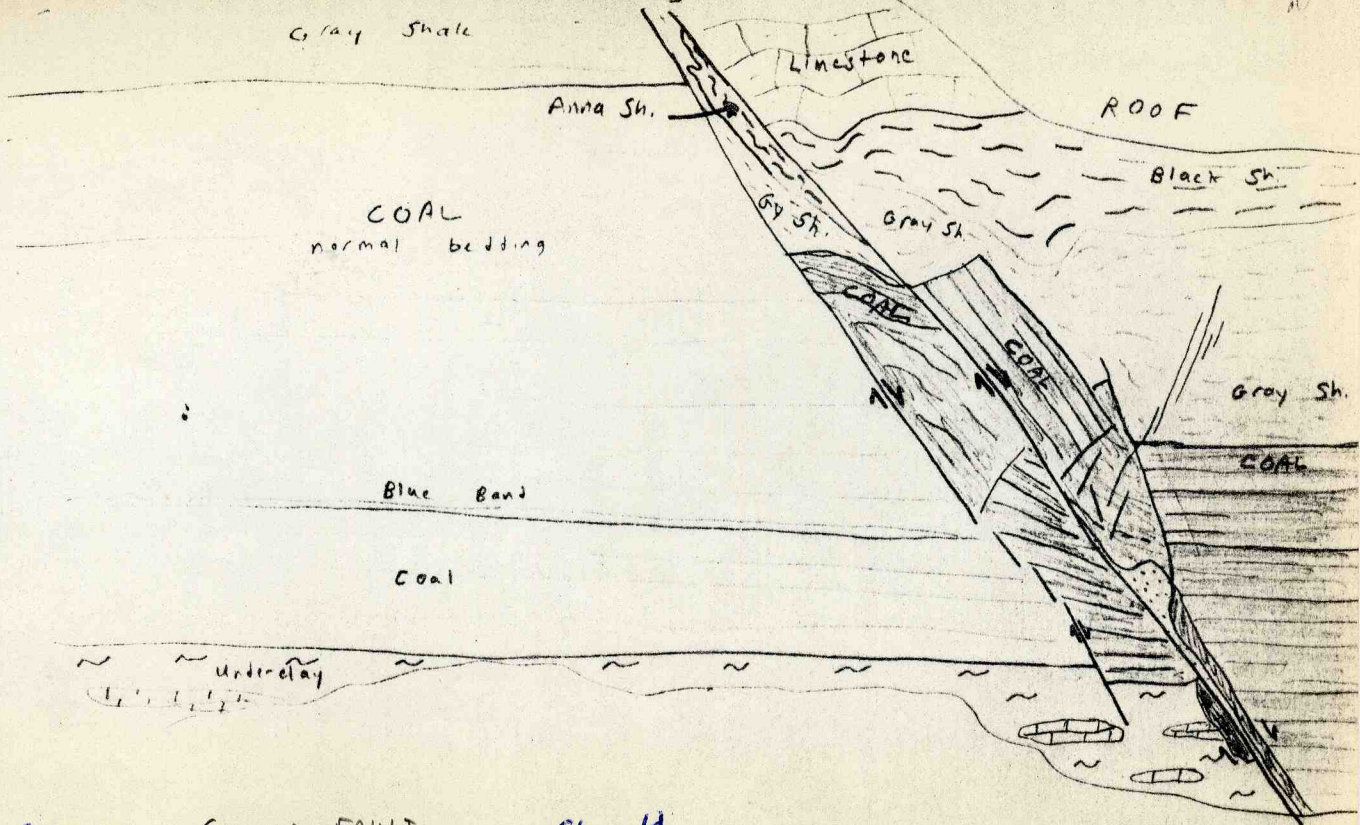
GIRARD FAULT,
ENTRY 3, MAIN S.

4.) Sketch of normal fault on the west rib of the 3rd Main South. See Krausse for notes and sketch of east rib.

The fault zone is narrow at the top of the entry

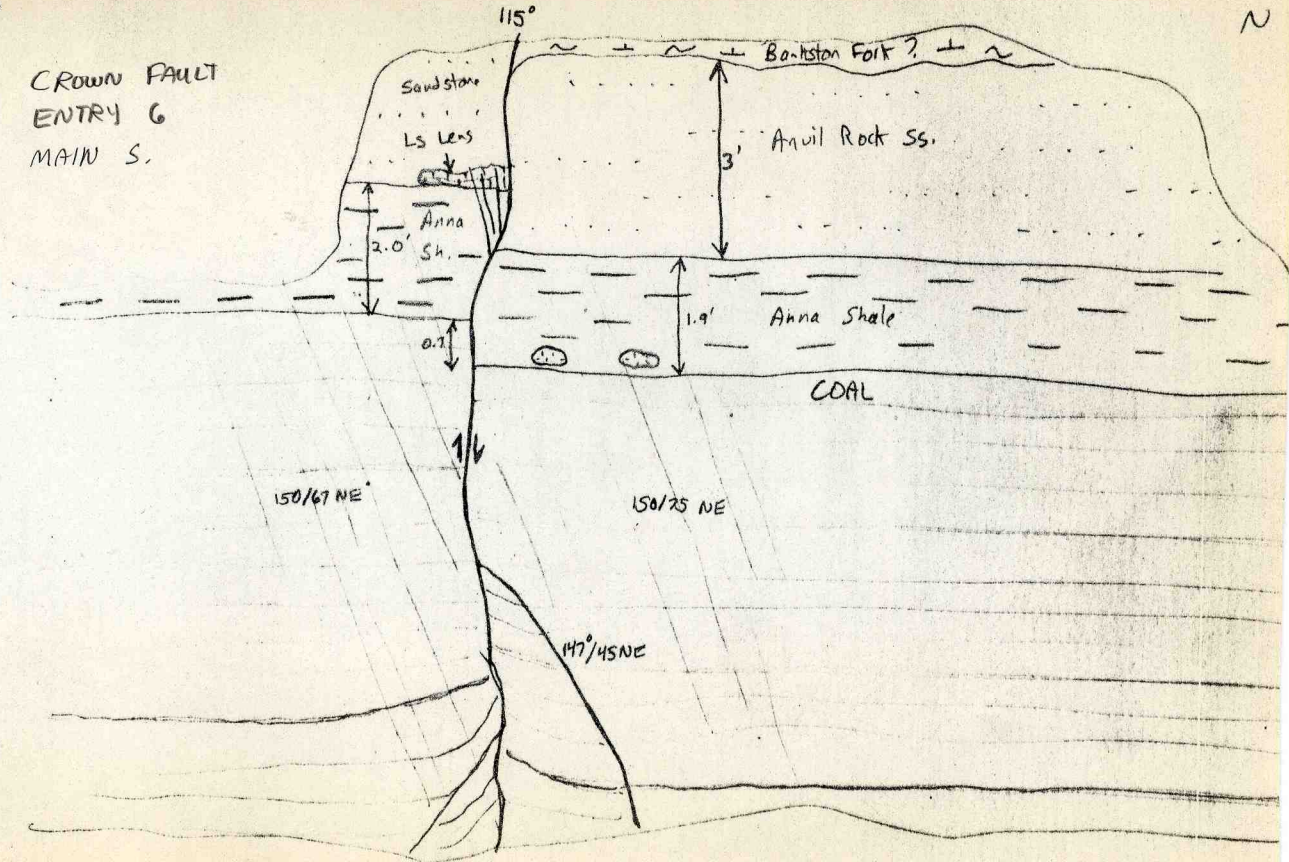
CROWN FAULT
ENTRY 6
MAIN S.

structure (sketched by John Popp on earlier visit). The coal is slightly lower on the north side of the graben, but the black shale/sandstone contact is approximately even across the fault zone. Thus, the black shale is thinner south of the fault than north of the fault. It is not possible to show how much if any lateral displacement has occurred.

The east rib also shows fractures trending 150/75 NE branching off the main fault. A couple of these have indefinite horizontal slickensides.

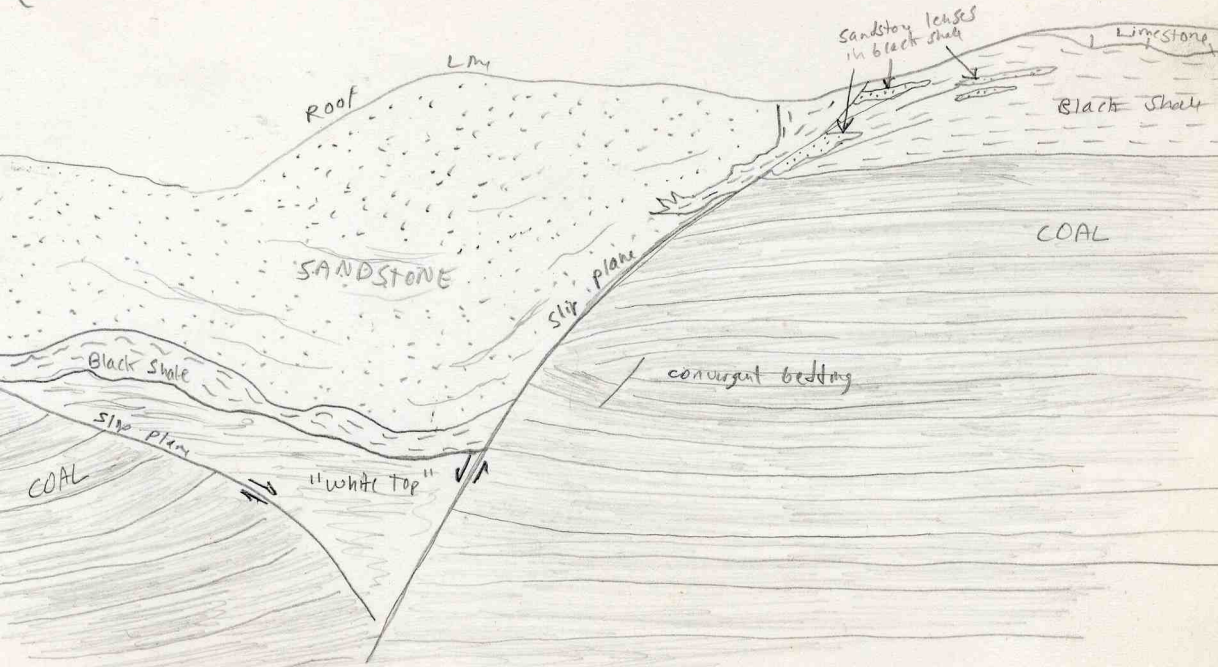
Stop 5

South end of sandst. roof area - east rib
About 8 feet

along the east rib, but not enough to hinder mining much.

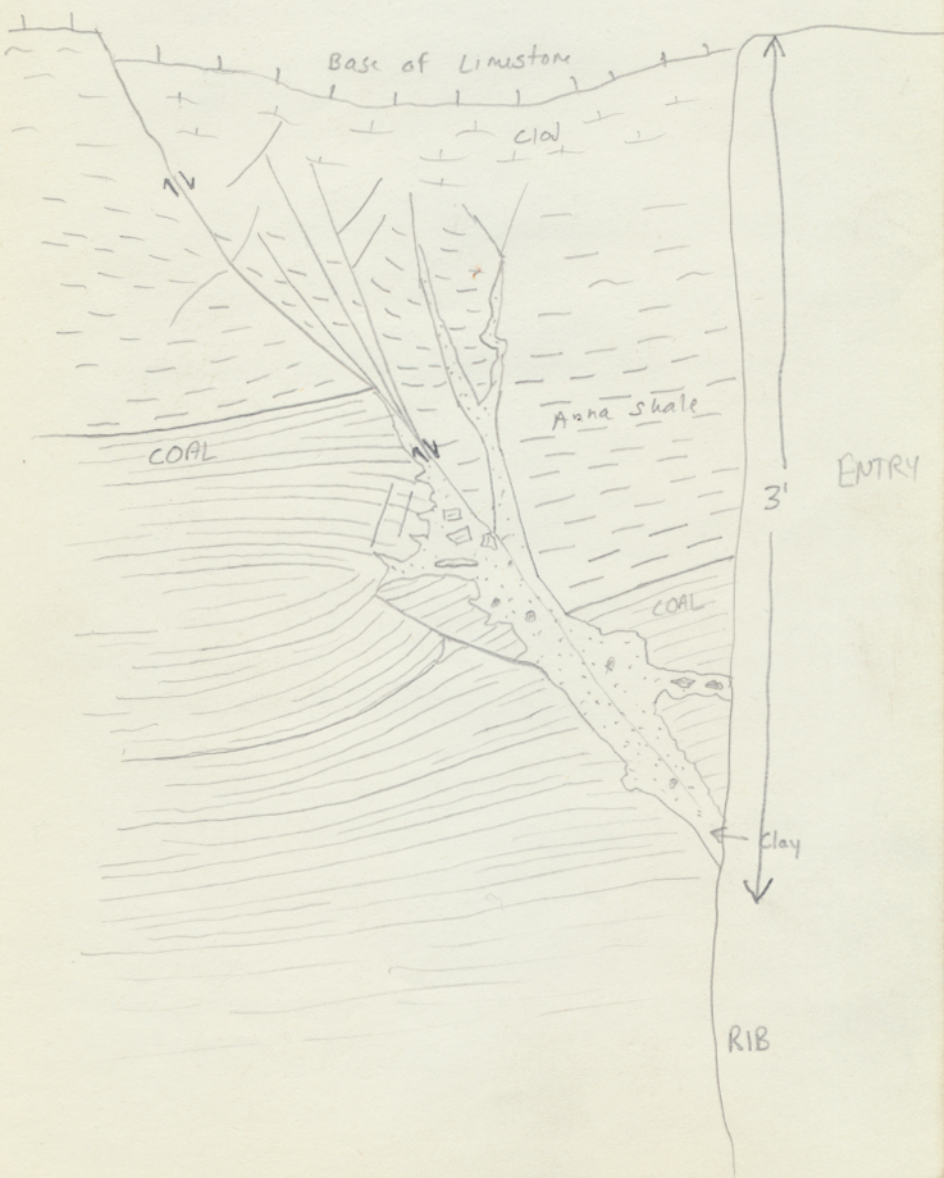
Stop 14
clay Dike - Looking North

The limestone forms an elongate bulge whose axis parallels the clay dike and lies along the trough formed by the slip. It is a real downward fold or bulge, not a graben; there is almost no displacement of the limestone along slips.

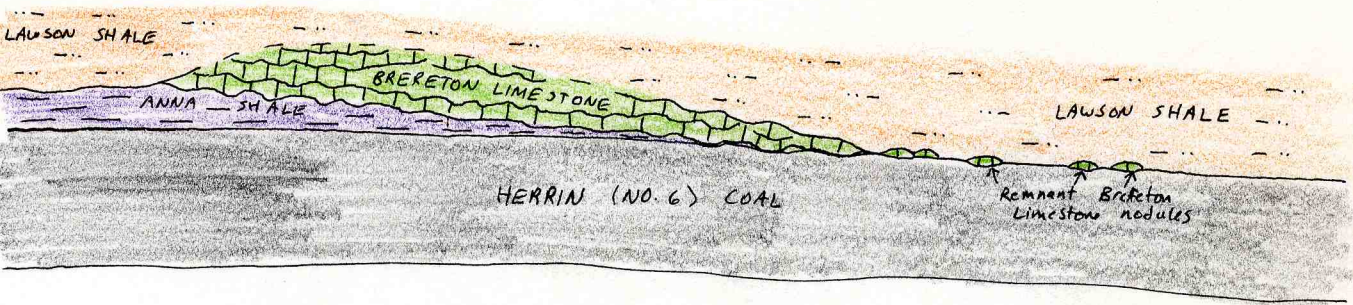
STOP 19
GENERALIZED VIEW

Limestone roof is intact through the intersection and the Lawson cannot be seen there. But on the southwest corner of the intersection the limestone is missing, and Lawson Shale directly overlies about half a foot of Anna Shale. The contact is knife-edge and scalloped.

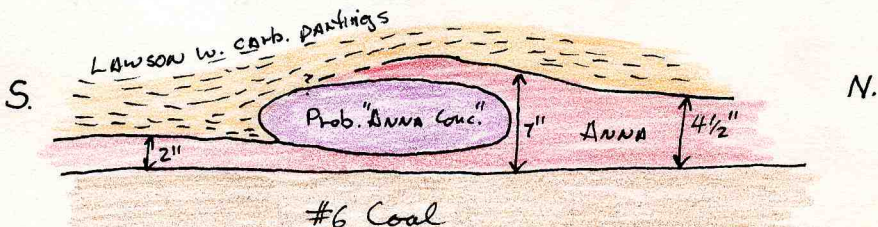
F. Area of variable th. Anna roof with Lawson sh. above. Lawson characterized by abundant plant parts (here oxidized yellow). At this point is a clear case of differential erosion of the Anna, i.e. on the S. side of an Anna concretion. Sketch; (w. rib.)

Another a/c in roof 6' E. shows Anna striped away from top and SE side. See sample B-6
