Sahara Coal Co. Mine No. 22
Underground Mine

SAHARA COAL COMPANY MINE NO. 22 SALINE COUNTY
February 26, 1981

Notes by John Nelson on visit with Steve Danner,
accompanied by Tom Fox from Sahara.

SAHARA COAL COMPANY - MINE NO. 22 - SALINE COUNTY
Highwall drift mine in Herrin (No. 6) Coal. Portal
in NE $\frac{1}{4}$ SE $\frac{1}{4}$ SE $\frac{1}{4}$ Section 22, T. 9S, R. 5E. Notes by
John Nelson on visit with Steve Danner, D.K. Lumm
and Terry Guest (Sahara). Carl Griffiths is mine
superintendent. *June 9, 1982*

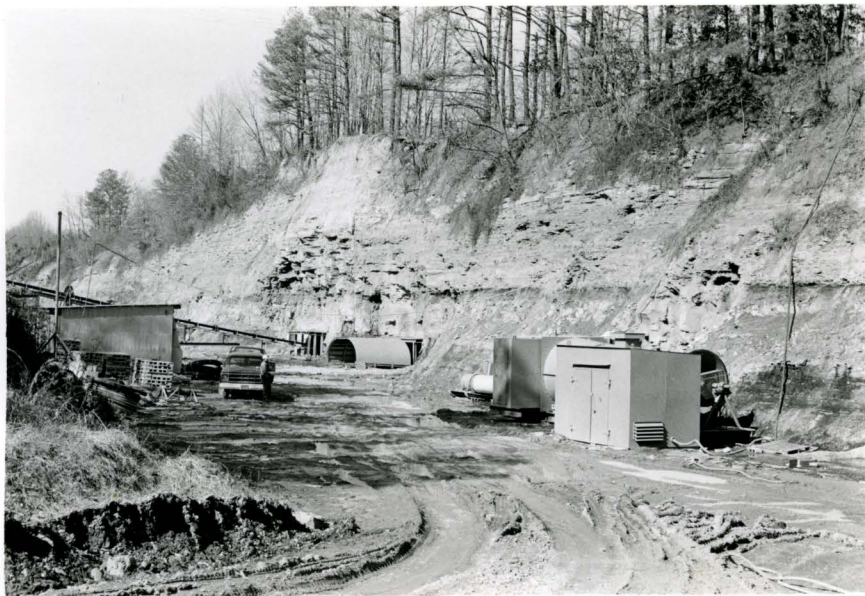
M-31-001.HB

View looking westward along highwall at portal of Sahara No. 22. At right is fan at intake drift. Near center is travel entry, with tin roof. Just beyond it the conveyor belt leaving the mine can be seen.

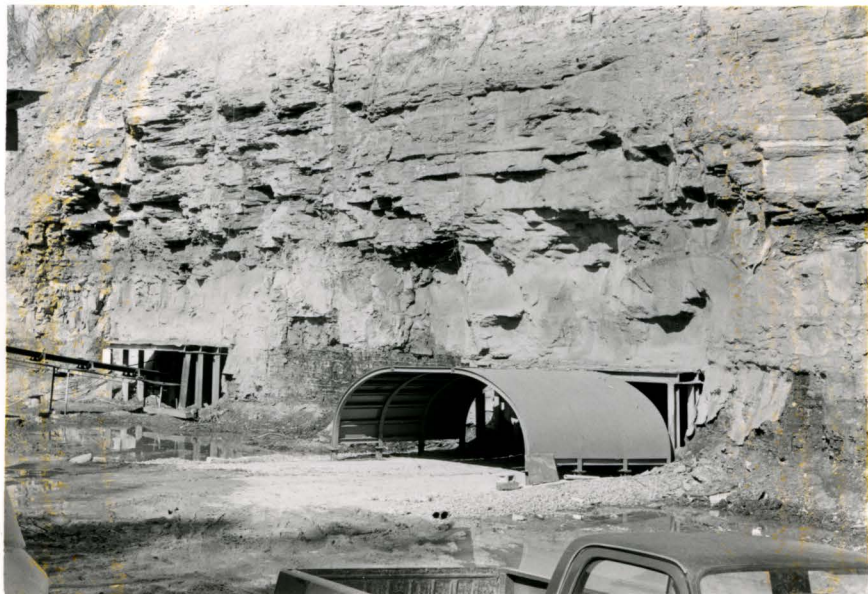
m-31-002.418

Closer view of portals of travel entry (right)
and belt entry.

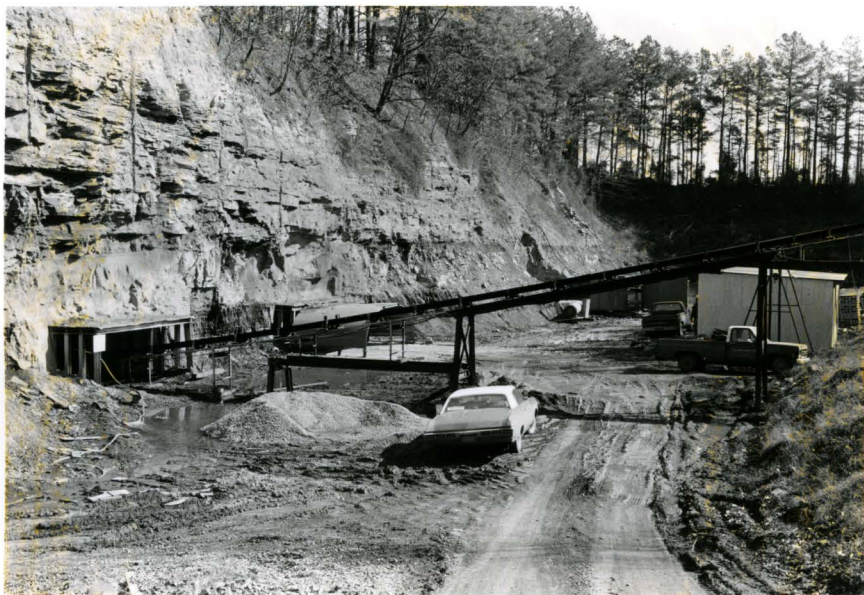
ma_31.003.tif

View looking eastward along highwall with belt entry at left.

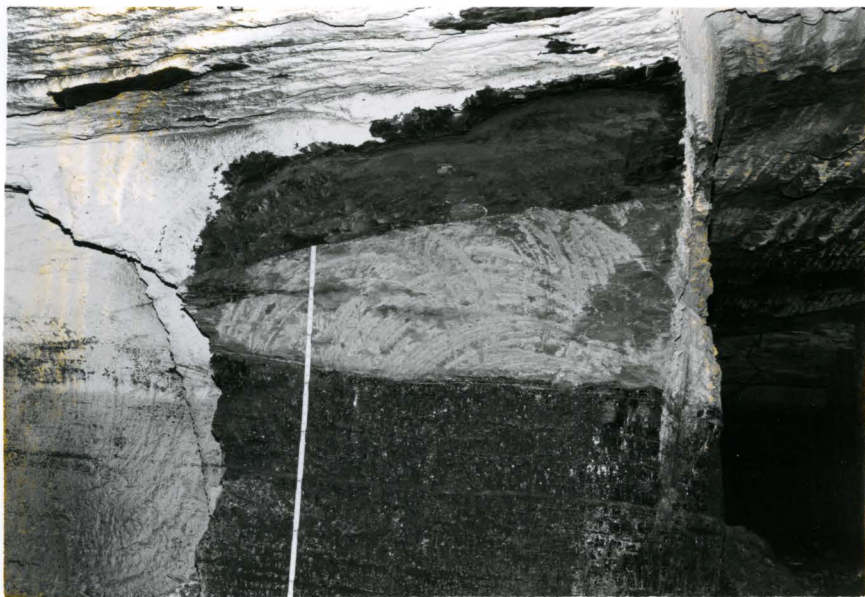
mn-31-004.tif

Margin of a lens of Energy Shale in Sahara Mine No. 22. Base of the black Anna Shale is at top of ruler. To left of ruler stringers of coal splay into the Energy Shale.

Lenses of Energy Shale occur in the roof and cause trouble in mining. One was observed near the faces in Entries 1, 2, and 3 between Crosscuts 45 and 47. The lens has abrupt margins (hidden by rock dust) and thickens to maybe 8 feet near the center. The Anna Shale and limestone ride up over the Energy Shale, though M.D. Brantley (who has a copy of I.M.N. 72, the "roof study") told us that the limestone tends to be missing above the gray shale. Nearly the full thickness of Energy Shale was mined with the coal, and bottom coal was left in place; this to avoid miring the equipment in soft muddy bottoms. Quite a bit of water is coming out of fractures in the roof. This is a shallow mine.

The Energy Shale here, as in many other mines, is medium to dark gray, poorly bedded, faintly laminated to non-laminated, smooth, slightly carbonaceous and is sensitive to moisture; although this mine is young enough that slaking has not yet taken its toll.

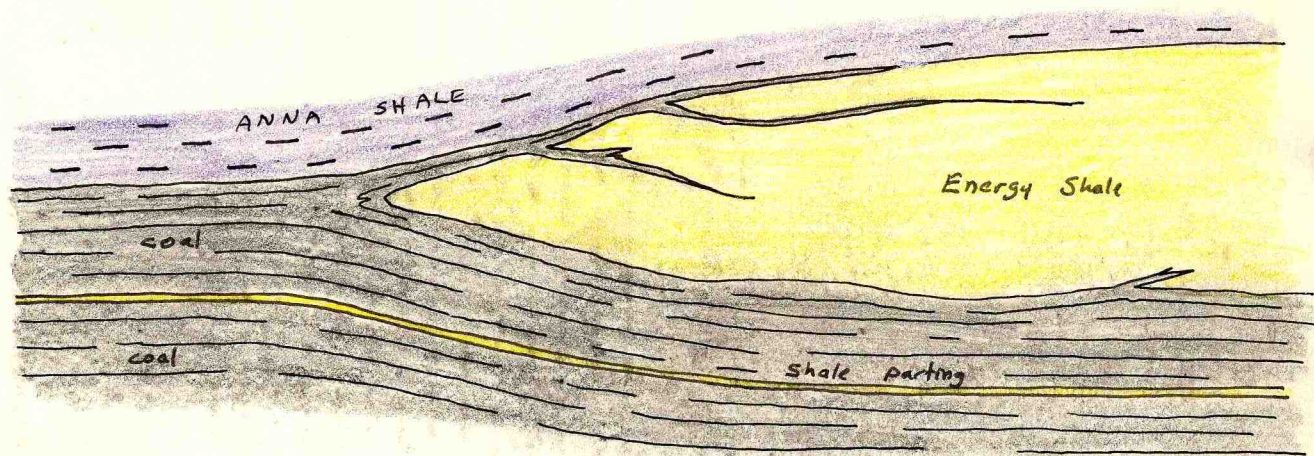
Sketch showing splitting of coal at edge of lens of Energy Shale on west rib of Entry G, at crosscut 15, Sahara No. 22.

At the southern margin of this lens is a clean exposure showing that the upper layers of the No. 6 Coal split away from the main seam and ride up over the Energy Shale for a short distance. The coal "rider" follows the contact between the Anna and Energy Shales. This shows that the Energy Shale was deposited contemporaneously with the upper layers of the peat. Farther into the lens, a thin (0.2') layer of argillaceous, coarsely fossiliferous, pyritic "bastard limestone" occurs at the top of the Energy Shale just below the Anna Shale.

The 6th Entry (westernmost) also was not mined beneath a lens of Energy Shale, between Crosscuts 15 and 19. Again the coal is seen to split and overlap the margins of the lens of gray shale (see sketch). The shale contains lenses of hard pyritic limestone up to 0.5' long and 0.2' thick.

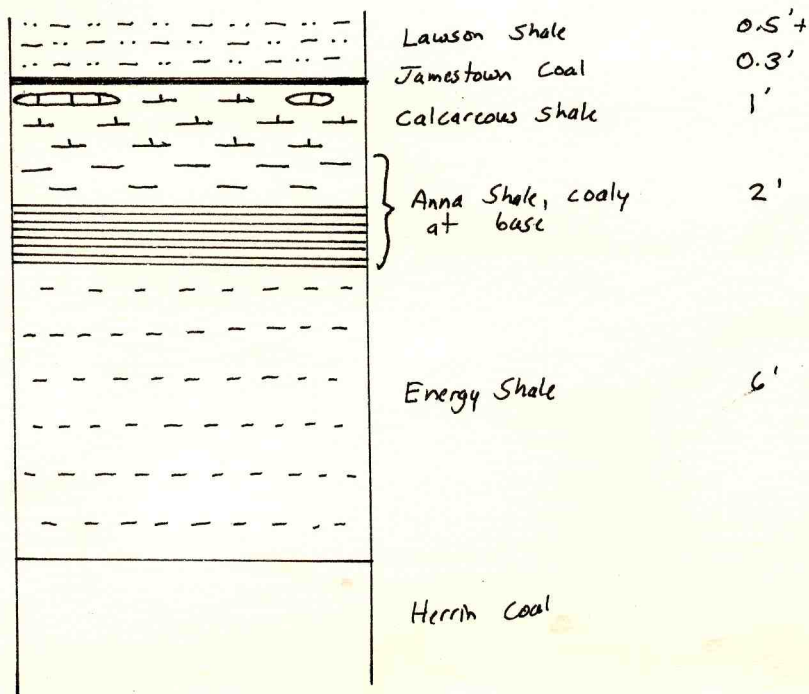
1.) No 3 Entry (haul road) of 2nd Main North near Crosscut 3: Large lens-shaped body of Energy Shale forms the immediate roof of the coal. The shale is so difficult to hold in the roof that the miners chose to mine the shale, leaving the coal in the floor. Thus the entry rises abruptly through the lens of shale. This condition, which we saw on earlier visit last year, sometimes is reported as "rock in the coal".

The section of strata exposed here is shown below. The Brereton Limestone pinches out above the thick Energy Shale. The Anna Shale is black, hard, and fissile, containing numerous thin parallel laminations of coal in the lower part. The contact of the Anna Shale to the Energy Shale is sharp. Above the Anna Shale is about a foot of dark gray calcareous shale, with coal streaks and lenses of brownish limestone. The Jamestown Coal, about 3 inches thick, overlies this. The highest unit exposed is medium-dark gray micaceous siltstone containing abundant well-preserved plant compressions.

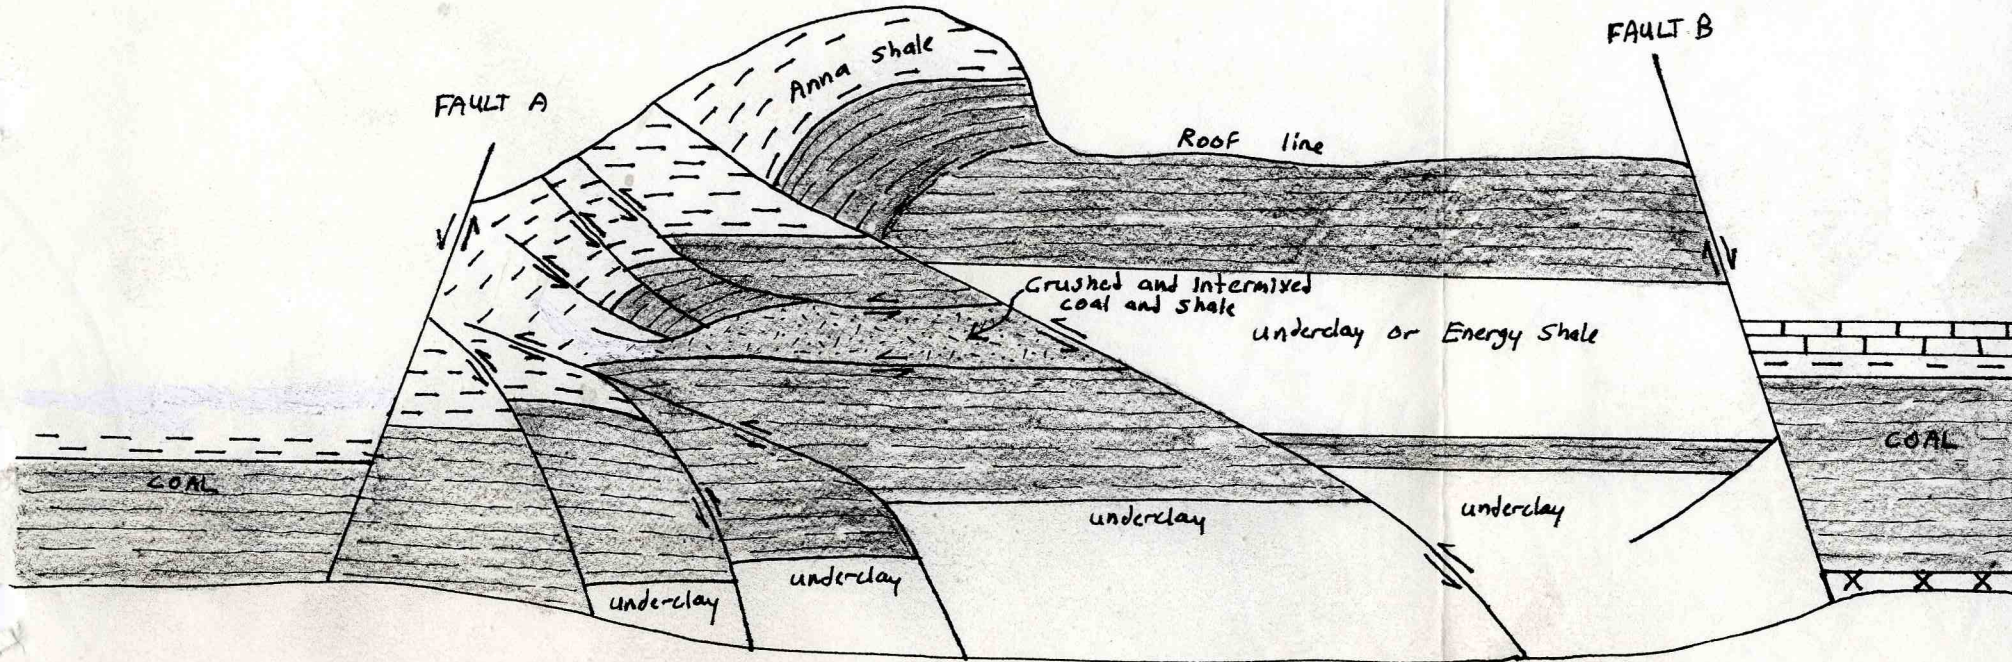
Cross-section of fault zone at Stop 4.

4.) Angled crosscut No. 15 between the No. 1 and No. 2 Entries: cross-sectional view of the entire fault zone (see sketch, over). The structure is amazingly complicated and it is impossible to do justice to it with a sketch. Many small faults and structures had to be left out of the drawing.

Basically there is a horst, about 30 feet wide, bounded by two high-angle normal faults (Faults A and B in the drawing). Fault A probably is the fault exposed at Stop 3. Faults A and B both trend roughly N. 30 W and dip steeply (almost vertically).

Within the horst is a great series of overlapping reverse faults and thrust faults whose dips vary from horizontal to nearly vertical. All of the larger faults dip toward the northeast but some small ones dip to the southwest. In places the strata have been strongly folded, by drag, and in some zones of horizontal movement coal and shale have been pulverized and intermixed. From the sketch it is apparent that several episodes of movement occurred, with older faults being truncated and offset by younger faults. I did not take the time to work out the sequence of events because this is rather a dangerous area.

My interpretation, based on my understanding of the mechanics of faulting in the Cottage Grove Fault System, is that the first action probably was normal faulting on Faults A and B. Continued movement along the main (master) faults of the Cottage Grove, north of the mine, then induced strike-slip movements on Faults A and B. These movements were such as to place the wedge-shaped block between the two faults under horizontal compression, with maximum compression perpendicular to Faults A and B. The compressive stresses resulted in thrust faulting and horizontal movements along the layers of the bedded rocks and coal.

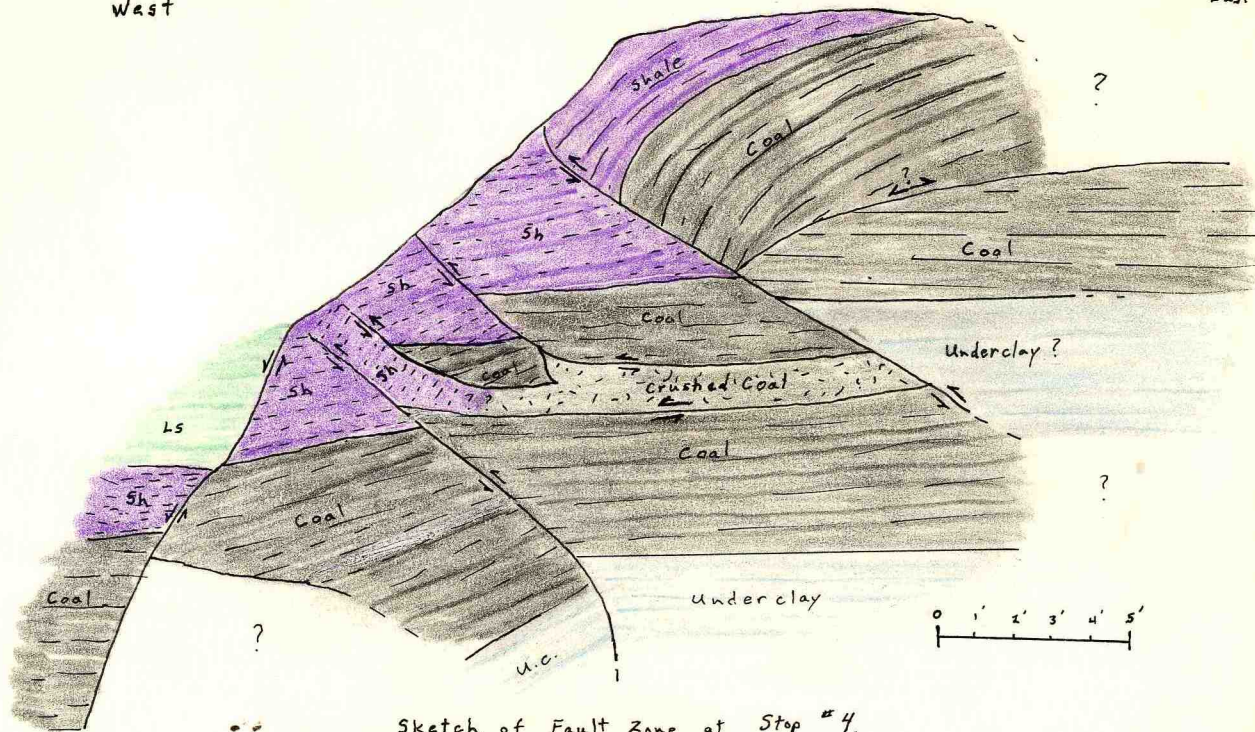
Sketch of Fault Zone at Stop #4.

This is the location which was reported to have "rock in the coal." A much more complex problem exists. Above the arch in this angled crosscut is a series of thrust and reverse faults within a 30 foot wide zone. These faults have displacements of a few inches to about 3 feet. The trend of these faults is to the NW; the dips onthese faults is to the NW; the dips on the fault surfaces varies from

Direct measurements and observations of the structures and lithologies could not be made for safety's sake; a significant roof fall with broken debris draping the arch made for dangerous conditions.

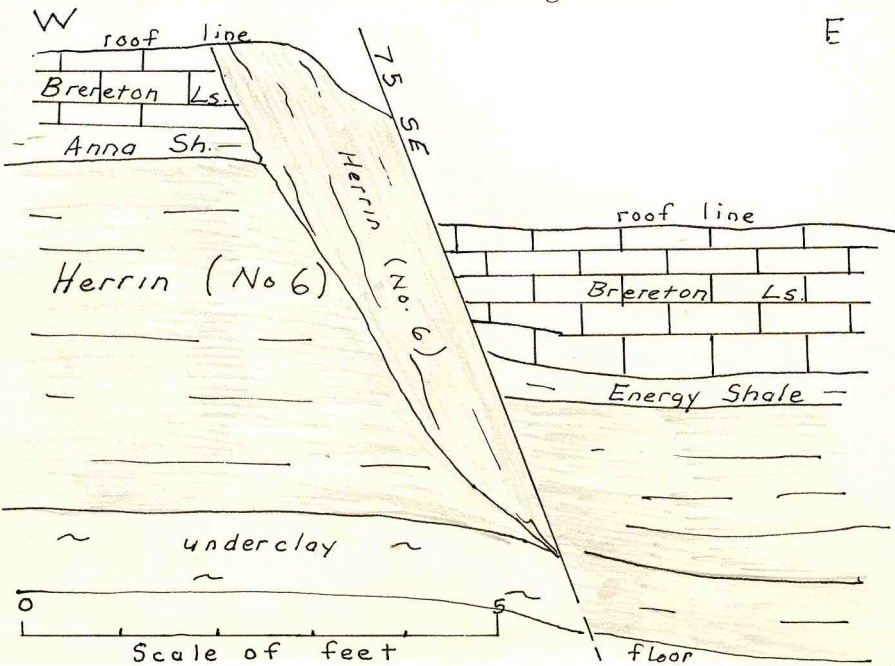
Cross Section View of south facing rib of crosscut is between Entries 2 and 3 looking north.

High angle normal fault trending N 30 W. with the downthrown side to the NE. There is approximately 3 feet of offset. The fault zone thickens from a few inches at the base to nearly two feet near the roof line. Nelson suggests the possibility of a strike-slip component on this basis. See his notes on this subject.
