Mine Index # 639

EL-B COAL CO. EL-BEN MINE NO. 2 LOGAN COUNTY

Heinz Damberger of the I.S.G.S. visited this mine several times in the latter part of 1968 in the course of a study of clay dikes or "horsebacks" in Illinois coal seams. He was accompanied on at least some of these trips by Ken E. Clegg of the Survey, and by Ronald Kern, at the time a graduate student in Geology at the U. of I. According to both Kern and Clegg, Damberger made numerous notes on his visits to El-Ben. These notes apparently are lost. Damberger was notoriously sloppy about filing his mine notes.

The following are photographs made by Damberger on several of his visits to El-Ben. These notes were found by Bob Ringler on 6/17/76, in a filing cabinet in Damberger's former office after Damberger had left the Survey. Also found in that cabinet was a ring binder containing more photos with captions, and notes and text relating to this and other visits. This notebook is now stored in the Coal Section Confidential Room (as of June 1976.) It is labelled "HHD, Clastic Dikes Ms."

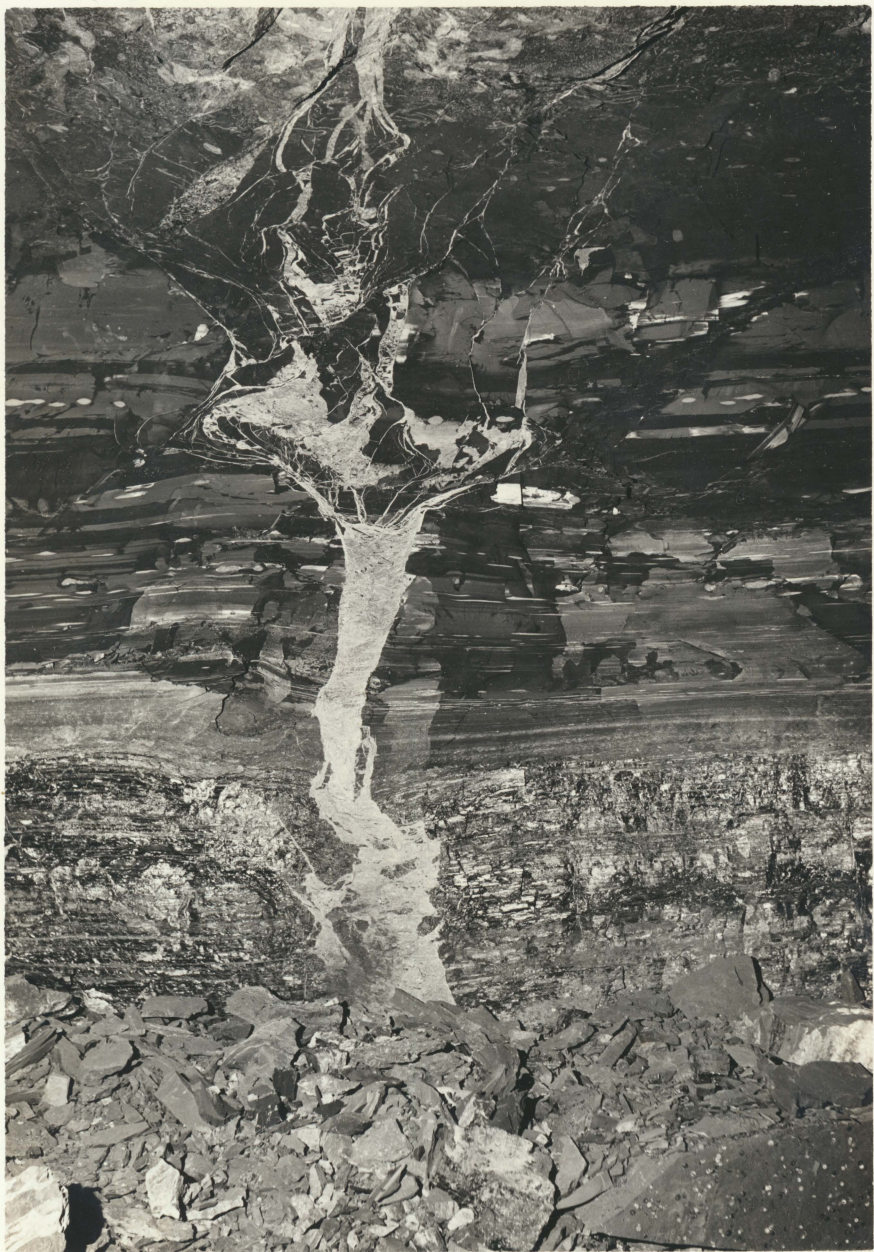
(Photo on next page) A large clay dike in the Springfield (No. 5) Coal and roof at the El-Ben Mine. The dike runs approximately vertical through the coal seam and about 2 ft. into the black shale roof. At this point the dike splits and diverges into many thin veinlets, forming a pattern much like the branches of a tree. Several of these branches converge higher up in the roof sequence, at the St. David Limestone Member (top center of photo.)

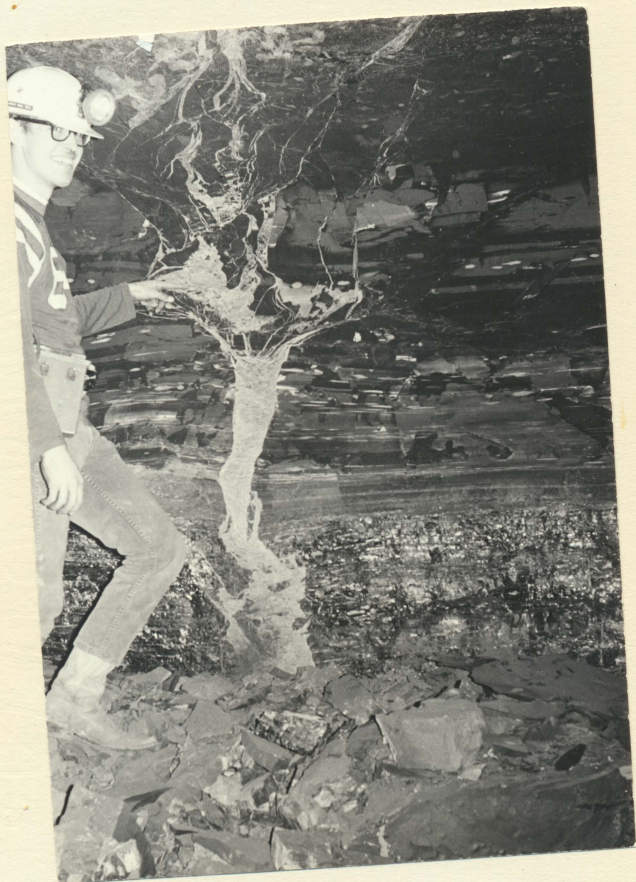
Ronald Kern pointing to same clay dike. Although Ron did a considerable amount of work on the study of clastic dikes, Damberger never mentioned his name in any of his publications on the subject. Similar controversies erupted in the Herrin (No.6) Coal Roof Study in 1975 when Damberger refused to acknowledge the work of co-workers Nelson and Ledvina in publications.

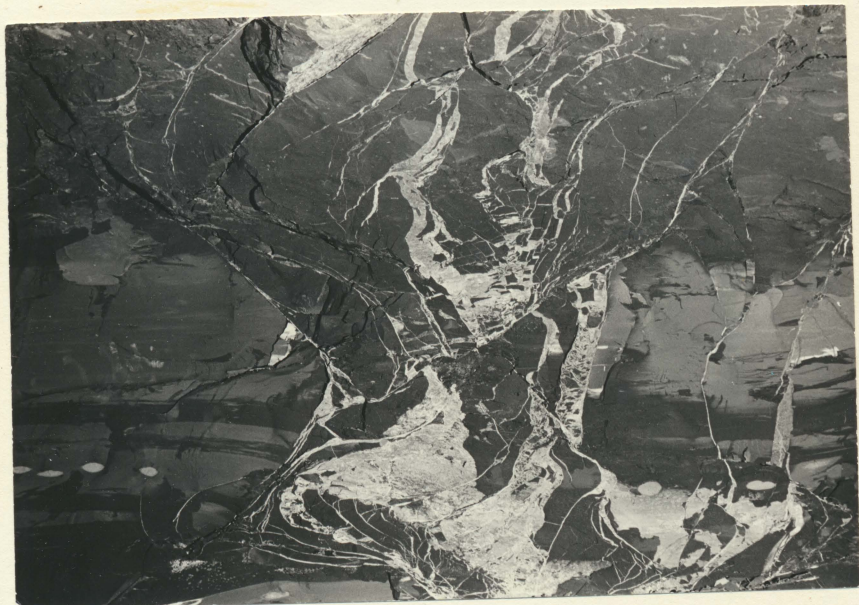
Closeup of upper part of same clay dike, showing branching divergence of clay material, and fractures in the roof. Note also the slight downward bending of the roof shale adjacent to the fractures in the left-hand side of the photo.

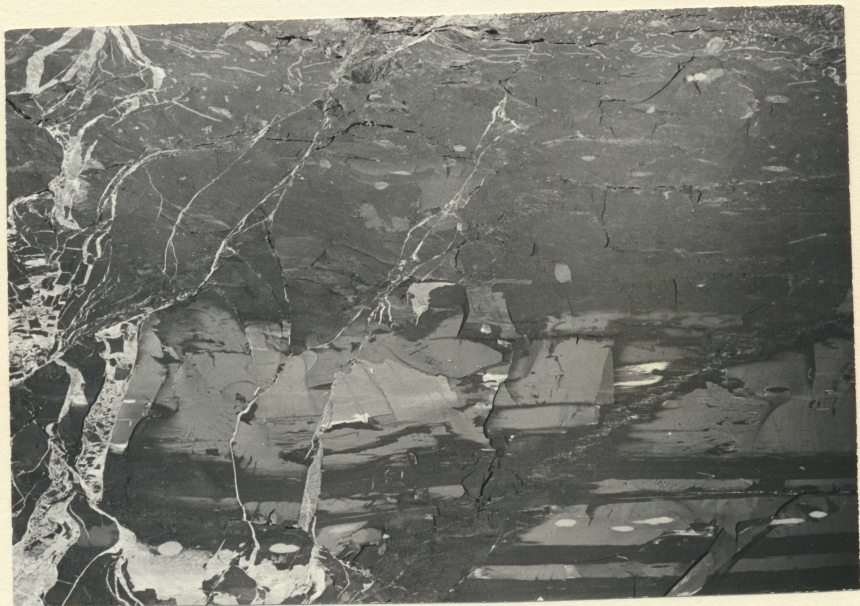
Upper right-hand portion of same clay dike, showing branching veinlets and fractures in roof.

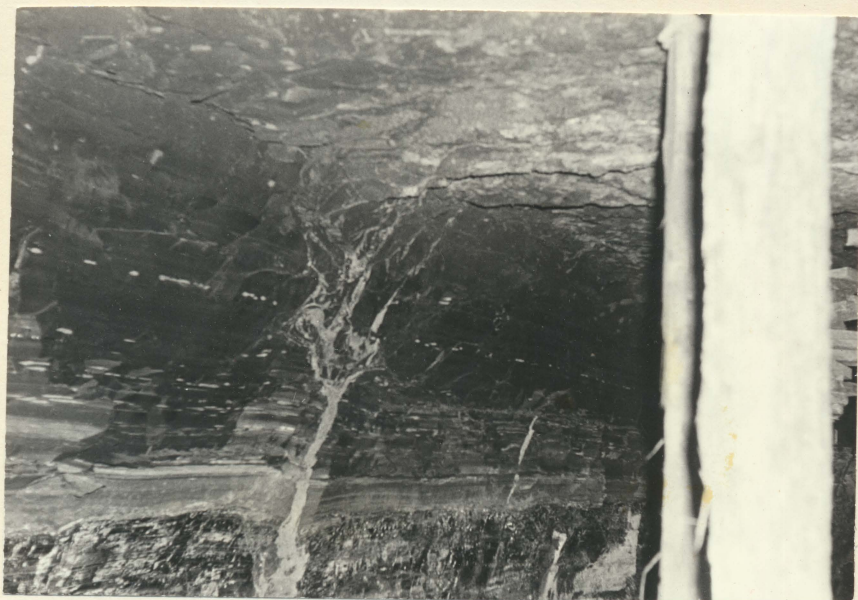
Same clay dike, opposite side of entry. Top of roof is the St. David Limestone. Effect of clay dike on stratification of roof rock is small; most pronounced near top of coal seam.

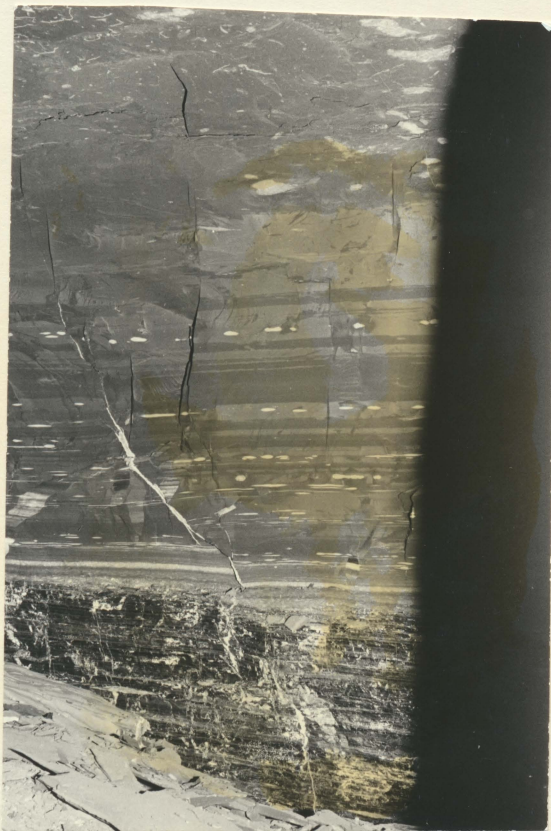
Small clay dike about 20 ft. north of location of previous photos. Displacement is a few inches just above coal top; displacement dies out both above and below. Hardly any clay filling is found along much of this fracture.

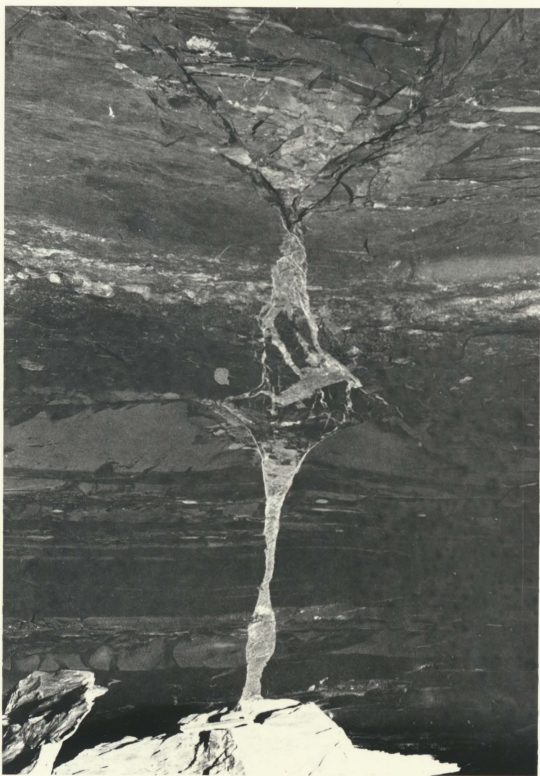
This clay dike is located in the 5th N Entry of the El-Ben Mine. A roof fall occurred here shortly before the picture was taken (note broken rock at bottom of photo.) Upward from the coal the dike splits, then converges, and then splits again in a funnel-shaped system of fractures 1 to 2 ft. below the St. David Limestone (top of photo.) These fracture systems weaken the roof considerably.

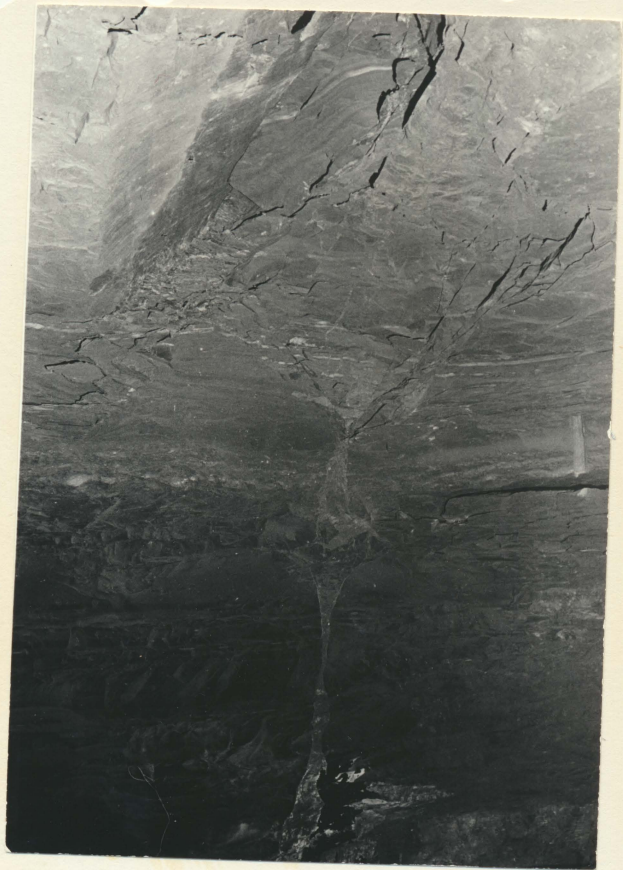
Same clay dike eight days later (10/23/68) .Clay dike is less prominent due to dust, but slip fractures in the roof are plainly visible.

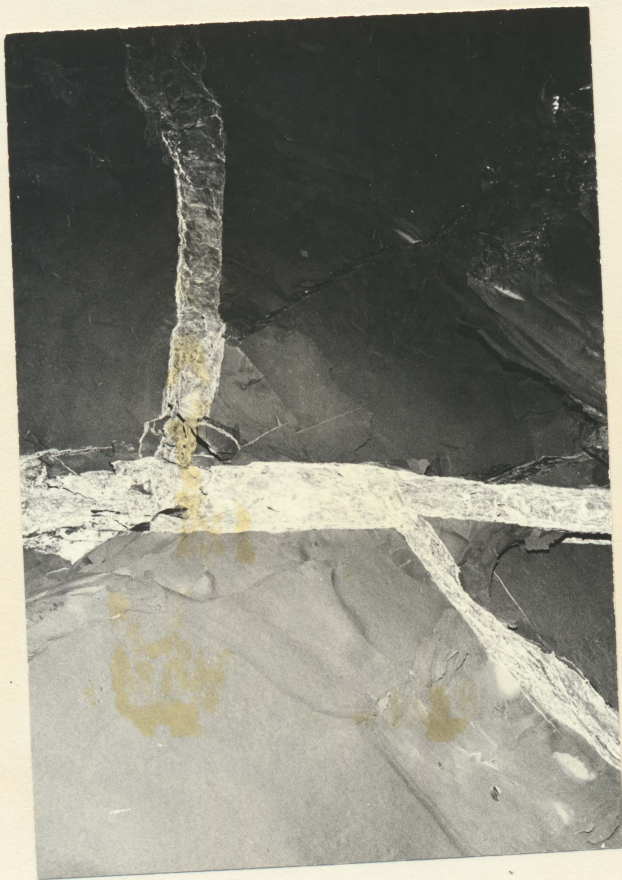
Intersecting clay dikes in the roof. Apparent offset of one of the dikes by about $1\frac{1}{2}$ ft.

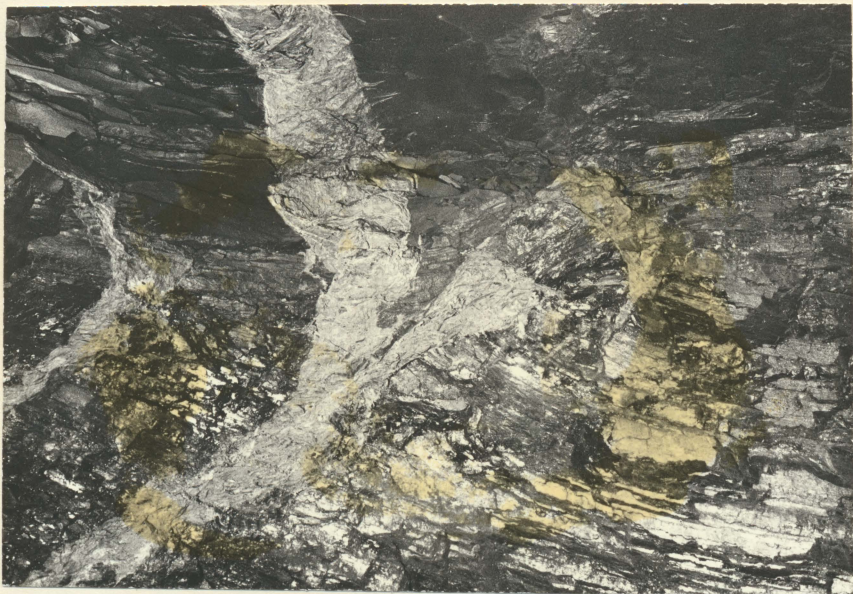
Same clay dike, viewed at coal-roof contact.

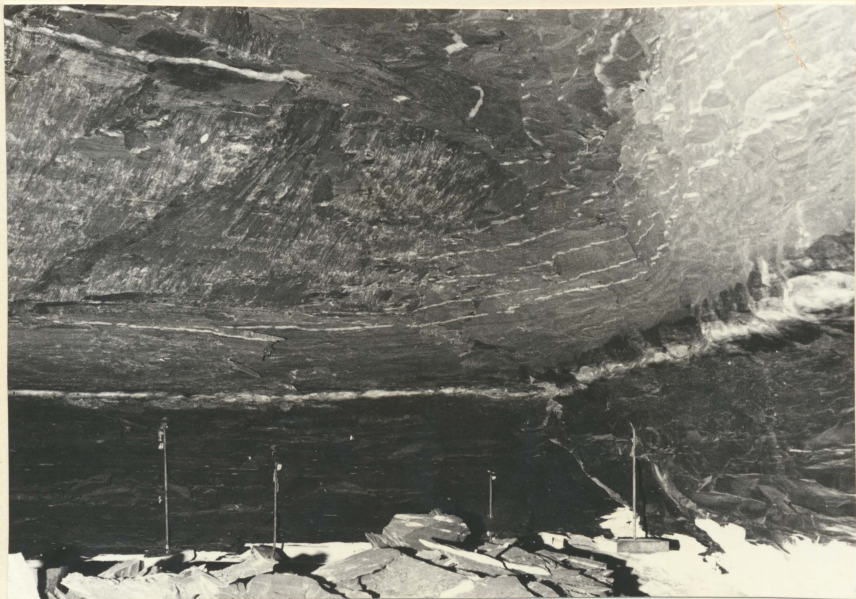
View in 6th North Entry of El-Ben Mine. Roof fall in connection with clay dike. First fall occurred in Sept. 1968 up to 6 ft. above the coal top. This fall was rebolted, but a second fall occurred just to the north about a month later (10/7/68).

The entry trends 155° , and the clay dike runs about 050° . A large slip-fracture at the top of the clay dike is plainly visible in the upper left of this photo. More small slip planes are present higher up, further weakening the roof. All of these run parallel to the clay dike. The dike itself is only 1-2" wide in the roof, thinning upward, and extending about one foot above the St. David Limestone (Thin white layer) as thin clay streaks. The limestone thins from about 6" at this location to less than 2" at the north.

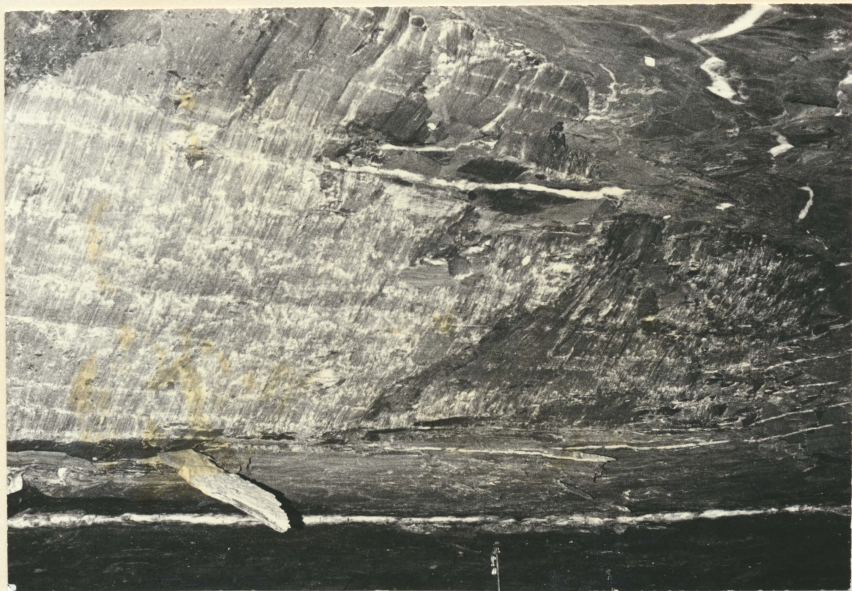
View of main slip-fracture in same roof fall as in previous photo. Clay dike runs along lower edge of the slip surface. The thin white band near the lower edge of the photo is the St. David Limestone.

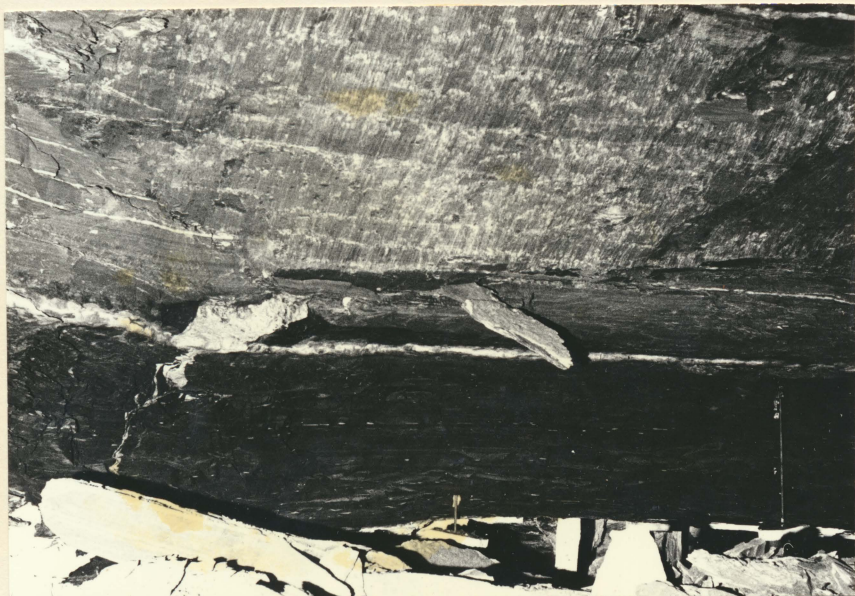
Another view of same. Note small thin clay dike to lower left, just below St. David Limestone.

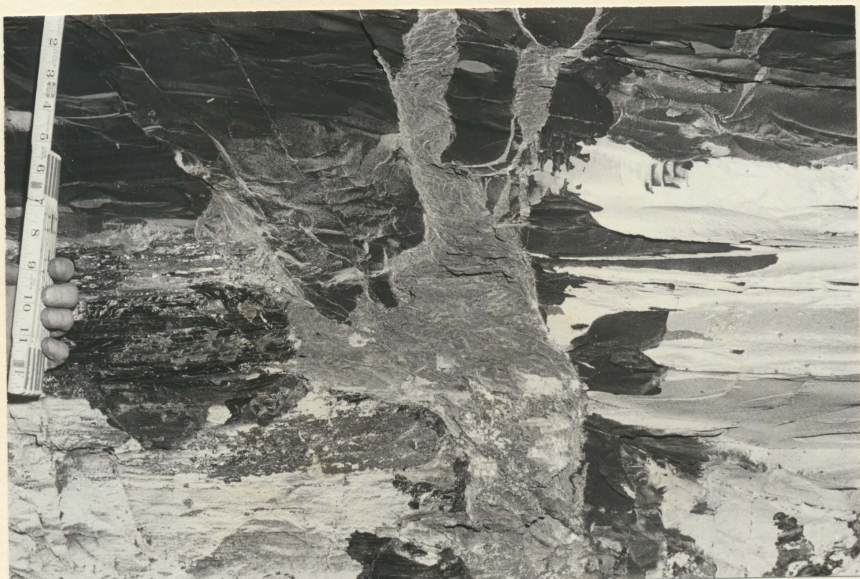
View of clay dike a few hundred feet south of the north end of the 5th North Entry approximately opposite the roof fall in the 7th North (sic) of previous three photos. Dike trends 035/55-75 NW, with about one foot of displacement to the NW at the top of the coal seam. As shown, the clay dike splits into several branches above the coal top. The southernmost branch (left) dips about 55°, becoming shallower upward. Much slickensiding weakens the roof. Stringers of calcite demonstrate shearing toward NW.

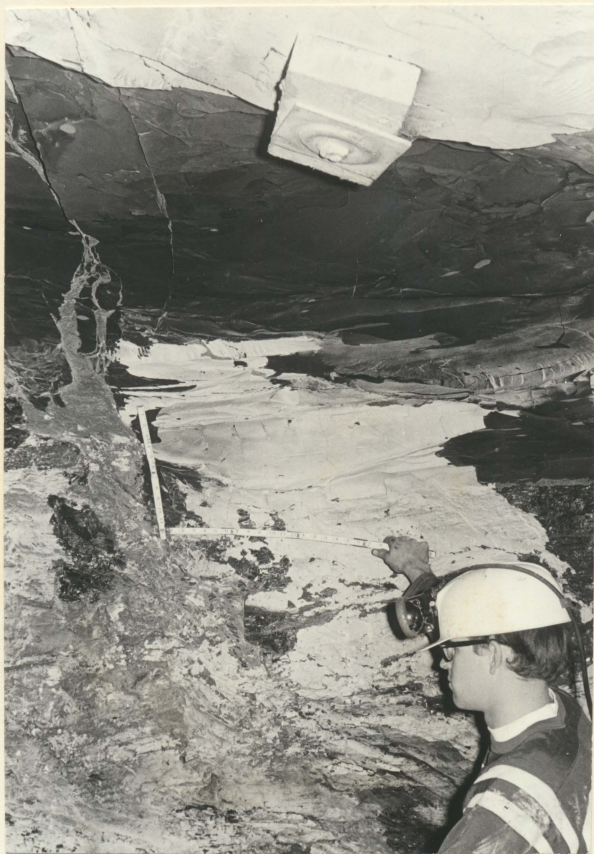
Ron Kern, geology grad student, examines same clay dike as shown in previous photo. He is holding the ruler parallel to top of coal seam on downthrown side of fault.

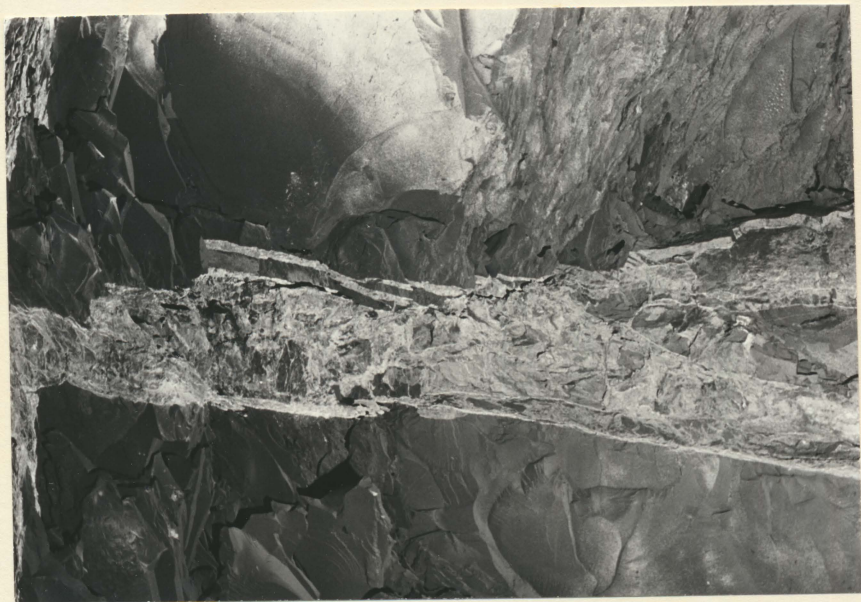
View looking directly upward at clay dike in roof;
near same location.

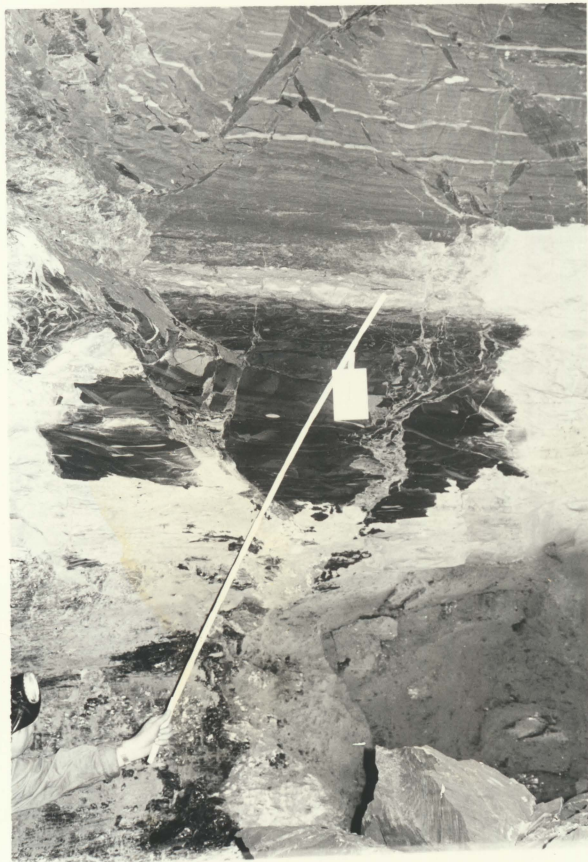
Clay dike in Springfield (No. 5) Coal. Dike branches and thins near the St. David Limestone (top of rod). The right branch appears to extend above the limestone as very fine fissures. The left branch of the dike (upper left in photo) consists of small veins connected with an irregular fault plane, the surface of which is still coated with a film of light gray clay. No influence of sedimentation can be seen.

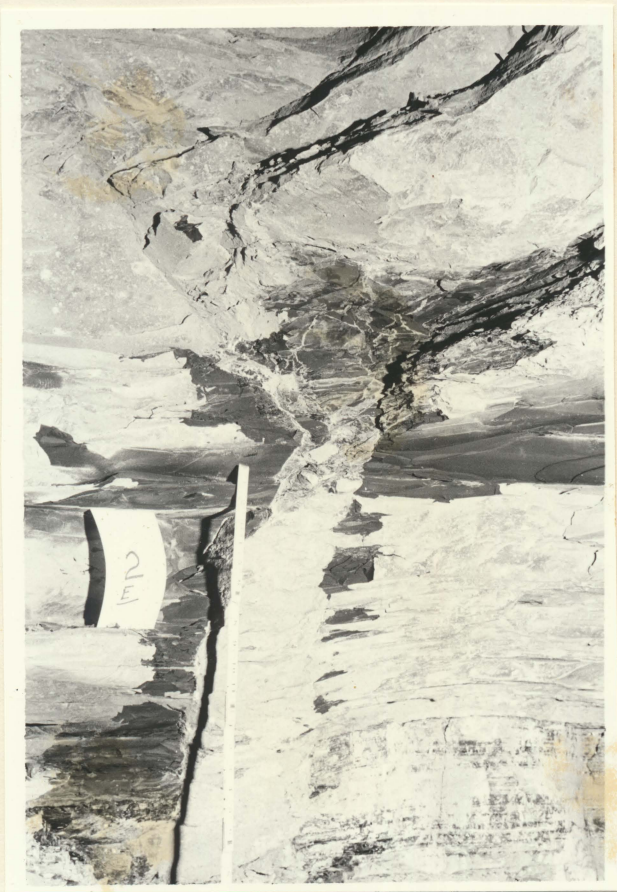
Same clay dike as in previous photo, opposite side of roof fall. Dike divides into thin fissures about 15" above the top of the coal bed, and bedding planes near the top of the coal are bent downward slightly.

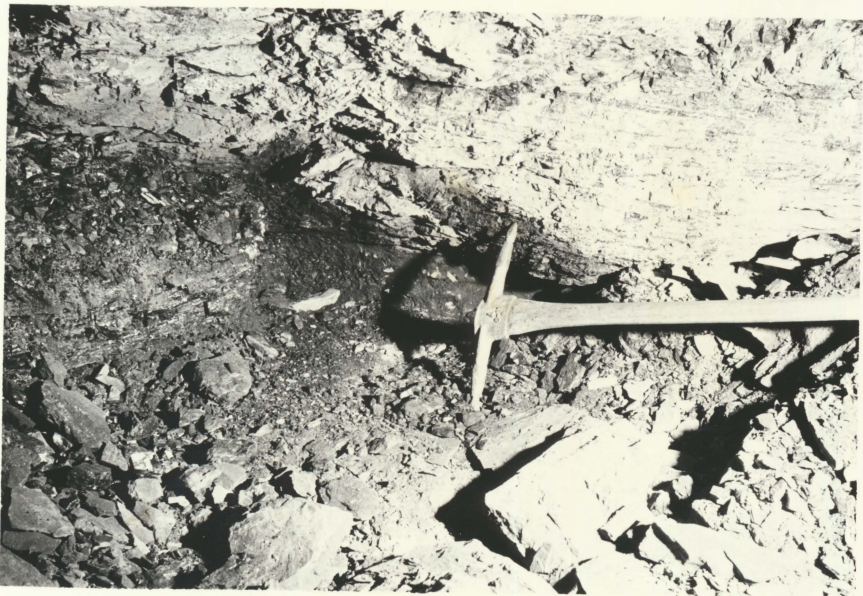
Base of same clay dike as in previous photo. The dike ends a few millimeters to a centimeter above the bottom of the coal seam. The coal directly below the clay dike is pulverized, but nothing abnormal was noted in the underclay to suggest penetration of the clay vein into the floor.

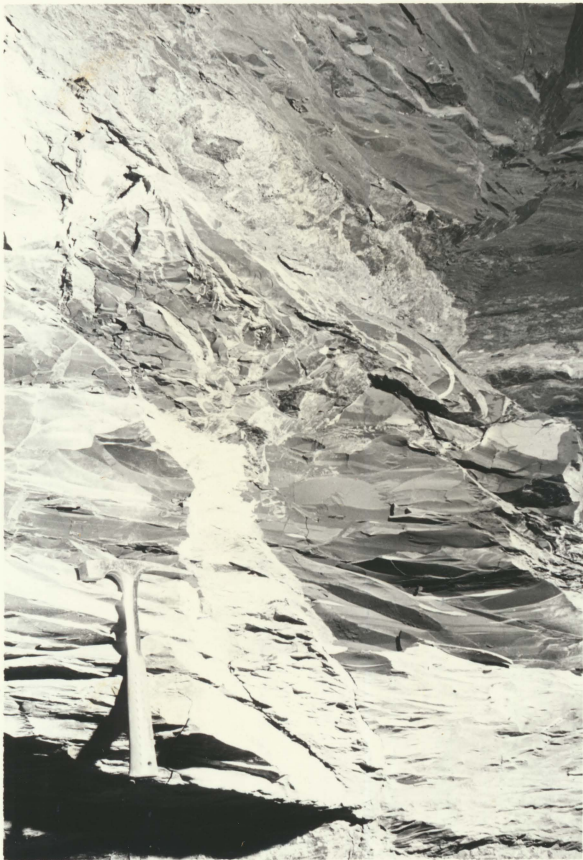
Same clay dike again, here viewed in the roof. Large associated slip runs from upper left to lower right, and the roof rock appears highly fractured.

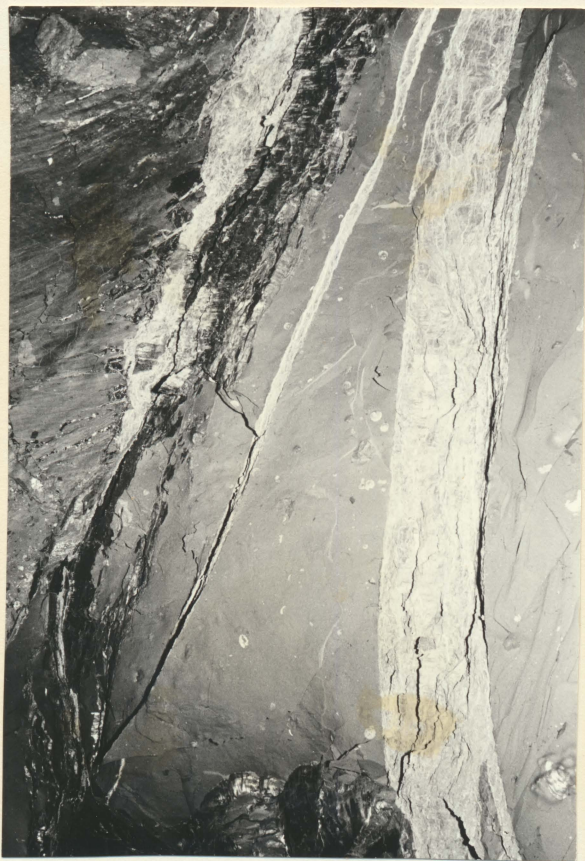
Trace of another clay dike (white) across the black shale of the roof.

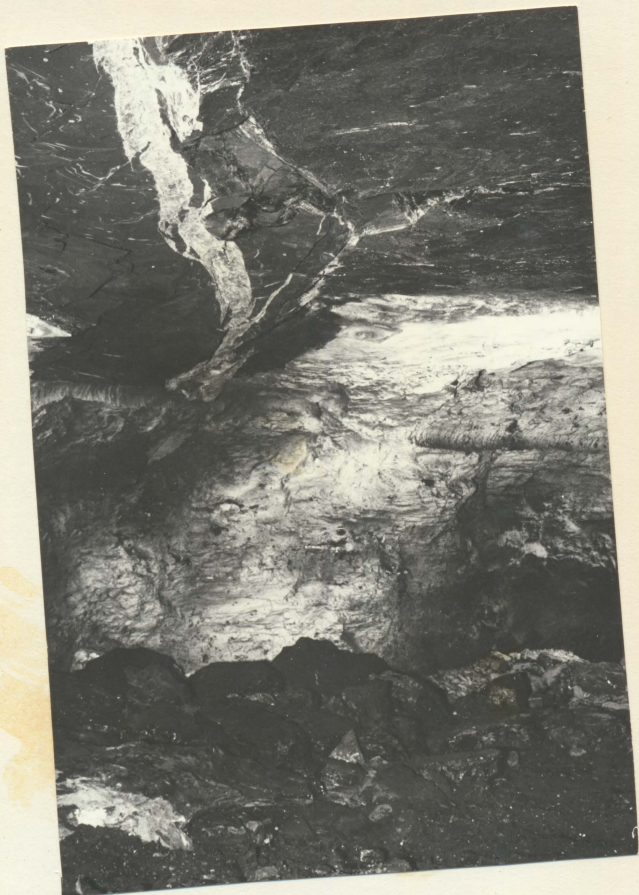
Side view of same clay vein in the roof. Rock in lower half of photo is white from rock dust.

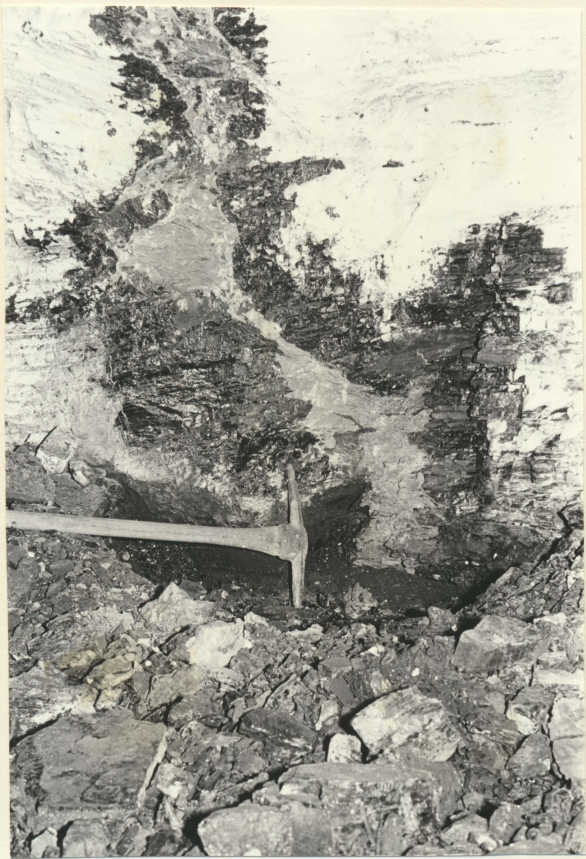
View of same clay dike in the coal. Dike does not enter the floor, but stops a few mm. to 1 cm. above, with pulverized coal beneath.

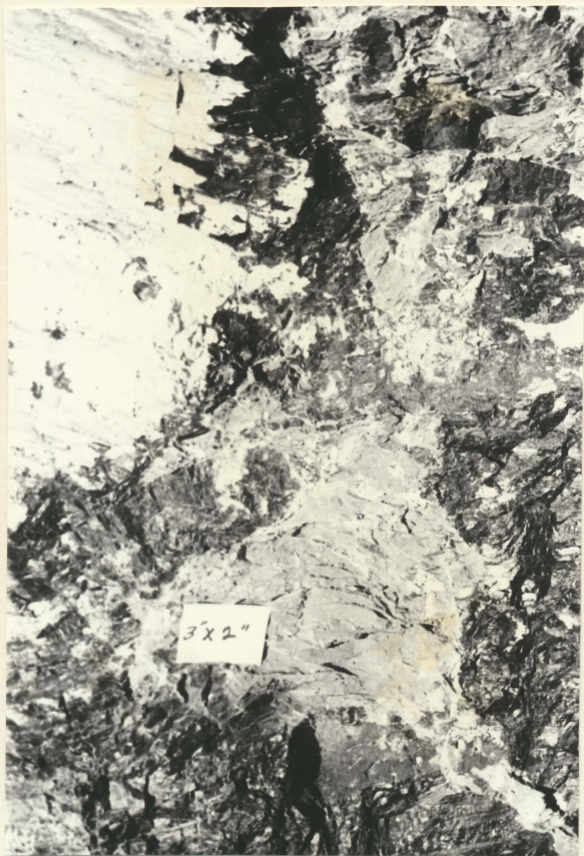
Closeup view of part of same clay dike.

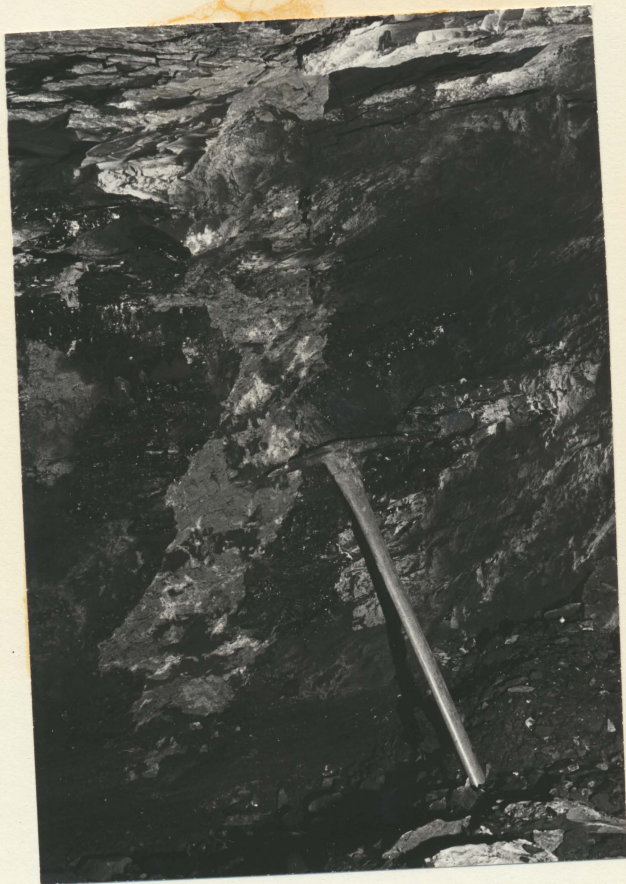
Clay dike in coal at north end of 5th North Entry. Roof fall occurred here, starting at this clay dike, which does not penetrate the floor. The clay filling usually is much harder through the coal than through the roof, probably due to differing secondary mineralization, mainly of calcite and pyrite.

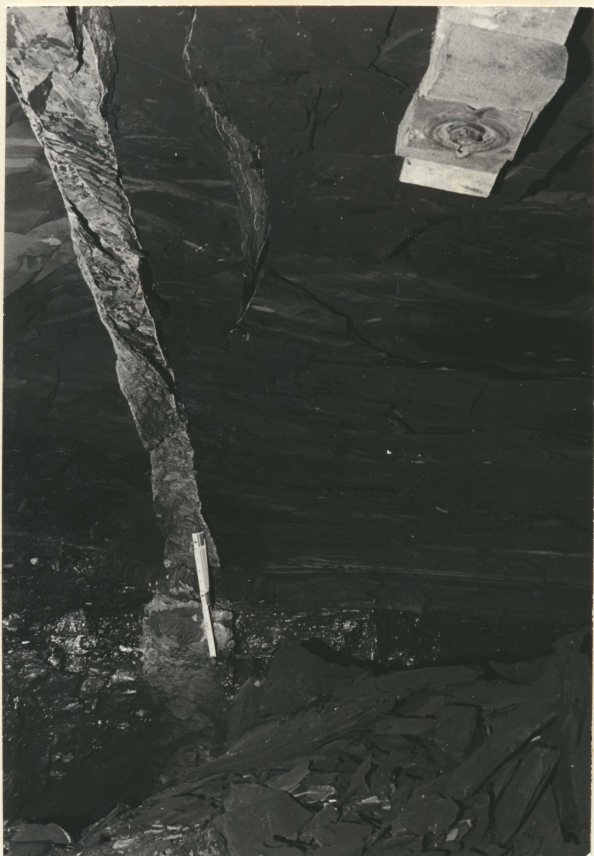
Same clay dike as in last photo, here shown in roof
and upper part of coal seam.

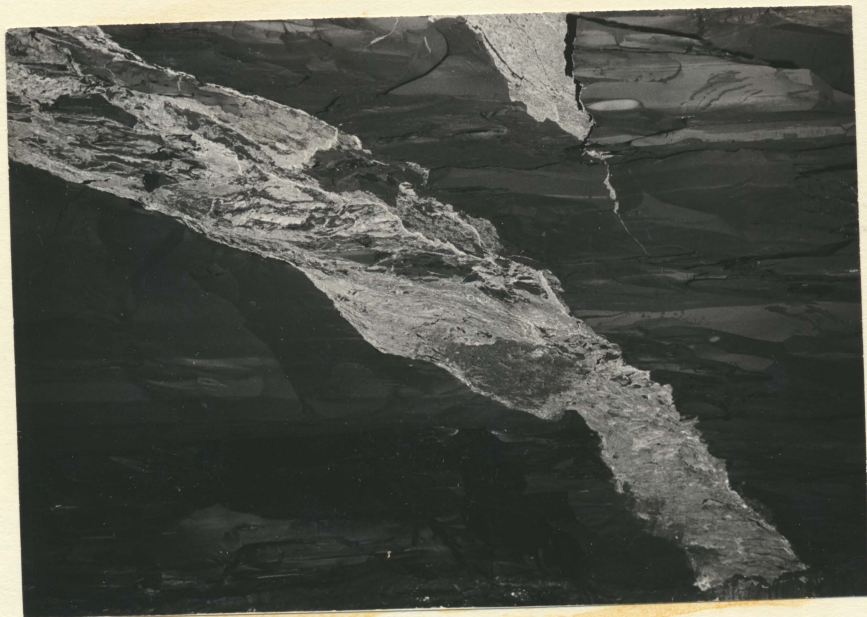
Clay dike in roof at north end of 5th North Entry. Dike filling was squeezed into the roof shale along bedding planes, very often in thin stringers. The pieces of roof shale seem to float in the clay more or less in the original position, indicating a more laminar rather than turbulent flow movement of the dike filling. The boundaries between the roof shale and dike filling always are very distinct; no intermixing took place. This strongly suggests that the roof shale had reached a certain degree of consolidation when the intrusion occurred.

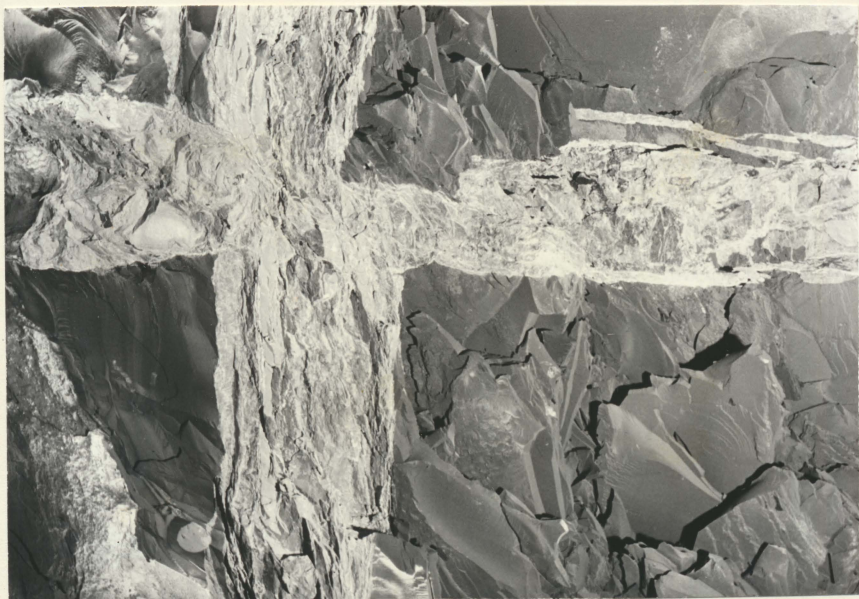
Near same location, two clay dikes intersect at right angles in the roof. Dikes are much softer in the roof than in the coal. The roof here is much disrupted by slickensided planes, which make it very treacherous.

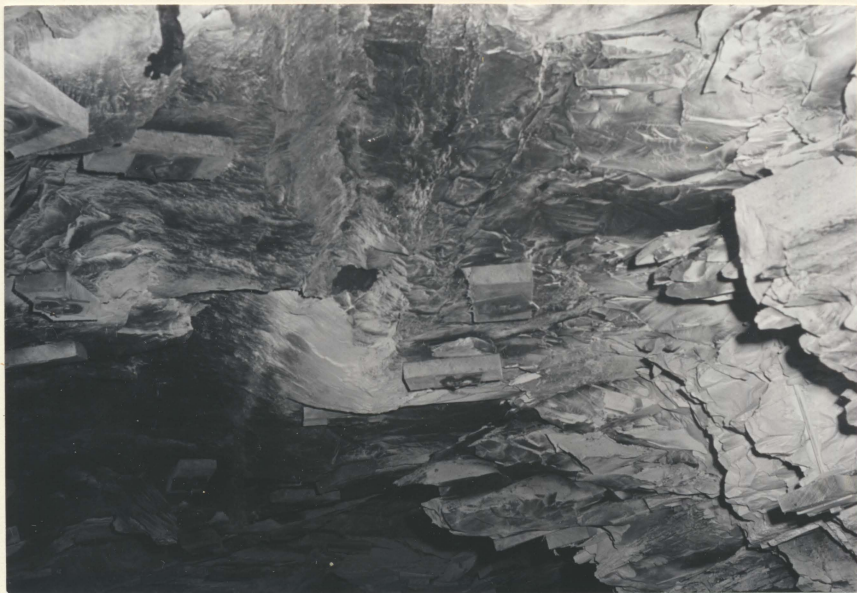
View looking southward from north end of 5th North Entry. Just left of center, a clay dike with slip fracture can be seen. This feature runs parallel to the entry and caused large and small falls along a distance of 60 feet.

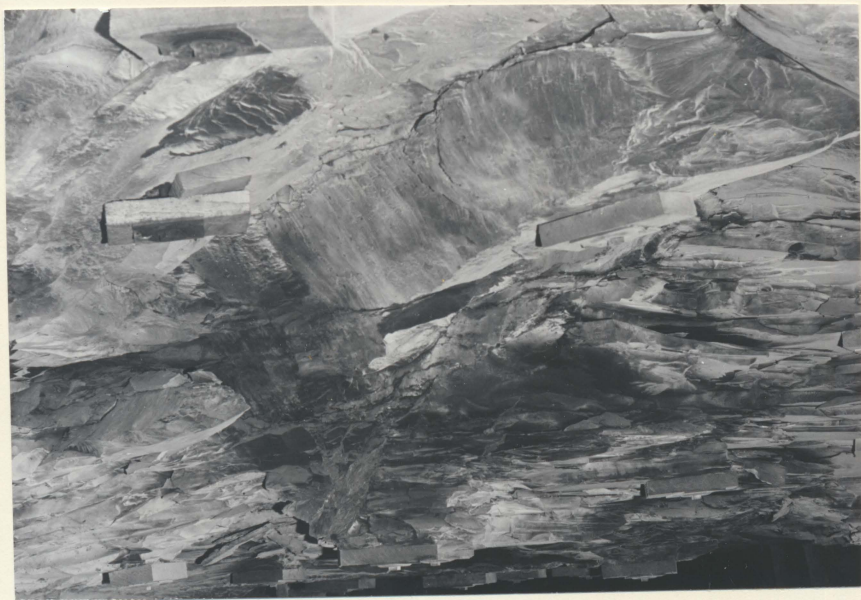
Different view of slip fracture along clay dike.
This slip caused a roof fall here.

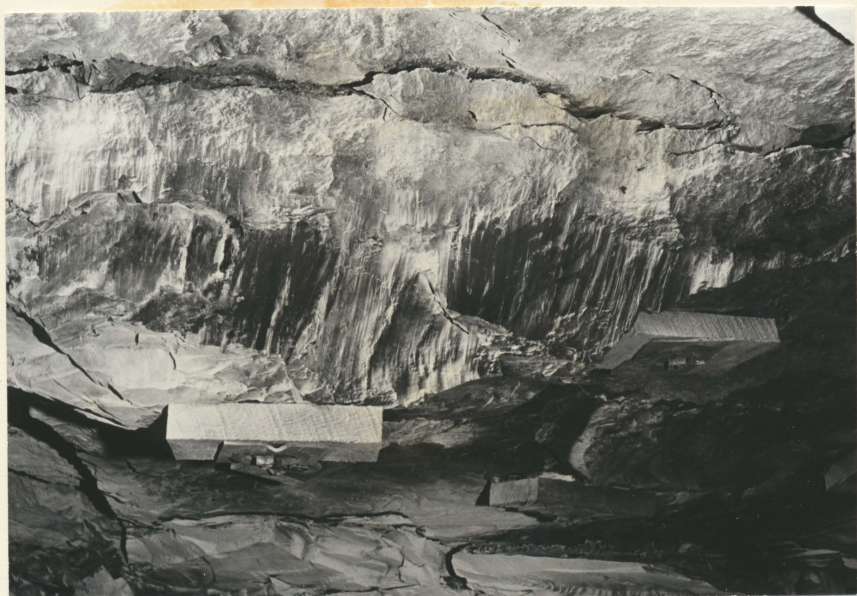
Closeup showing highly polished and slickensided surface of same slip fracture.

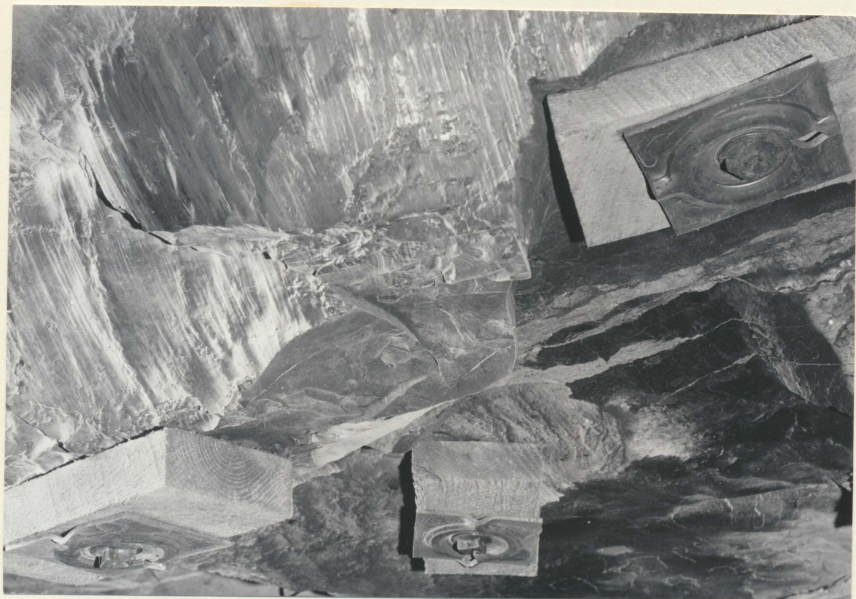
Another view of the same.

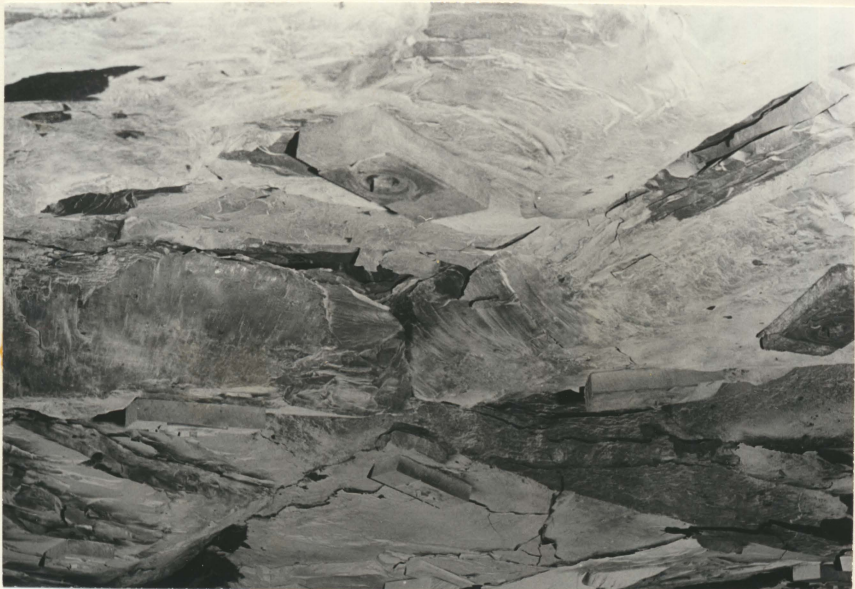
Near same location, two slip fractures associated with clay dikes meet at right angles in the roof.

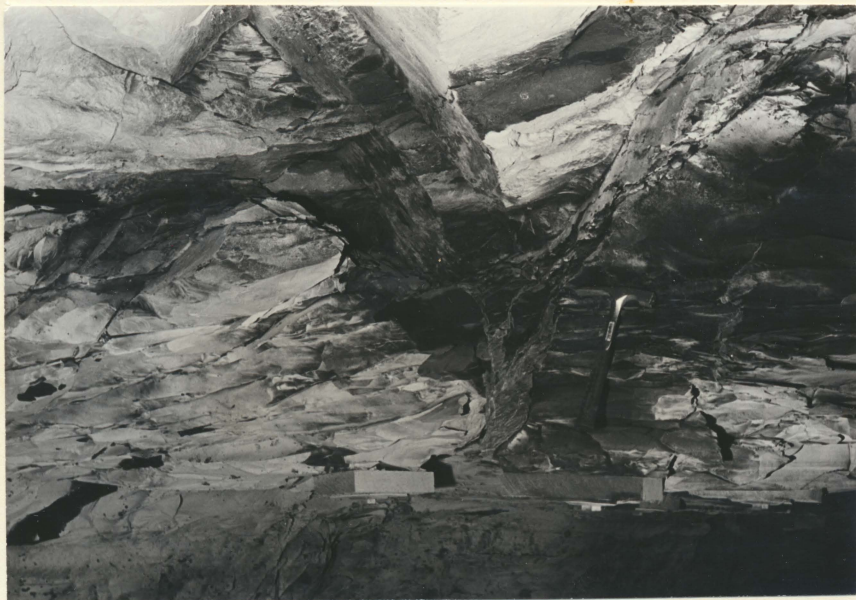
Same area, showing a clay dike splitting into two branches just left of hammer. Slickensided slip-fractures are associated with both clay dikes.

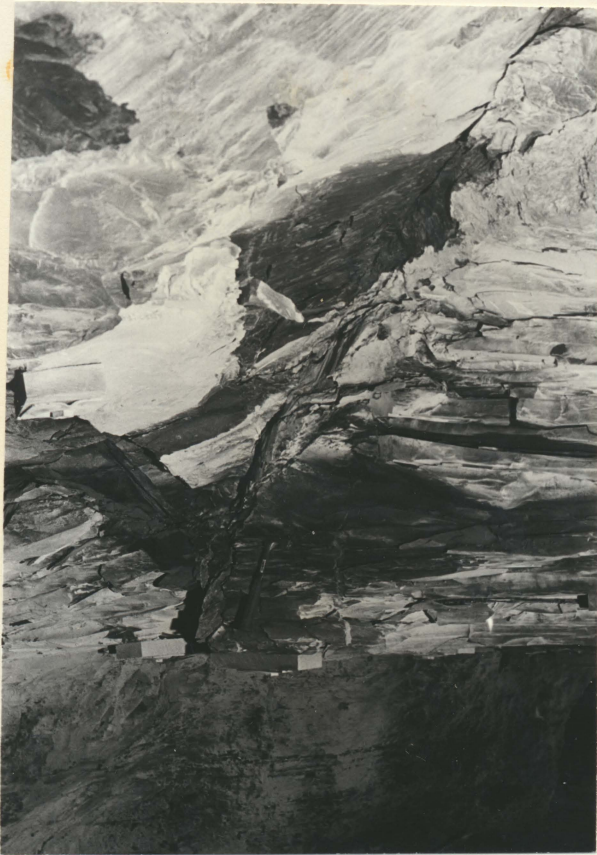
Same feature seen from a different angle.

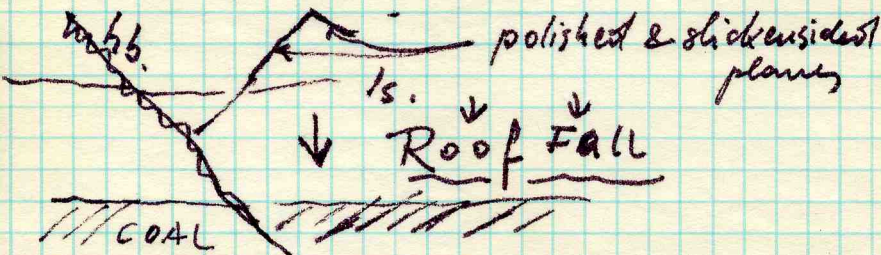
Such polished surfaces above "horsebacks" and at about right angles have been noticed in several other case and add considerably to the weakening of the roof and increase the possibility of roof falls (see sketch).

Only very long bolts, resin bolts, should perform best in this case, may be able to hold the rocks up in the vicinity of "horsebacks"; they should reach up into the "soapstone" and the anchoring surface should be much longer than in the usual type of anchors.

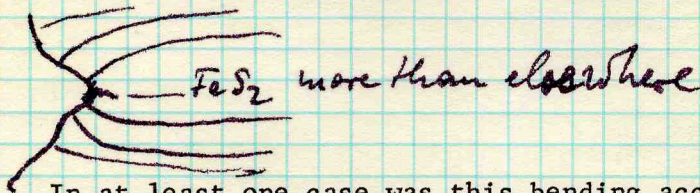
As has been observed many times before, the laminae of the coal seam are bent towards intrusions of clayey dike filling into the coal (photo and sketch).
