Slope Mine  
 RIOLA MINE  
 Mine Index No. 1018  
 Vermilion County

Visit to Riola Mine of Catlin Coal Co.

February 8, 1996

## Visit to Catlin Coal Company's Riola Mine

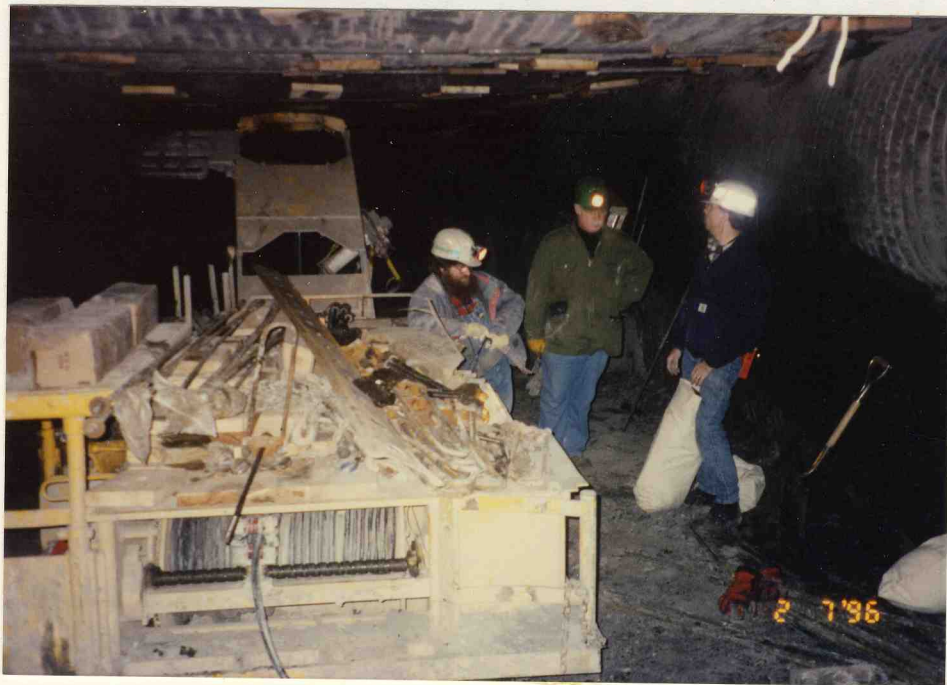
A scene during construction of the Riola Slope. An area was excavated by continuous miner, bolted, trusses erected, and then concrete poured around the trusses. Mine Foreman Ray Pitman leans against the roof bolter. Geologist Spencer Young is in the middle and Colin Treworgy on the right. The light colored rock in the wall on the right is Farmington shale. The dark area below it is the Danville Coal. A channel sample was taken at this spot.

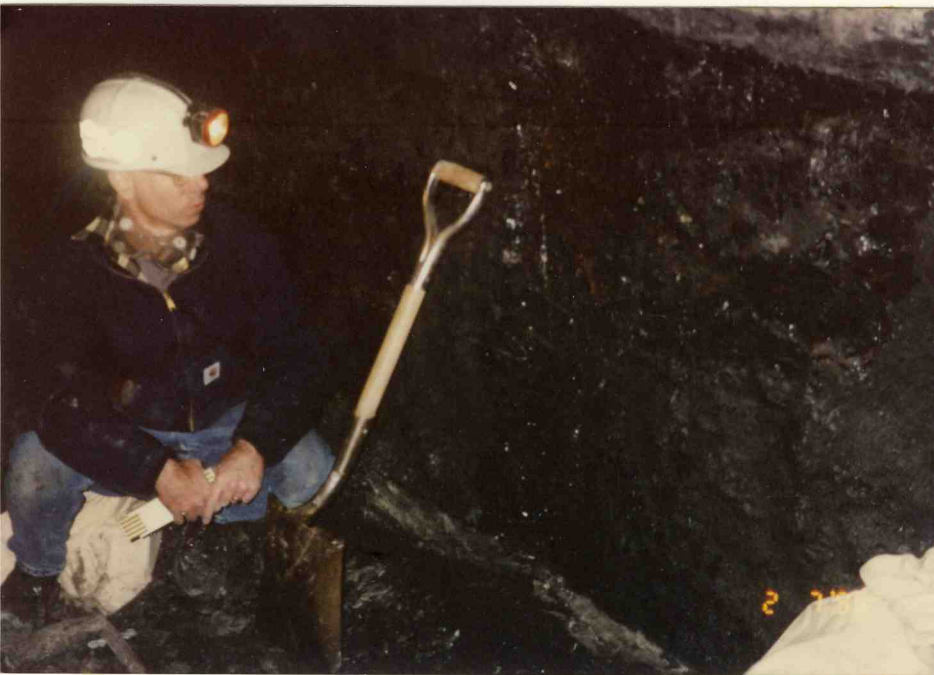
Colin Trewoogy kneeling by the Danville Coal.  
A channel sample was taken to the right of the  
shovel handle.

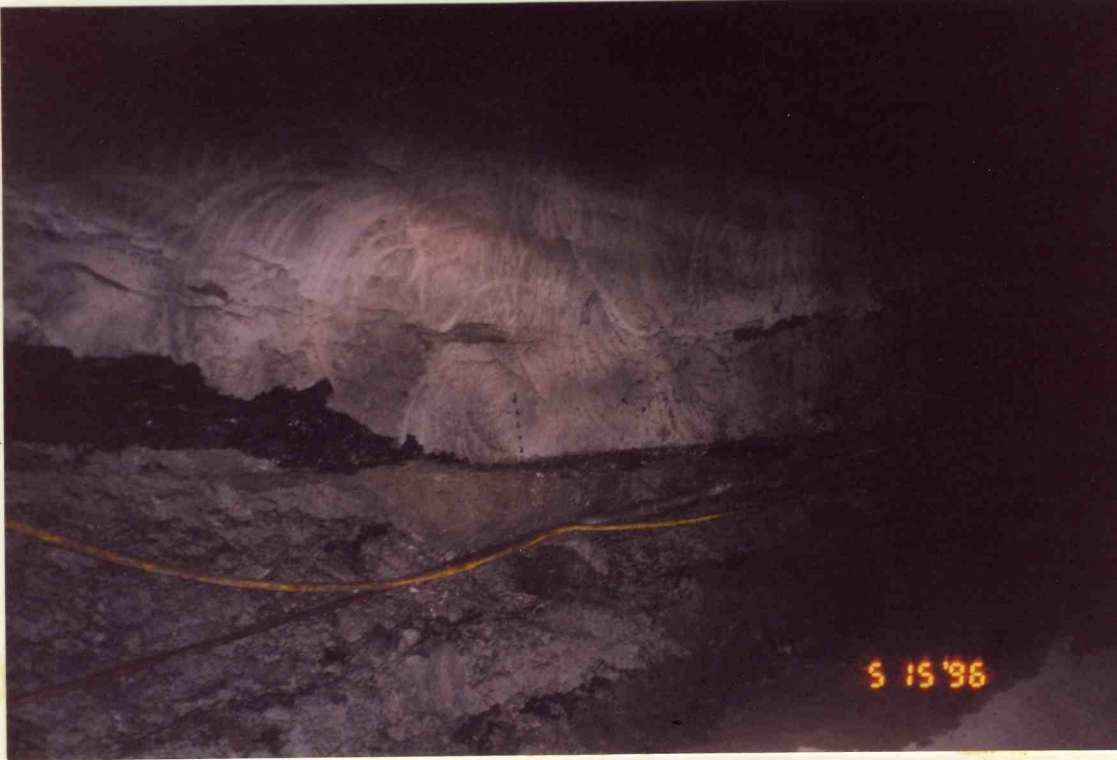
B. Photo northeast of photo A. Probably between stations 1 and 2 on map.  
← see photo A

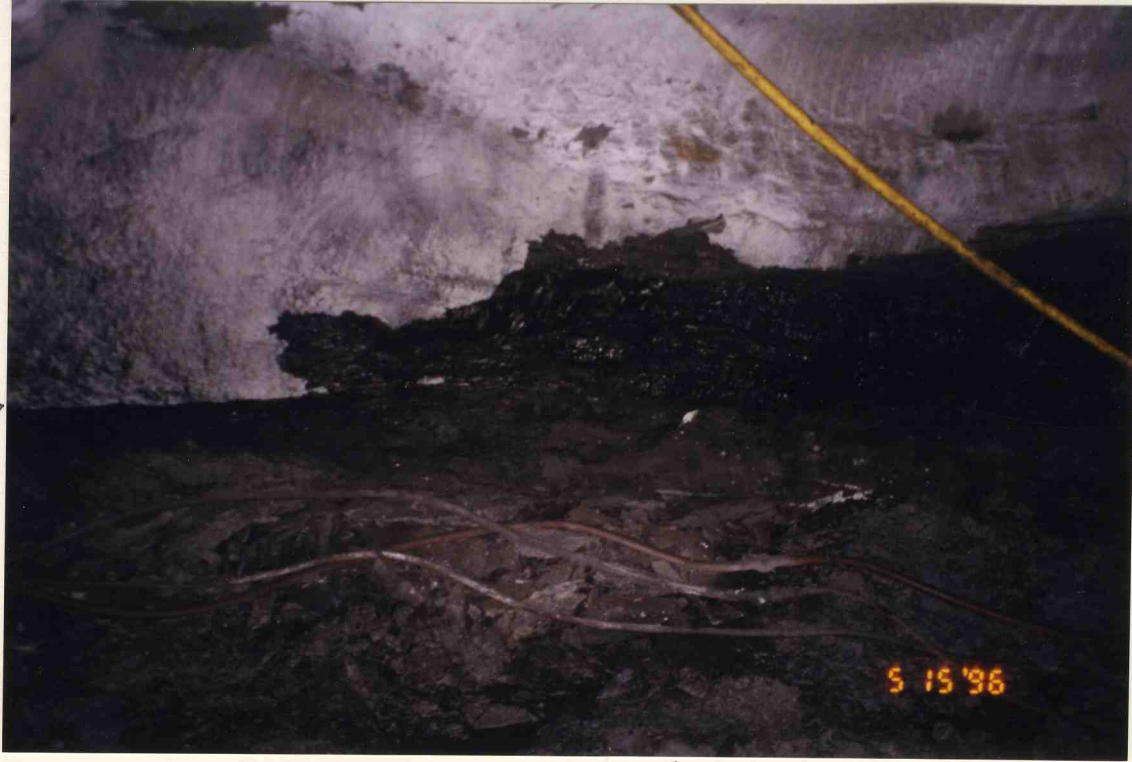
A. Photo taken looking northwest, probably near station 1 on map. The top and bottom of the coal ~~have been sheared~~ are bounded by shear planes. The roof sediments, coal, and floor have been distorted and contain flow features and microfaulting and thrusting.

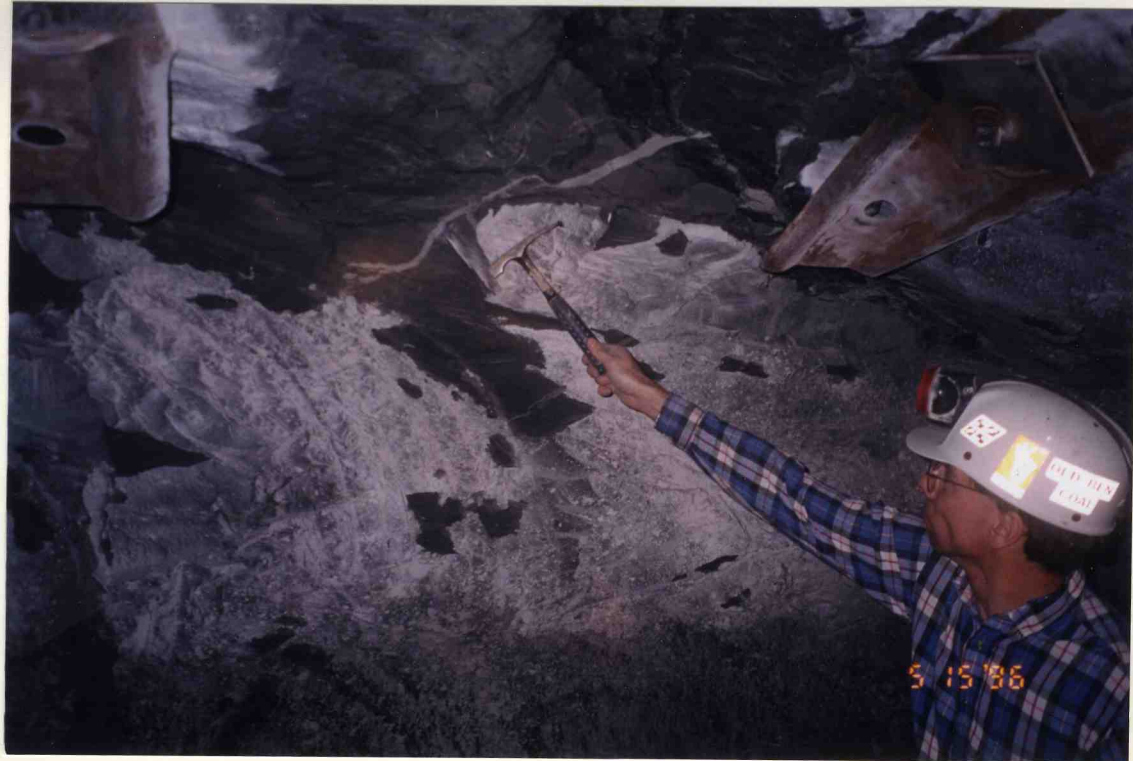
Disturbed roof sediments above coal. Photo probably taken somewhere between map stations 2 and 3. The shear surface is not readily visible at this location.

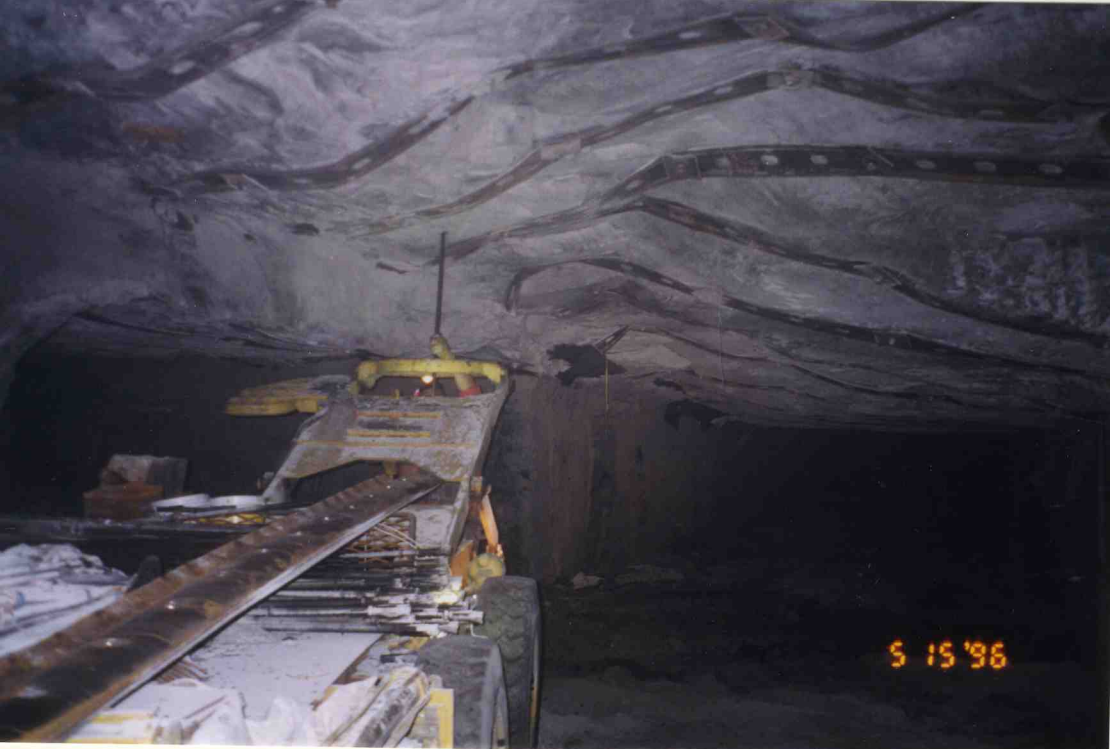
disturbed roof near map location # 2 ?  
the shear surface is near the top of the coal.

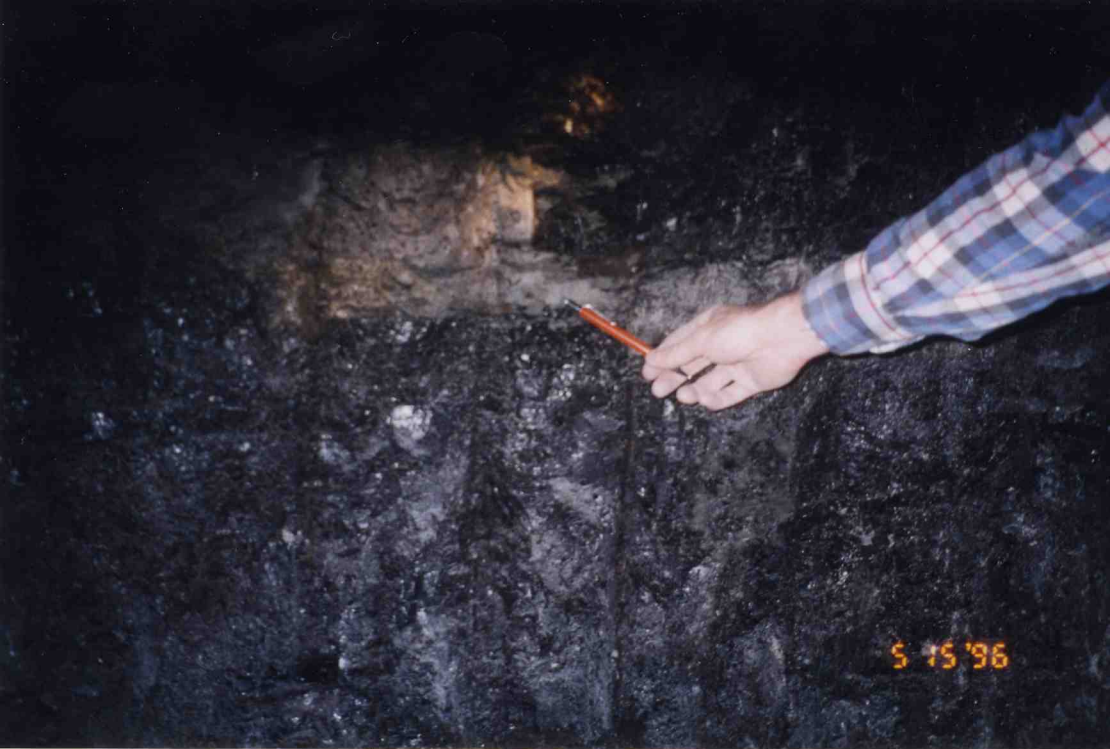
sediments "intruded" into coal. The location of this is uncertain.  
probably between stations 1 and 5.

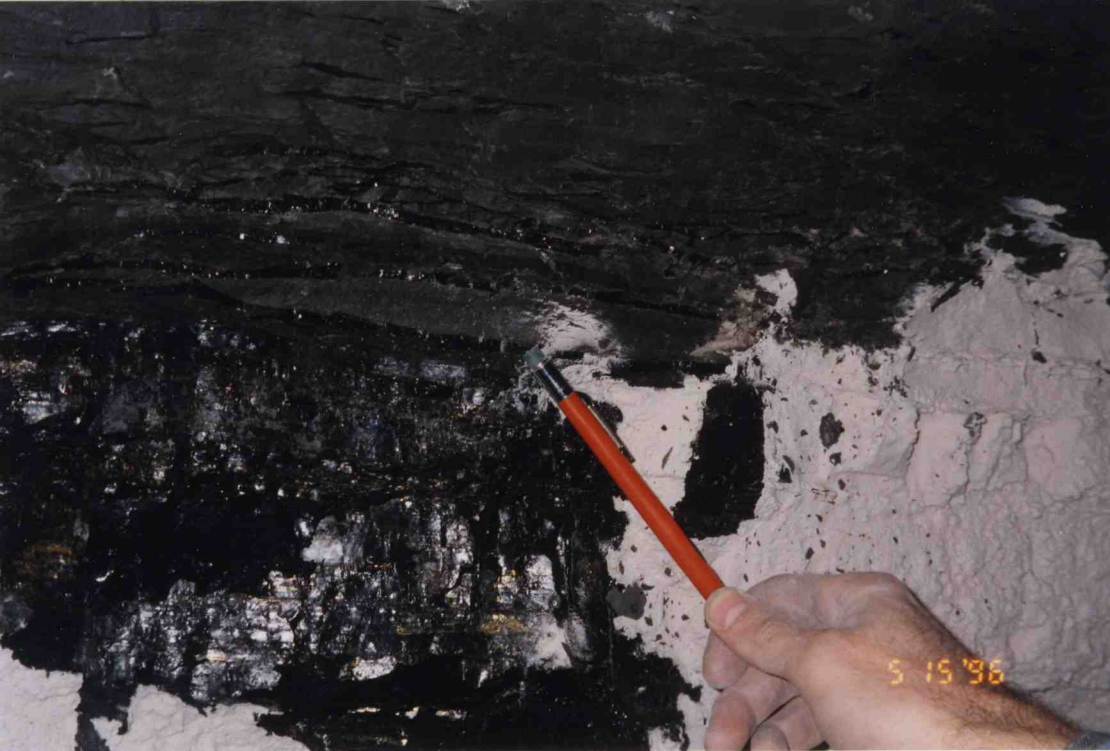
bedded sediment above shear zone at top of coal.  
with faulting and thrusting in sediments.

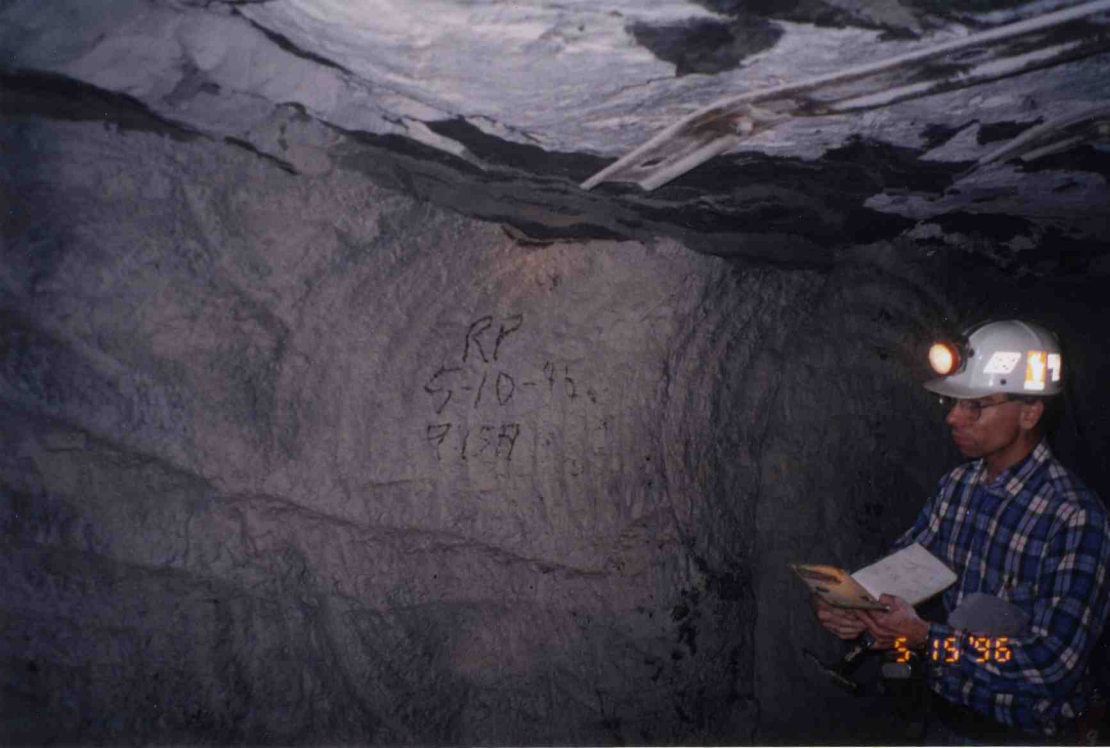
photo was probably taken near station 6. Rida Mine  
seam is nearly full height. Disturbed roof, including possible liquifaction f  
exposed above the coal. Colin Treworgy holds the notebook.

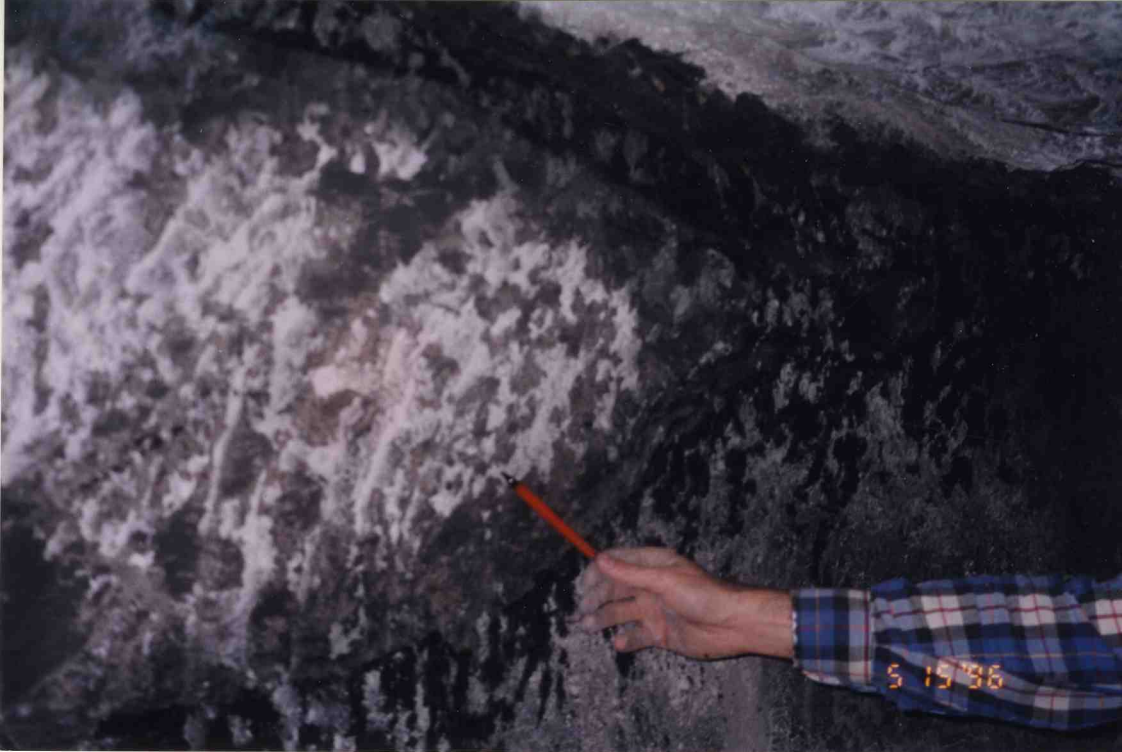
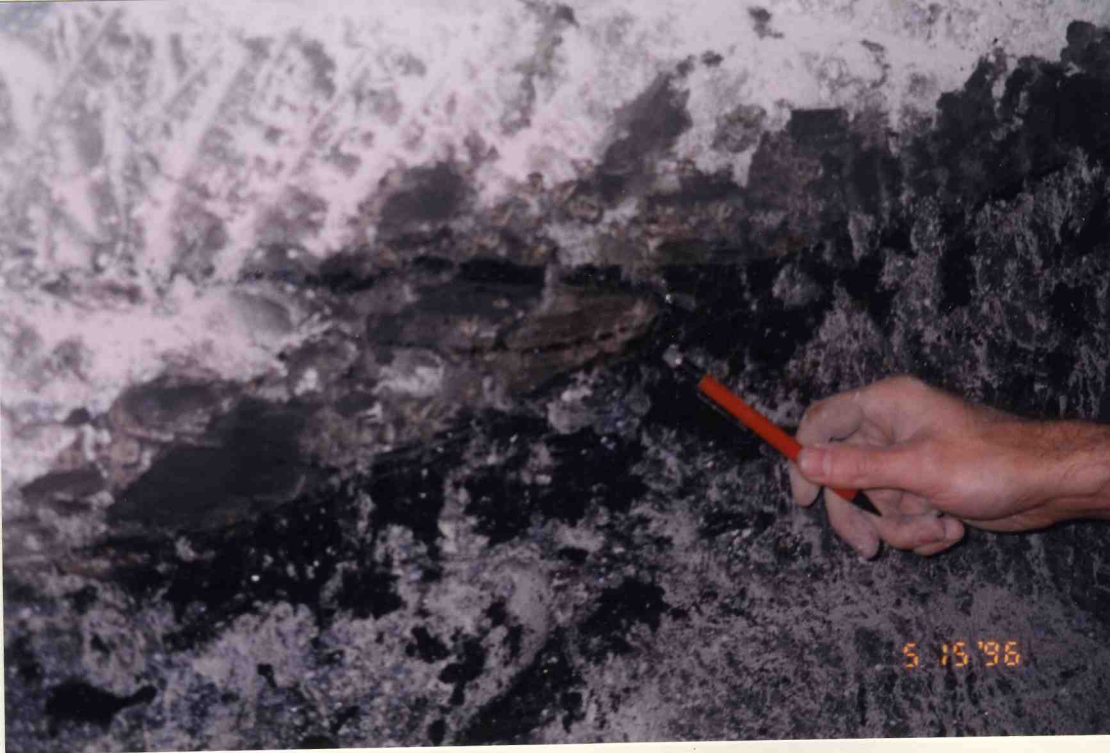
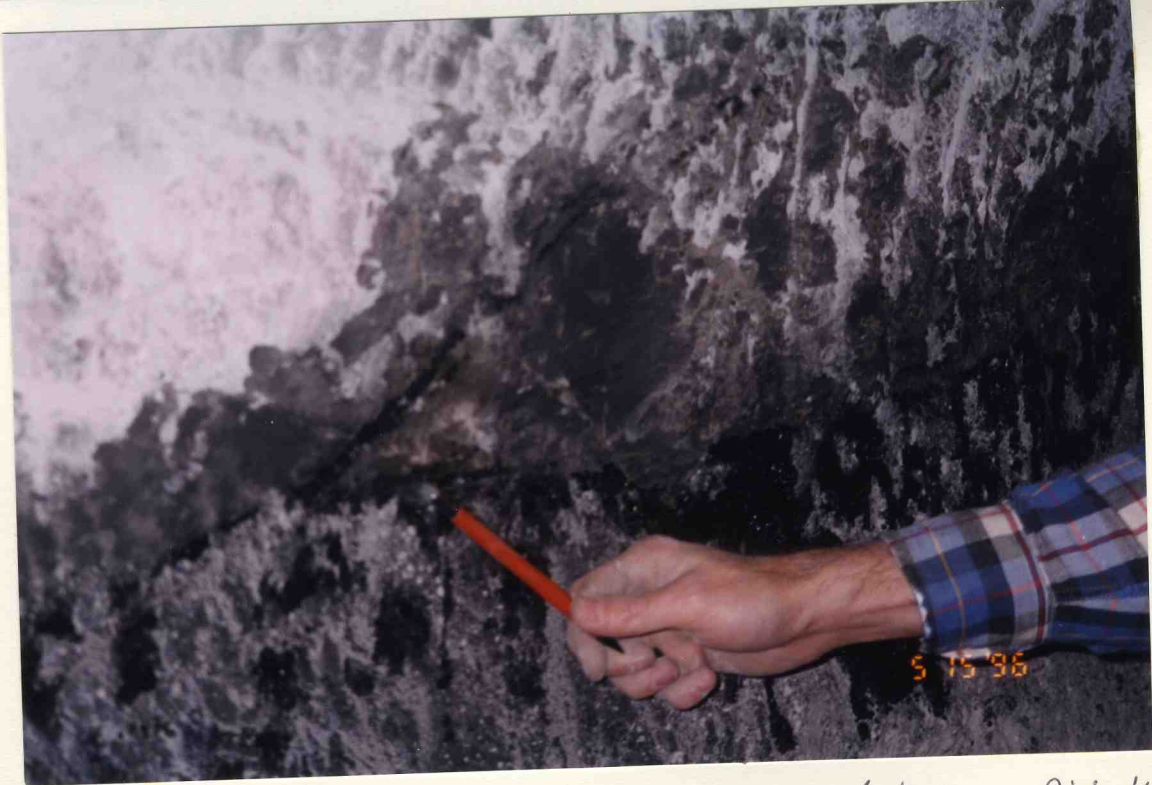
Apparently closely associated with the shearing are occasional "rolls" in the roof that extend down into the coal. One "classic" roll was observed in location 7:

right half of "classic" roll, location #7, 5/16/1999 Riola Mine  
photo 1 of 3

5 cell location #7 Riola Mine 5/16/1999

... side of mill. location #7 5/16/1999

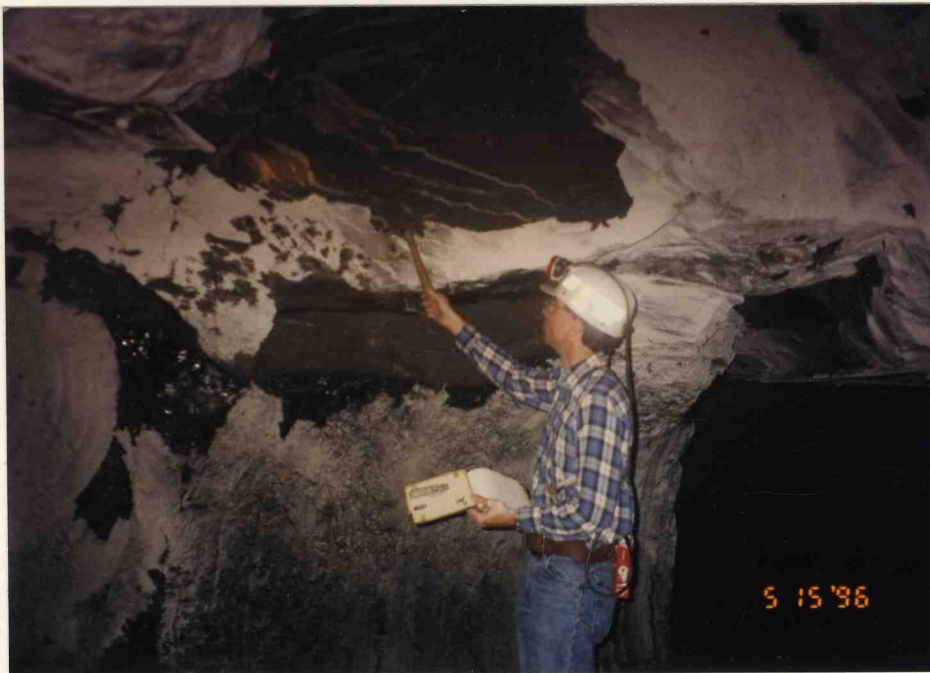
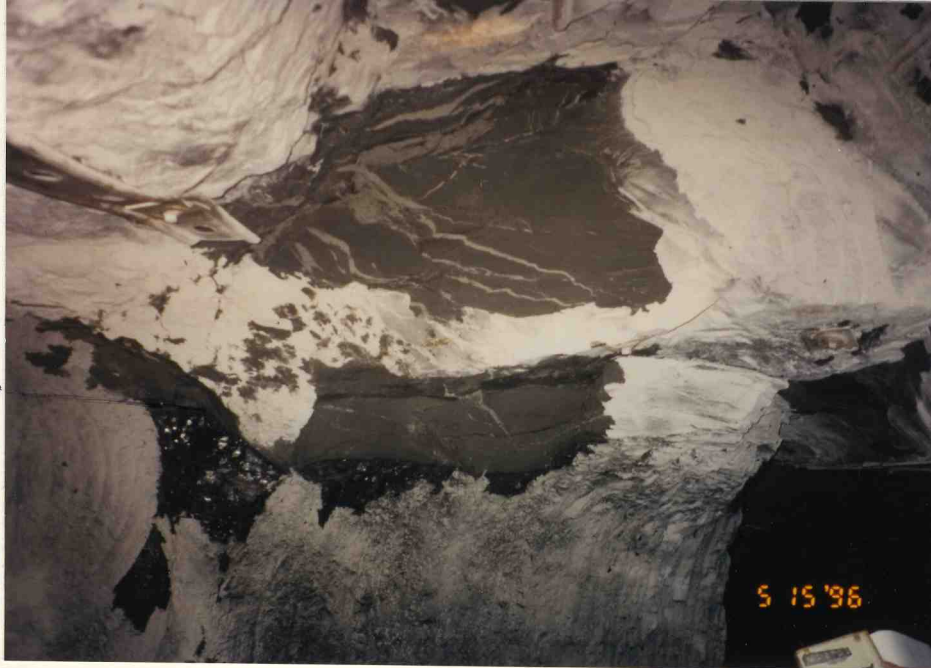
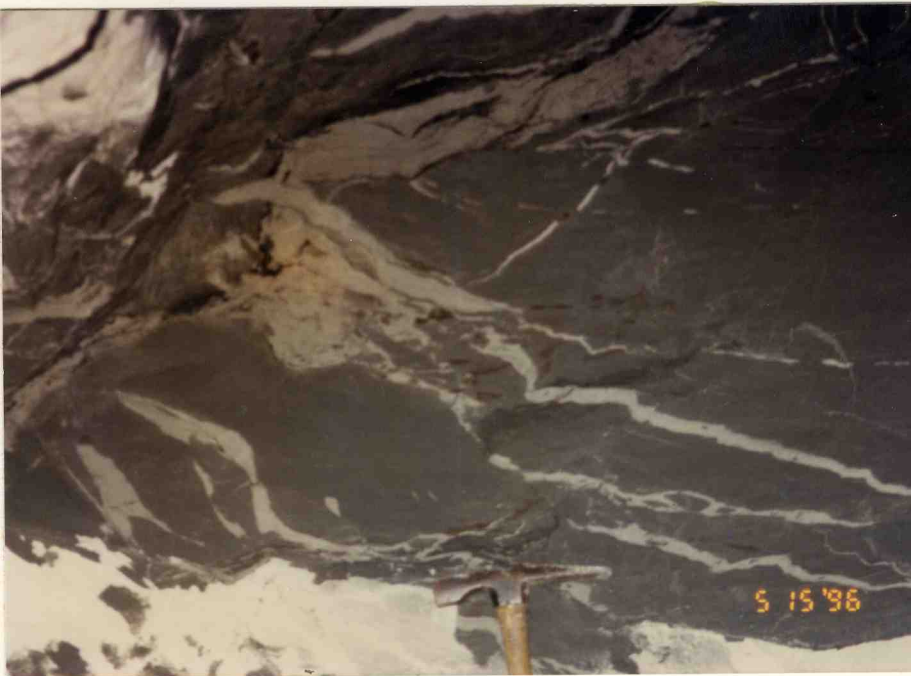
In several places we noticed that sand had been mobilized (including locations 12 and 12); thin irregular veins of fine sand were observed in several places within disturbed roof rock and also within the coal. In one place (location 12) an irregularly shaped body of sandstone up to about ½ ft thick was found about 3 ft below the top of the coal; on one side it ended abruptly, apparently because it was sheared off there. At the same site several small very irregularly shaped sandstone inclusions were observed within the coal seam, apparently brought into the seam along shear zones when the disturbance happened.

Colin Trewoogy holds hammer by thin layers of fine sand just above shear surface. These appear to be sand liquefaction features. Location #11 on map.  
5/16/1999, Rida Mine

Another view of the shear surface and sand liquefaction location #11, 5/16/1999 Riola Mine

Close-up of layers of fine sandstone.  
Location 11, 5/16/1996 Riola Mine

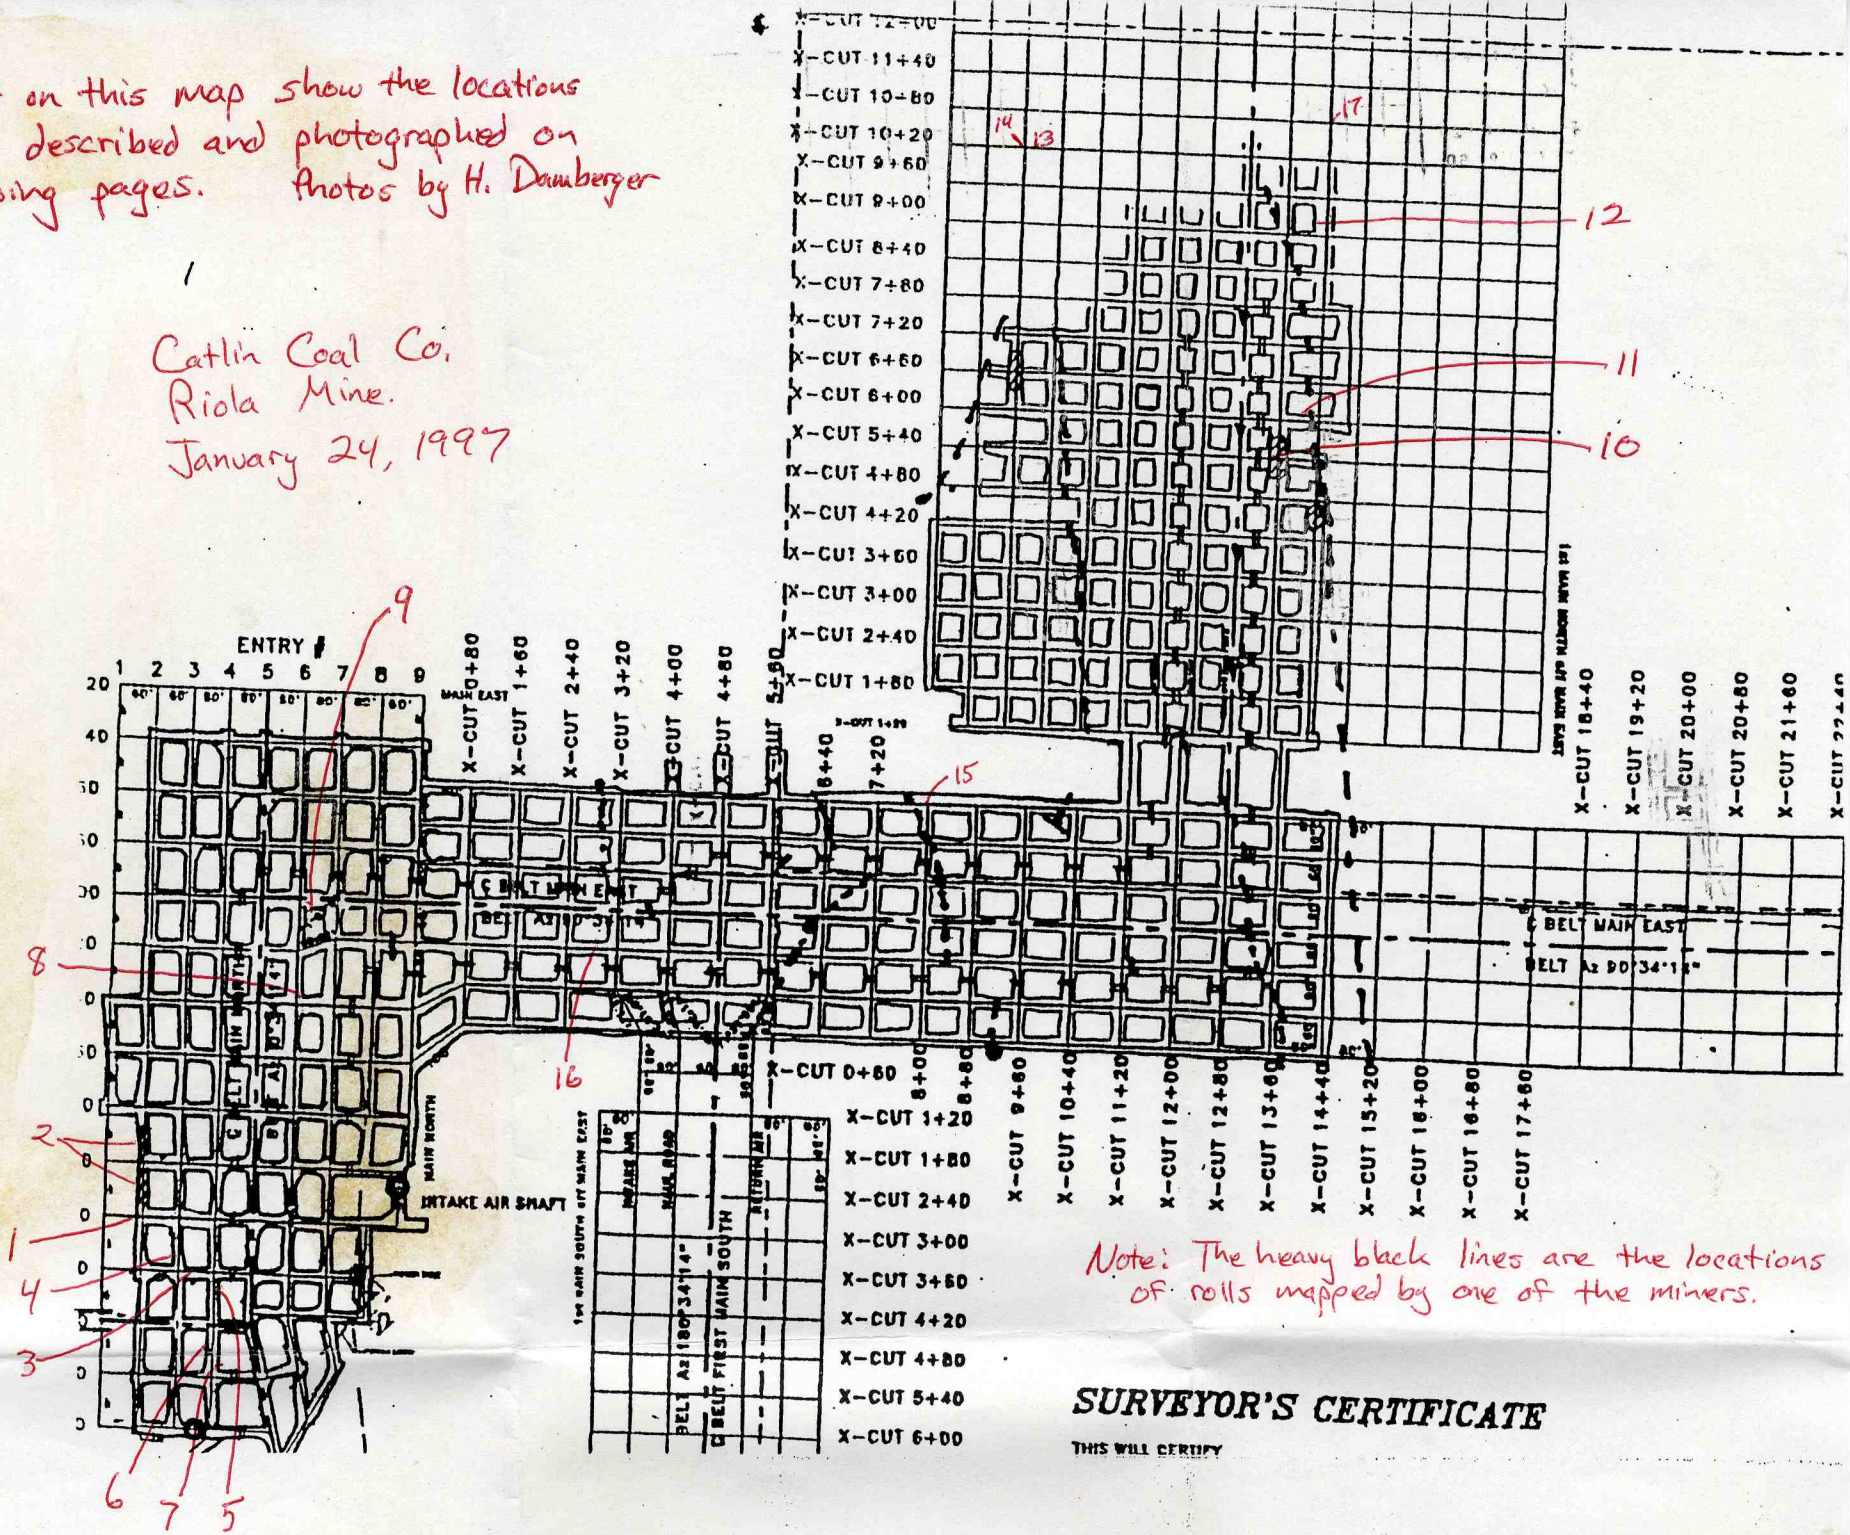
Catlin Coal Co.  
 Riola Mine.  
 January 24, 1997

Note: The heavy black lines are the locations of rolls mapped by one of the miners.

In the meantime, Ray ....? (foreman?) has mapped several roof disturbance features (they didn't have a name for them yet) in the 2nd Main North Panel and put on their 1"=400' scale mine map (see copy below). These features - they turned out to be very similar to the "rolls" we had observed and mapped in several mines with similar "gray shale roof" in the Quality Circle of southern Illinois, during our roof studies in the 1970s - have a definite trend to them: a few degrees W of N, more or less; and they can be traced for hundreds of feet. Charlie said that most of their roof problems in the 2nd Main North panel seem to be related to these features. They are coping with these as best they can. For instance, if feasible they modify the mining pattern so rolls will not run along entries, and particularly intersections; rather, they try to arrange pillars such that rolls are mostly over pillars, and in cross cuts; they also increase the size of pillars locally, or do not mine some rooms, especially near areas of major roof failures, to stop the roof failure from spreading.

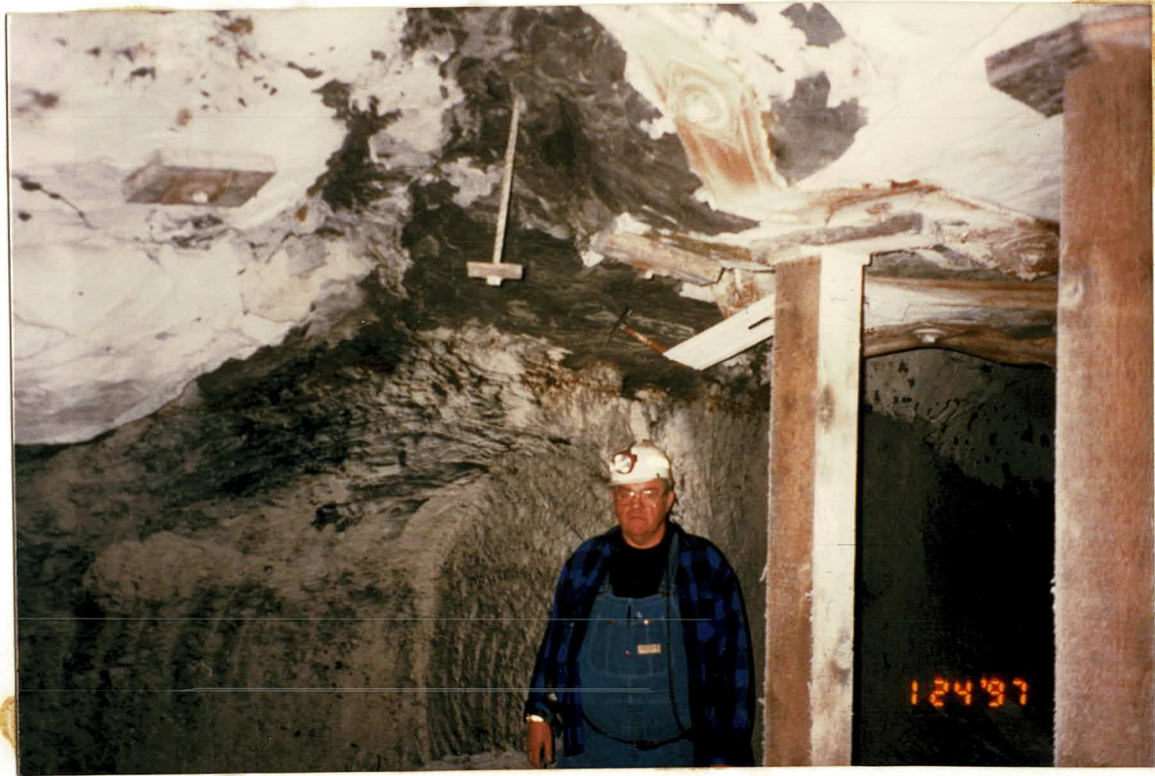
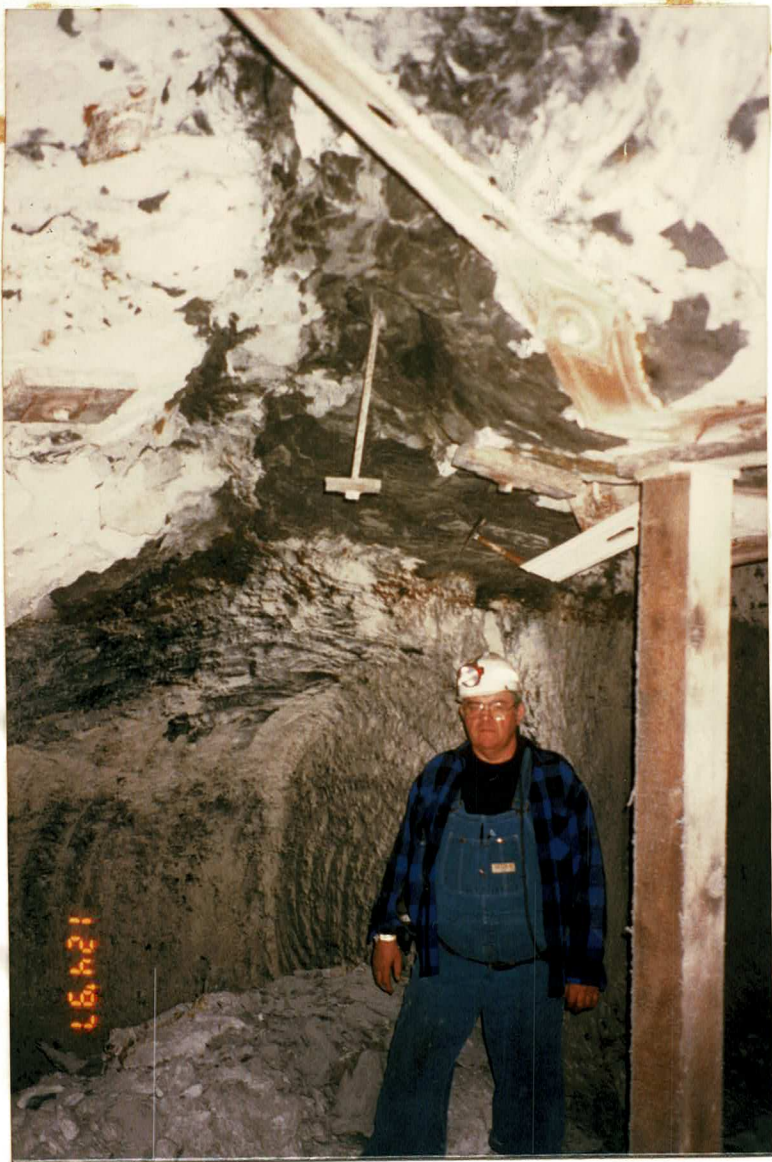
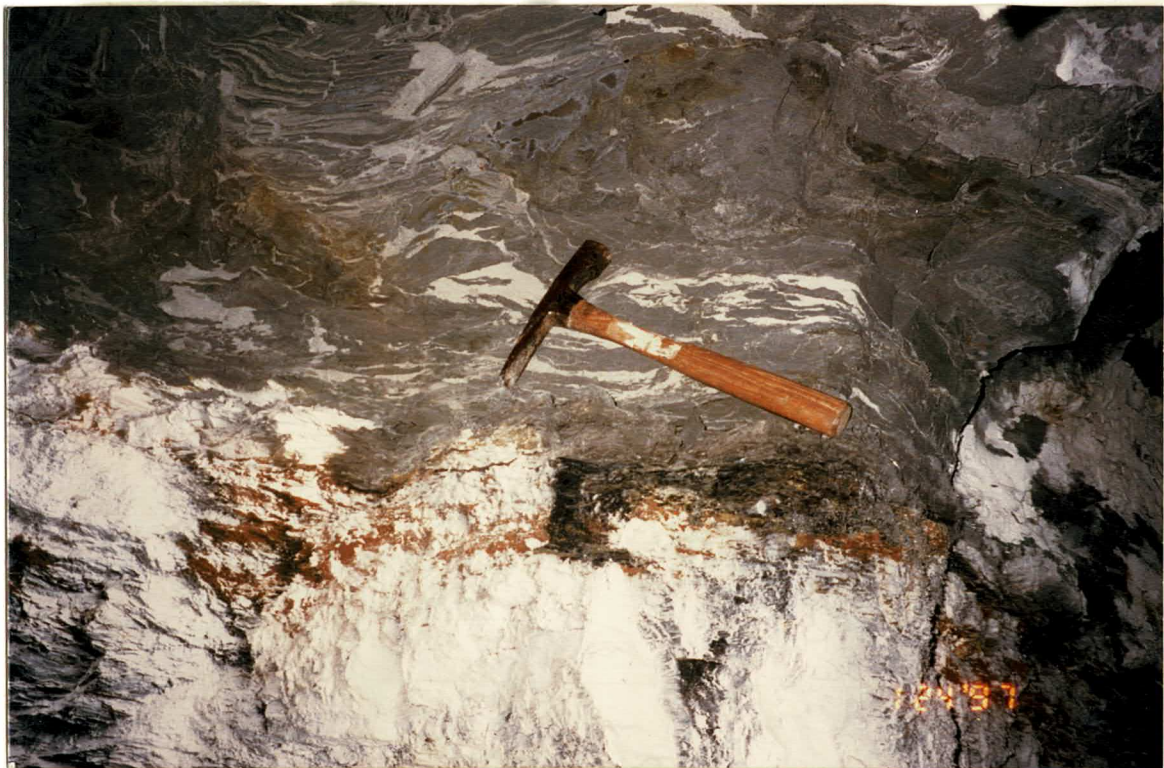
Location 1. The coal rises in elevation about 5 feet. At the top of the rise, the roof is disturbed and consists of grey shale with thin siltstone laminations. There are many indications of soft sediment flow. Thicker bands of silt or fine sand have inclusions of shale and flow structures. In places, the coal appears pulled up into the overlying sediment. Heinz took three photos of the northwest corner of the intersection. Charlie reports that the coal rises and falls in elevation in other parts of the mine and that the floor is usually weak in the low areas.

Another view of the northwest corner of intersection, map location #1.  
Note hammer on wall above Charlie Austin.

Charlie Austin, mine supt.  
Northwest corner of intersection. Map location #1.  
Note hammer on wall above Charlie.

Close up of disturbed sediment. Northwest corner of intersection, Location #1.  
This is a close up of the hammer seen in the previous two pictures.

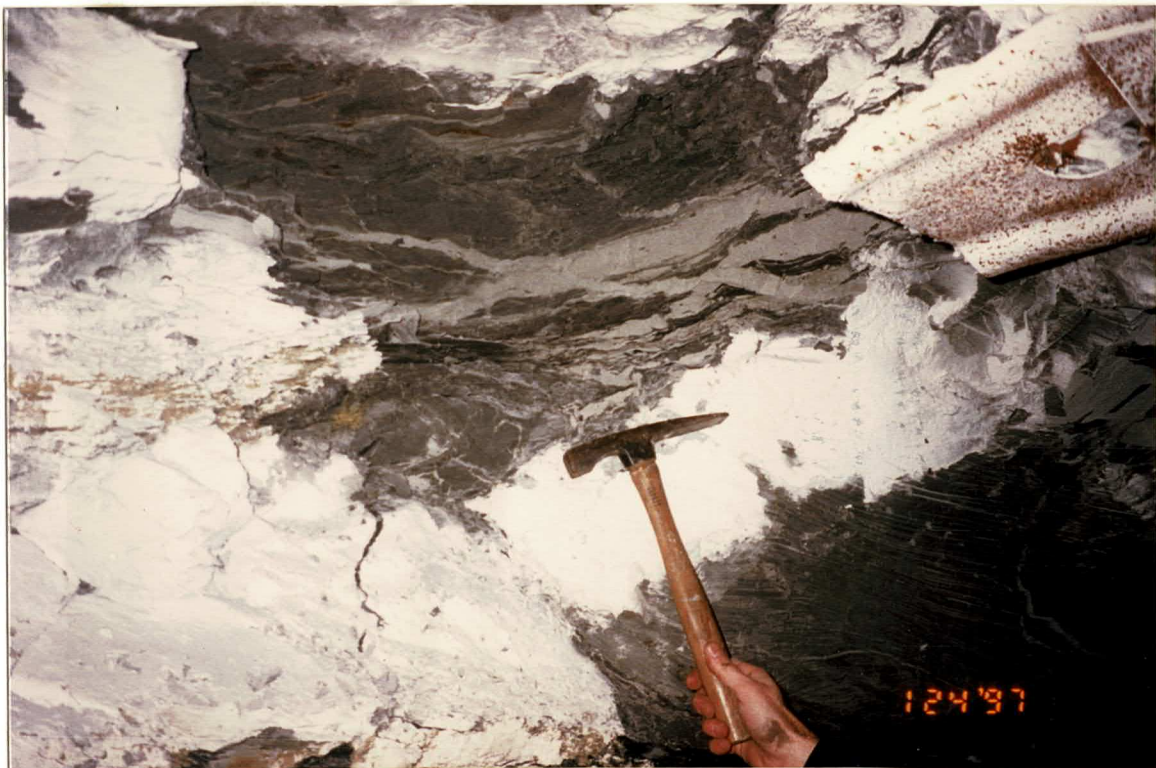
East wall of entry, just south of intersection at map location 1.  
Close-up showing disturbed bedding and sandstone veins in roof above coal.

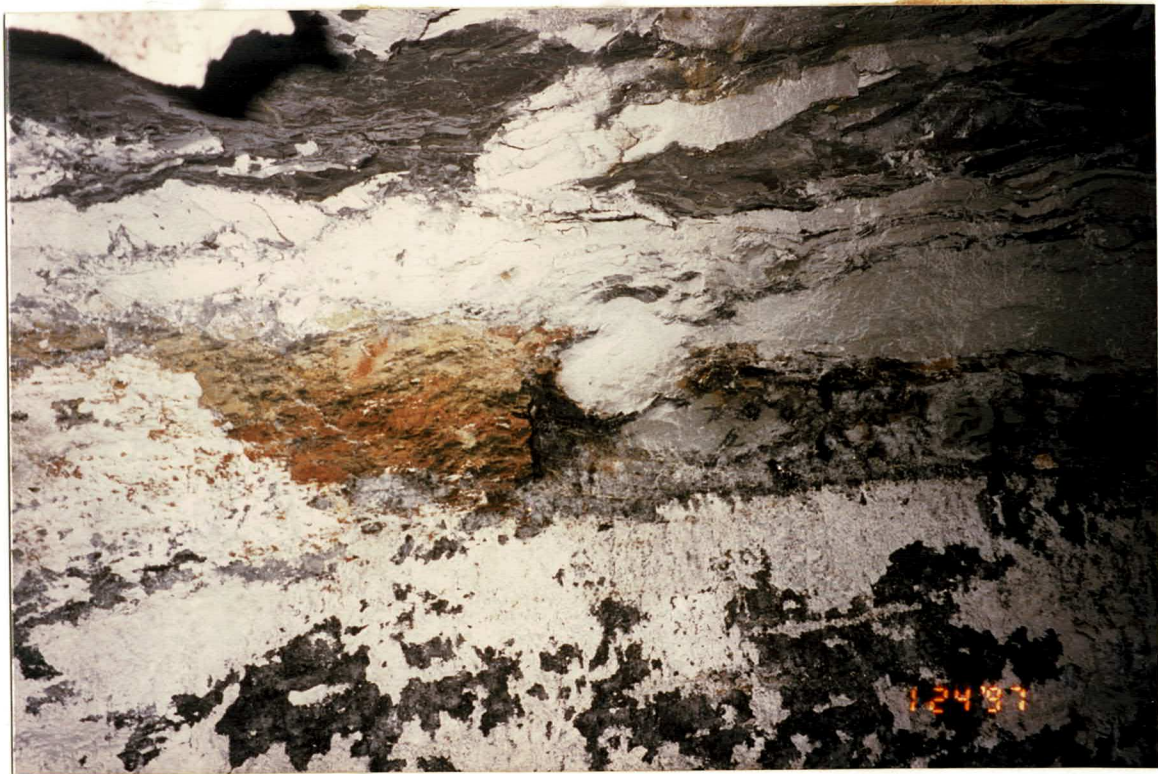
This photo was taken at location 3 or 4. Note disturbed roof sediments, micro faulting, sandstone veins, and irregular contact between coal and roof.

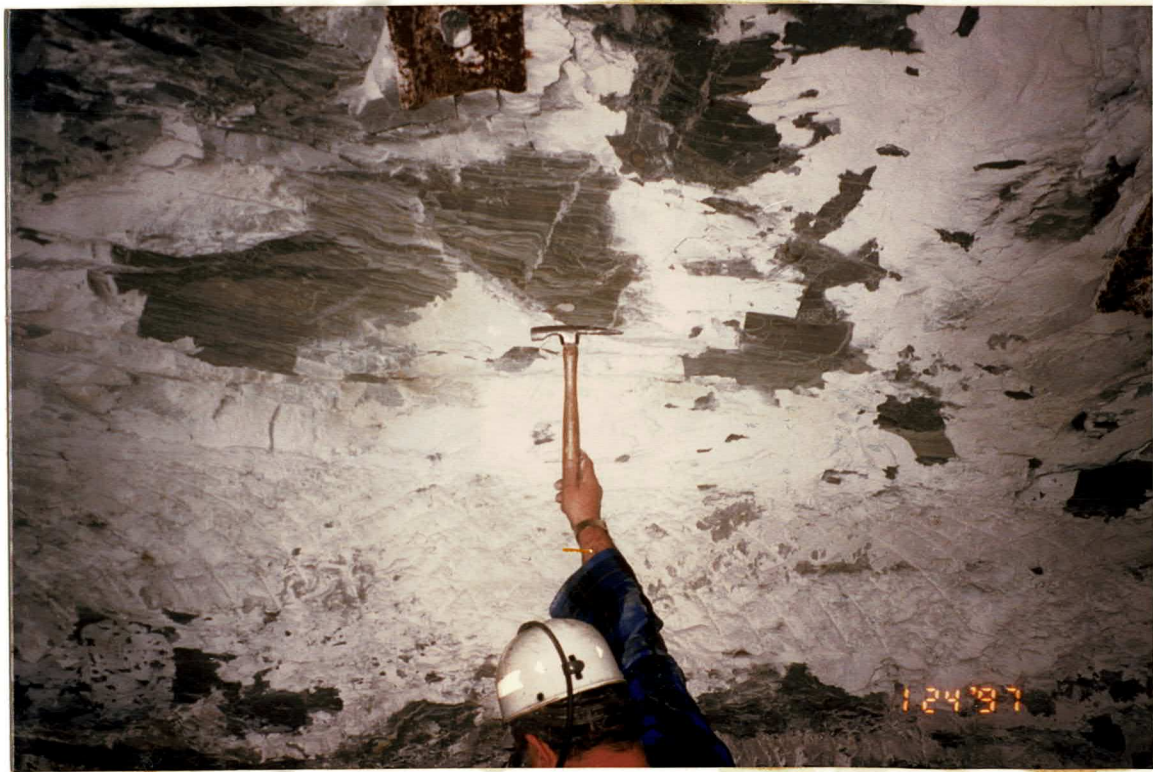
5. A photo of a sand-filled fracture in the roof. Charlie Austin is holding the hammer.
6. A photo of a coal stringer extending up into the roof material. Charlie Austin holds the hammer.

Location #5. Note sand-filled, near vertical fractures in roof sediments.

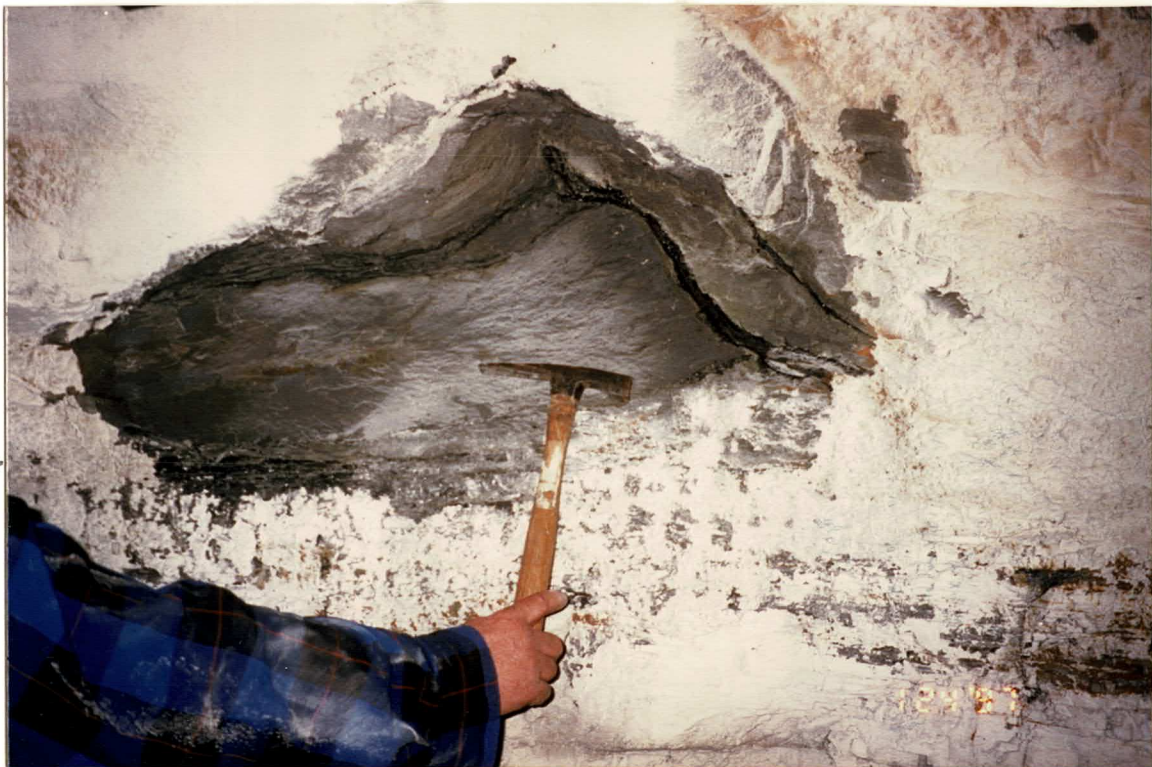
Location #6

A coal stringer extending up into roof sediments.
