Slope Mine  
 RIOLA MINE  
 Mine Index No. 1018  
 Vermilion County

Visit to Riola Mine of Catlin Coal Co.

February 8, 1996

## Visit to Catlin Coal Company's Riola Mine

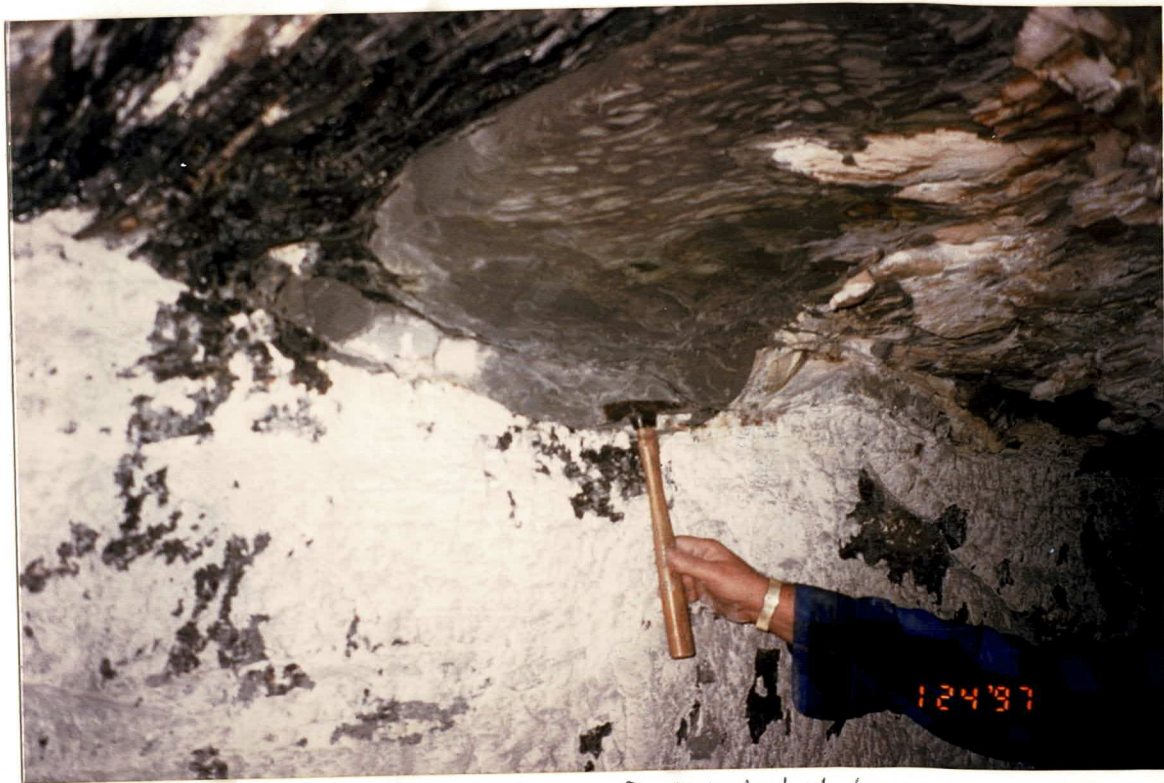
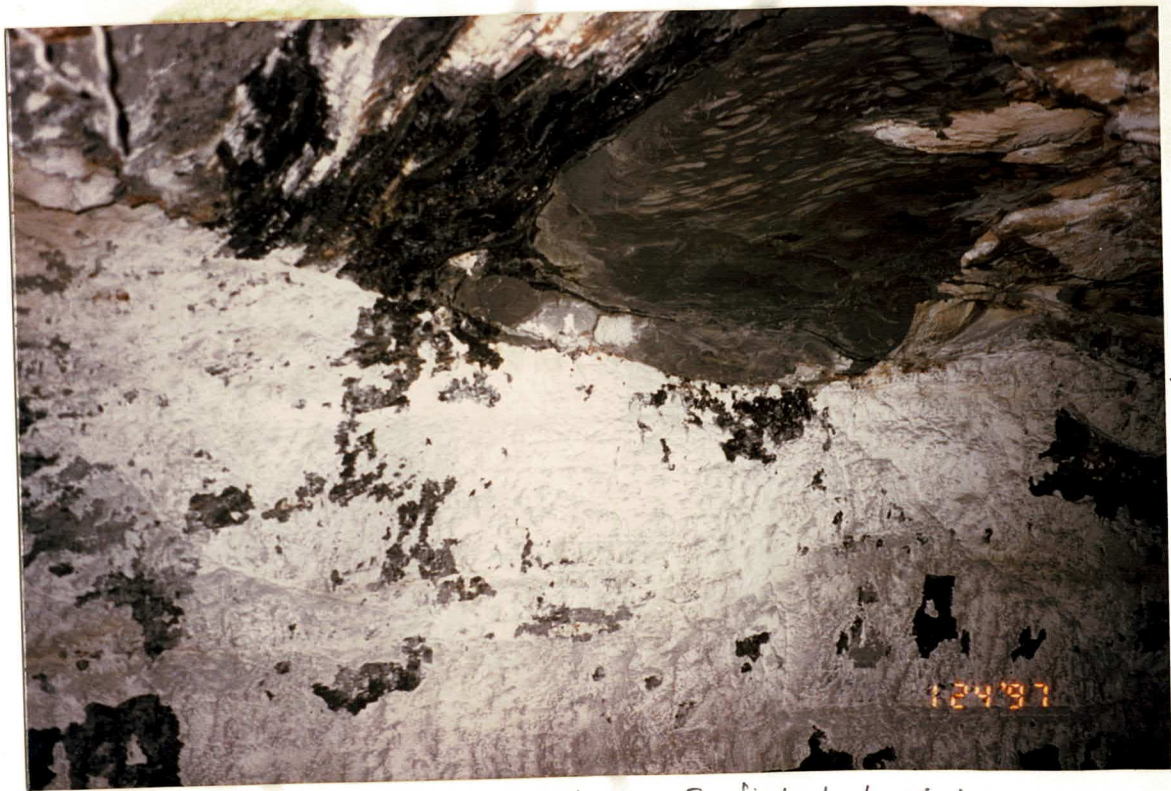
8. A coal rider 4 to 6 inches thick rises from the top of the coal on the west side of the entry to about 3 feet above the coal on the east side of the entry.

Location #7. A coal rider above a lense of disturbed shale.  
The next photo is of this same scene, but better focused.

Location 7. A coal rider above a lense of disturbed shale.

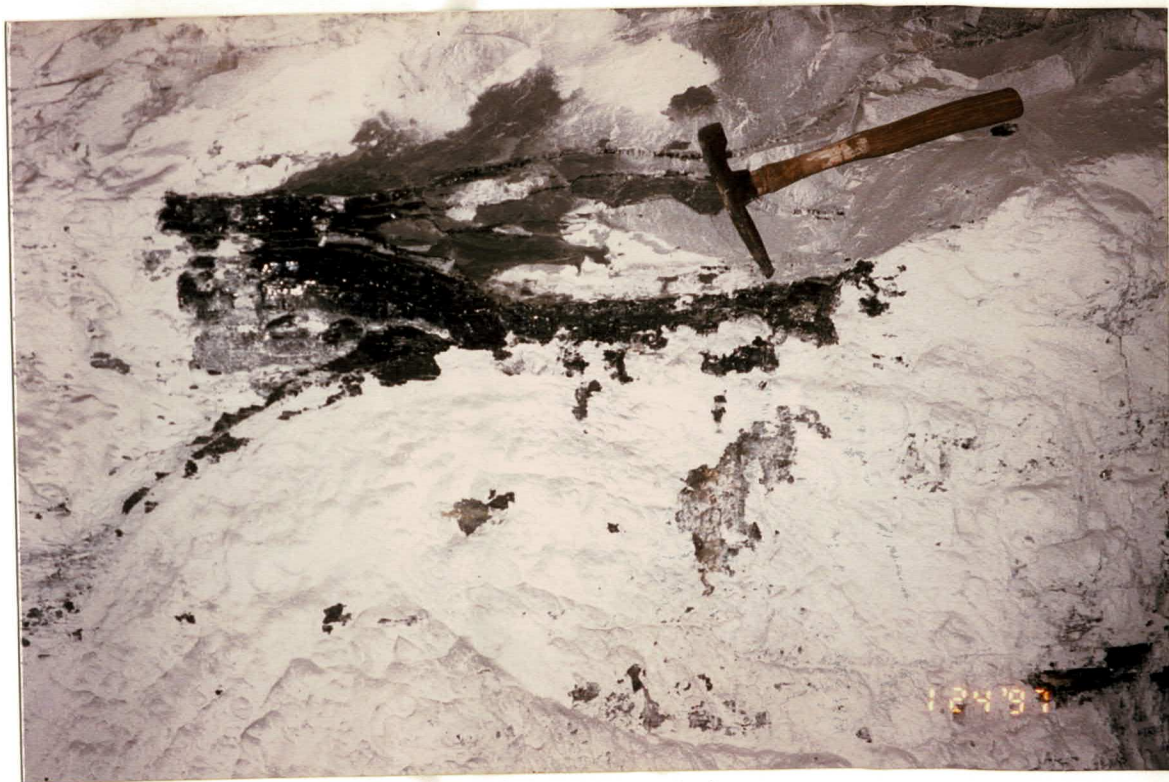
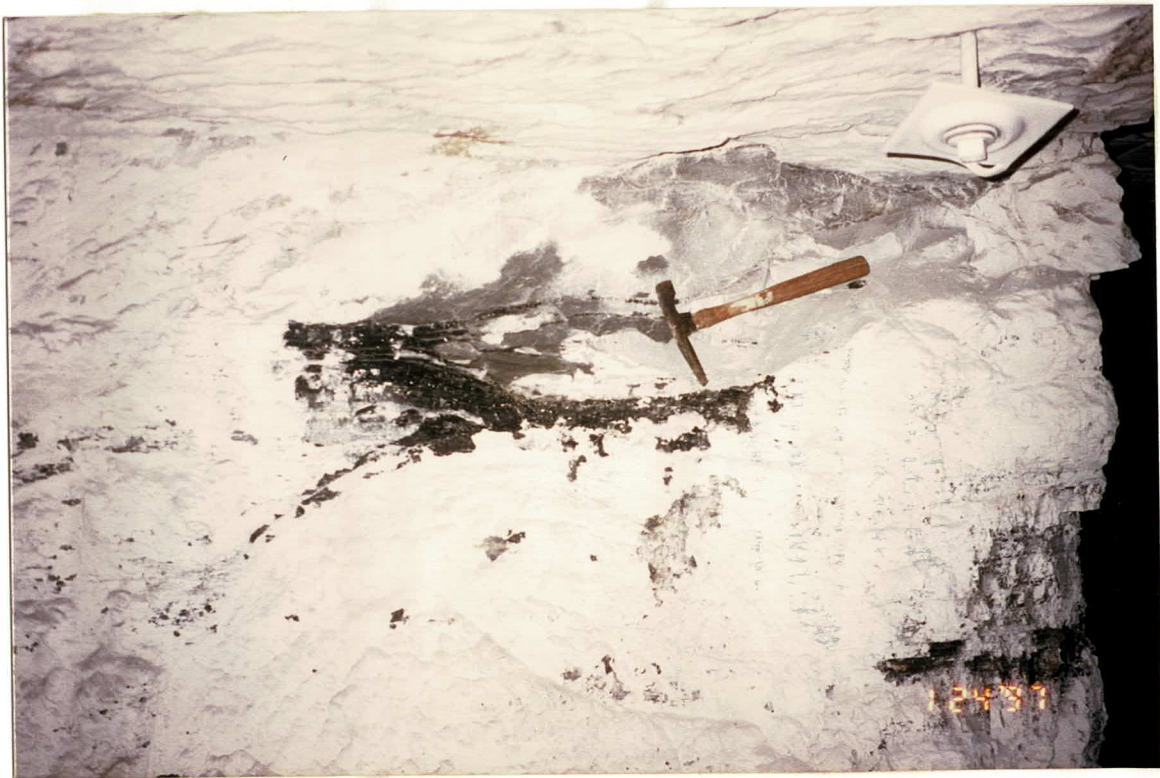
9. Photos taken of a small roll containing sand.

Location #9. A small rock containing sandstone.

Location #9 Another view of the small roll containing sandstone.

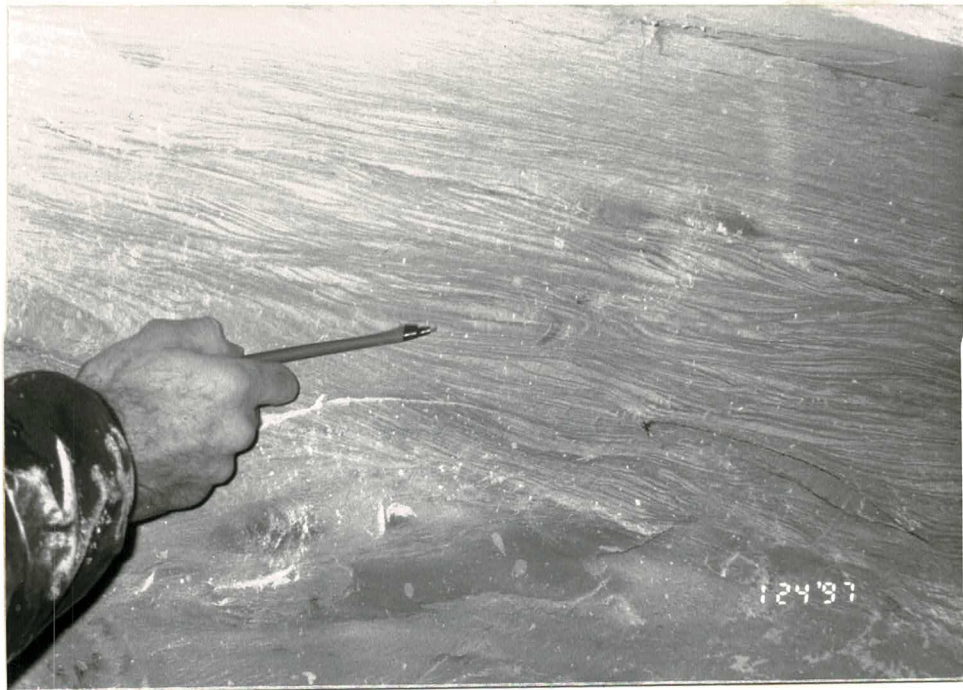
10. Site of a large roof fall. The mine has left the rock on the floor and graded the entry up over it. The roof rock at this location consists of shale with abundant thin laminae of siltstone and a few thin stringers of coal. The bedding of the lower-most sediments is nearly horizontal parallel to the coal, but each succeeding layer is slightly more inclined. At a distance of several feet above the coal the bedding appears to dip about 20 degrees to the north. The rock separates easily along the bedding planes. No major slips or disturbances were observed. Two photos were taken of Colin pointing at the sediments with a pencil.

Location #10, Close up of roof rock

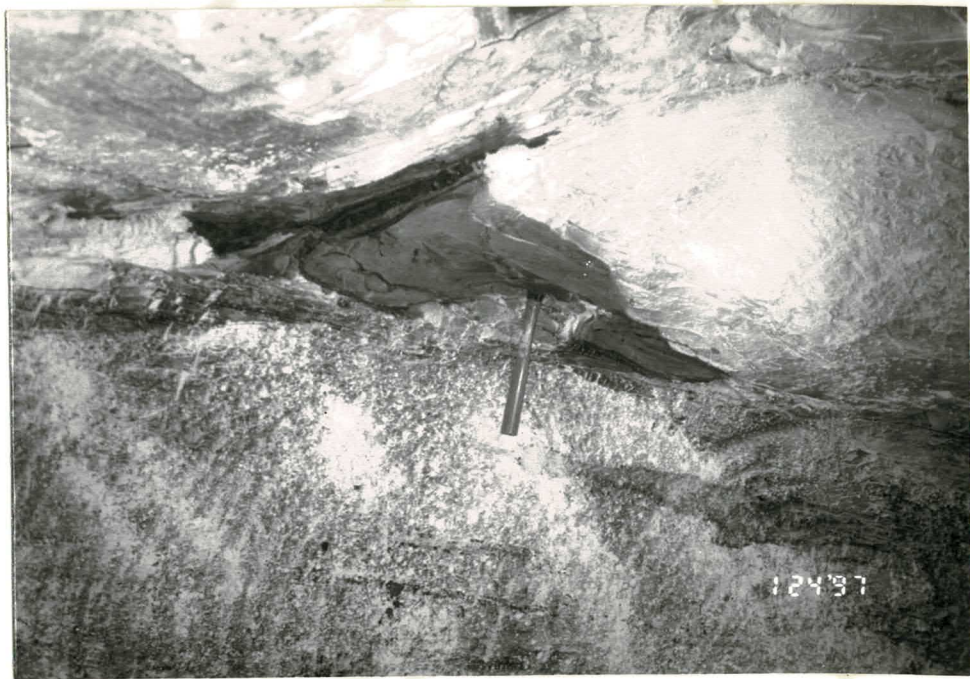
A large roll. Location #11, Riola Mine

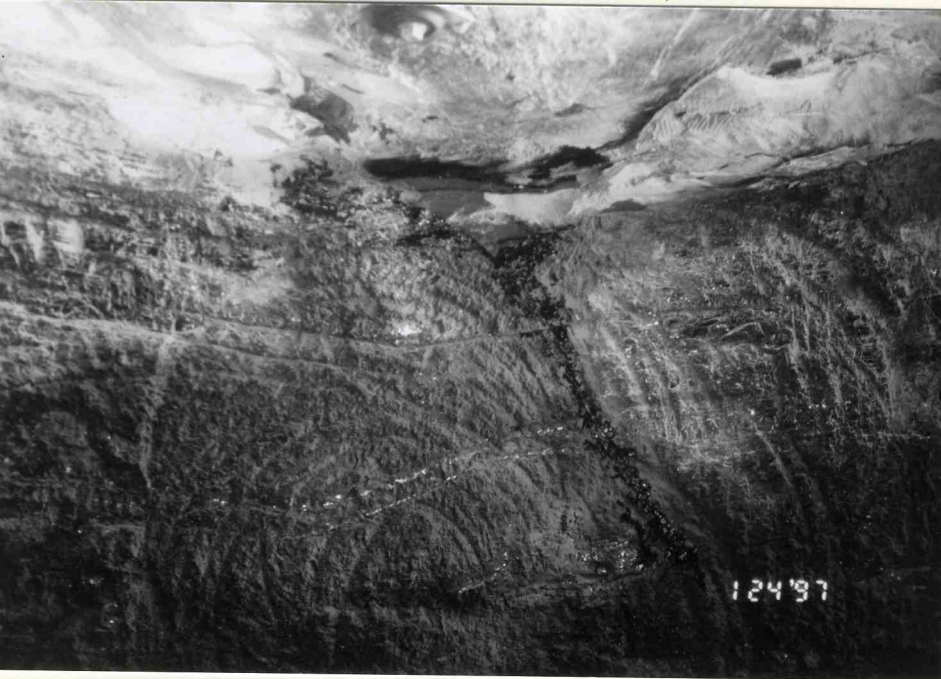
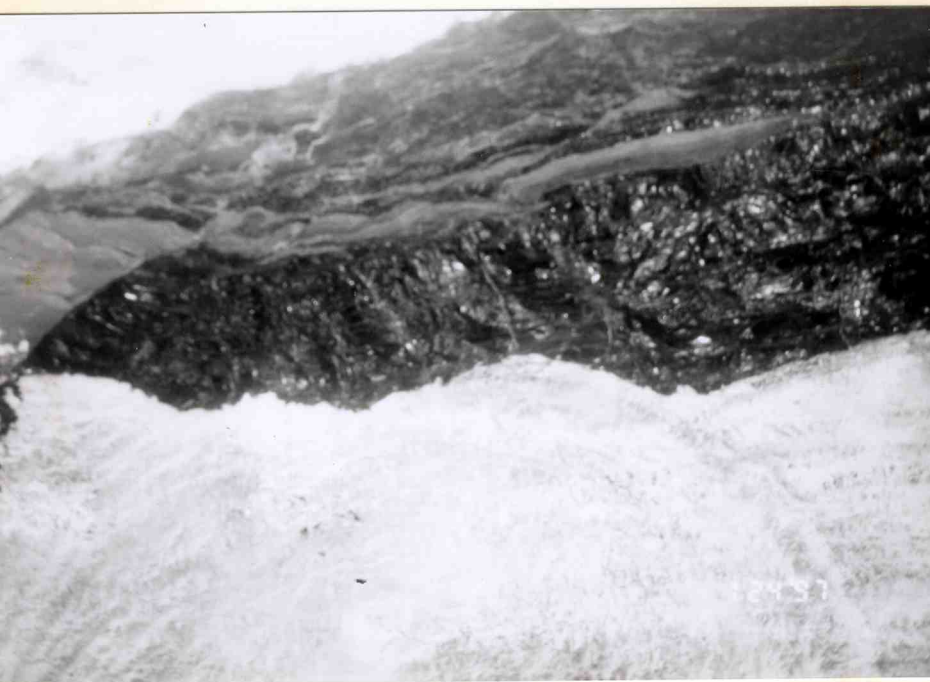
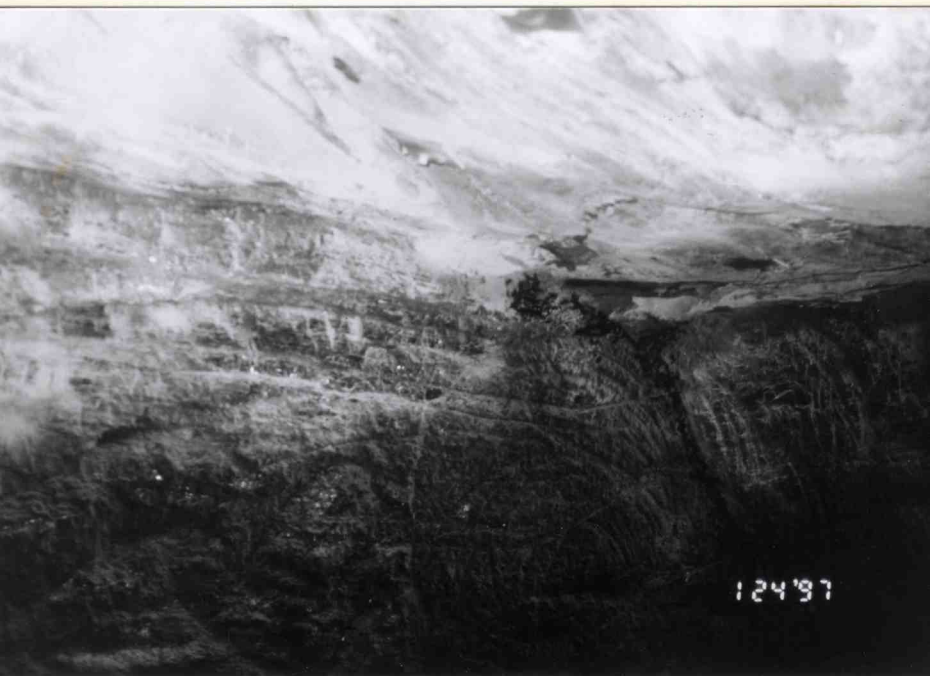
11. Photo of Colin in front of a large roll.
12. Photo showing displacement of the coal in the roof.  
Numerous horizontal tree impressions are in the immediate roof along the entry east of this spot.
13. Photos taken of a roll in the south rib.
14. Photos taken of rolls in the north rib.
15. Shale with thin laminations of silt and some thicker bands of sandstone. There are several slips in the sediments. The coal thins to about 4 feet or less. Water is dripping from the sandstone layers in the roof. The entry to the east has been timbered.
16. The coal thins to about 3 feet for a short distance between cross-cuts. On the south wall the thinning occurs as slip-bounded steps (see sketch). The north wall appears to be smoother.
17. Numerous horizontal tree impressions and two vertical stumps observed in the immediate roof.

Displacement of coal. Location 12, Riola Mine

Displacement of coal into roof rock.  
Location 12                      Riola Mine

Displacement of coal at top of seam.  
 Location #12, Riola Mine

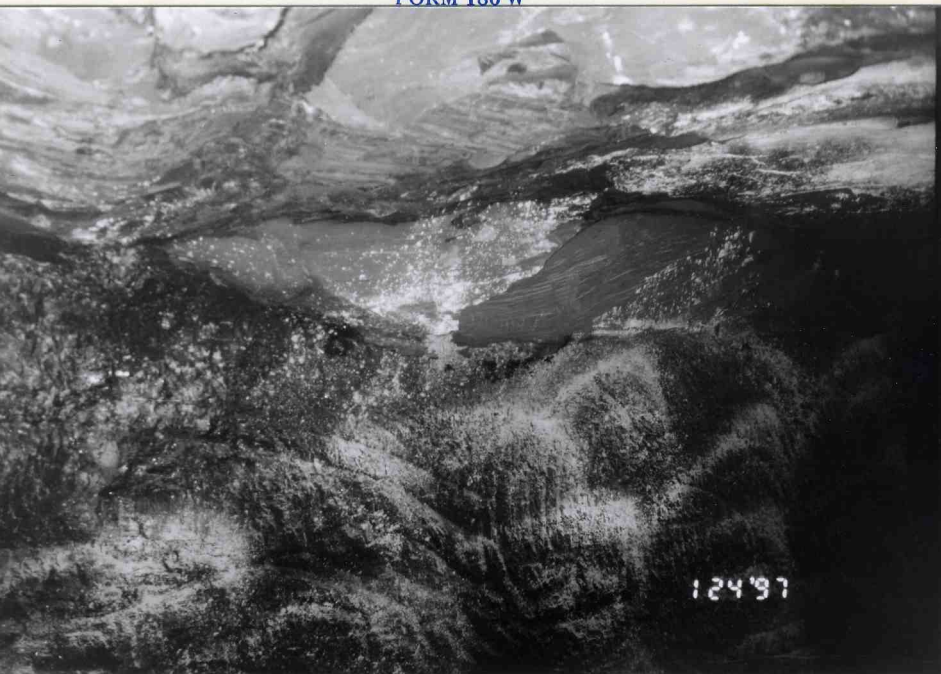
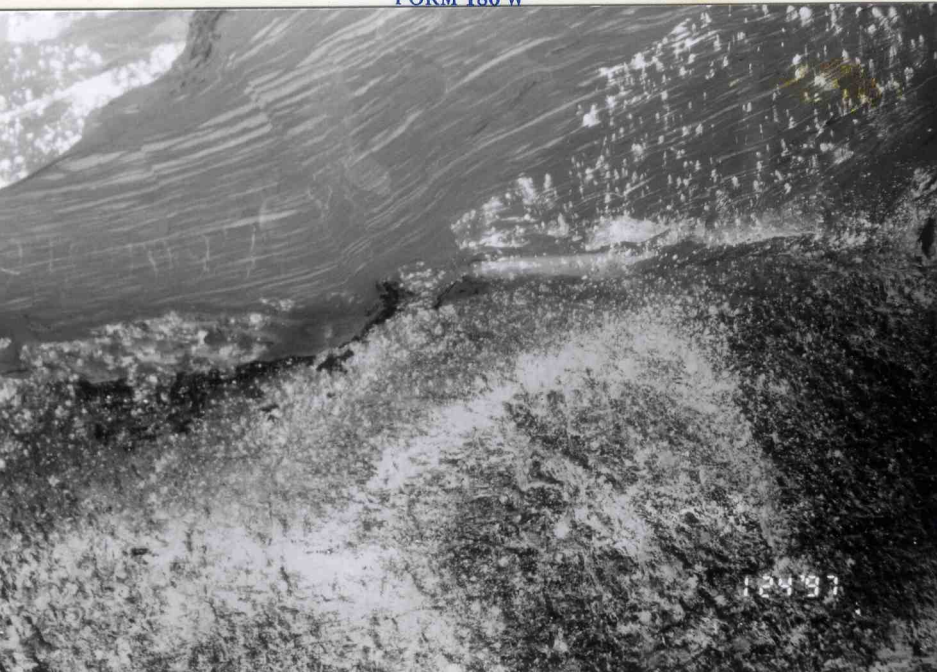
Roll, south rib, location 13

Closeup of roll, south rib, Location 13, Riola Mine

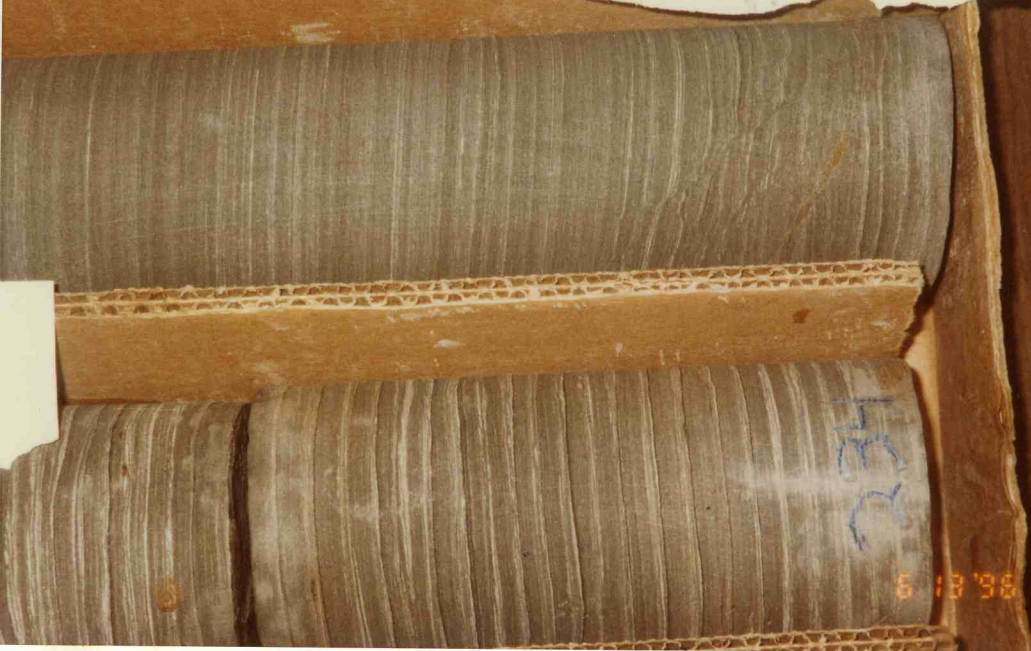
Close-up of micro slumping in core from Catlin Coal Co. hole #2
