Nubay Mining, LLC
Liberty Mine
Saline County, IL

Notes by John Nelson on visit with Tom Moore, Russ Jacobson, Scott Elrick, and Andrew Louchios, February 5, 2004.

Nubay Mining, LLC, Liberty Mine - Saline County, Illinois. Notes by John Nelson on visit with Scott Elrick and David Moore; Bob Clarida and Steve Reynolds from Nubay. August 31, 2005.

Notes by John Nelson on visit with Scott Elrick of the ISGS and Bill DiMichele of the Smithsonian Institution, June 30, 2006.

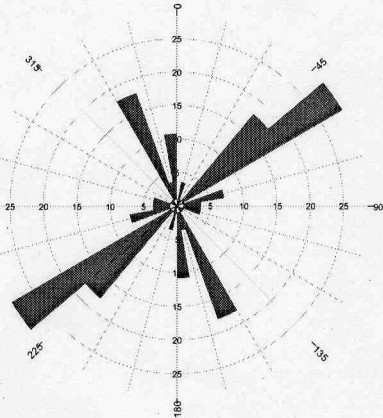
Liberty Mine Coal Cleat Orientations

Direction	Dip Angle	Dip direction	kind of cleat
285	80	S	b
55	90		f
50	85	S	f
355	90		b
55	88	N	f
350	90		b
340	88	E	b
50	90		f
275	90		b
85	90		f
350	90		b
70	90		f
330	90		b
40	90		f
50	90		f
335	90		b
15	90		
70	90		f
45	90		f
45	90		f
40	90		f
335	90		b
55	90		f
50	90		f
40	90		f
335	84	W	b
55	90		f
330	90		b

Calculation Method Frequency
 Class Interval 10 Degrees
 Min.Length Filtering .. Deactivated
 Max.Length Filtering .. Deactivated
 Azimuth Filtering Deactivated
 Data Type Bidirectional
 Population 28
 Maximum Percentage 28.6 Percent
 Mean Percentage 10.0 Percent
 Standard Deviation 8.48 Percent
 Vector Mean 84.83 Degrees
 Confidence Interval ... 26.83 Degrees
 R-mag 0.64
