FIELD NOTES
Illinois State Geological Survey

ARCLAR C C
BIG Ridge Mine
MIndex 1015

Arclar Co. - Big Ridge Mine

Arclar - Big Ridge Mine
1st North off 3rd East
Fault zone examined by
John Nelson, July 1, 1993.
Scale 1:2400 (1 inch = 200 ft.)

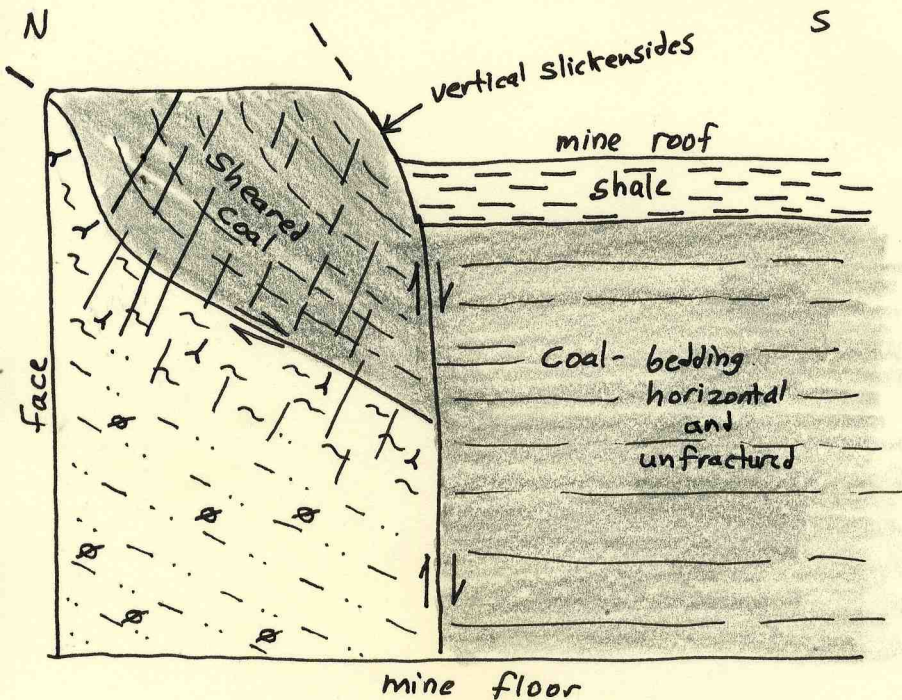
Site 7, view of east rib

- 6) Heading has barely stubbed into a small normal fault south of the main fault. Trend $N70^{\circ}W/70^{\circ}SW$, throw about 2 feet down to SW, and strata are vertical or nearly so.
- 7) Next crosscut to west, exposure of a larger fault that may be a continuation of the one at Site 6. It is a normal fault with the north side upthrown a little more than the height of the entry; underclay

in the footwall is juxtaposed with coal in the hanging wall. The fault bifurcates in dip direction, isolating a lens-shaped slice of coal. See sketch (next page). The steeply dipping segment of the fault strikes N50°W.

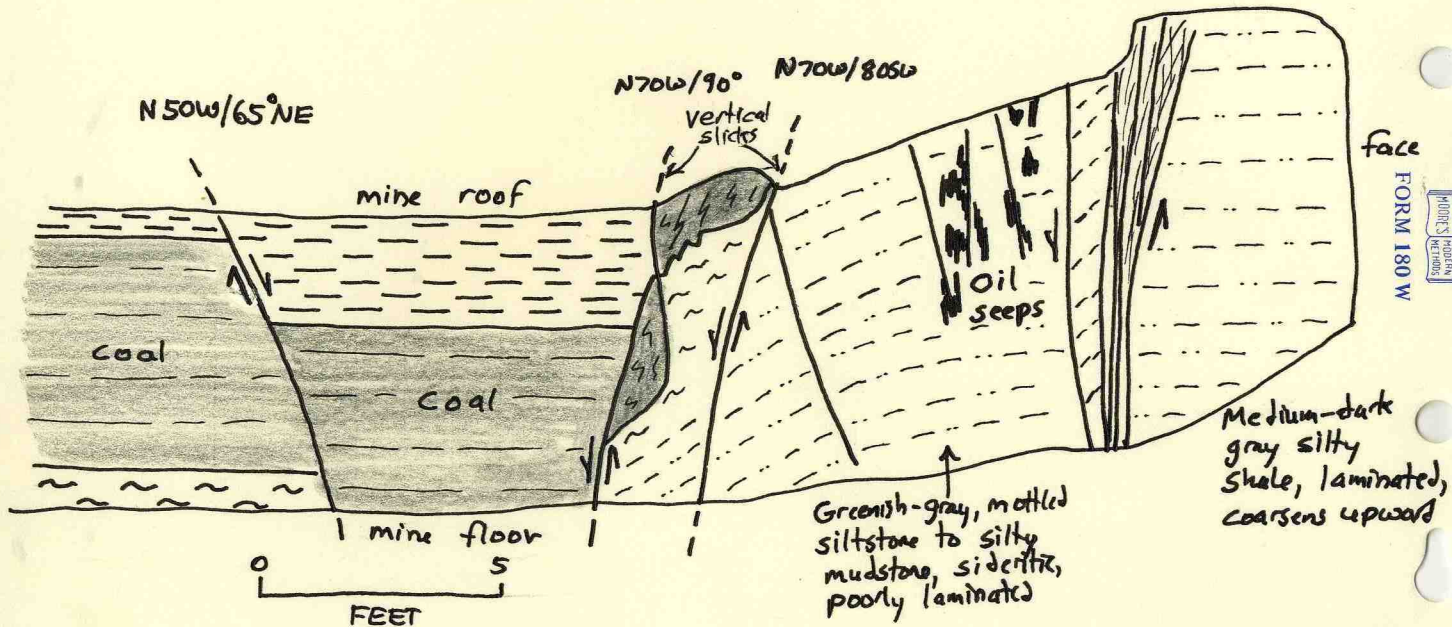
Site 10 - view of west rib

- 8) At corner of Entry 10, a normal fault is exposed—probably the same fault as at 6 and 7 but with larger displacement. Trend N65°W/65°SW, very sharp and planar, thin coal and clay gouge, barely any drag, vertical slickensides. Footwall is light greenish-gray siltstone, grading to claystone at top. Estimated throw 8-10 feet.
- 9) Next heading to west stubbed into normal fault, as at Site 8. Vertical slickensides and a dragged-up slice of coal confirm the displacement being up to the northeast. About 10 feet south of the large normal fault, a small normal fault is present. It strikes N65°W and the throw increases toward the NW.
- 10) North-trending heading has been driven through fault zone, giving the best overall view of both normal and strike-slip faults. (See sketch, next page.)

The fault nearest the face (northernmost) has horizontal mullion and slickensides with faint overprint of vertical slicks. Strong drag in a fault slice along this fault indicates displacement down to the south. All the other faults here are normal faults; slicks indicate pure dip-slip, or nearly so.

Zone trends
N 70W / 88° S.

Note the oil seeps adjacent to the strike-slip fault. A small amount of gas and occasional drips of water are coming from the large normal fault.
