HARRISBURG COAL CO.  
MINE # 1

HARRISBURG COAL COMPANY      WILLIAMSON COUNTY

Visit by John Nelson 9/21/77

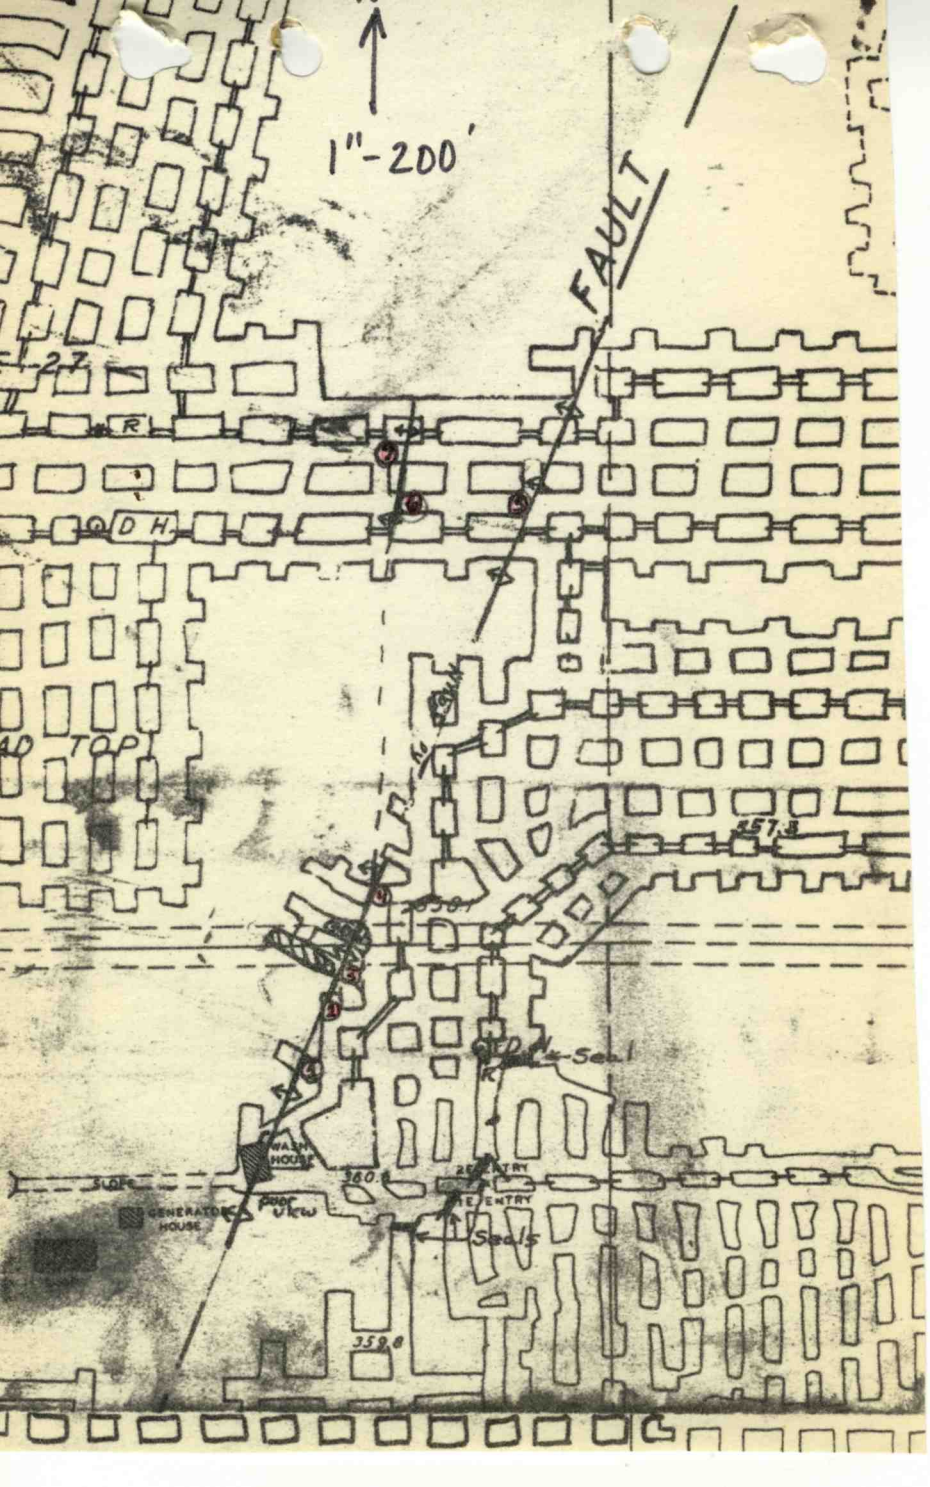
#### Numbers Refer to Locations on Map

The main reason for visiting this mine, aside from general interest, was to examine the fault shown on company maps crossing near the slope bottom. This is one of three fault systems shown on the map; all trend N-S or slightly east of north. The fault near the bottom is the only one currently accessible.

- 1.) Fault as seen here is a low-angle reverse fault trending about 045/20 SE with the SE block thrust over

the NW block. Vertical displacement at the top of the coal is 0.75' on the north rib and 1.1' on the south rib. Slickensides on the fault plane trend in dip direction. The fault cuts all of the exposed coal seam and roof.

Along the fault plane is a zone of crushed coal an inch or more wide. The fault plane splits and some branches appear to die out along bedding planes.

2.) This room barely mined into the fault. A low-angle shear plane with pulverized coal is visible near the floor at the face. Impossible to tell much here.

3.) Room driven across fault. All of the roof below the fault plane has fallen out as far back as I can see. There is a zone of crushed and contorted shale along the fault plane and this turned to mud making a very bad plane of weakness in the roof.

4 ) Fault not seen in this area. According to Andy Jones it has turned to a due north heading and the rooms were not driven far enough west to intersect it. There is said to be bad top at the faces of the rooms, which are inaccessible due to gob and standing water.

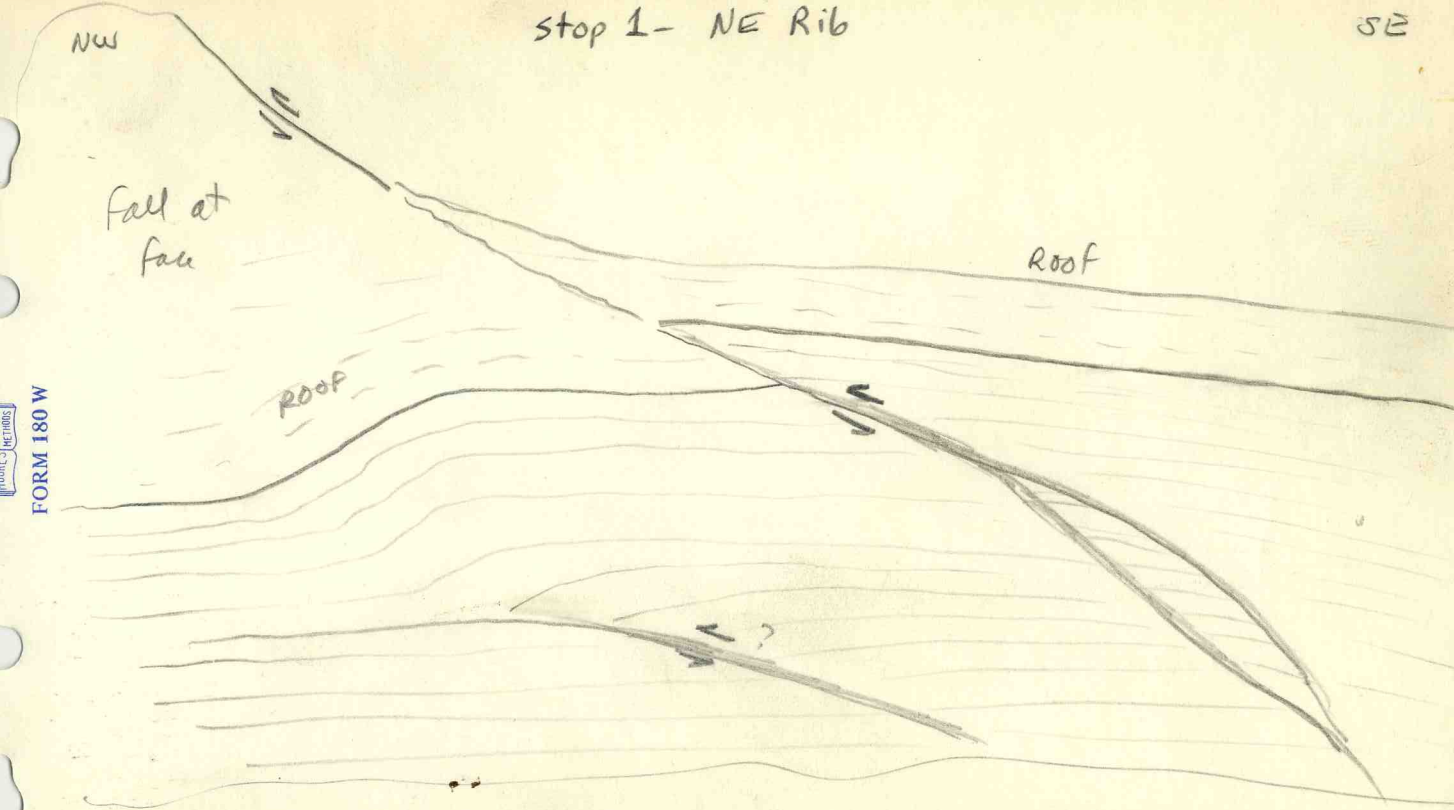
stop 1 - NE Rib

The roof consists of shale, medium-dark gray, moderately hard, well-bedded, finely silty, and finely carbonaceous. It forms excellent top away from the fault zone though there are a few narrow open fractures parallel with the fault.

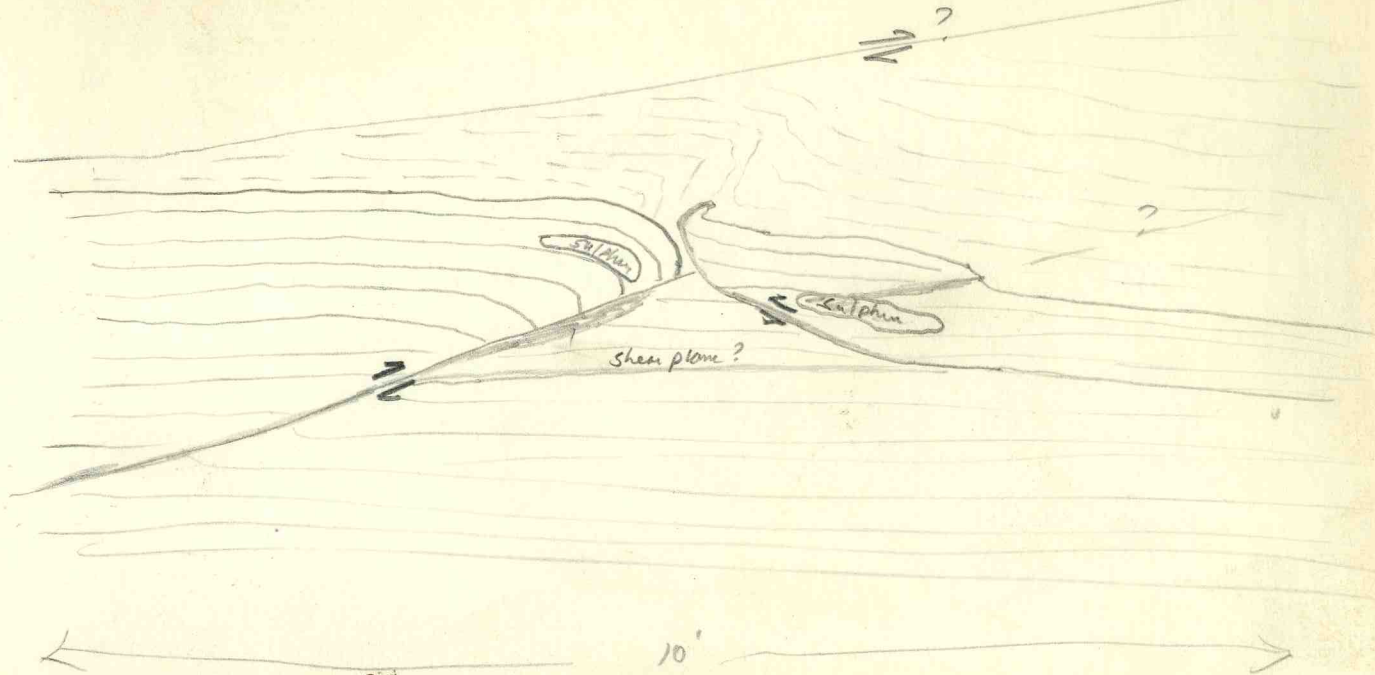
stop 3 - S Rib

The coal seam is barely displaced here but effects of shearing and folding are obvious. See sketch. Note in sketch low-angle fault antithetic to main (SE-dipping) fault.

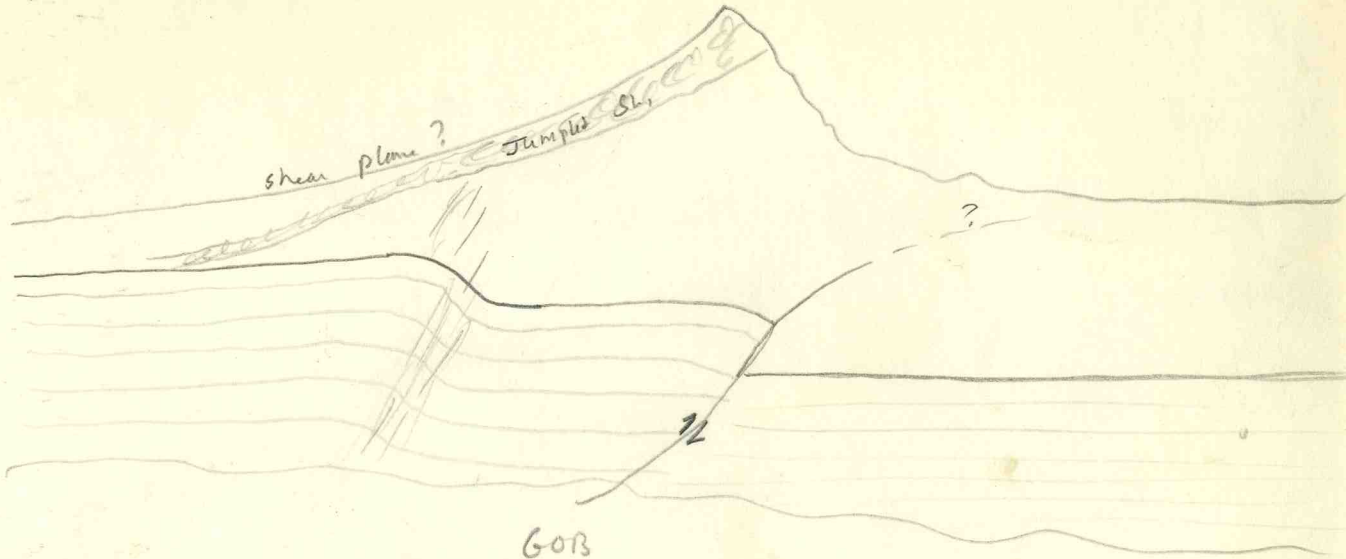
stop 5 S ~20' W

5.) Faults here appear as a zone of multiple fractures. To the north the crosscut has fallen in along a series of fractures trending 015-025. All of these dip westward at moderate to almost vertical angles. It appears that some may curve sharply, becoming horizontal. The fractures are not easy to trace in the roof shale because weathering has removed the slickensides.

West of the intersection is a flexure and a small reverse fault in the coal (see sketch). The thrusting again is toward the west. Note in the sketches that the fault plane and fold axes are steeper than those seen at previous stops. This view is of the south rib. There is a shallow reverse fault on the north rib, but it is poorly exposed.

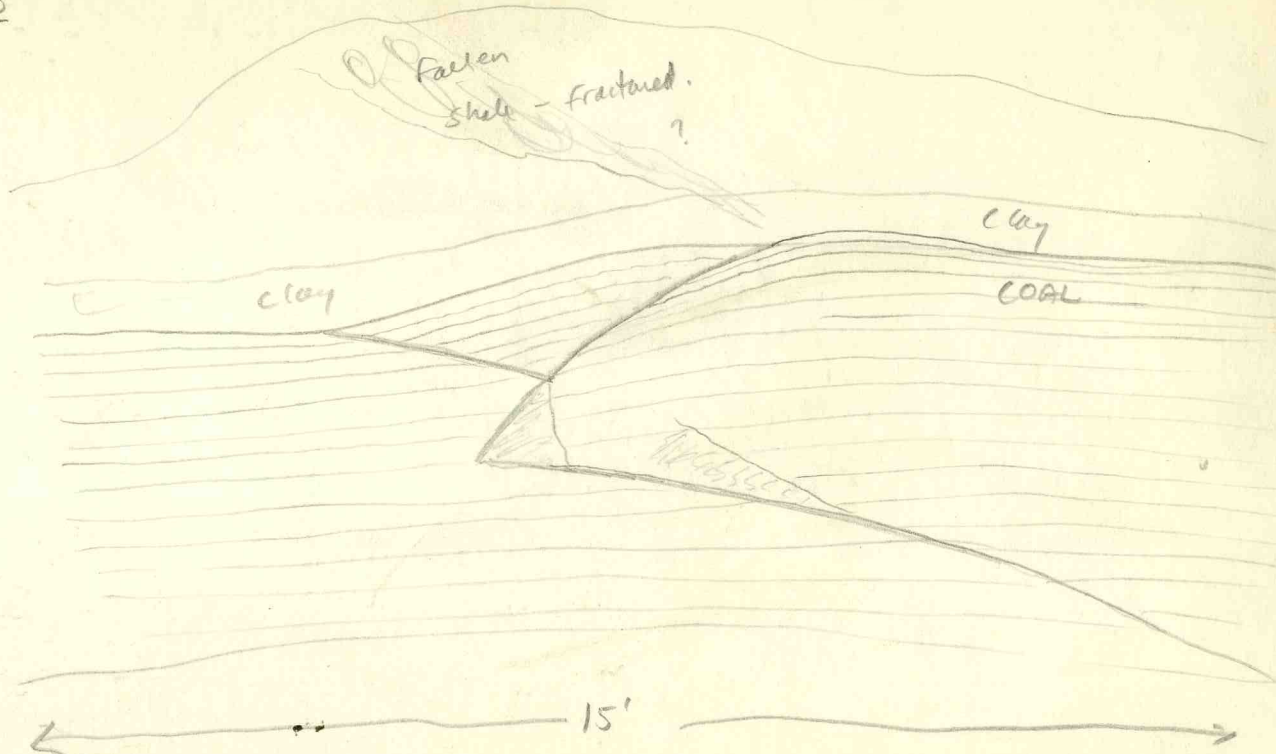
Stop 6 Looking S

6.) Another fault zone about 200' west of that at Stop 5. Mostly low-angle to horizontal shearing is seen, with practically no vertical offset. Difficult to determine directions of movement. See sketch.
