American Coal Company - Millennium Portal Mine - Saline County

Notes by John Nelson on visit with Tom Moore and Russ Jacobson, accompanied by Greg Smith from the company, February 19, 2004

**American Coal Company - Galatia Mine - Millenium Portal
Saline County, Illinois**

Notes by John Nelson on visit with Greg Smith of American Coal,
January 9, 2004.

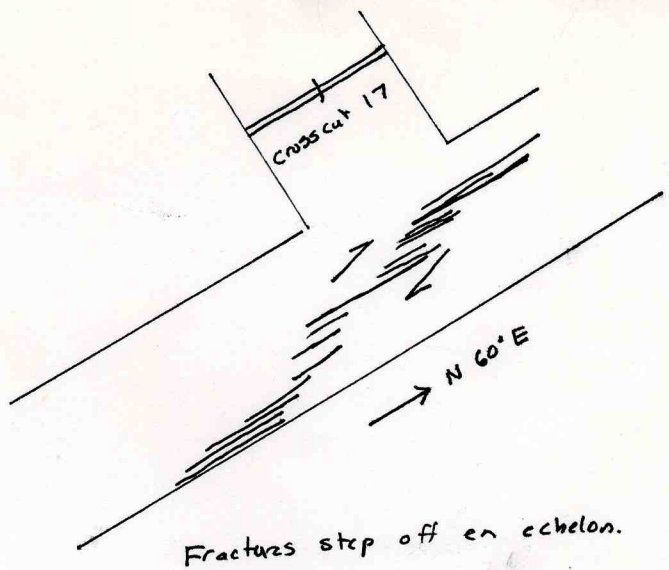
On belt entry between crosscuts 16 and 17, a water-bearing fracture zone strikes N 60° E. This is a bundle or swarm of parallel joints that step off to the left, in *en echelon* fashion, as you walk along them. Crushed shale and mud fills the wider fractures, and water is pouring out in many places. Continuing northeast, the intense fracture zone dies out into ordinary joints.

Fractures step off en echelon.

The fracture pattern in both cases suggests right-lateral strike slip.

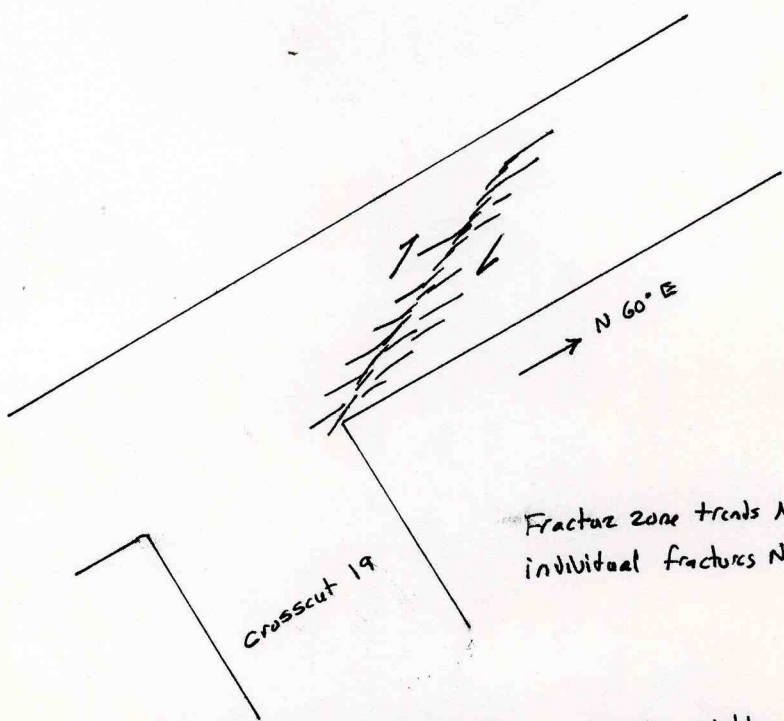
On the travelway (middle entry) between crosscuts 19 and 20, a fracture zone strikes N 25° E and dips vertically or nearly so. The shale is crushed, and the N 25° E fracture is flanked on both sides by closely-spaced N 60° E fractures that extend only a few feet away. This feature is presently dry. See sketch.

Fracture zone trends N 25° E, individual fractures N 60° E.
