Truax-Traer Coal Co. Hillsboro Mine

CONSOLIDATION COAL CO.
HILLSBORO MINE

Mine Index No. 871
Coal Report No. S-5

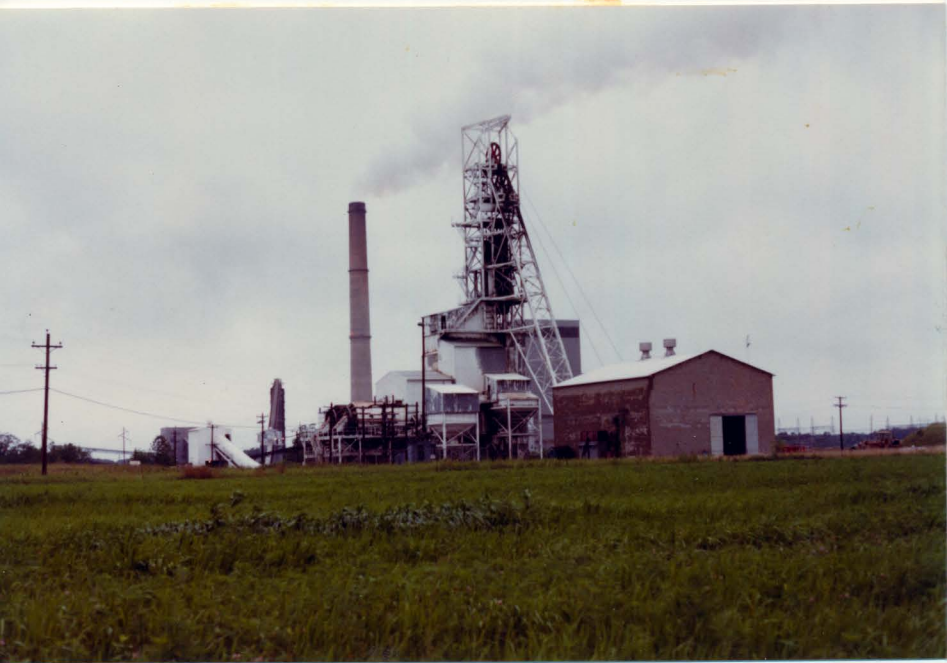
mn-22-001, JJP

Skip shaft of the Hillsboro Mine, with
smokestack of the C.I.P.S. power plant
behind. Note twin rotary crushers
(just below stack) and overland conveyor
belt that carries crushed coal from the
mine to the power plant.

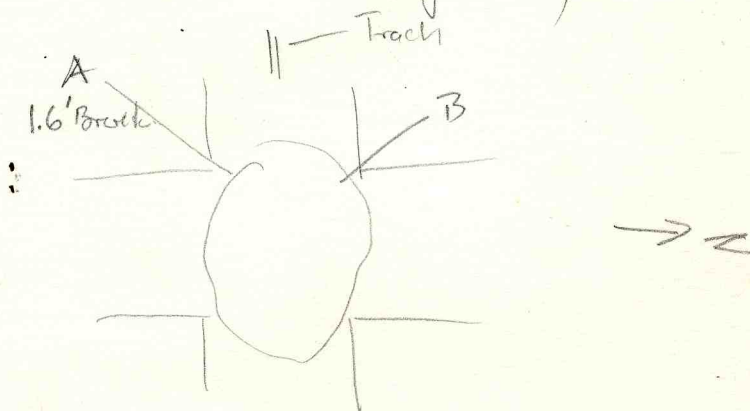
Hillsboro Man East at intersect west of
3rd North Roof Fall in Brucke and
"Amul Rock" (Lawson with Conglomerate.)

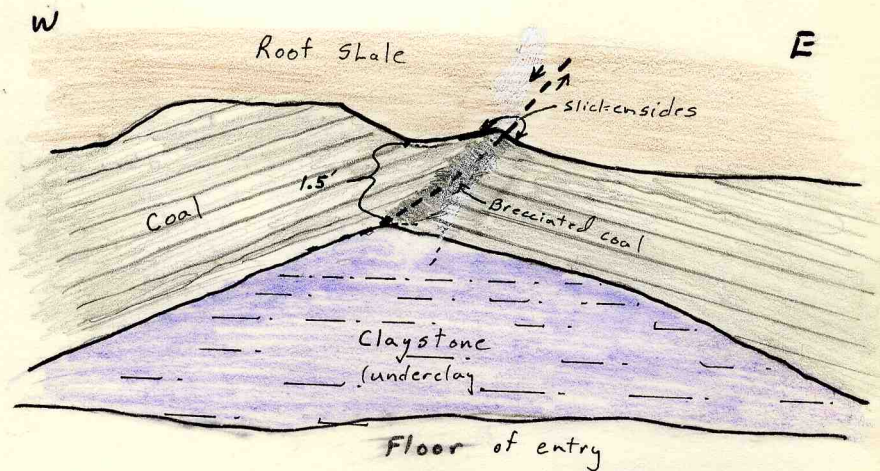
Fault: (2nd South Submains off Main East)
Trends N40W across entry. Fault area
is a topographic low in this entry. Faulted
area is approximately 50 ft. wide. Coal on
east side of fault dips to east at approx. 20
degrees. Sharp contact with underclay (clst).

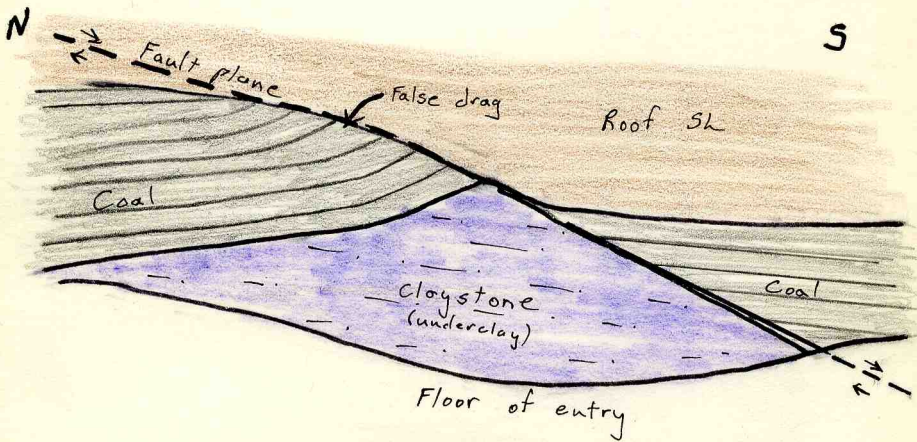
Fault: (2nd South Submains off Main East)
Coal on north side of fault is inclined with evidence of false drag. Coal on south side is level. Moderately sharp contact along fault; little or no gouge (breccia).

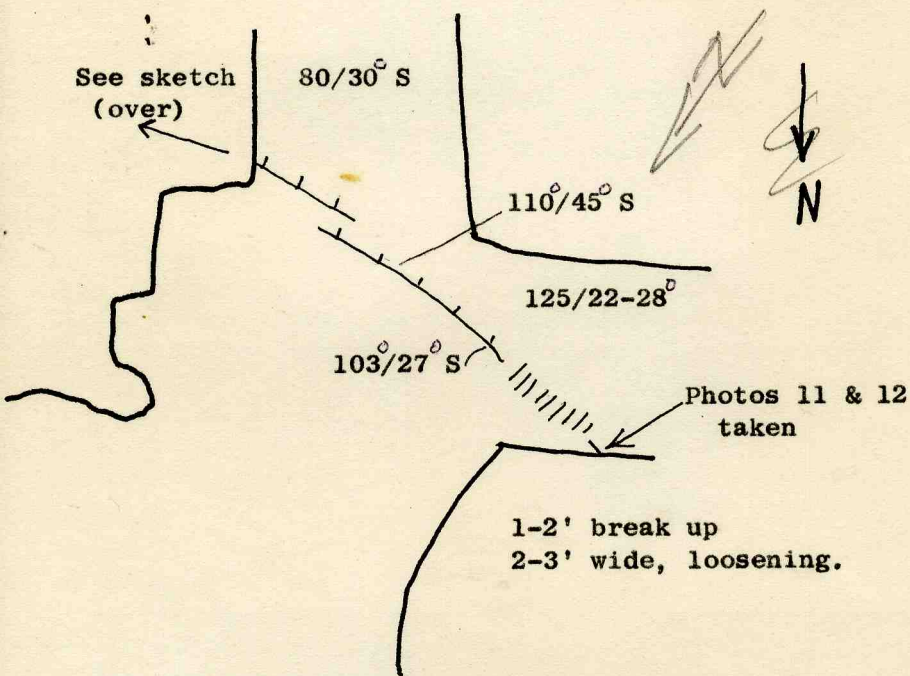
- ① H.F. Krause took notes. station H.F.K. #1
- ② Slip in crosscut (see drawing below.)

Photos show "Bastard Limestone" lense with several slips around and through.

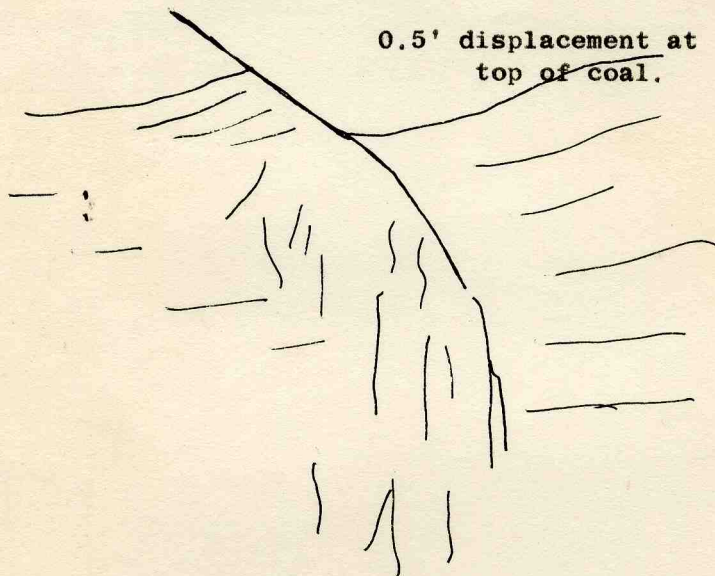
Side view of slip from Note 2.

Calcite slickens.

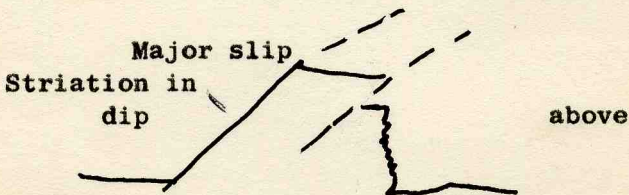
36. Major slip 35-40 87, with parallel sub-slips, small fall above belt 1.5-2'

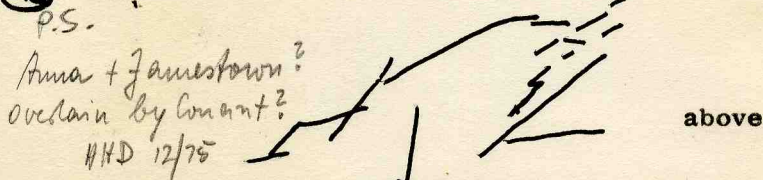
37. Fall 3-4' high, mostly between two prominent slips.

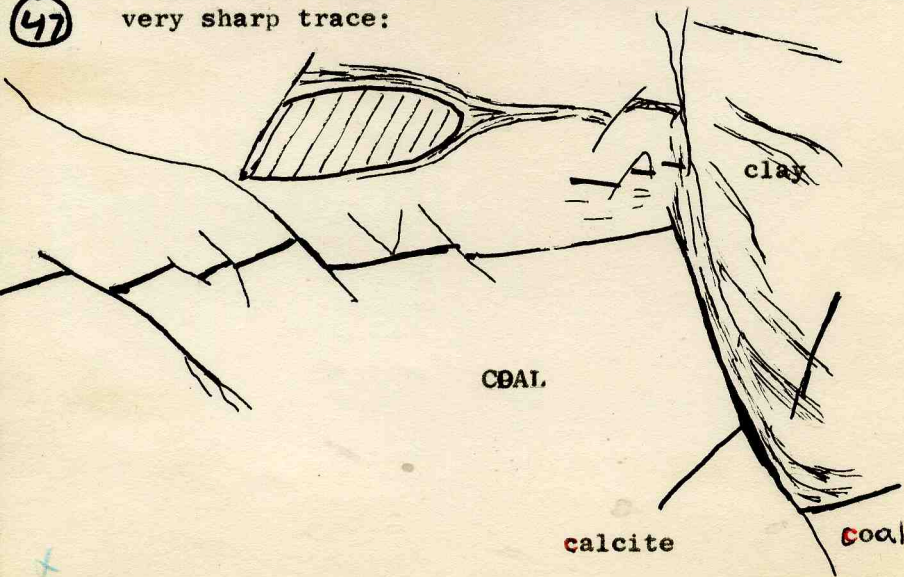
38. Major slip with 1.8' displacement at top of coal, very sharp trace:

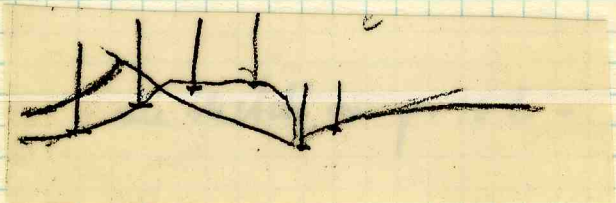
40. Some uncontrolled falls - looks like roof fall, but roughness is mostly caused by shallow dip of fault and switch in control level:

Whole cross cut up to stop badly disturbed, fault plane cuts well into coal but seems to peter out within coal.

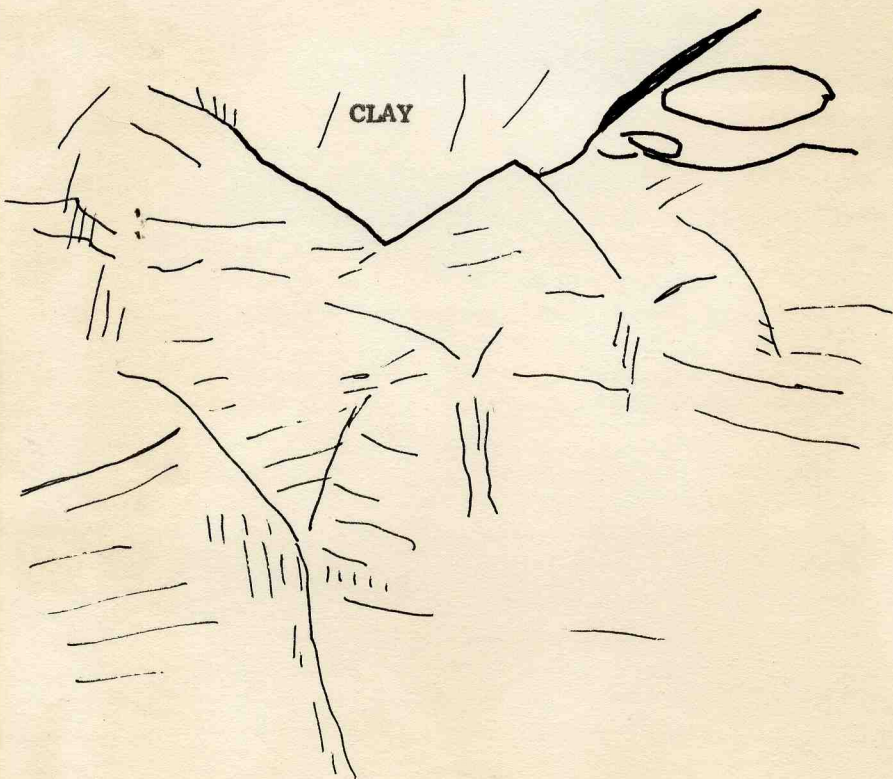
Drawing of slip in south rib, Stop 94.

S. rib: Several irregular slips with clay "plug" at top, lots of "petering" **Hi Pete!** down and sideways, would make good photo, associated with thick concretion, which may be cause for different appearance. Strike 110° , dip 42° to SW.

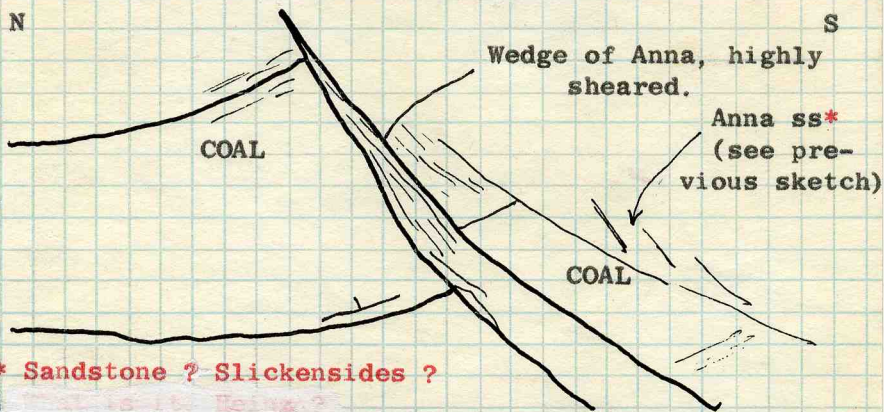
102. Fault plane cutting through coal into underclay ~4.5-5.5' displacement: 27° \swarrow 100° .
103. Major fault plane, quite variable in dip, seems to shallow out in coal, roof fell right along fault plane, probably as high as 6-8' in places; average trend across entry: $105-110^{\circ}$, 5-6' displacement. $27-30^{\circ}$

Both fault planes form system, seem to merge upwards by shallower dip of southernmost major fault.
