AMAX Coal Company - Wabash Mine, Wabash County, IL.
 August 7, 1984. Notes by John Nelson with Wm.
 DiMichele, Don Eggert, Dana Meier and Larry Klobuka.

AMAX Coal Co. - Wabash Mine - Keensburg, IL (Wabash County). May 12-13, 1986. Notes by John Nelson - mapping with Dave Ingram and Greg Molinda from U.S. Bureau of Mines, and Larry Klobuka, AMAX.

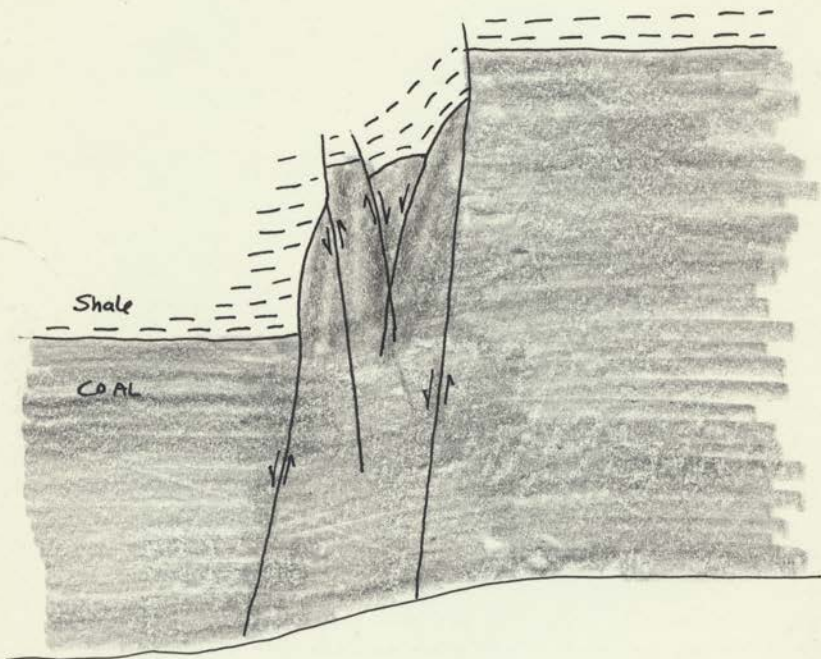
LOCATION B

B. No. 5 Entry, about 30 ft. east of survey point 16698. Fault, continuation of fault at Location A; now strikes N-S, with the west side downthrown 3.0 feet on north rib. Fault is compound with zone of fractured coal and shale about 2 feet wide. All fractures dip steeply. Minor reverse faulting within the zone; suggests two opposite movements, or possibly a component of strike-slip-striations are indefinite.
