HILLSBORO MINE
 (Coffeen)
 1st SE entries

Notes & Map by H. F. Krause. 12/3/74
 Hillsboro Mine (Coffeen), Consolidation Coal Co.
 (Numbers of study sites refer to map of H.-F. K.)
 Location: 1st SE entries, from "parallels" south-
 wards. (in intake air)

Hillsboro Mine (Coffeen) Consolidation Coal Comp.
1st SE Entry at overcast belt entry into E-W parallels
study site # ①

Consolidation Coal Co.
 Hillsboro Mine
 Main East Entries
 Jan. 29-31, 1975
 C. J. N.

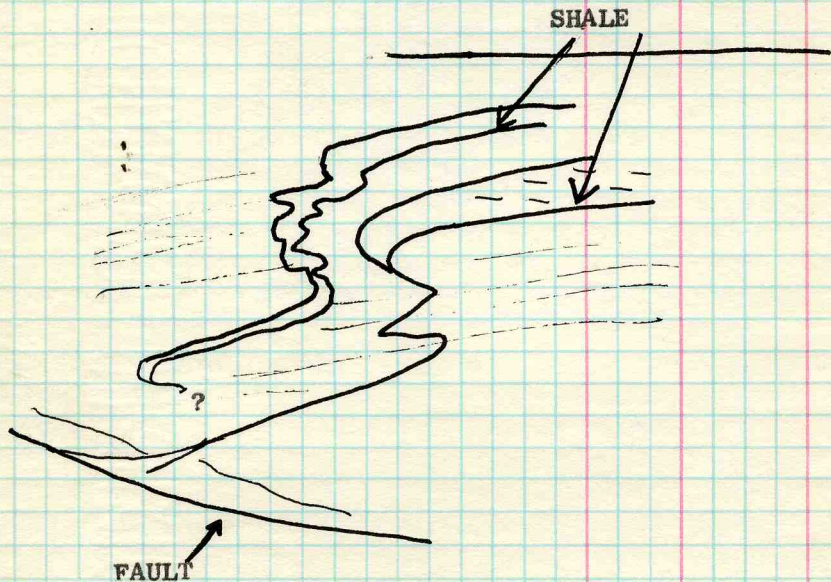
Drawing which goes with Note 206.

206. In hanging wall of fault: nice clay dike on E rib traceable in limestone roof to other side where it is hardly visible anymore due to fault, but definitely is still there. Clay dike in coal continues up from the Anna Shale and into limestone. Slaty Anna Shale is finely brecciated with thin veinlets of much lighter material through it. Zone gets wider. Further up Anna Shale has clay filling, still further up seems to get more limy. In limestone also limy filling (of course).

Also: in Anna Shale unusual burrow-like balls, 1-2" ϕ , smaller near base, larger near top. Balls contain shell breccia. Occasional thin lenses with shell fragments. This is in lower slaty portion of Anna Shale.

Shale crosses bedding in coal as indicated in sketch; stuff looks like disturbed Anna Shale? Sample taken.

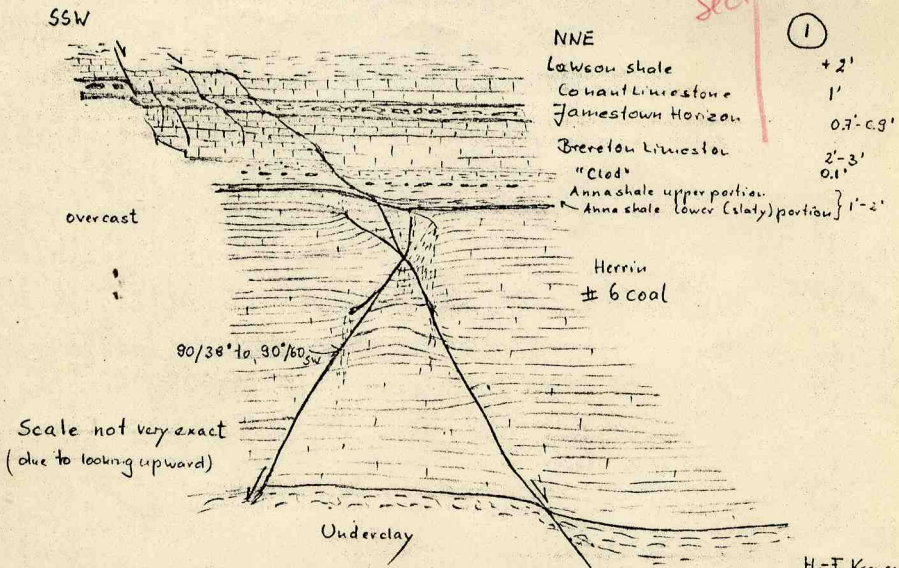
①

1. At overcast over ^{house} ~~farm~~ belt-entry in parallels, to be seen cross section of Brereton Limestone 2-3', Clod 1', Anna Shale 1-2', Herrin (No. 6) Coal, upper portion of underclay. Brereton Limestone is pushed into an upper and lower bed by a thin (few inches) of calcareous shale. Anna Shale can be subdivided (although there are transition) into uppermost portion weak mild dark gray shale with horizon of phosphatic nodules; below: dark gray mild shale; below: dark gray mild shale with another horizon of phosphatic nodules; below: very well bedded "slaty" very dark carbonaceous shale with frequent little (less than ~~minimum~~ thickness) coal streaks. Whole sequence is cut and displaced by several smaller slips (= small faults) of "clay dike type" (comp. H. H. Damberger's description of structural features in coal along clay dikes; see also my drawings in these notes). For further details see following sketches. Layers X slip shows 2' displacement.

- NNE
- LaWoon shale + 2'
- Cowart Limestone 1'
- Jamestown Horizon 0.7'-0.9'
- Breerton Limestone 2'-3'
- "Clod" 0.1'
- Anna shale upper portion } 1'-2'
- Anna shale (lower (slaty) portion) }

main slip
in Anna shale 107/52 NE
in upper Coal 110/65 NE
in lower Coal 105/71 NE

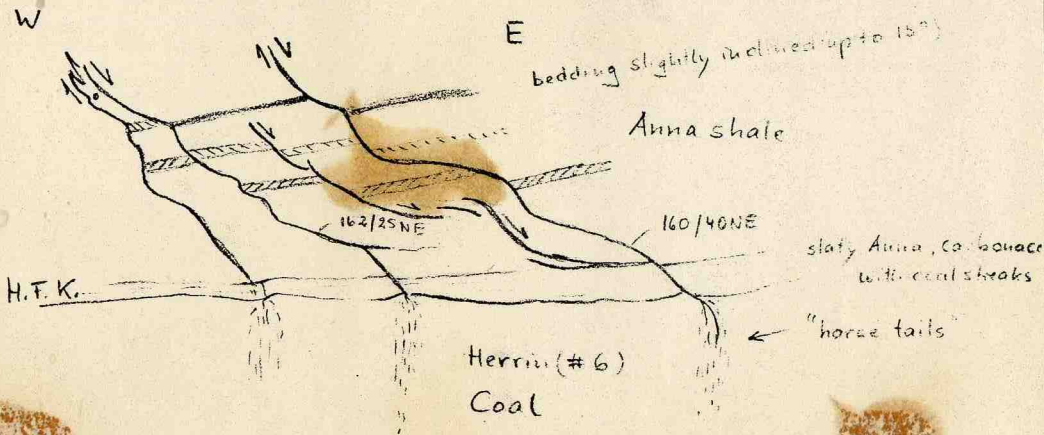
Sketch of small slips in Anna shale displacement few cm
 study site # 2

2. Small roof fall, only slabs and chips of Anna Shale dropped, initiated due to 1 big and several accompanying very small slips in the roof with a considerable change in strike and dip, curved slip surface bearing from 30/40 NW over 85/25 North NW to 160/40 East NE. See following sketch.

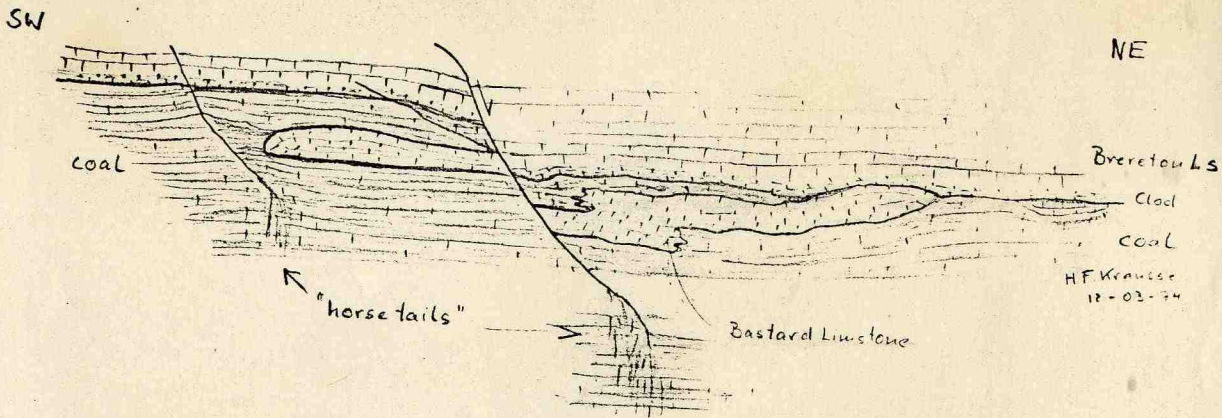
H.F.K. study site # 5

Photos 4-6 looking North 330° East. Clay dike and clay dike-type fault cutting down from roof (Brereton Limestone) and lenses of "Bastard" Limestone between Brereton Clod/Coal streak and Herrin (No. 6) Coal) into coal. Lower portion of coal contains wide irregular ^{by or bordered} ~~carved~~ clay vein. Fault has sheared and displaced through the lense of "Bastard Limestone" and "Smeared" ^{or} as dragged some of its material between fault surfaces. Vicinity of fault and clay dike is fractured by numerous, mostly irregular ^{oriented} spaced and ~~area bed~~ cleats, which mostly are coated ^{by} as or filled with ~~syril and learyte.~~ ^{pyrite and baryte.}

Photo 6: ^{still larger} ~~Shale layer~~ area of fault and clay vein, note particularly: the clay-dike-type deformational features in coal surrounding the vein. ^{ju} For center of coal seam prominent fusain layer having been cut by fault and vein.

Clay dike - type slip

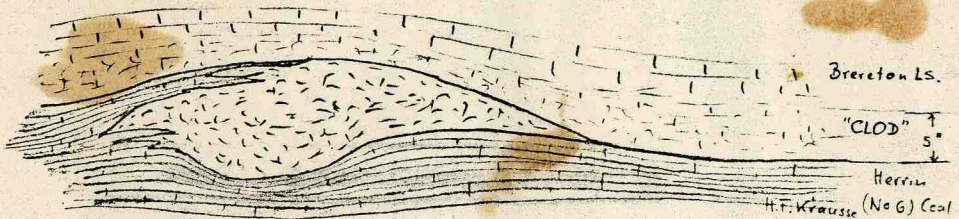
14. Thin clay dike with small fault/clay filling about two-three inches, fault 100/55 NE - Roof shows coal with "Bastard Limestone" then 5" of clod and then Breerton Limestone, no Anna Shale developed.

14 "Bastard Limestone" lenticular in top portion of coal below "Breerton Clod" no Annashale determined

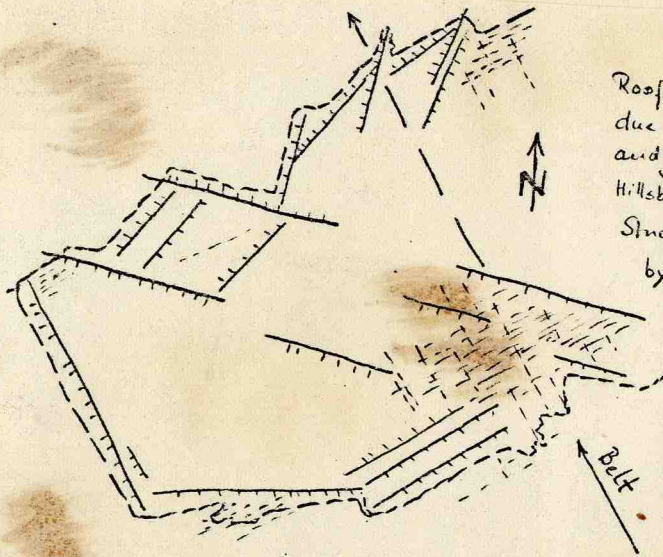
Anna Shale is intensively jointed, joints support roof rock falling (fall is however, caused by clay dike-type faults) Two sets of joints. a) prominent direction: 60/86 SE; 80/83 SE, 77/85 SE, 73/87 SE, 69/88 SE, 66/90, 74/87 SE, 55/83 SE. b) Smaller and scarce: 145/86 SW; 148/88 SW, 151/90, 143/89 SW, 146/87 SW, 148/90, 153/89 NE. Main cause for roof fall is intersection of clay dike type faults intersecting : a) 100/42 NE; b) 3/40 West c) 65/63 SE 88/45 SW 10/36 SE 68/38 NW

All intersecting several times with several surfaces almost like ~~the~~ sets; additionally faults 75/47 SE, 10/30 NW, 135/36 SW, clay dike with few inches filling 115/33 NE.

Roof fall in belt entry
due to various faults
and joints

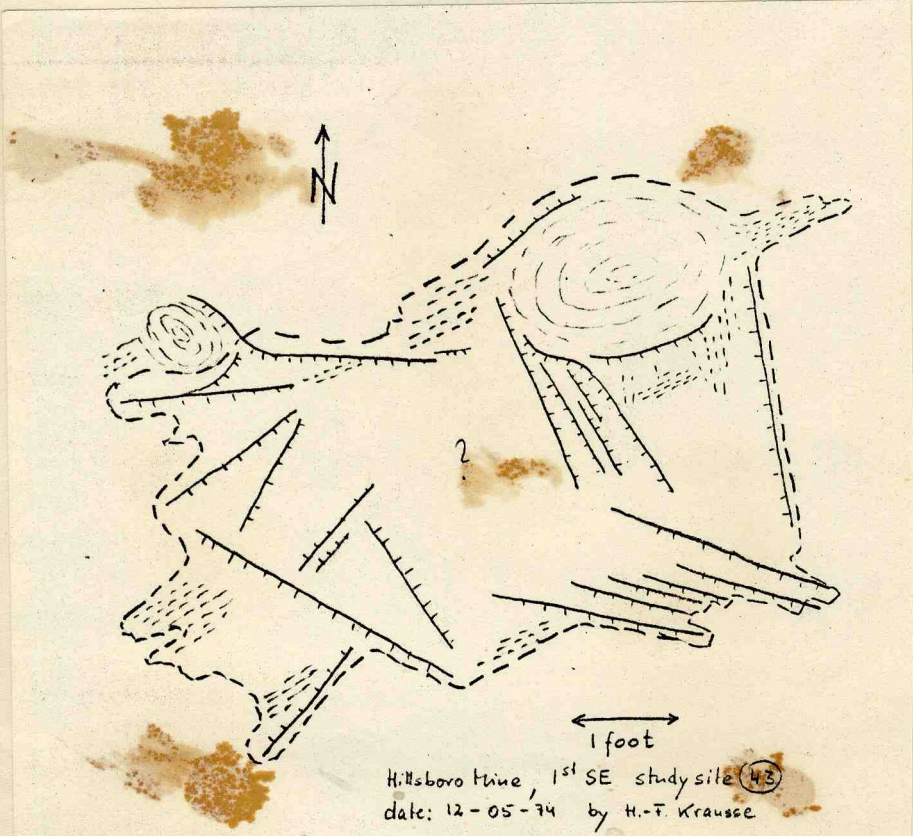
Hillsboro mine, 1st SE study site 43
date: 12-05-74 by H.-T. Krausse

43. Roof: Anna Shale; smaller roof fall along numerous smaller and medium size faults in roof rock and small joints. Faults 35/58 SE; 40/60 NW; 55/53 SE; 88/45 SE, 100/47 SW; 110/50 SW; 120/34 SW; 145/zone 145/39 SW; 148/133 SW; 170/46 SW. Joints: 57-68/85 SE-87 NW

X Roof fall in belt entry, due to various small faults and joints

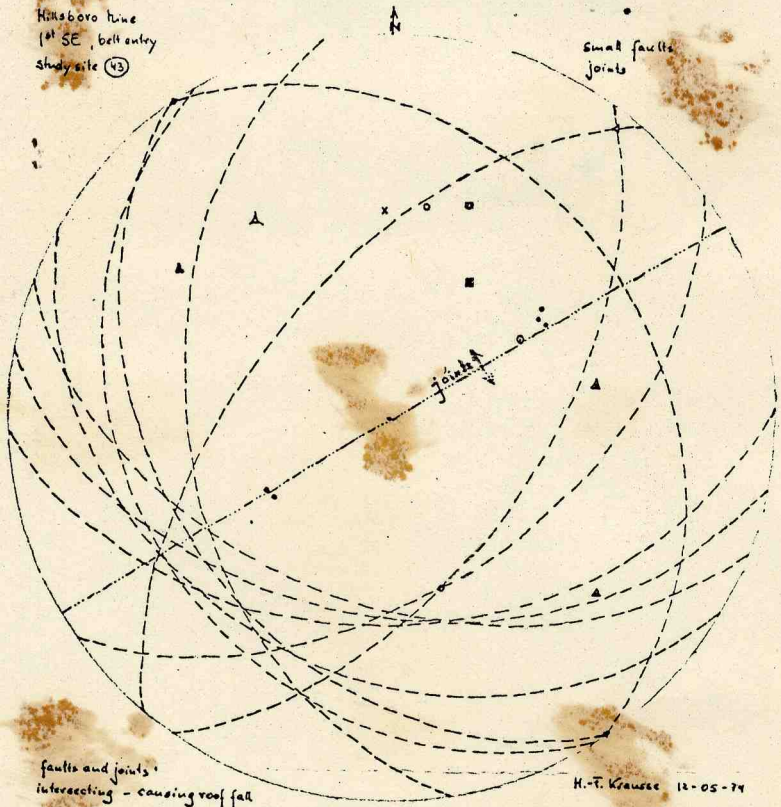
Hillsboro line
1st SE, belt entry
study site (43)

faults and joints
intersecting - causing roof fall

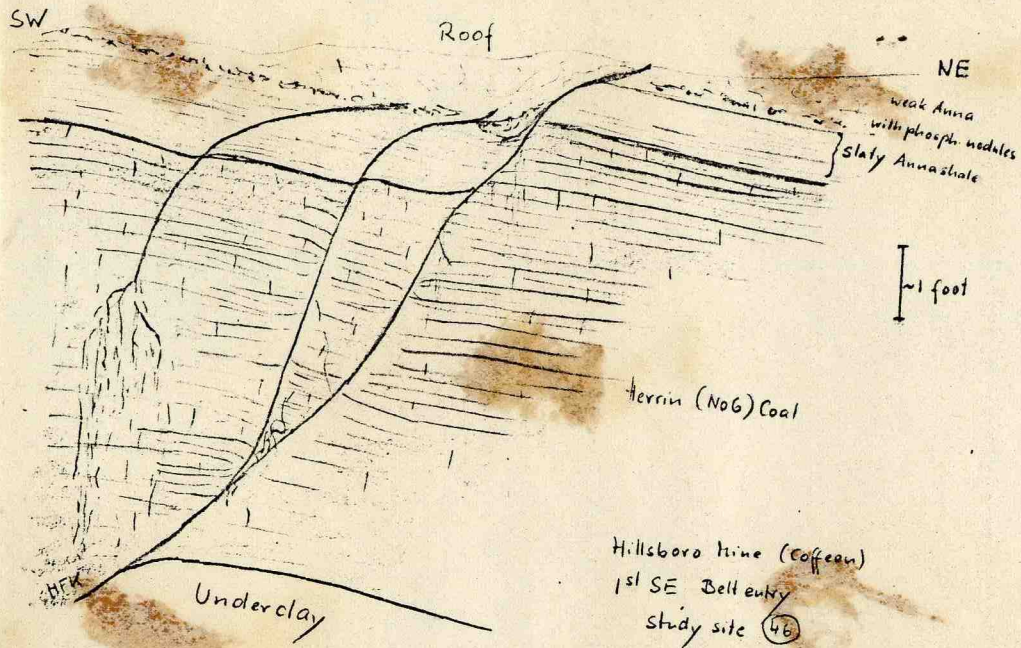
Hillsboro lime (Coffeen)
 1st SE Belt entry
 study site (46)
 by H.F. Krausse 12-05-75

46. Roof fall at this study site caused by clay dike type faults and joints. Main fault 96/47 SW displacement 2' passes through coal totaly and up into? Brereton? *Conant* Limestone above. Immediate roof 3.2' Anna Shale.. Main fault is accompanied by 2 bigger ones.

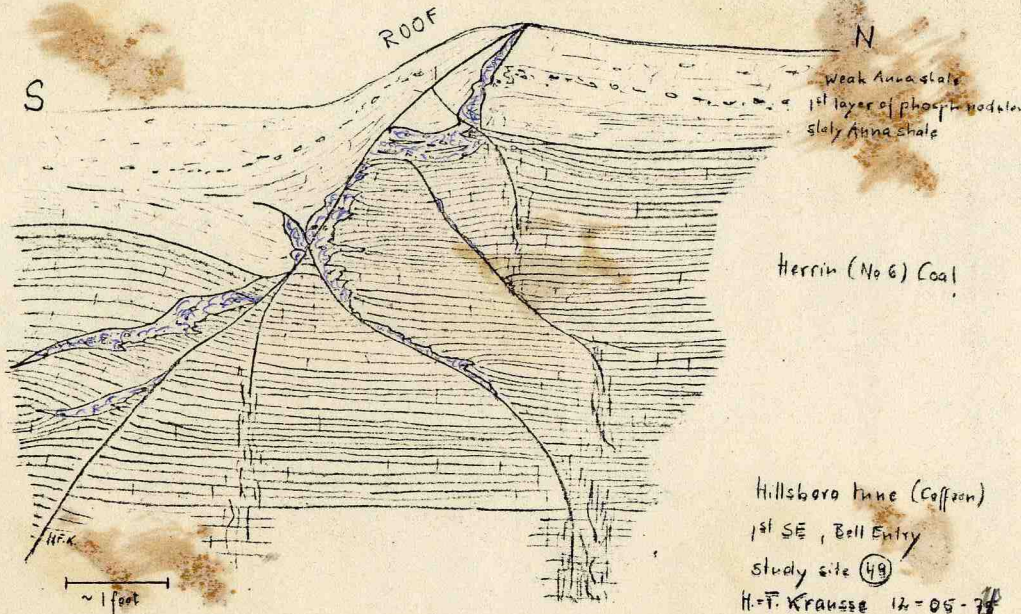
49

(249)
49. Clay dike with several small faults. 92/32 South; 90/45 South/ 95/25 NE; 95/63 NE; 70/50 SE; 85/40 SE; 85/27 NW; 56/50 NW. This is almost first time, one of the few times, where clay dike filling can be observed in and within Anna Shale.

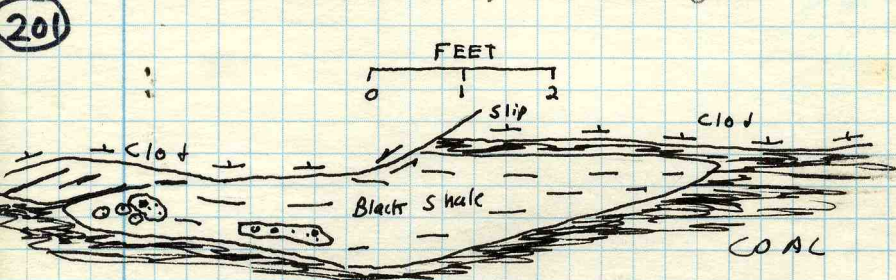
1. NW corner of intersection, view looking NW.

Pod of impure, black slaty shale with abundant phosphatic lenses and coaly stringers, also contains irregular pockets of brecciated brown limestone in brown shaly matrix - as shown.

This apparently is a pod of Anna Shale, here overlain by "clod" and massive limestone.

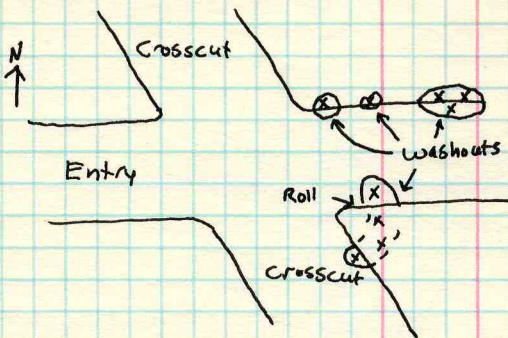
- (208) 8. Washout with splits as at 1, about 4 feet wide, 1 foot deep at center, limestone roll over the top, extending about 4' out from rib. Coal below washout fractured, disturbed, mineralized.

Same (?) washout also noted around corner. No limestone roll.

The lower layer of clod in this area becomes very soft, flaky, with abundant plant debris, fossilized tree branches and thin coal streaks. (Grunch.)

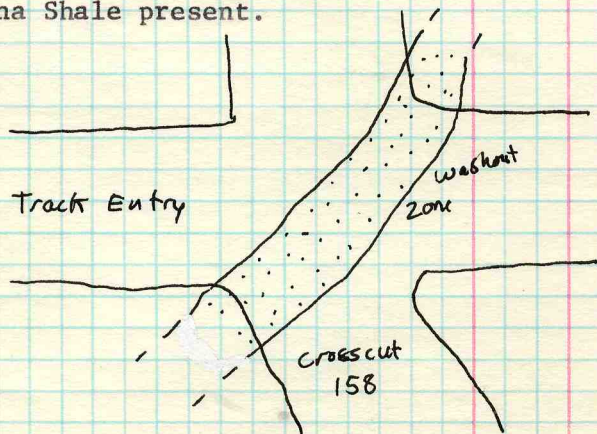
13. Minor washout with coal splits. Less than 0.5 feet high but 10 + feet wide. Small amount of black Anna Shale present.

Trace of washout across entry marked by thick slabby clod.

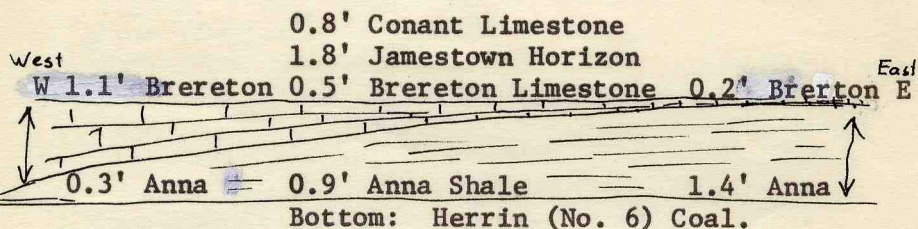
Anna Shale thins out ^{to} downwards the ^{west} east, thickness decreases from 1.4' to 0.3' within the width of entry at the same area the Brereton Limestone above Anna Shale increases from 0.2' in the ^{east} west to 1.1' in the ^{west} east. The Jamestown Horizon does not show a coal stringer in this place.

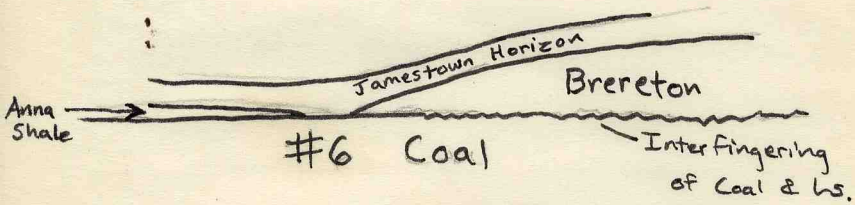
42. Brereton Limestone wedges out against Jamestown Horizon, Anna Shale very thin. See diagram below.

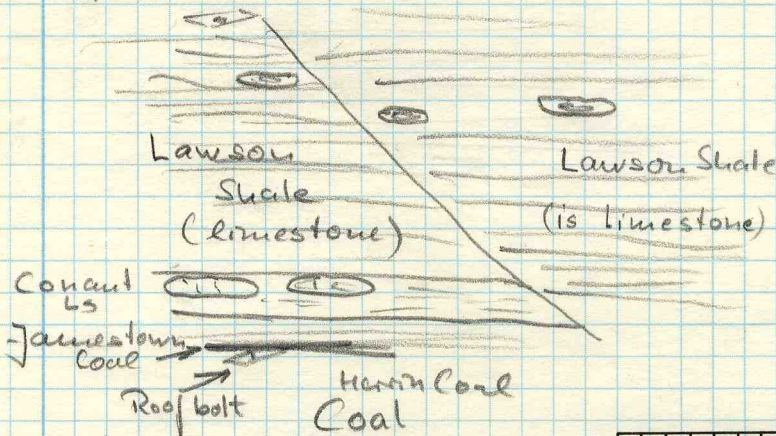
Pho. # 24

(166) 146 Photos (facing north)
 Section of: Lawson Shale
 Lawson Shale "limestone"
 Conant Limestone with nodular concretions
 all truncated by clay dike type fault

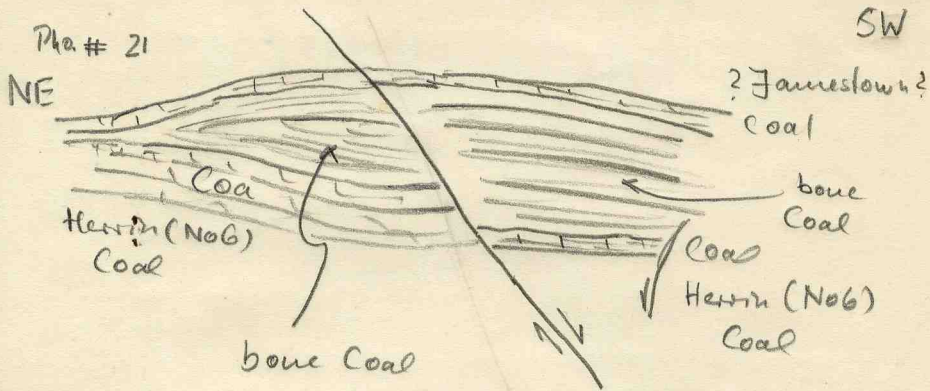
147 Two photos (facing northwest) of Anna Shale/bone-coal in uppermost portion of coal seam (or? Jamestown Horizon?)
