OLD BEN COAL CO.
MINE # 21

Mine Index No. 863 S-23

OLD BEN COAL CO.
MINE NO. 21

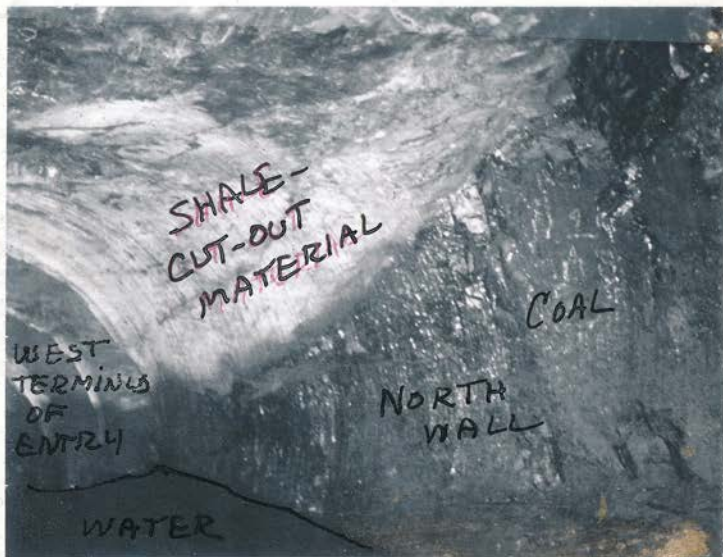
Station A - west end of 6th West North
Old Ben Mine 21

North Wall (right) and west terminus (left) of
entry showing shale cut-out extending into coal.

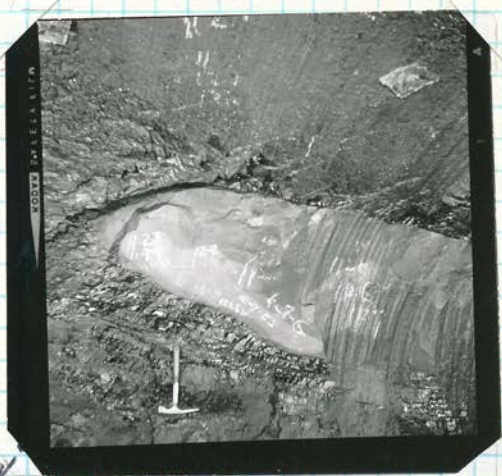
Looking south into S. wall of entry. Intrusion
of siltstone extending laterally back into coal.
A cut-out is found just to the right of the
picture.

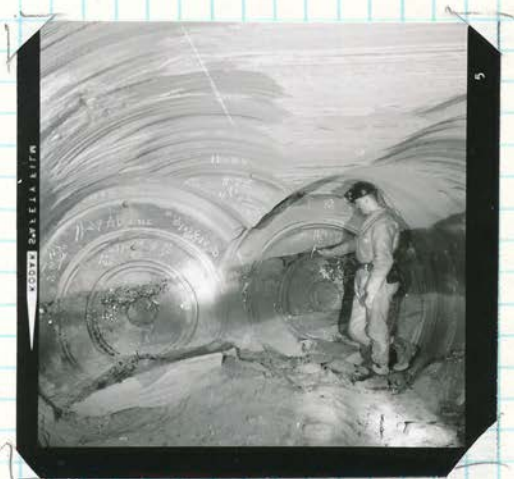
Station C (cross-Cut) 85th North off of 5th West
 North (about 20 feet north of 5th W.N.) 185' from
 S. line, 80' from E. line, SE NE, Sec. 2-5S-1E,
 Franklin County

Station C - end of 85th north (off of 5th W.N.)
 showing only 25" of coal remaining.

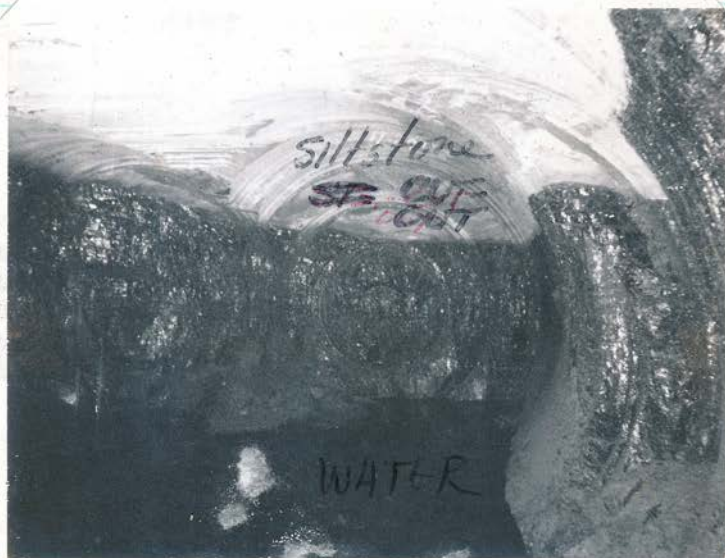
At west terminus of 4th West North, 110' from S. line,
180' from E. line of SE NE, Sec. 2, 5S-1E, Franklin
County

Station D - Western terminus of 4th W.N. showing
siltstone cutting down into coal.

Coal is almost completely cut-out and replaced by shale and siltstone, base of channel-fill varies from planar to slightly irregular.

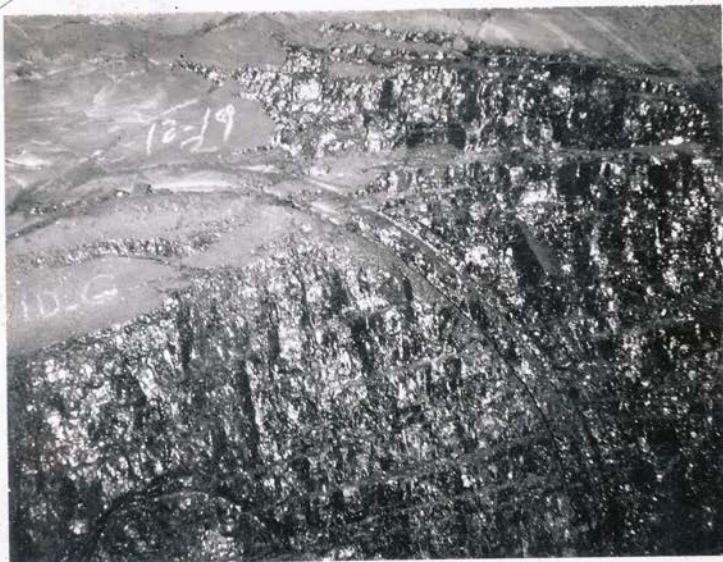
South end of 73rd South off of 1st W.N., 430' from S.
line, 1490' from W. line, SW SW, Sec. 1-5S-1E
Franklin County

Station K - south end of 73rd S. off of 1st W.N. -
close up showing intimate intertonging of coal and
shale (diameter of outside circular mark is 7')

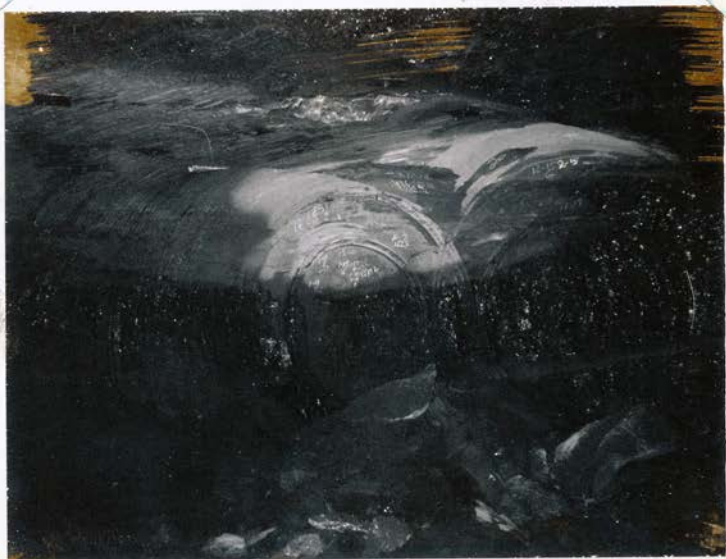
South end of 73rd South off of 1st W.N., 430' from S. line, 1490' from W. line, SW SW, Sec. 1-5S-1E Franklin County

Station K - showing shale splits in upper and lower parts of face.

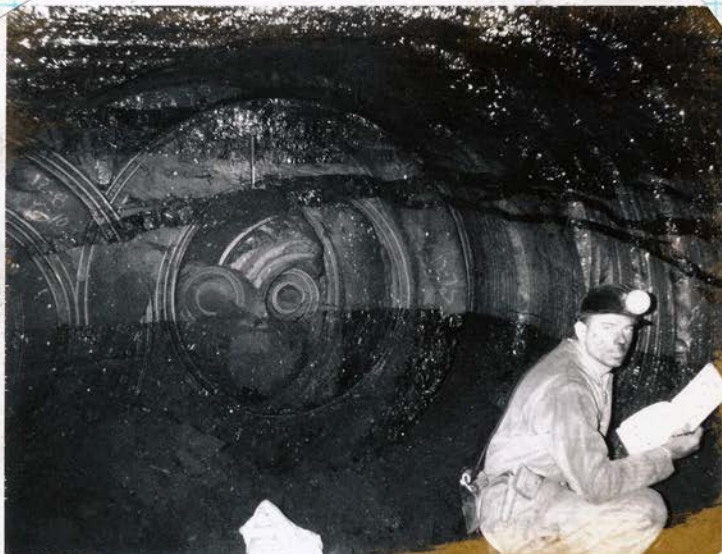
South end of 76th south off of 1st WN, 290' from S.
line, 1300' from N. line, SW SW, Sec. 1-5S-1E,
Franklin County

South end of 76th South - shows prominent shale
split in coal.

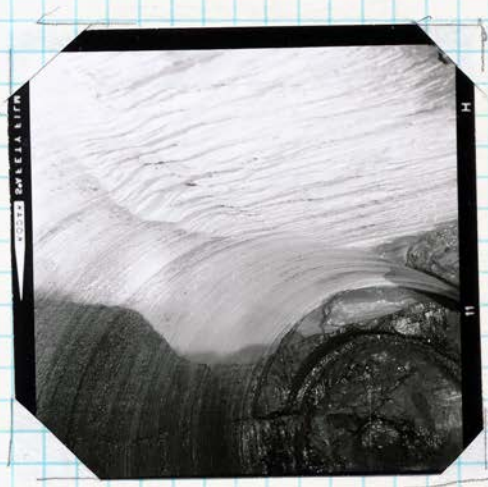
West end of southernmost entry turned off of 76th South, 315' from S. line, 1030' from N. line, SW SW, Sec. 1-5S-1E, Franklin County

Station 0 - west end of southernmost entry turned off of 76th S. Top part of coal is cut-out by siltstone.

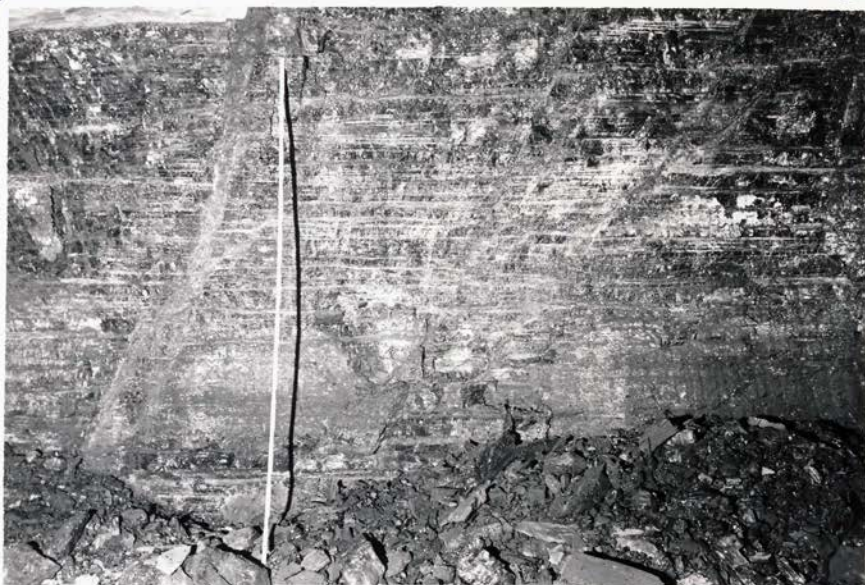
Photo 9- Krausse. Lower view of same fault in Photo 8. Main fault is just left of ruler. To the right of ruler several small parallel normal faults are barely visible; they offset partings in the coal.

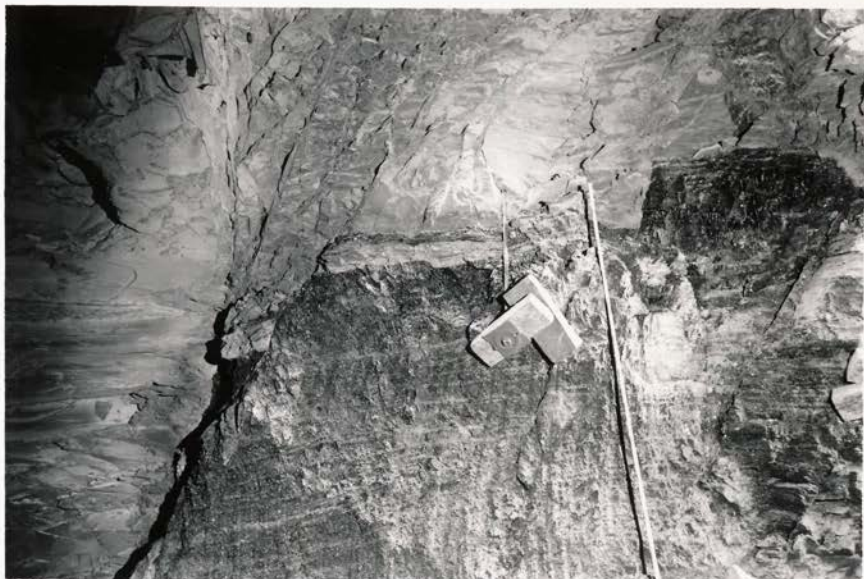
Photo 10- Krausse. Complex fault zone with large normal fault to the left, a small horst to the right, and numerous parallel fractures having little or no displacement. Location: stop 16 from Nelson's notes, 8/17/76.

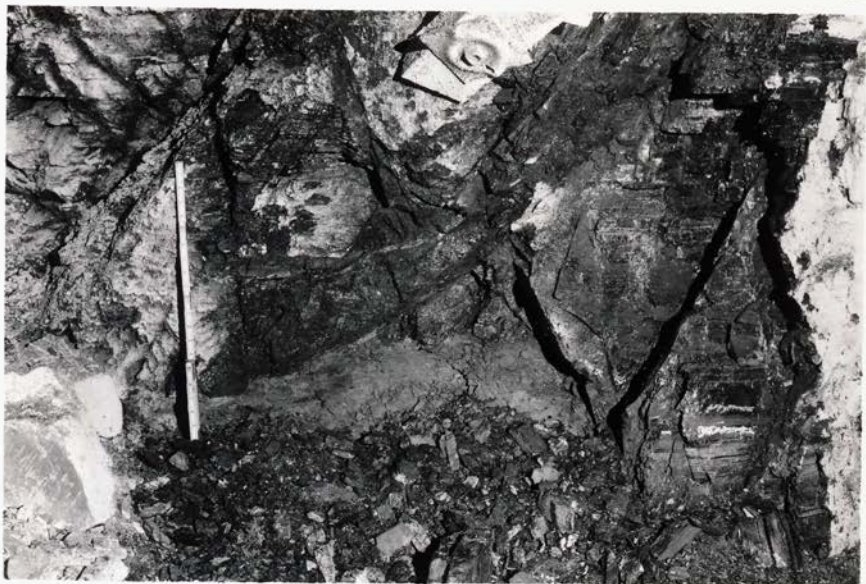
Photo 13A- Krausse. View below Photo 12, showing faults near base of coal. Just below center of photo a small horst is present; the underclay is squeezed upward. Note the abundance of faults in the coal.

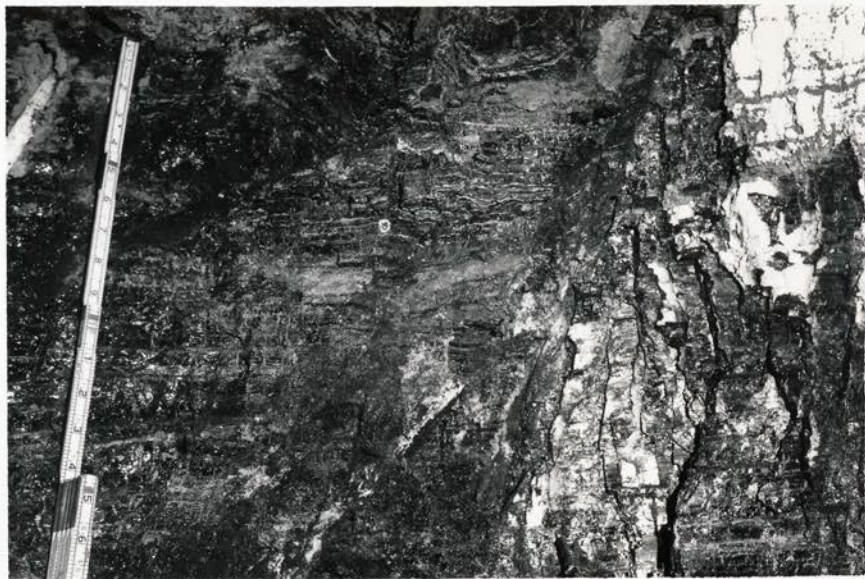
Photo 19- Krausse. A close-up view of part of the right side of Photo 18. Some layers of coal exhibit ductile deformation; they are slightly folded or crinkled. Ductile deformation is not common in the Rend Lake Fault System.

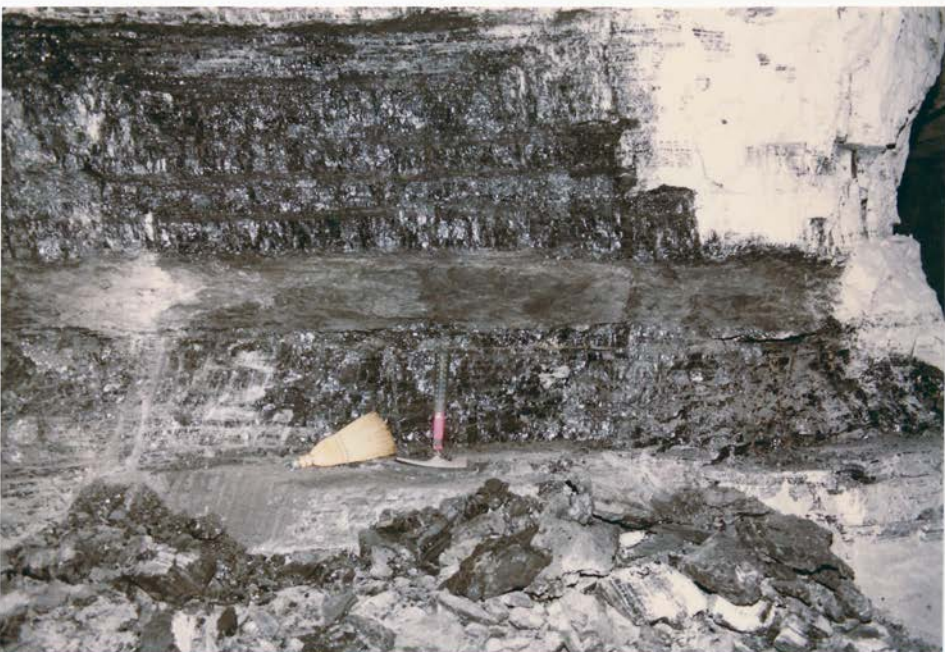
View of the "blue band" at Location M. Hammer and broom resting on a parting in the lower part of the seam. The underclay is not exposed. "Blue band" is 0.56' thick here. Note black shale partings in the coal above the "blue band"

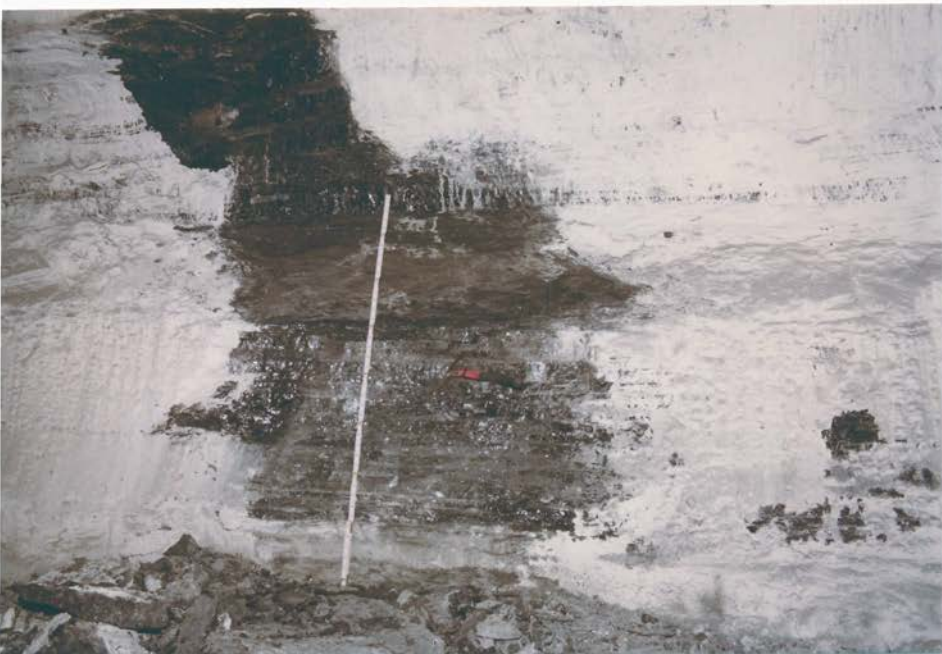
Lower part of coal seam at Location O. The Blue Band, behind top of ruler, is 1.2 feet thick. Base of ruler rests on underclay.

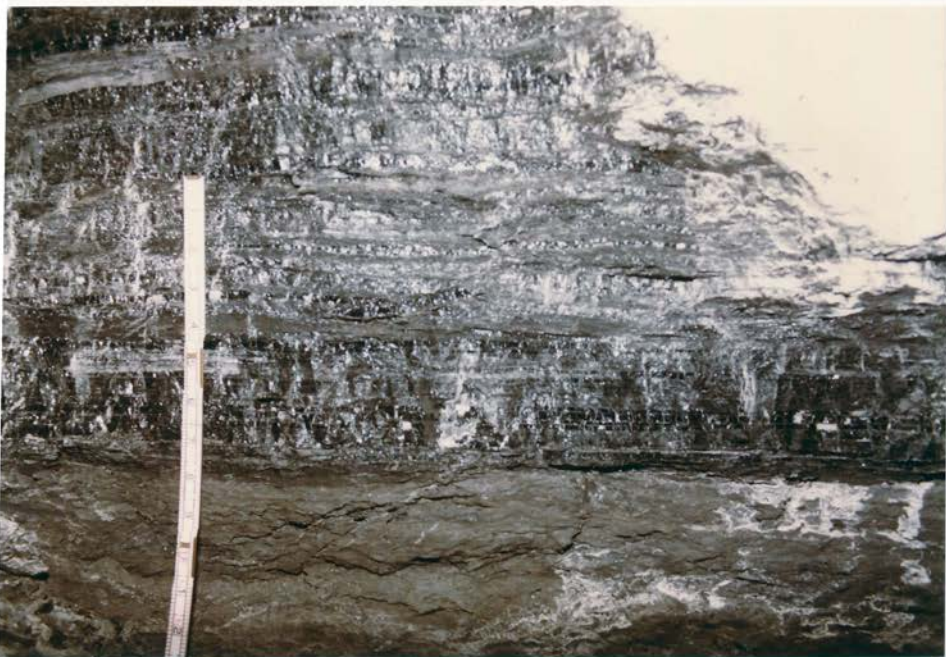
Closer view at Location O, showing the upper part of the "blue band" and also the lenticular bands of black shale in the coal above the "blue band".
