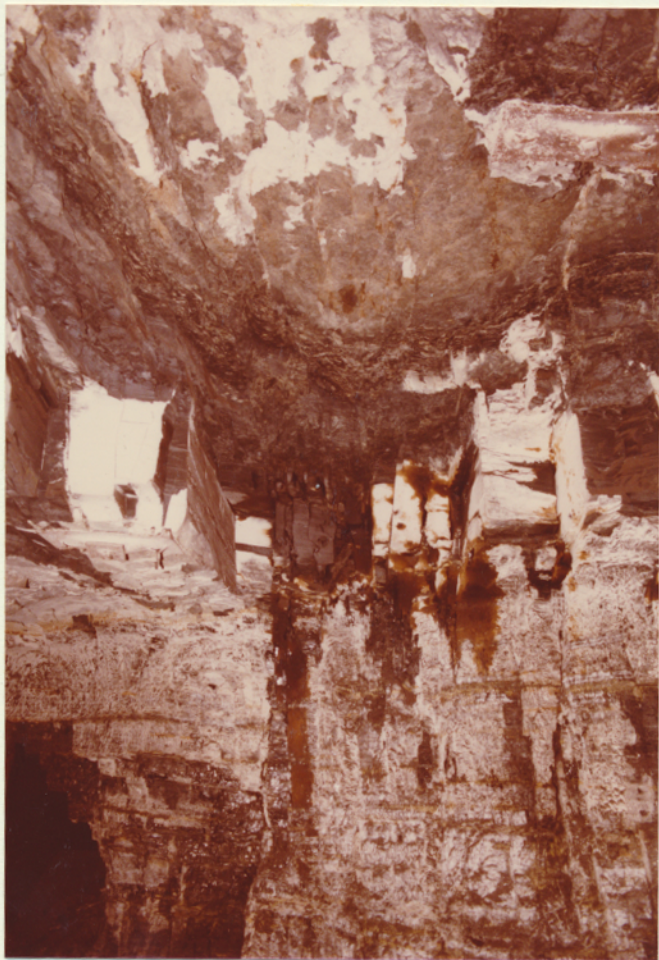
Oil-stained fractures along strike-slip fault in east entry of the 8th Main South. Top of entry is base of Brereton Limestone; black blocky Anna Shale below, then the coal. White color is rock dust.

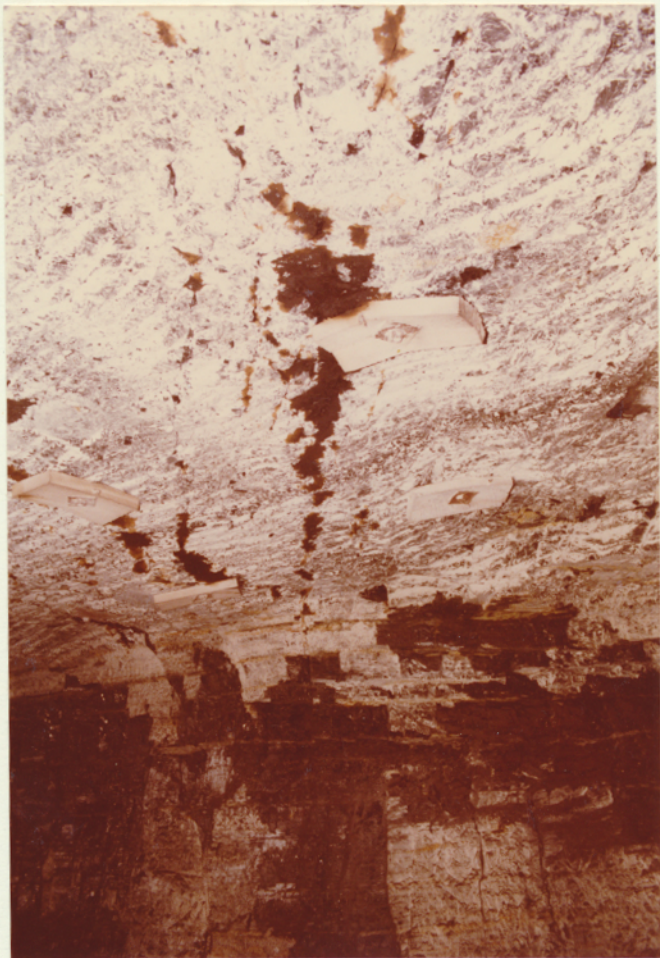
Slightly south of above location; oil seepage along fractures in the top coal has stained the rock dust.

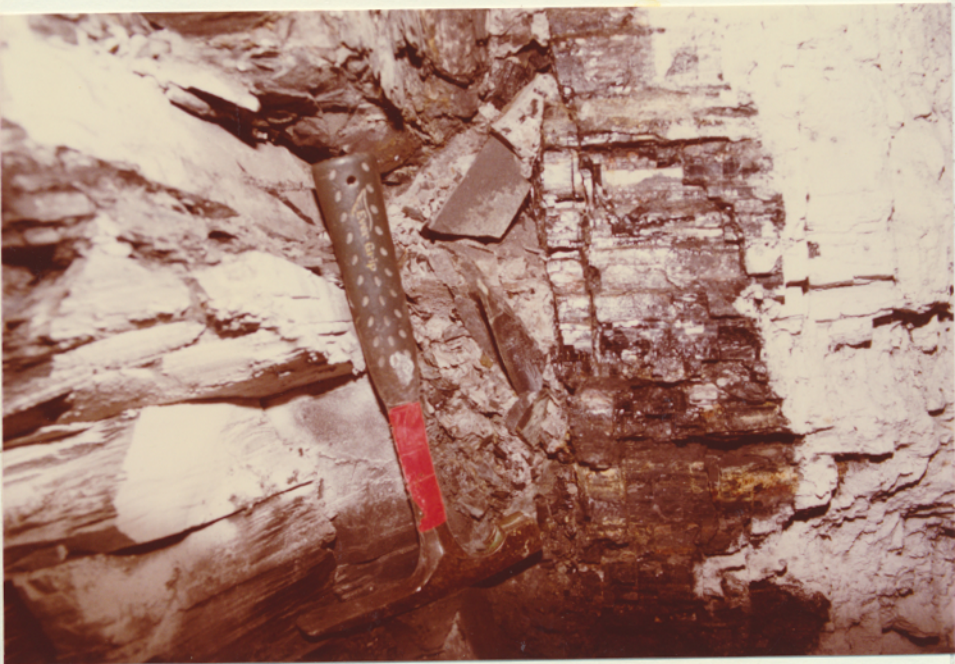
Closer view of the same. The tilted pieces of Anna Shale are in their natural position, held in place by a claylike matrix.

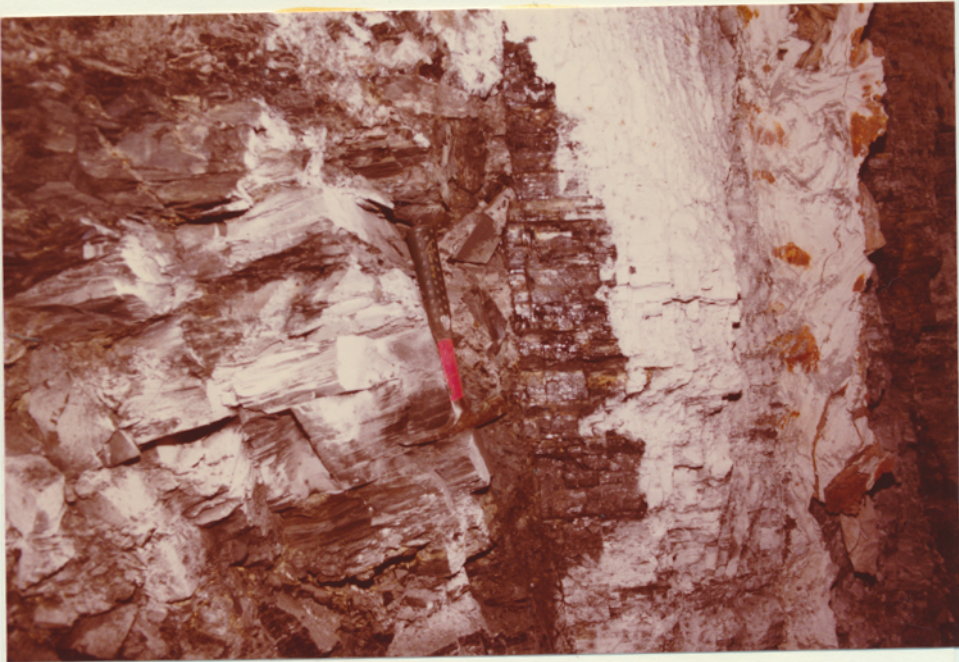
Same fault on opposite side of the same pillar.
Coal on right; Anna Shale on left dropped down into
a narrow graben, and brecciated.

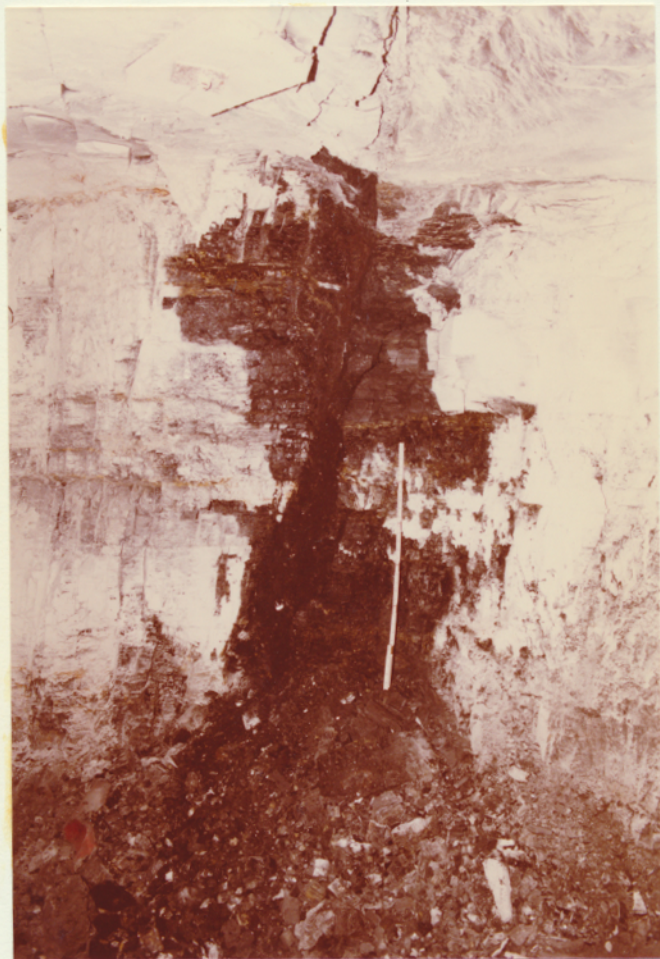
Fault on travelway of 8th Panel South. Coal is up-thrown 2.7 feet on the southeast (left) side of the fault. Coal is folded and pulverized along the surface of movement.

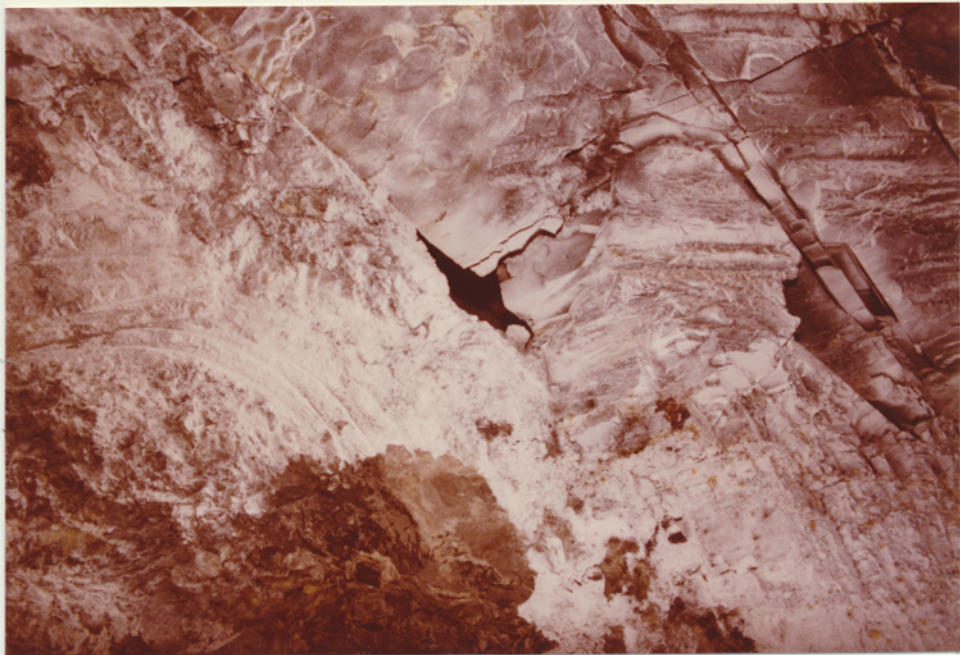
View looking obliquely upward at the same fault, showing an open cavity or fissure in the roof along the fault. This extends upward several feet.

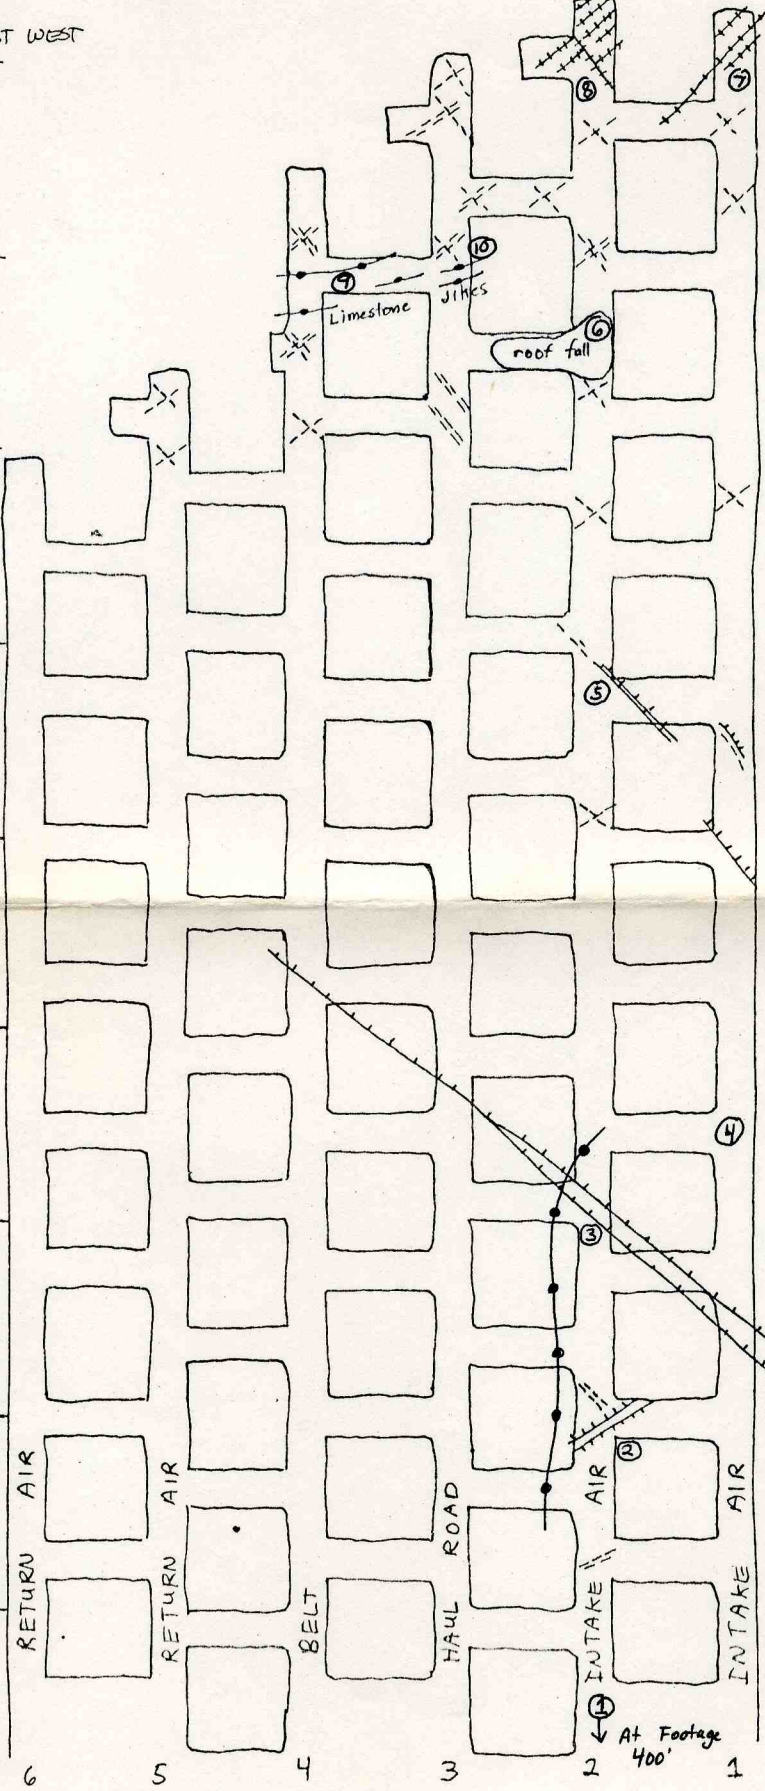
CROWN II MINE
4th North off 1st
Main West - Main South

3. Very pronounced fracture zone of inclined fractures and normal faults striking N. 40-45° W; fractures dip 50-75° NE and SW; some nearly vertical; they cut at least 5 ft. upward into roof and all the way through the coal. Normal displacements of several inches; coal and shale pulverized (gouge); coal mineralized in places; very definite slickensides plunge vertically (dip-slip movement). This zone extends across Entries 1 and 2 (intake air) and through intersecting crosscuts.

5. Fracture zone trending N. 45° W., similar to the one at Loc. 3; includes steeply dipping normal faults, one with about 8 inches of throw, other smaller normal faults and nearly vertical fractures in a narrow, intensely shattered zone. Slickensides plunge vertically or nearly so. Both coal and Anna Shale are displaced.

6. Huge roof fall, mostly hidden by steel archway, on Entry 2. It extends 25 to 30 feet above the coal. From what I can see no faults are present, but jointing and fracturing in immediate roof are very strong. Fall exposes, from the coal upward, about 4 ft. of dark gray Energy Shale, 1 foot disturbed Anna Shale, 10 feet of sandstone, then 10 to 15 feet of olive-gray mudstone or claystone, pieces of which are still falling.

7. Wide open fractures striking N. 50° E. in Brereton Limestone at face of Entry 1 (footage 1530') and in crosscut between Entries 1 and 2. The fractures are visibly open several feet upward from the base of the limestone and some are lined with small sparkling crystals, others are filled with mud and pieces of broken limestone. There is a zone of such fractures, parallel or en echelon with each other.

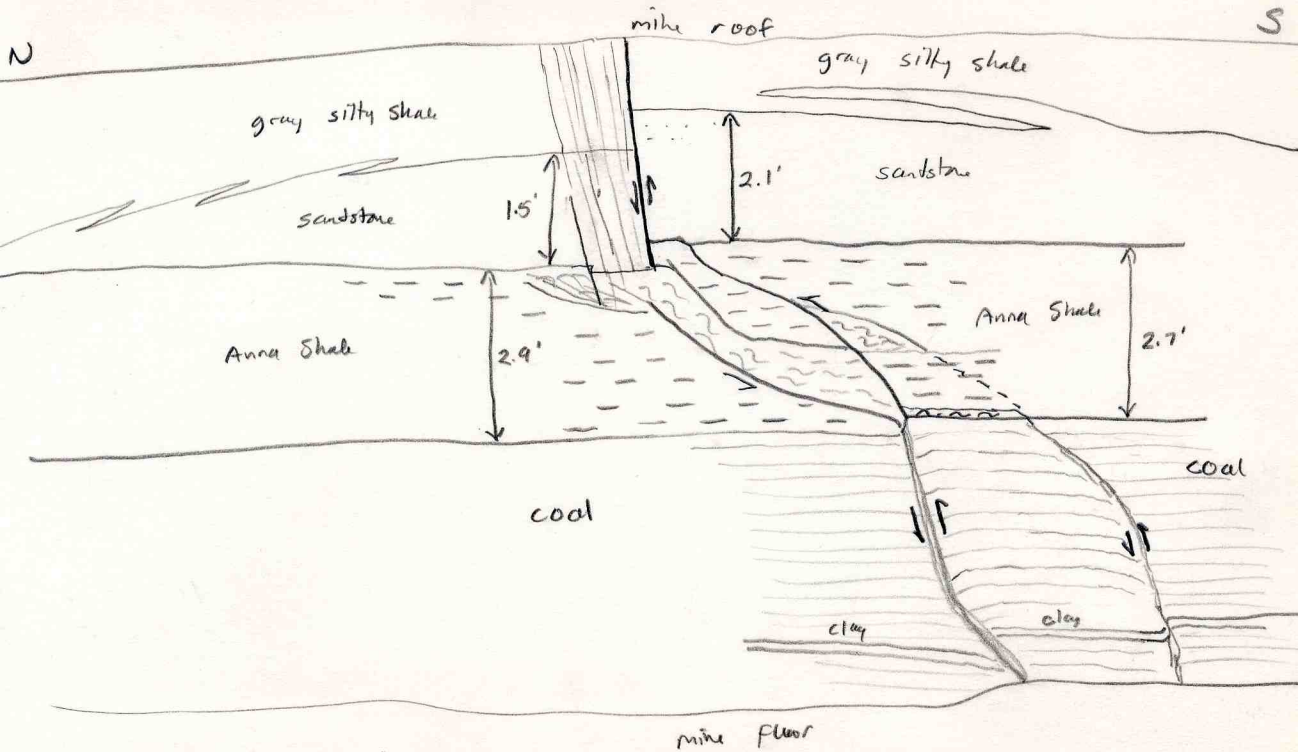
Location 4- Fault on east rib of No. 2 entry.

strike-slip movement. Reverse faulting is best shown on the east rib where the Anna Shale on the south is thrust over very thin Brereton Limestone and Anvil Rock Sandstone on the north. Vertical offset is about 1.5 feet at the top of the Anna and less than half that in the coal. Displacement on the west rib is less than a foot. Definite near-horizontal slickensides in Anna Shale. Direction and amount of lateral slip cannot be determined. North of fault Brereton Limestone is very thin due to erosion at base of sandstone. South of fault only the base of the limestone can be observed.

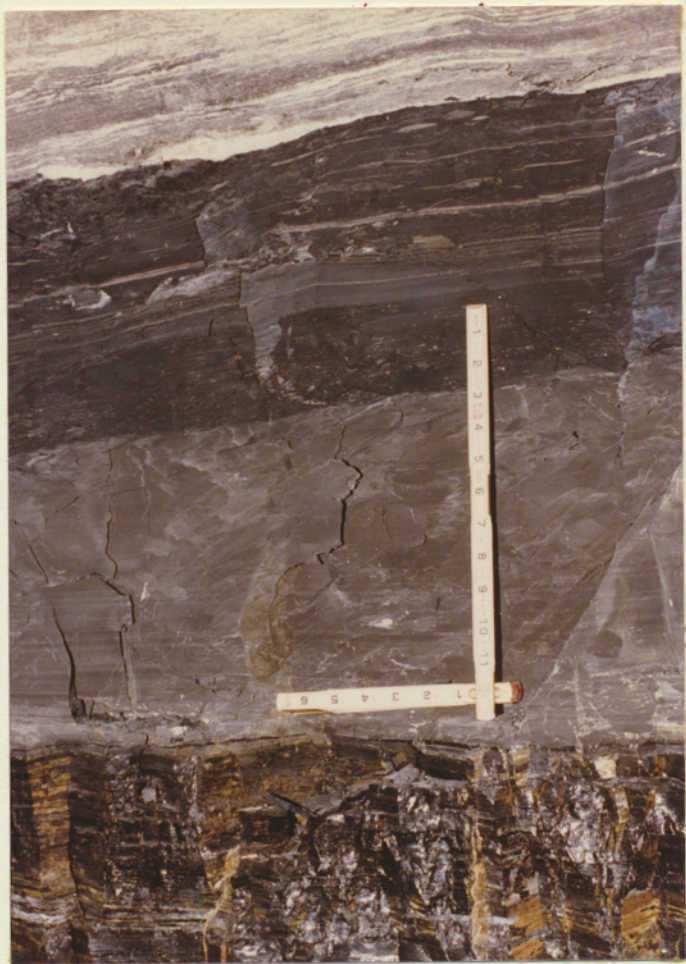
From base upward: Herrin coal bed; gray Energy Shale (note parallel laminations); black Anna Shale, lower contact unconformable; Anvil Rock Sandstone, lower contact unconformable.
