Black Beauty Coal Co.  
Vermilion Grove Mine

Black Beauty Coal Company - Vermilion Grove Mine. Underground mine is Herrin (No. 6) Coal, tipples located about one mile north of Vermilion Grove in southern Vermilion County. Notes by John Nelson, January 18, 2002.

## Vermilion Grove Mine, Vermilion County

## **Black Beauty Coal Company - Vermilion Grove Mine - Vermilion County**

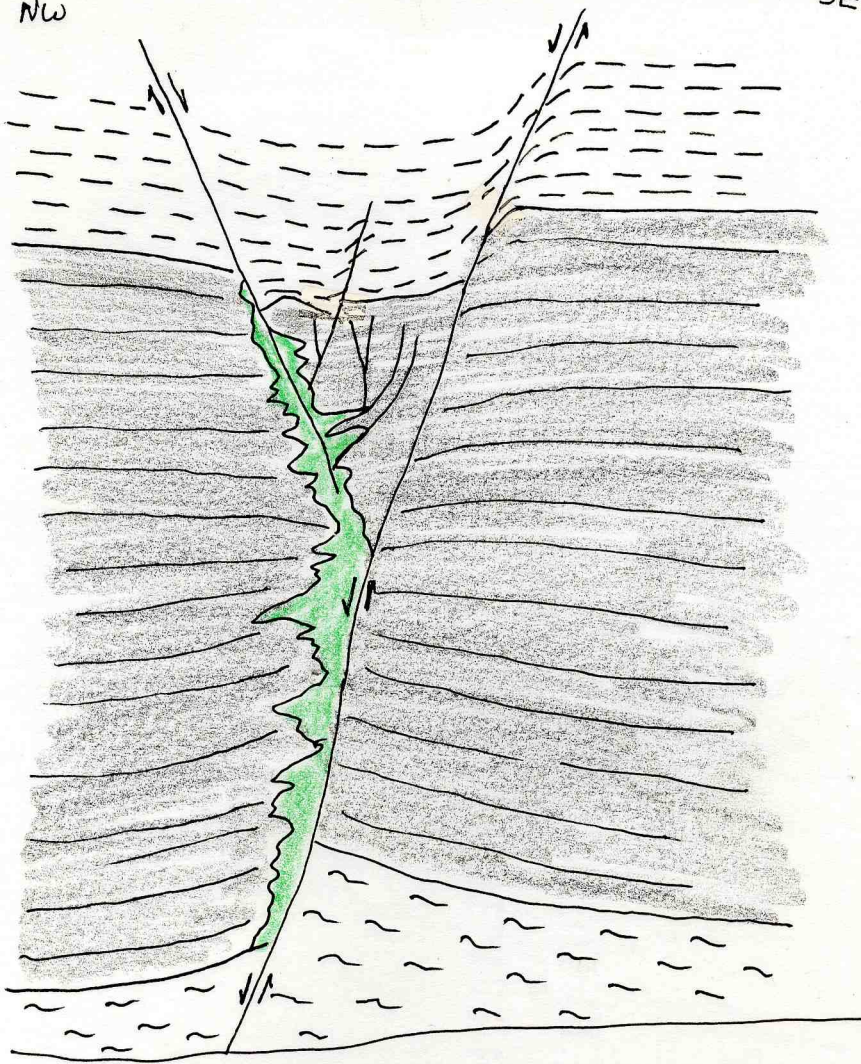
Clay Dike - Vermilion Grove Mine

The single clay dike at Vermilion Grove follows a linear trend approximately N 45 E across the panel for a known distance of about 1,500 feet. It gradually dies out at its northeast end. The southwestern continuation lies in unmined coal. For a clay dike to be this straight and long is remarkable. Near all of the hundreds I have mapped in other mines follow curved or sinuous courses and have no preferred orientation.

The dike itself is filled with soft light-colored clay. It may follow a fault plane through the coal, or take a zig-zag course. Many intricate small sills and clay veinlets crisscross near the main dike, but maximum width is less than one foot. The coal shows "false drag" and convergent bedding, all typical for clay dikes I have seen elsewhere. Also as is typical, the underclay bulges upward along the dike.

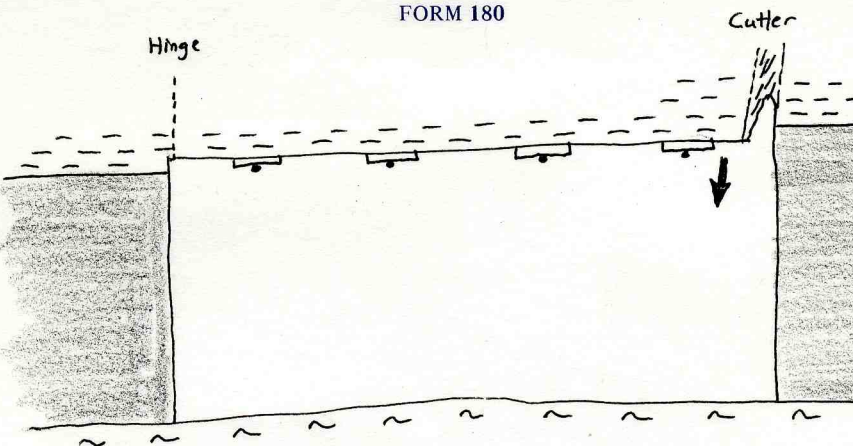
In several places it is evident that roof is failing in cantilever fashion. That is, as a cutter forms along one rib the entire span of roof is hinging downward about a pivot point above the opposite pillar. This is shown by sharply tilted slabs of shale along the break line (See sketch). In places I saw a V-shaped arrangement of shale slabs similar to a kink zone; however the tilted shale slabs on the inside of the entry are merely loose pieces that are sagging. Where cutters form along both ribs, presumably the span of roof is inching downward as a single mass. Eventually a massive roof fall may result.

Cutter developing along one side of entry  
Roof behaves as a cantilever.

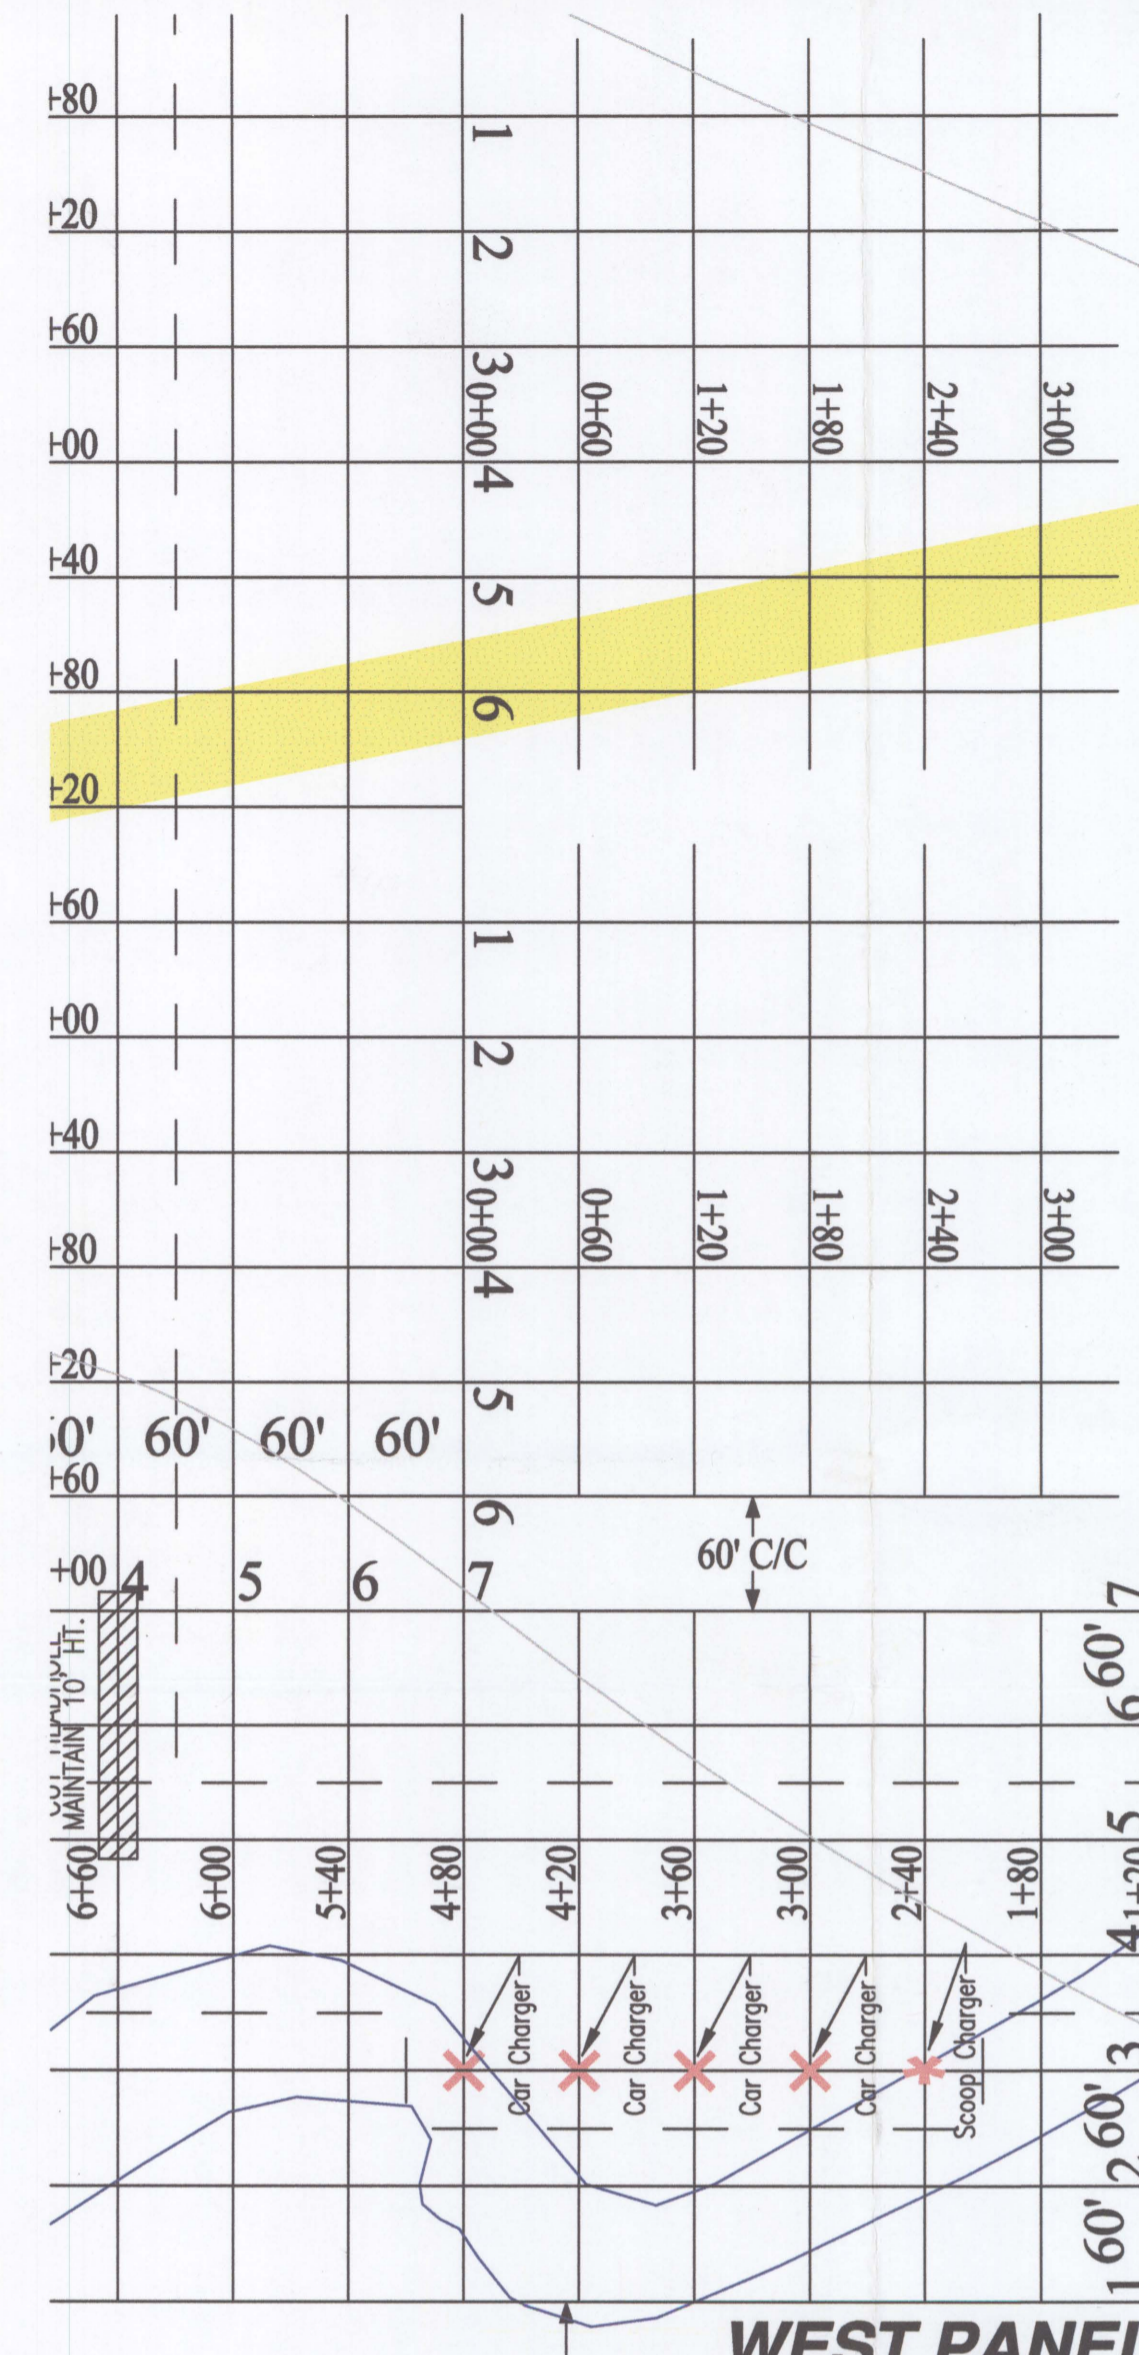
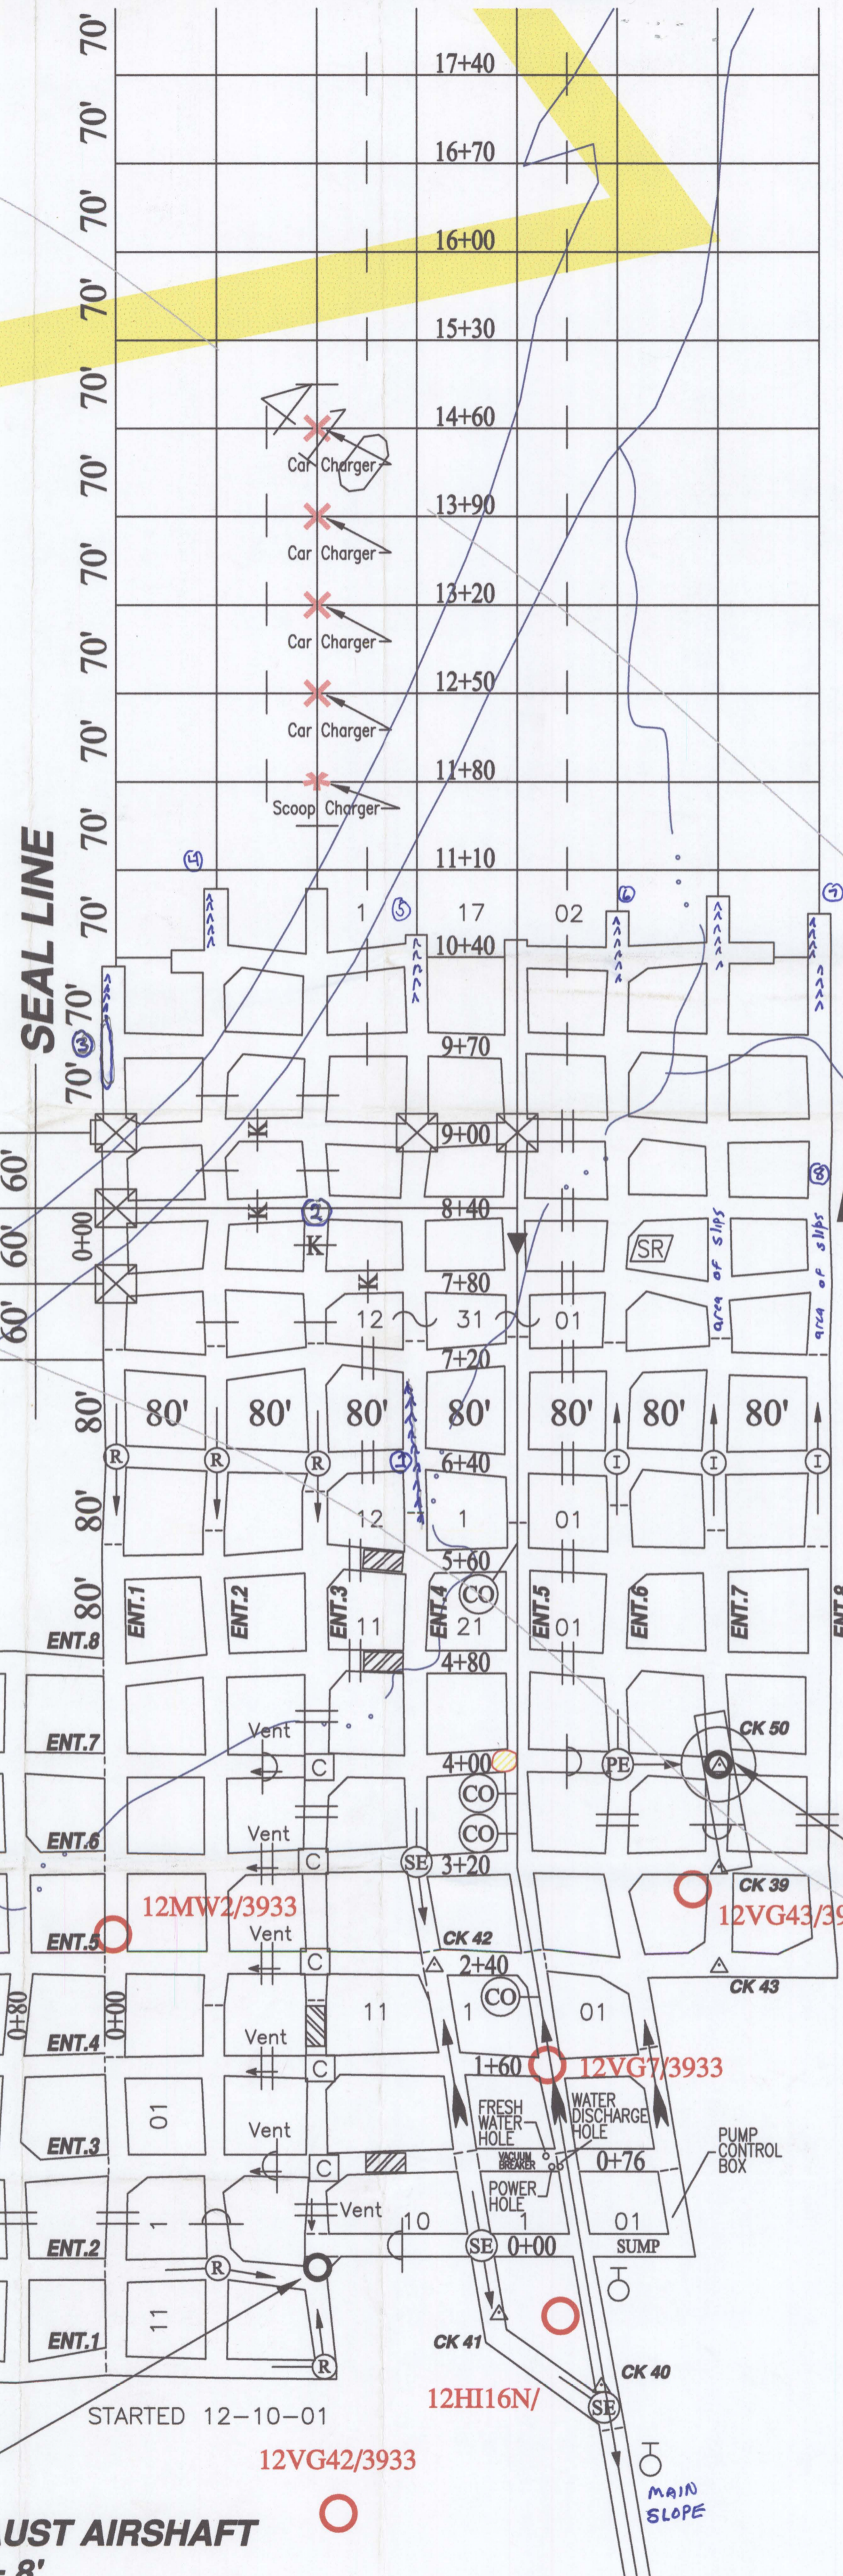
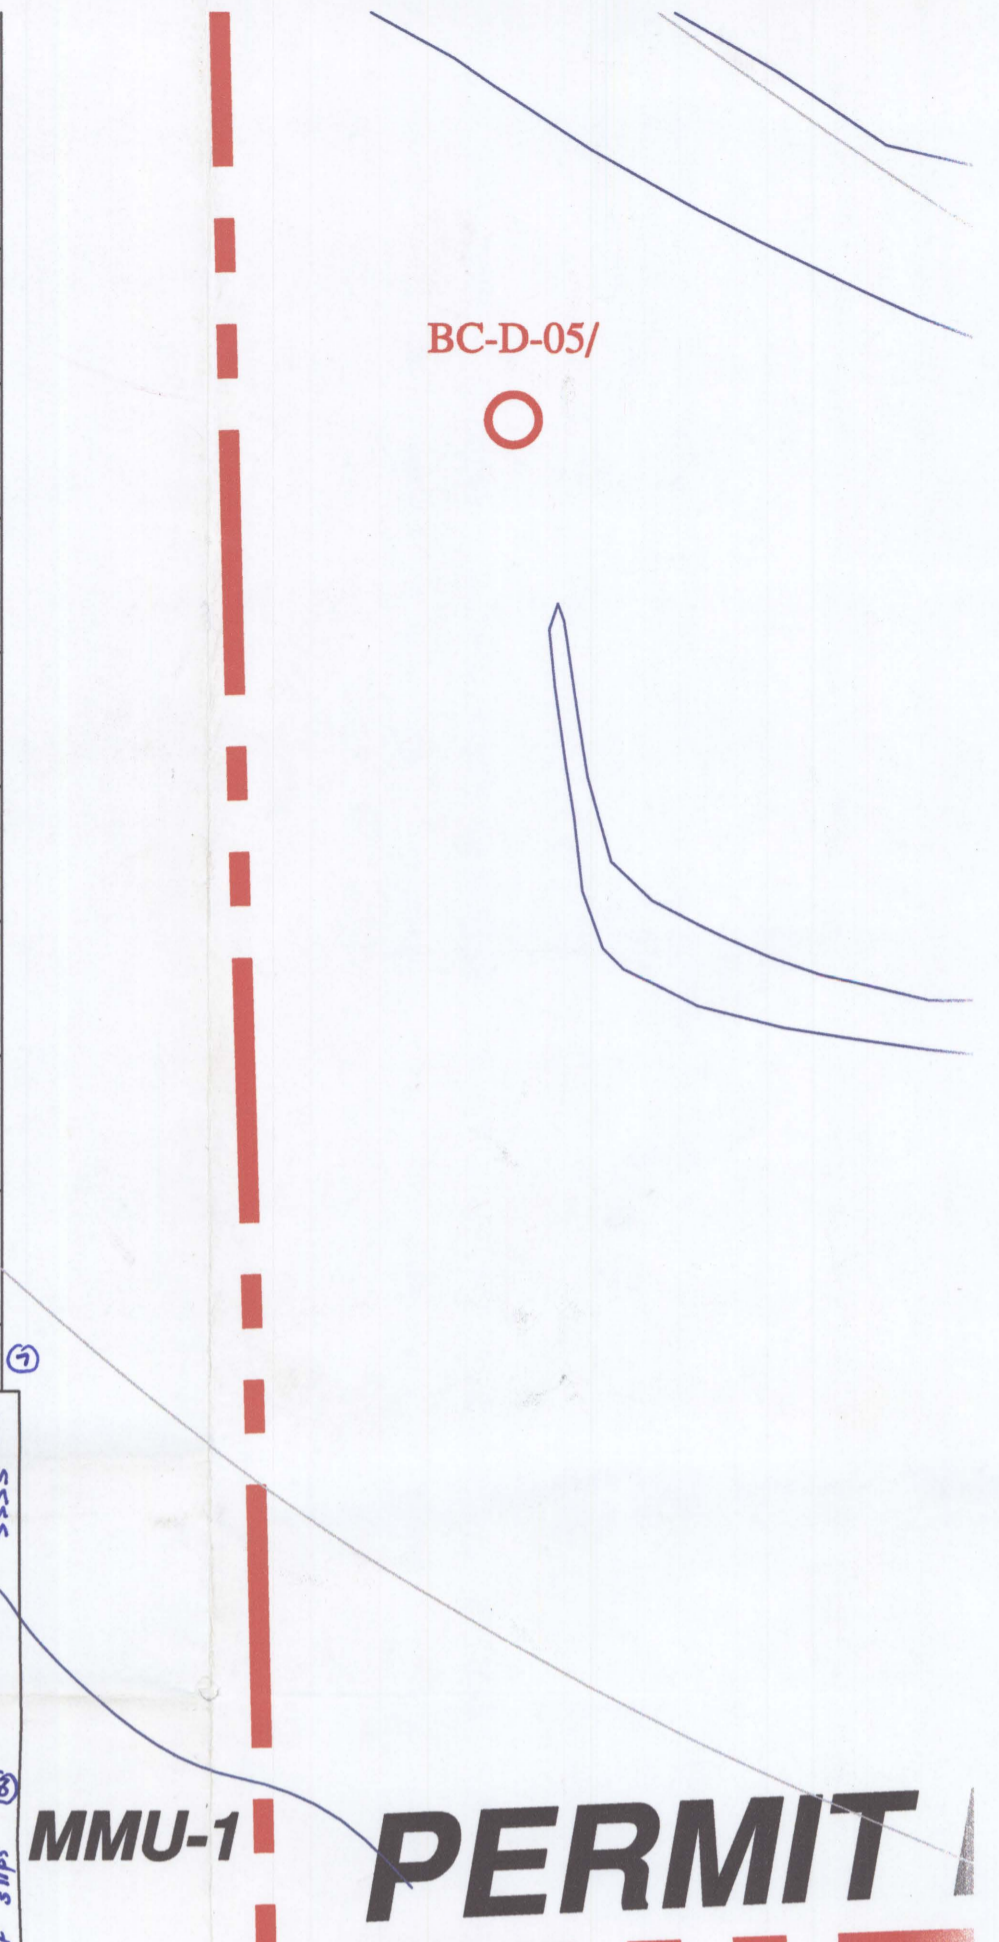
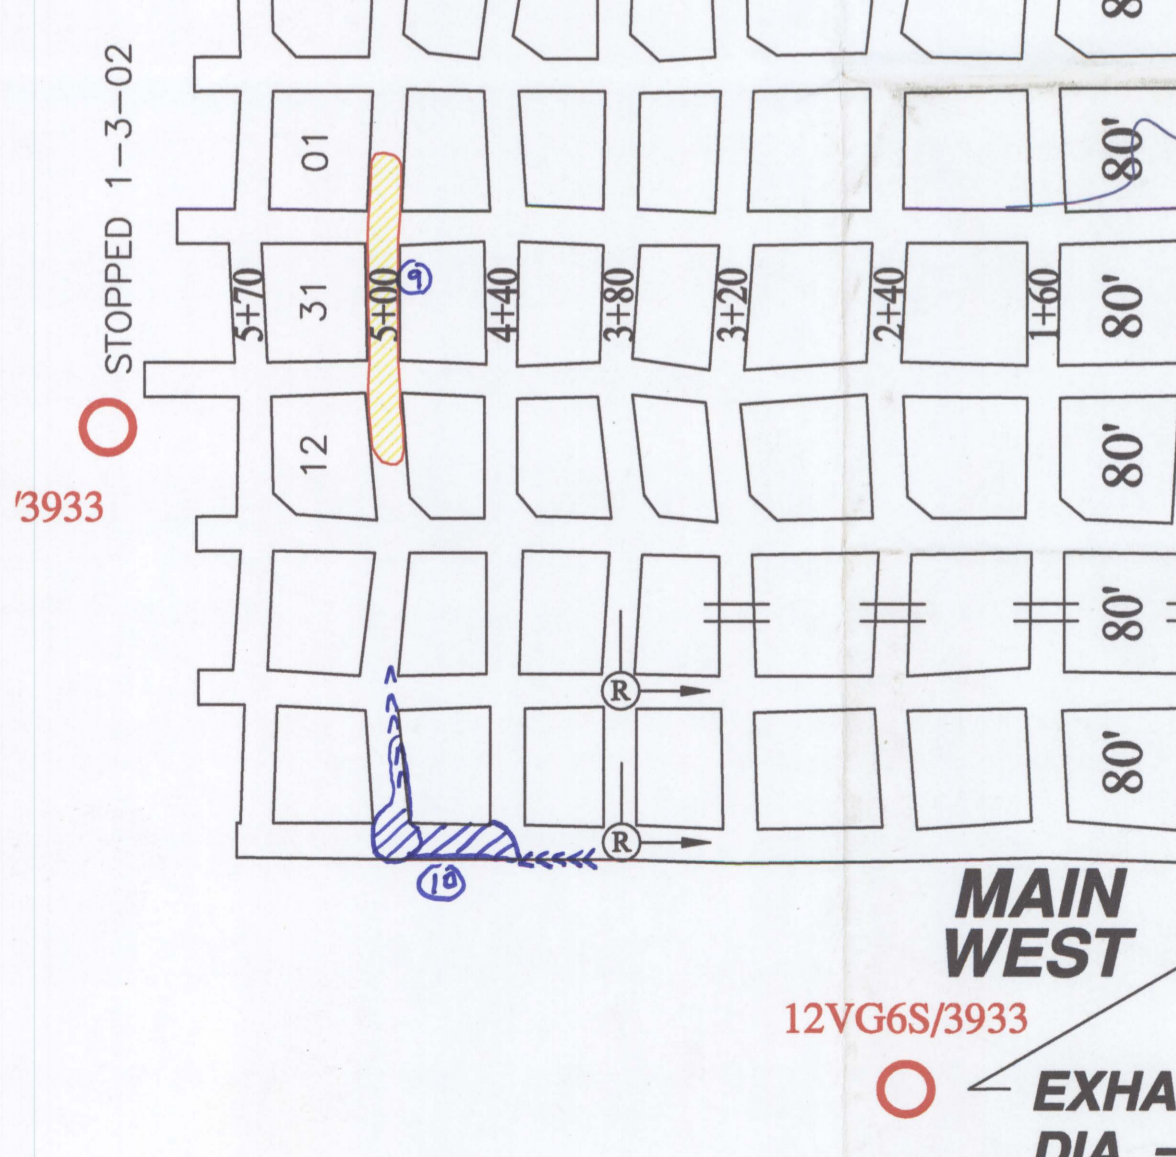
**MAIN NORTH**

- ① Notes by John Nelson 1/18/02
- ↑↑↑ Risk zone
- ▨ Roof fall, crosshatched where blocking entry.
