SAHARA COAL COMPANY MINE NO. 7

Visit to Sahara #7 Mine

Tuesday, Feb. 5, 1985

Sahara Coal Company - Mine No. 7
Saline County - February 5, 1985

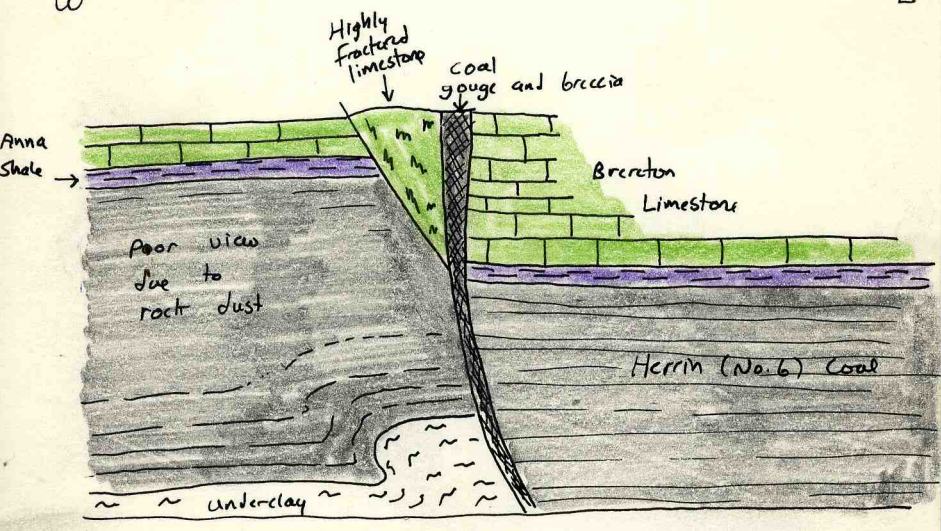
Sketch of fault on north rib of track entry

Very little drag, and a very thin zone of gouge. About 40 feet to the east a second fault trending N 15° ~~W~~^E/ 60° NE, with 3.3 feet of normal throw down to the NE. Peculiar structure on the north rib, however, indicates either strike-slip displacement or a component of reverse movement. See sketch.

The main offset is a normal fault, but note the reverse flexure in the floor on the footwall, and the coal gouge along the fault above the position of the Herrin coal on either side of the fault.

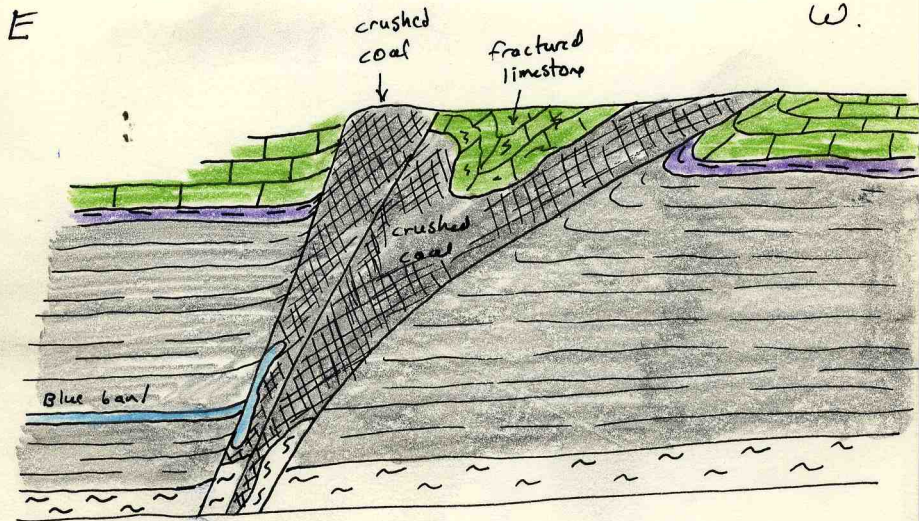
Sketch of same fault on south rib
of belt entry, about 60 ft. north
of track entry.

On the belt entry the same fault has practically no net offset, but again slices of coal are upthrown, and slices of limestone downthrown, within the fault zone. Drag and displacement on the westernmost, low-angle branch of the fault clearly indicate reverse movement. See this sketch. Slickensides plunge about 45° SE.

Almost no net displacement across fault,
but fault slices show both normal and
reverse offset.

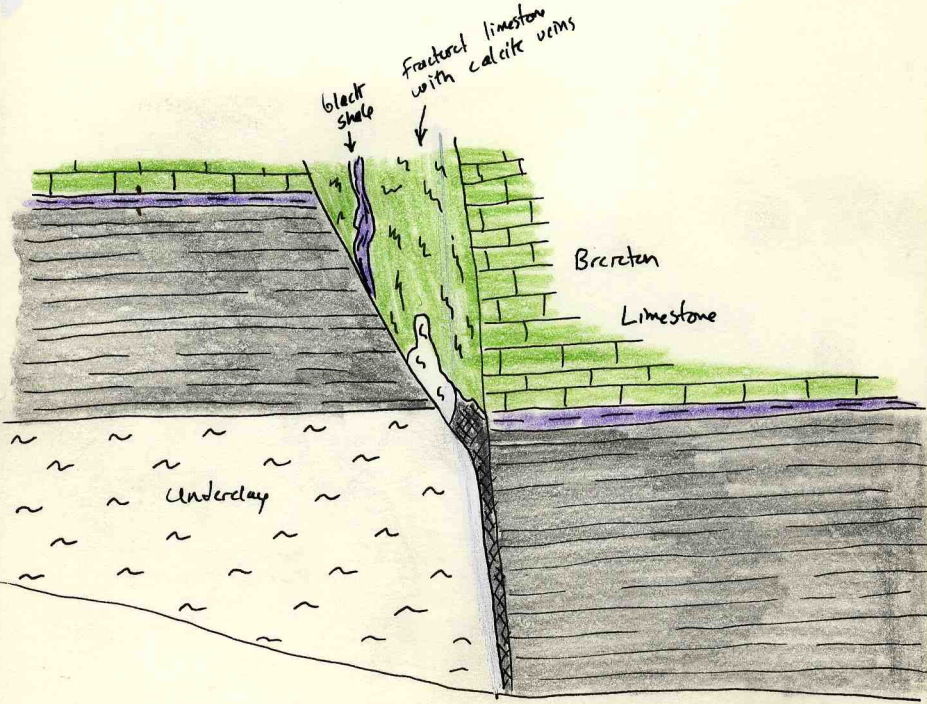
Sketch of same fault in Crosscut 11,
about 100 feet southeast of tract entry.

South of the track in Crosscut 11 is a much cleaner view of the same fault. There it trends N 15° W/ 77° NE and the NE side is down about 5.3 feet, bringing the floor of the coal on the footwall opposite the roof on the hanging wall. Again an indication of strike-slip and/or two periods of movement; a narrow shoot of gray clay (underclay) projects upward in the fault zone above its level on either side of the fault.

The fault splits upward, with a wedge of Brereton Limestone between the branches. The limestone is heavily fractured and laced with calcite veins, some over an inch wide. Faint slickensides are seen; some are nearly vertical but others are oblique to nearly horizontal.

At first glance a simple normal fault,
branching upward; but note underclay
squeezed upward along fault plane.
