OLD BEN COAL COMPANY
MINE NO. 25

COAL MINE—PRODUCTION

OLD BEN COAL CO., Mine No. 25
Franklin Co.
November 17, 1977

OLD BEN No. 25 MINE - GEOLOGY AND GENERAL CONDITIONS

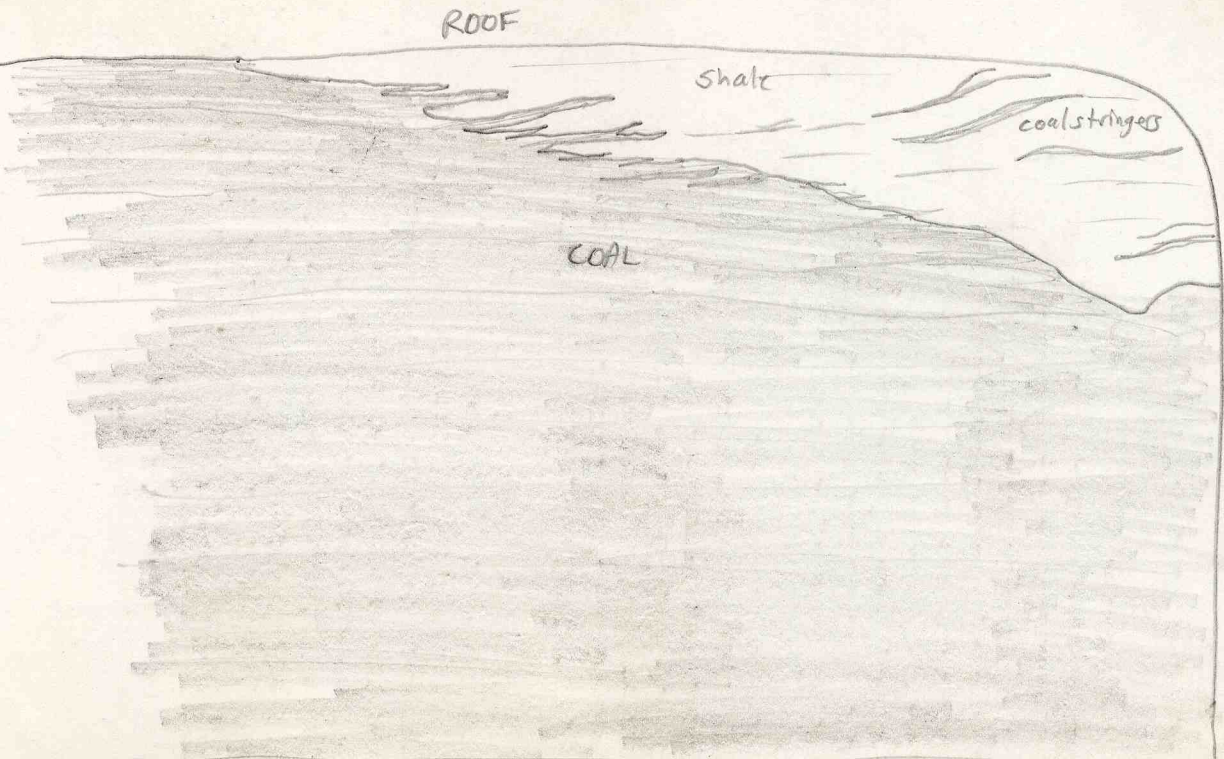
Stop 15 - North Rib
View of large "roll" in 1st west

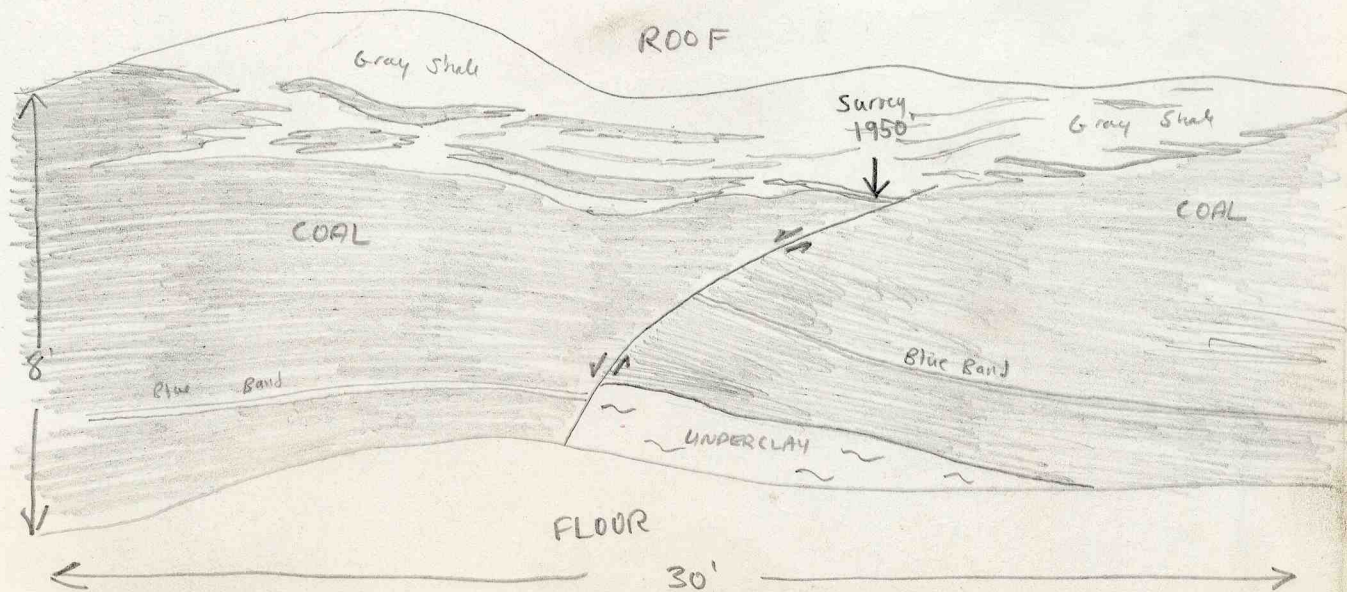
Step 16 - General View w Rib.
Partly Interpretive
50'

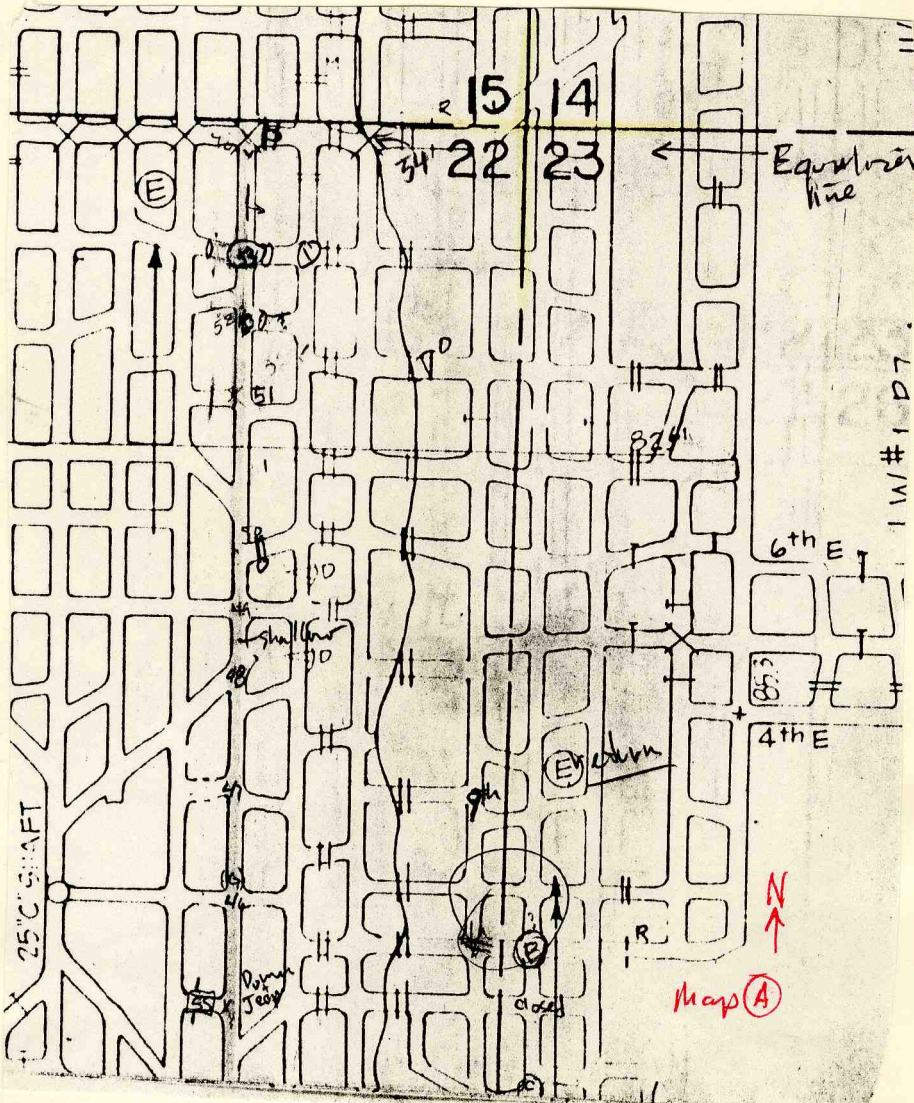
Map A

cc46 Energy Shale has pref. fracture pattern in NE-SW direction.

cc47 Weak E-W fracture in Energy

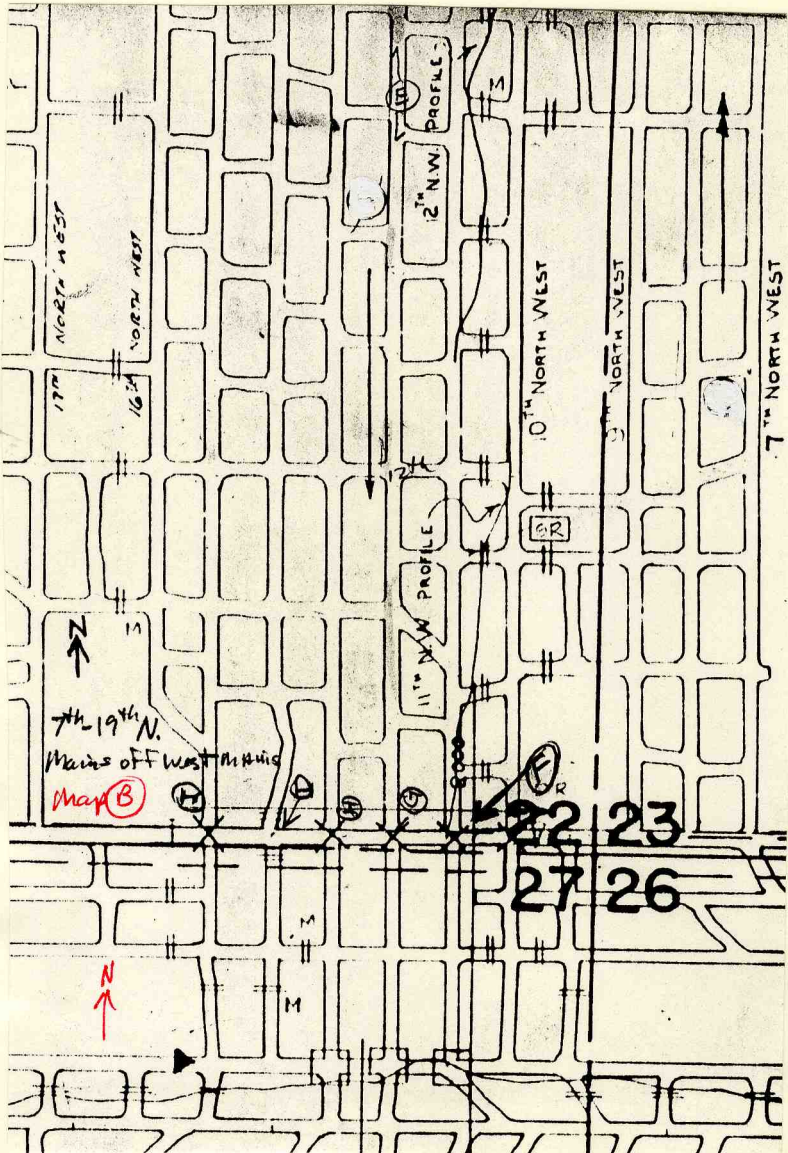
Map B

cc52 Weak "kink zone" for short distance near left side of entry. Chugh thinks it is from compression. It looks indistinct to me and could also be due to weathering of lower roof; area is 6 yrs. old. The bottom 0.4' of roof has potted out in several directions between lines of bolts in the area. A siderite nodule band position at 0.4' up was not seen to be broken in the area. Top coal was originally bolted in this area.
