ZEIGLER COAL CO.
 MINE # 4

Mine Index No. ~~0210~~ 0662
 County No. 1604
 Coal Report No. S-83

WILLIAMSON COUNTY

Zeigler Coal Co. U. G. Mine No. 4, Williamson County/
Ill.

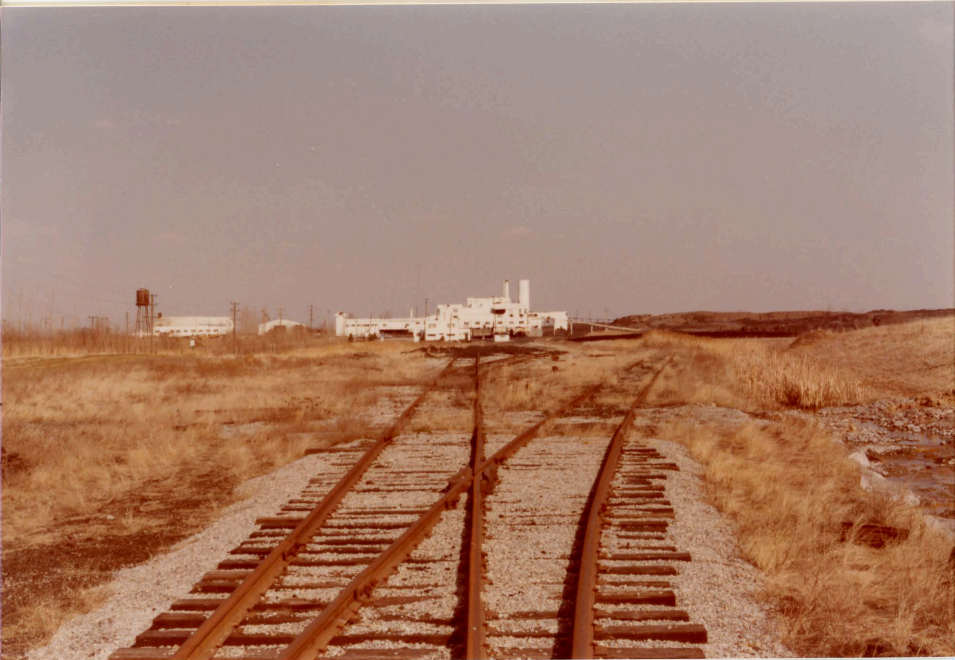
Tipple of Zeigler No. 4 - recently
abandoned. John Nelson, March 1981.

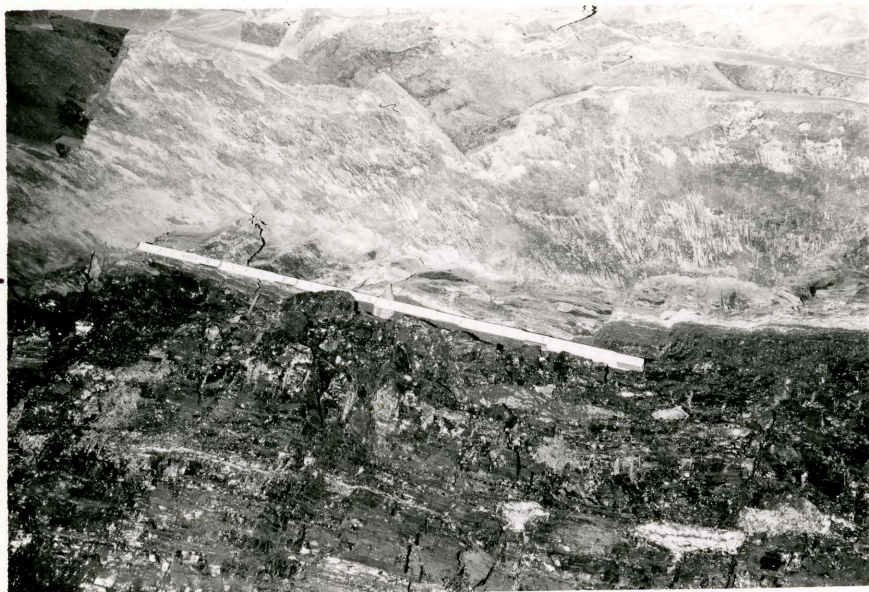
STOP 3

Slickensides on bedding surface in roof shale. Striations trend N 7 E and the beds dip approx. 8-10 to north. Shale apparently has moved ~~south~~^{north}ward relative to coal. (= uphill!)?

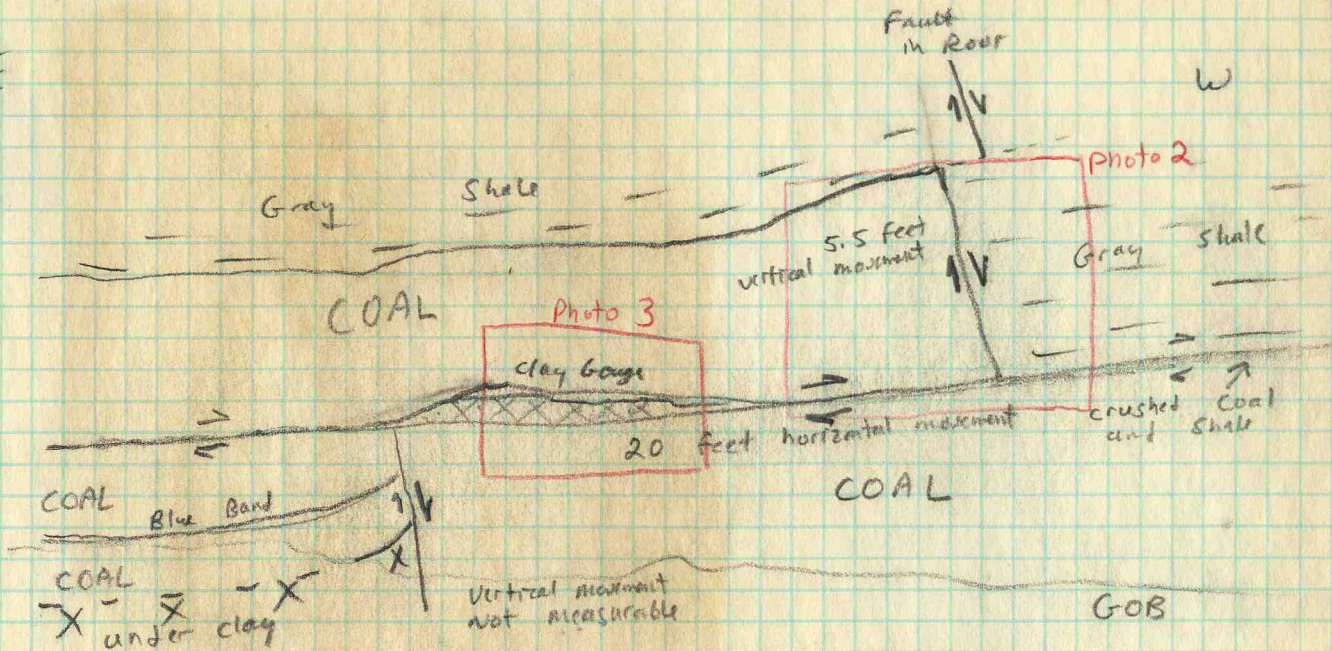
Stop 4 - Generalized view South Rib.

Geometry of Horizontal Offset of Fault at Stop 4.

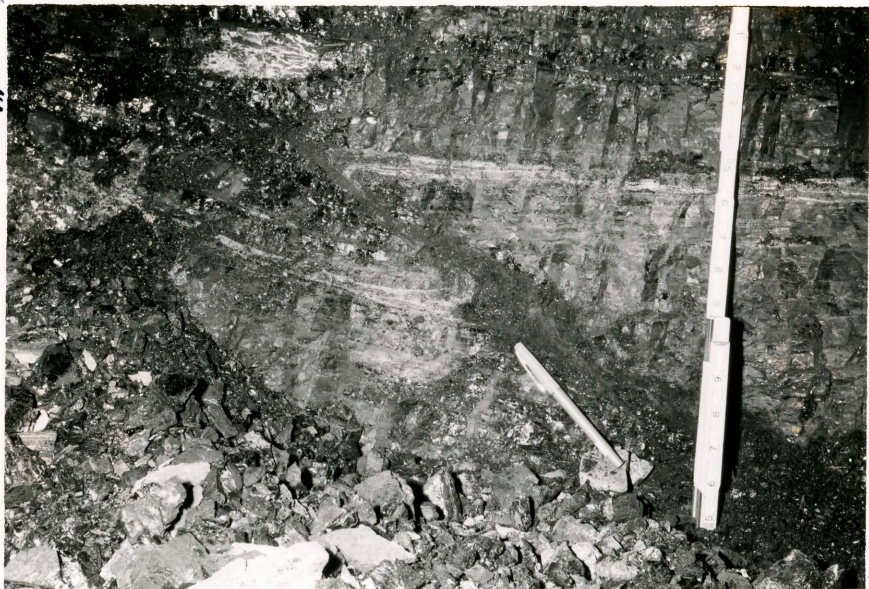
STOP 7

Flexure in coal seam with clay band folded into a tight "S" shape. Intensity of flexure increases downward. Pulverized coal along axis of flexure (pen).

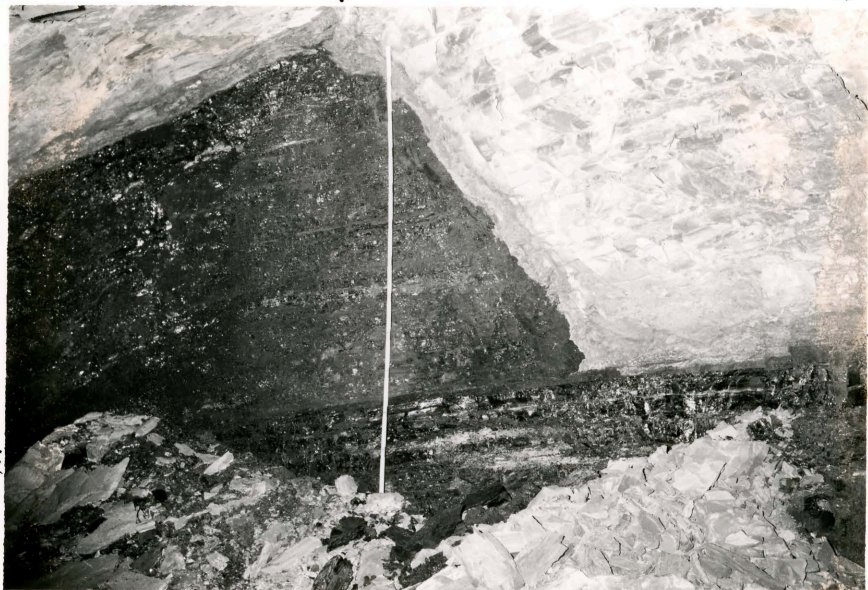
STOP 4

High-angle normal fault displaced by horizontal movement along bedding plane in coal. The upper block moved to the west (right) relative to the lower block. Note dull, fractured appearance of coal in upper block as compared to shiny coal with uninterrupted layering in lower block.

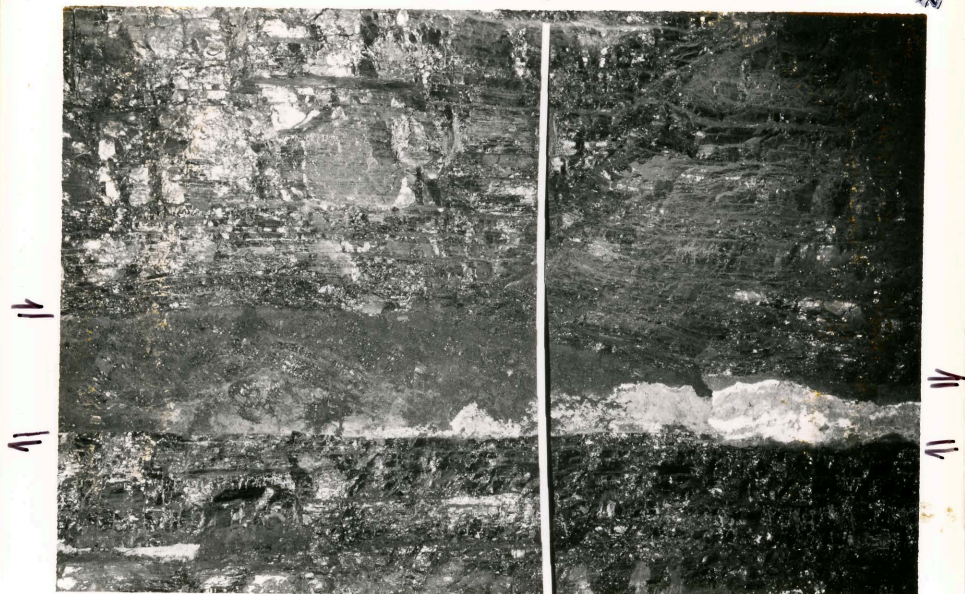
STOP 4

Pulverized coal and clay found along zone of horizontal shearing. Zone is up to one foot thick. Upper half of coal seam moved to west (right).

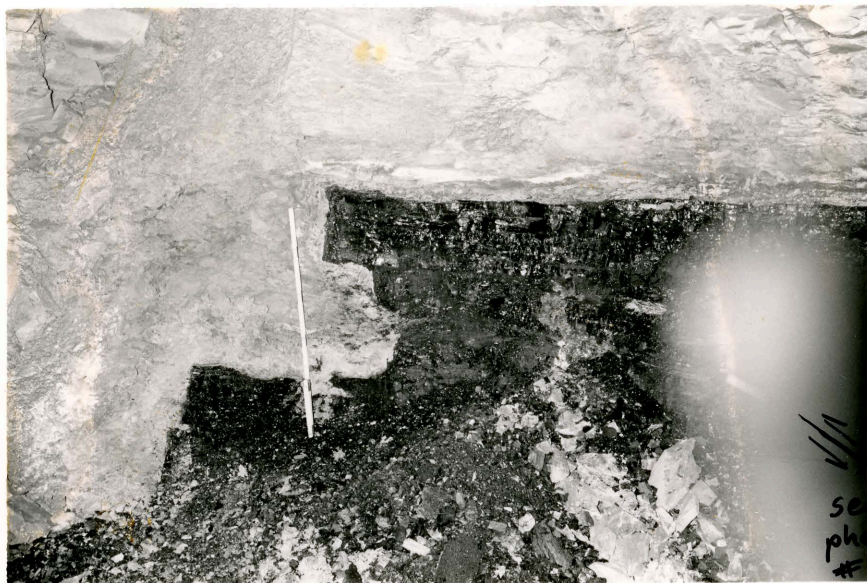
STOP 7

Overall view of north rib showing normal fault offset by horizontal movement along bedding planes. Sharp flexure in coal to lower right; unfortunately Fred's thumb got in the way. See Photos 8 and 9.

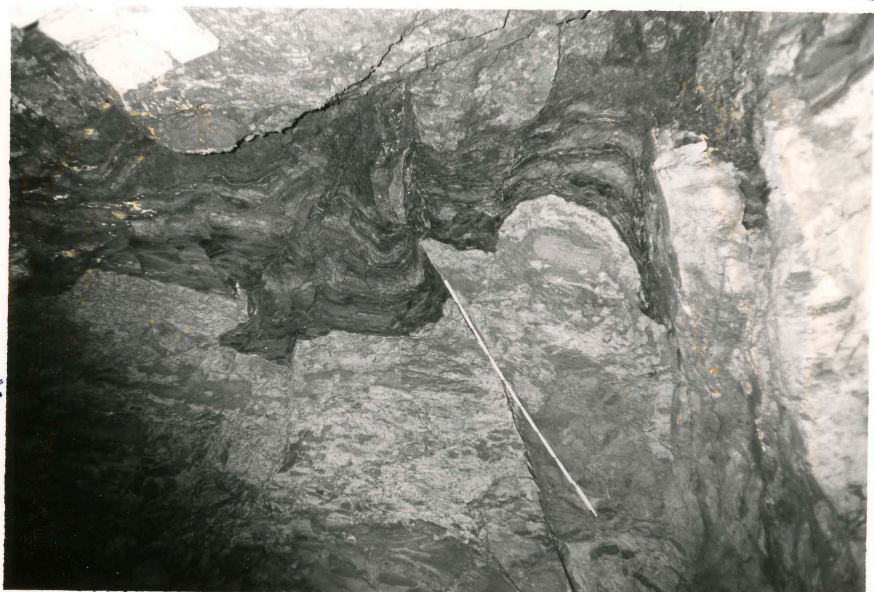
STOP 9

Complicated faulting of Anna Shale (dark, top) and Energy Shale (light, bottom). Both normal and reverse faults are present, and the shale is strongly folded and fractured. Note Anna Shale dragged sharply downward along faults at upper right.

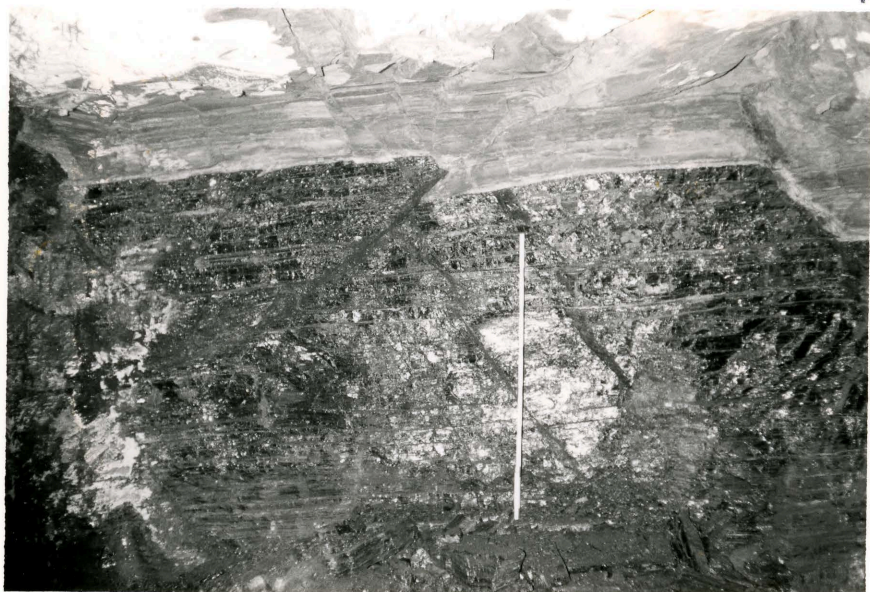
STOP 13

Small normal and reverse faults displacing the upper part of the coal seam and the roof shale. Coal is cut by numerous inclined fractures with little or no displacement.

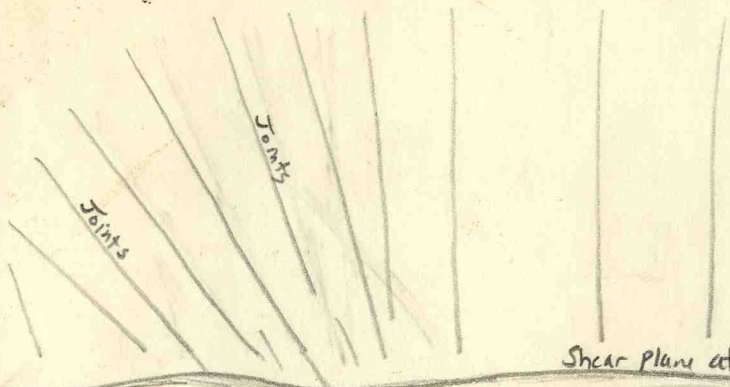
Shear plane at Coal / Roof Contact

and locally this thickens to a crushed zone several inches thick. Vertical fractures do not cross this zone- they probably are truncated and displaced. Other shear planes within the coal seam are locally apparent.

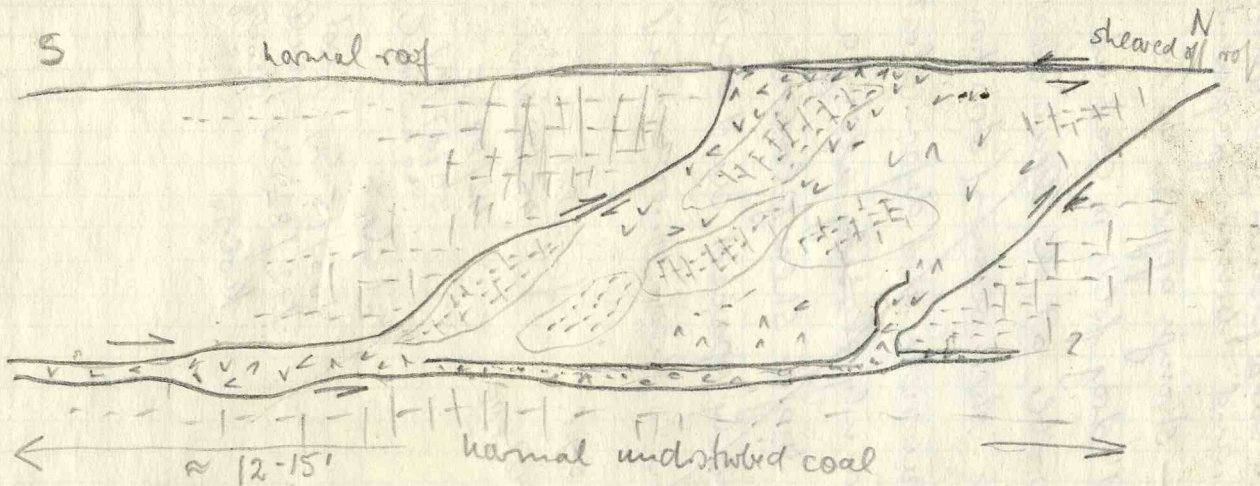
Station ② downhill overthrust of coal on coal
 tilted blocks of coal "swim" in finely crushed or we
 pulverized coal breccia. main or major shear plane
 is very hard while upper portion are ~~more~~ less compacted
 roof rock gray (Energy shale) almost undisturbed
 joints 110/75 SW

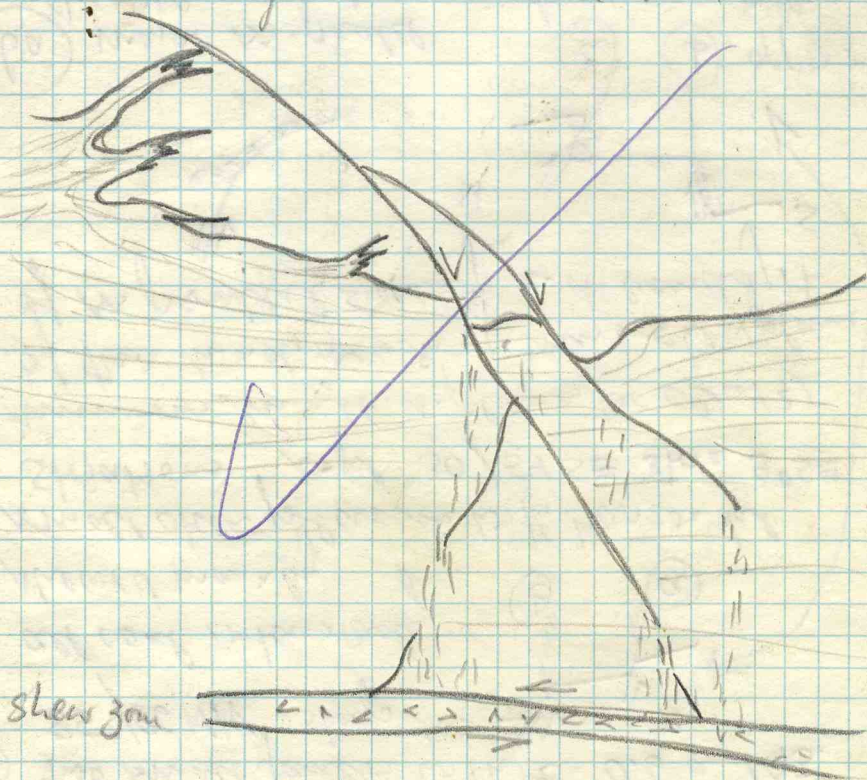
Roll and shear fault + joint trend is older
the shear zone.

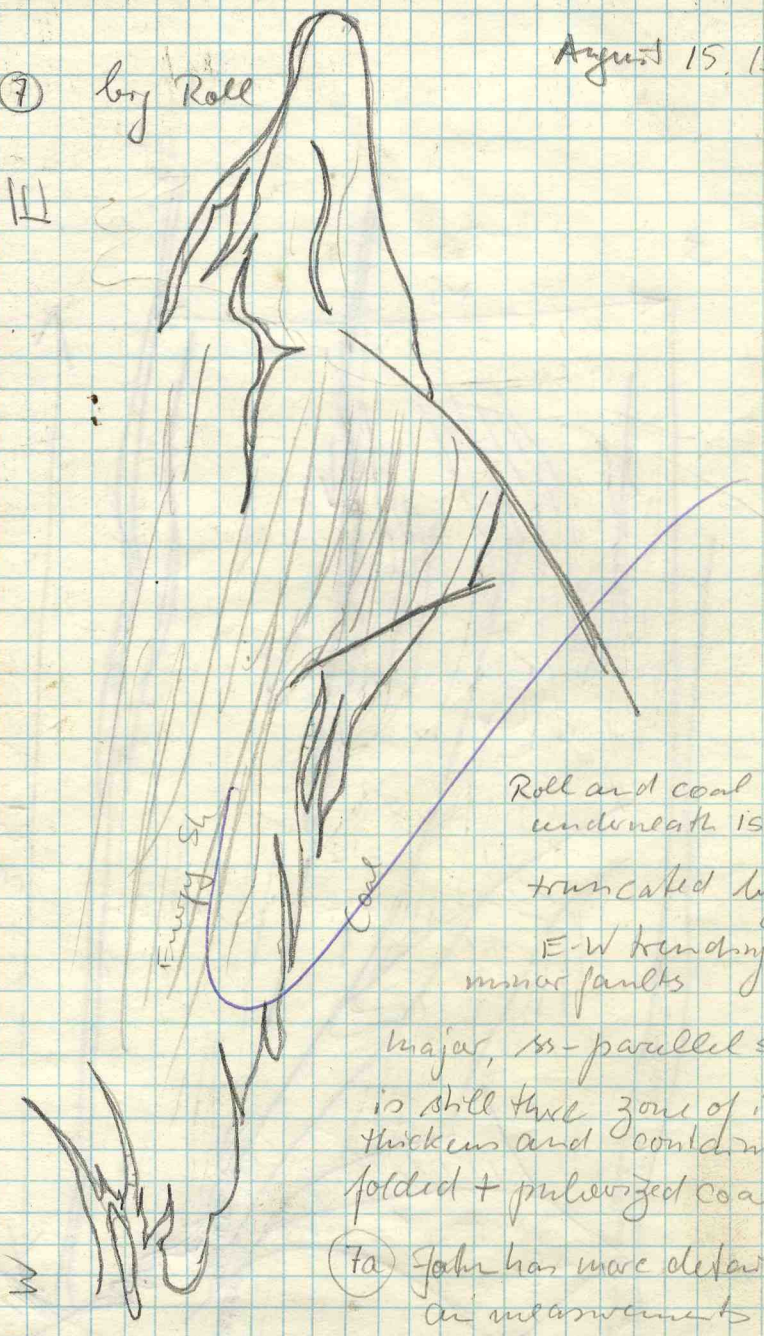
Roll and coal
 underneath is
 truncated by
 E-W trending
 minor faults

major, ss-parallel s-plan
 is still the zone of it
 thickens and contains
 folded + pulverized coal

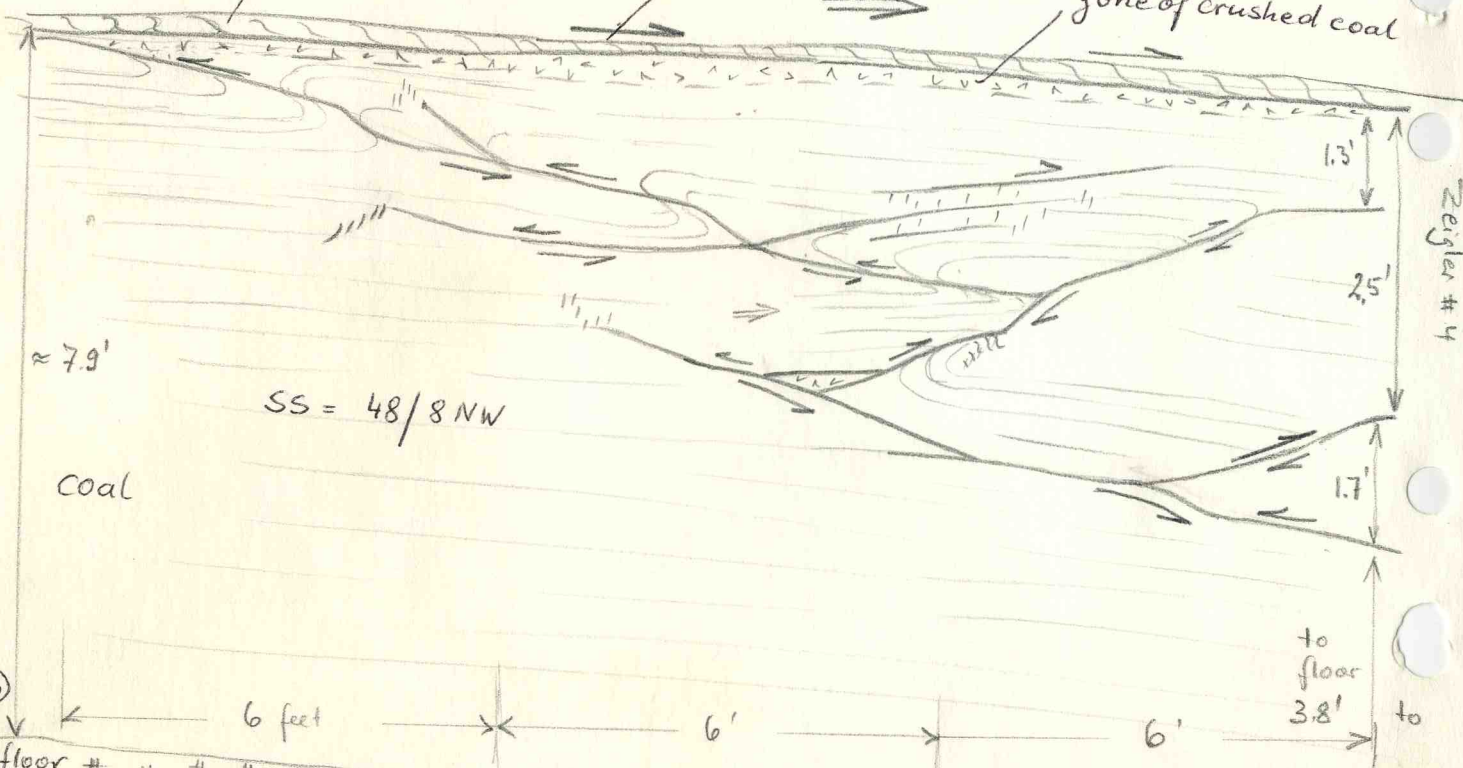
(2) Change of position of major ss-parallel s-plane (ss-parallel = parallel to bedding) from interior of coal bed to top of coal.

The upper bench of the coal have been sheared down-slope from SW towards NE, at this point s-plane "shifts" along two low angle reverse faults to top of coal and only roof rock has been sheared off. In disturbed zone of low angle s-planes tilted blocks of coal "swim" in finely crushed or even pulverized coal breccia. Zone along major shear plane and below it contains very hard compacted well bedded coal, while upper position is weak and less compacted more loosened up. Roof rock medium gray, almost undisturbed Energy Shale. Joints in Energy Shale 110/75SW

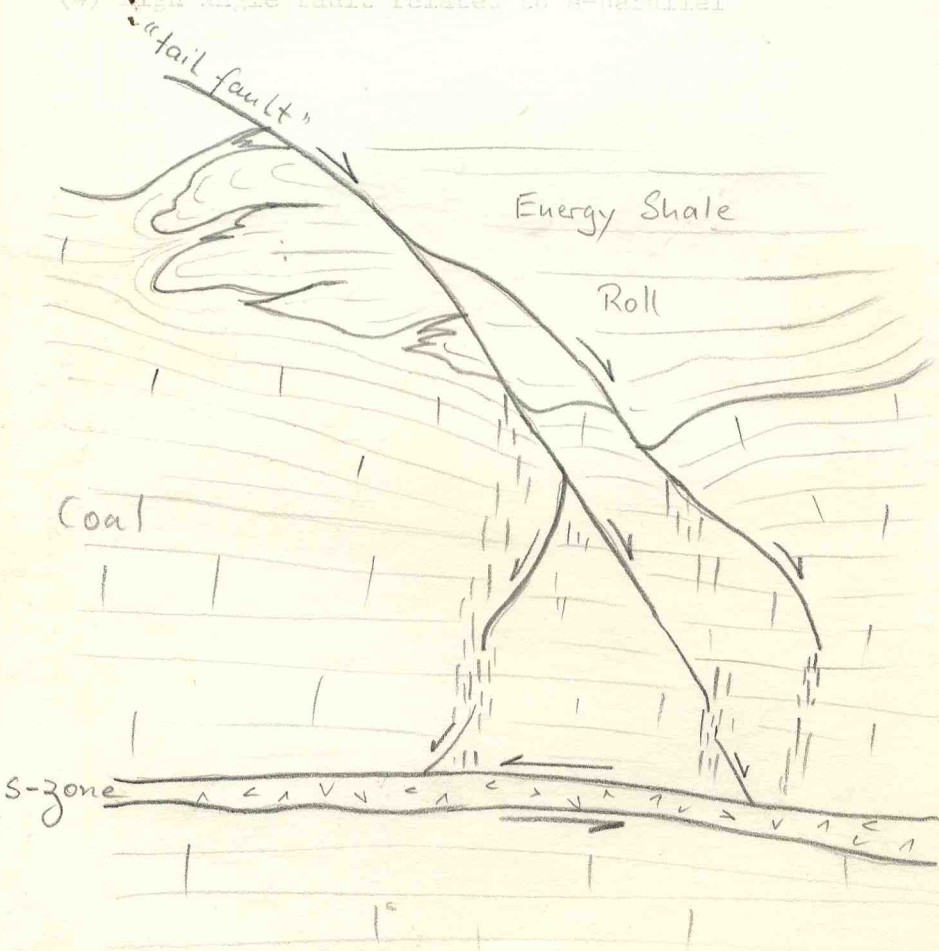
(4) High angle fault related to ss-parallel s-zone, probably extension fault due to differential movement downslope and collapse of beds. J. W. Nelson has more details.

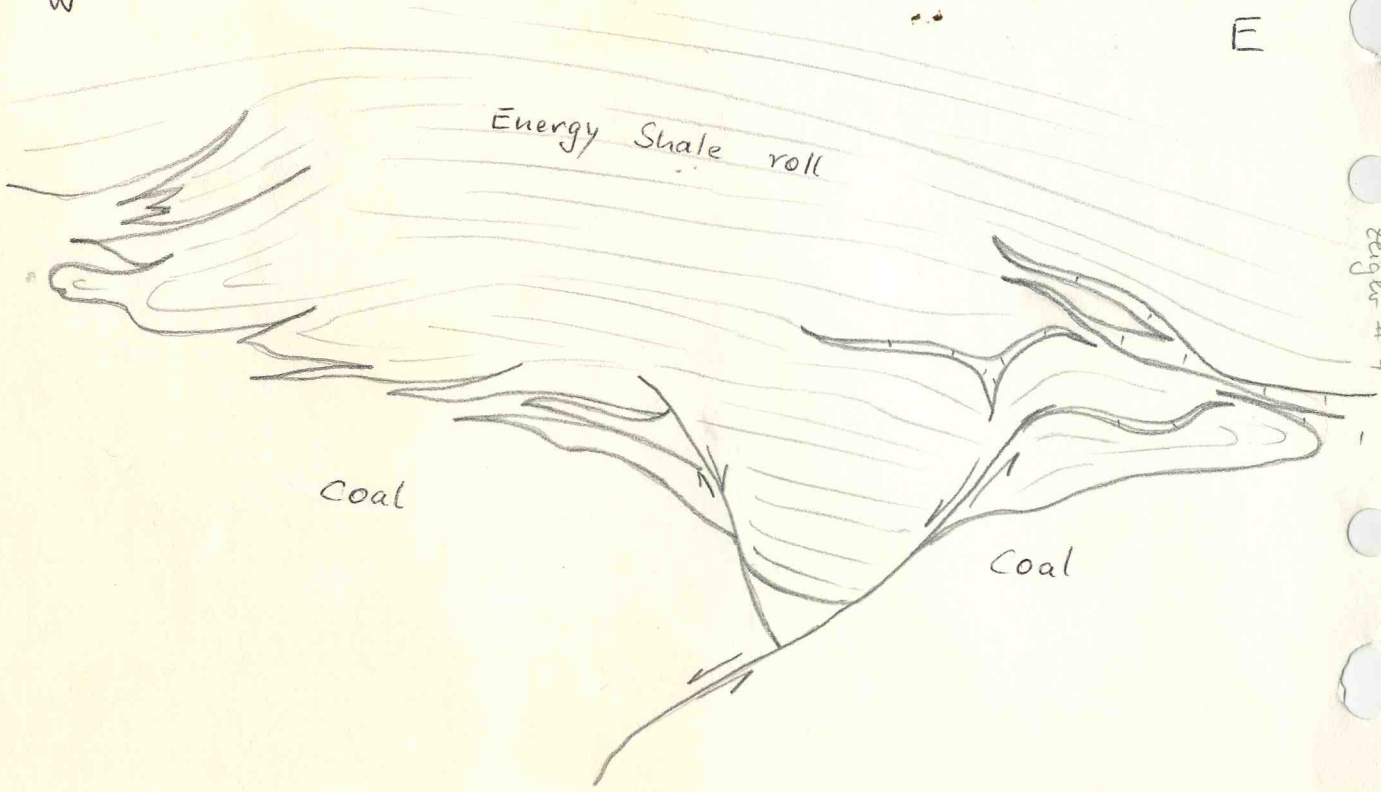
(7) Large roll of gray Energy Shale in top of coal, 5' down into coal at north side. Roll is a double-toe roll (soft sediment folded and deformed shale at both toes, no real tail of roll developed.) Main body of roll is wedge shaped with nearly horizontal bedding in it. Usual compaction faults (normal throw) at eastern third form small graben, at bottom of roll and on top coal. East-west trending minor high angle normal faults (see map) seem to be younger than the roll because they truncate the roll and the compactional toe - fault. Both are truncated by ss-parallel s-plane, which is thicker here and contains as well folded coal laminations as pulverized and brecciated coal.

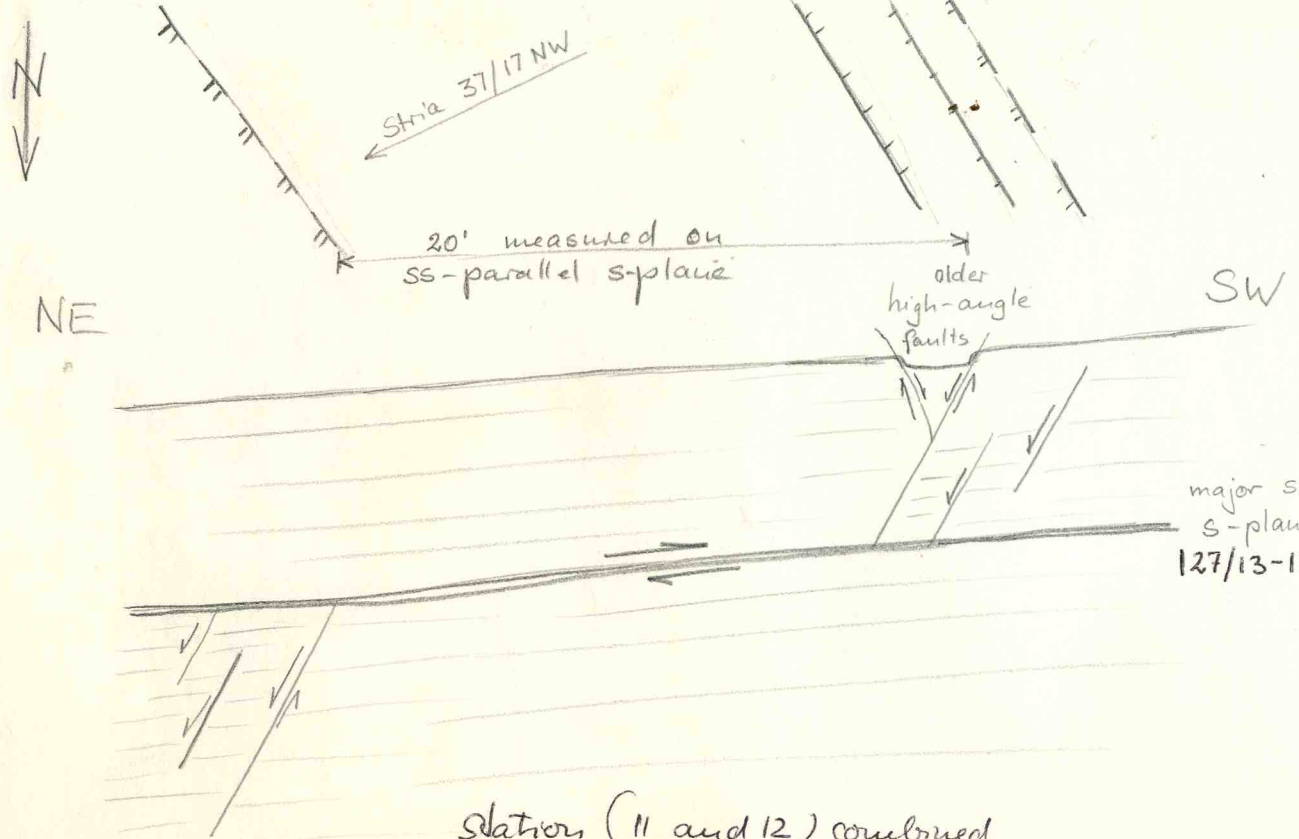
stations (11 and 12) combined.
 sketch, no scale! high angle faults displaced by ss-parallel s-plane

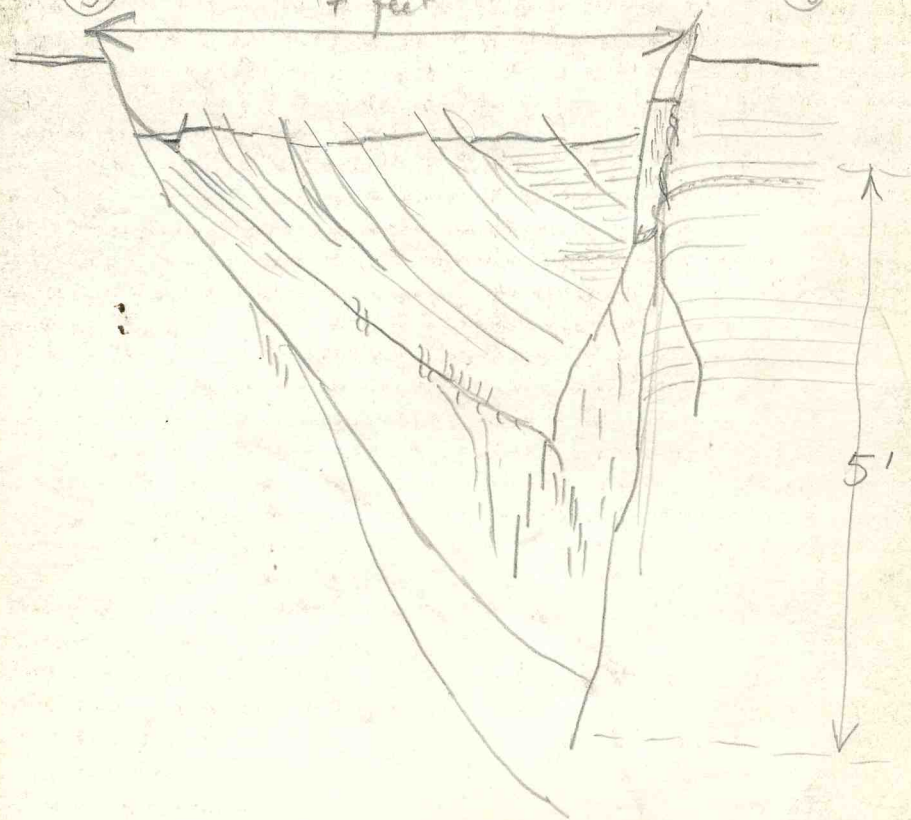
⑧ "Collapse fault" in Cottage Grove
 fault syst. "reverse fault + normal fault"
 as of station ⑧ huge wave and wave
