Sahara Coal Co. Mine # 21

SAHARA COAL CO. MINE NO. 21 SALINE COUNTY, ILL.

Notes by John Nelson on visit with Roger Nance and H.-F. Krausse, with Bob Gullic and John Lane of Sahara, on May 27, 1977.

Purpose of visit was to examine faulted areas and select regions for possible future detailed mapping in our study of the Cottage Grove Fault System.

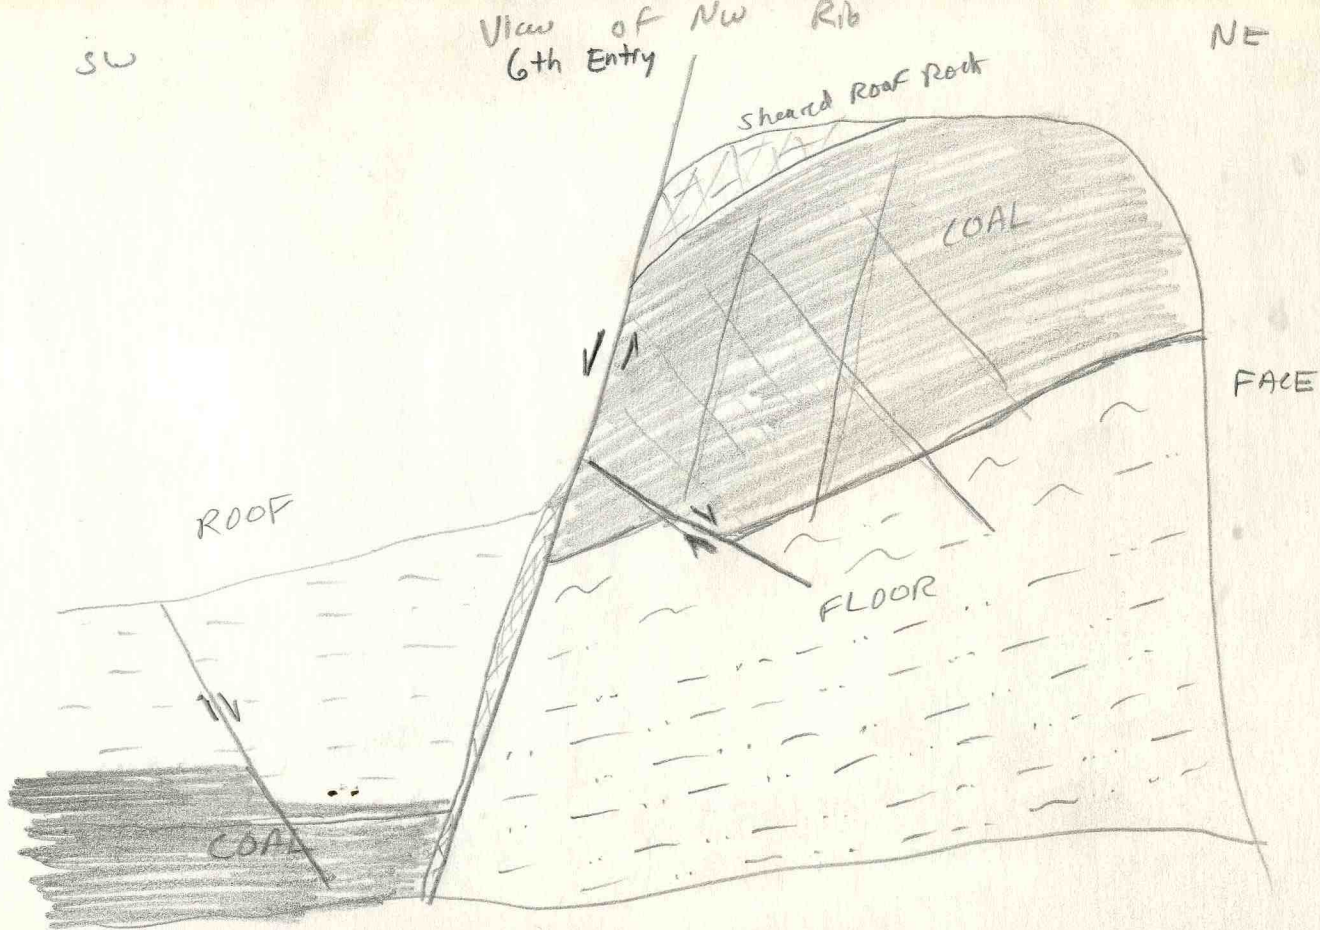
View of NW Rib
6th Entry

Face of 6th Entry Normal fault trending 160-165/65 SW at face, with 10-11' displacement. Continuation of fault at face of 7th Entry. Coal on the upthrown side dips 20-30 toward the fault and is sheared by anti-thetic fractures. Gouge zone along fault plane up to a foot wide containing sheared roof and floor rock. Numerous parallel faults and fractures of small displacement outby the main fault. Top is good except at the main fault, where roof is badly sheared.

Sheared Roof Rock

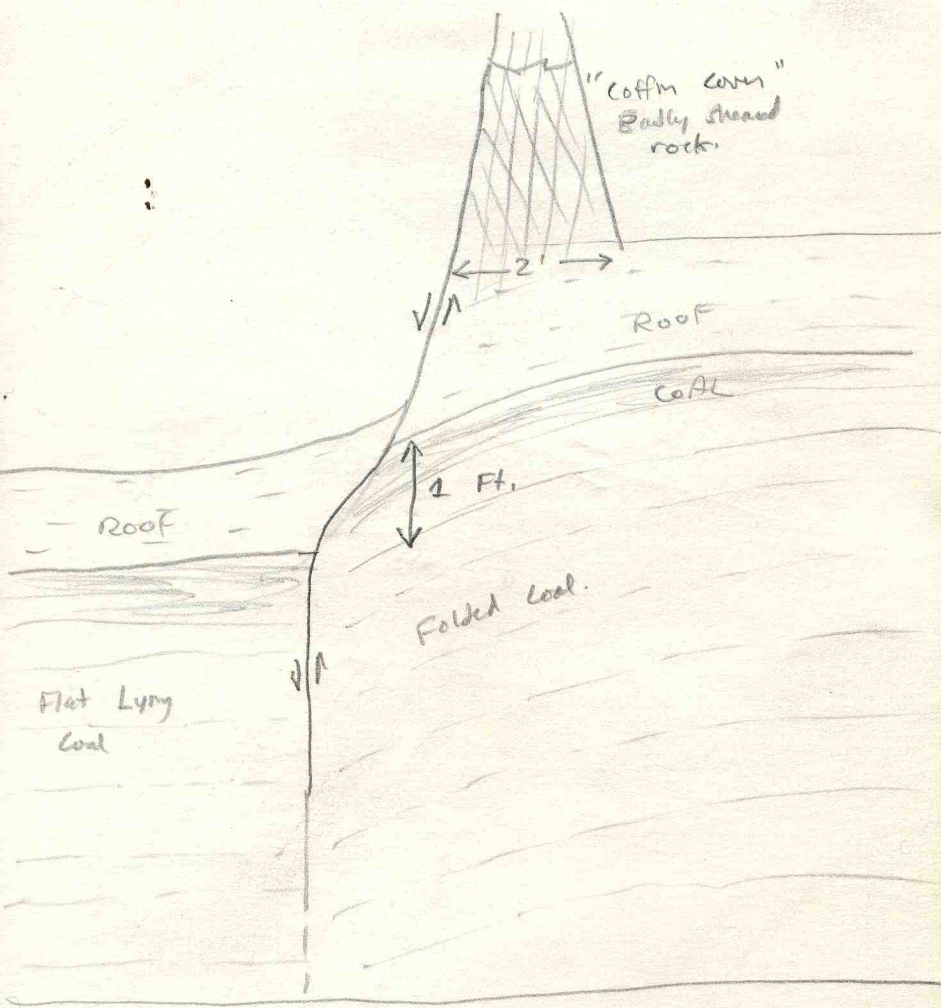
5th Entry - NW Rib
Just in by last crosscut

Face of 5th Entry About 50' outby the face a pair of high-angle faults form a "coffin cover" in the roof, with badly sheared rock between. See sketches (over).

"Coffin Cover"

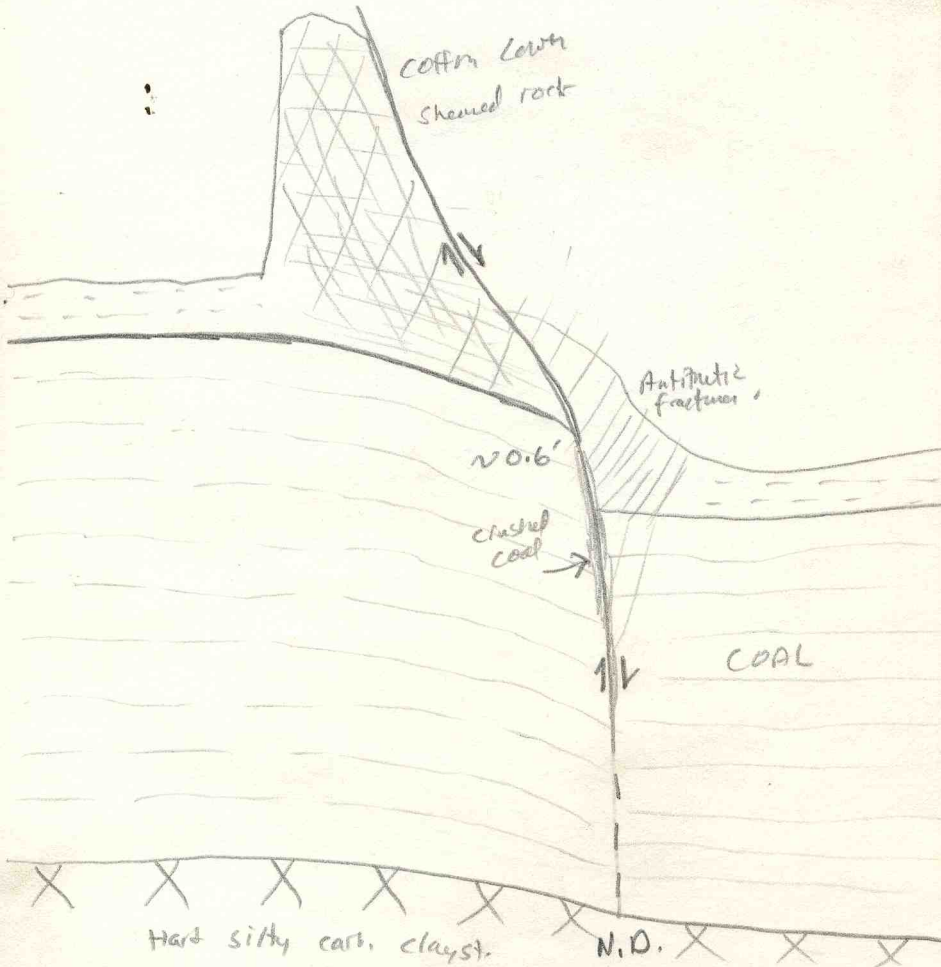
5th Entry - SE Rib.

" Coffin Cover "

Trunc of fault 155°

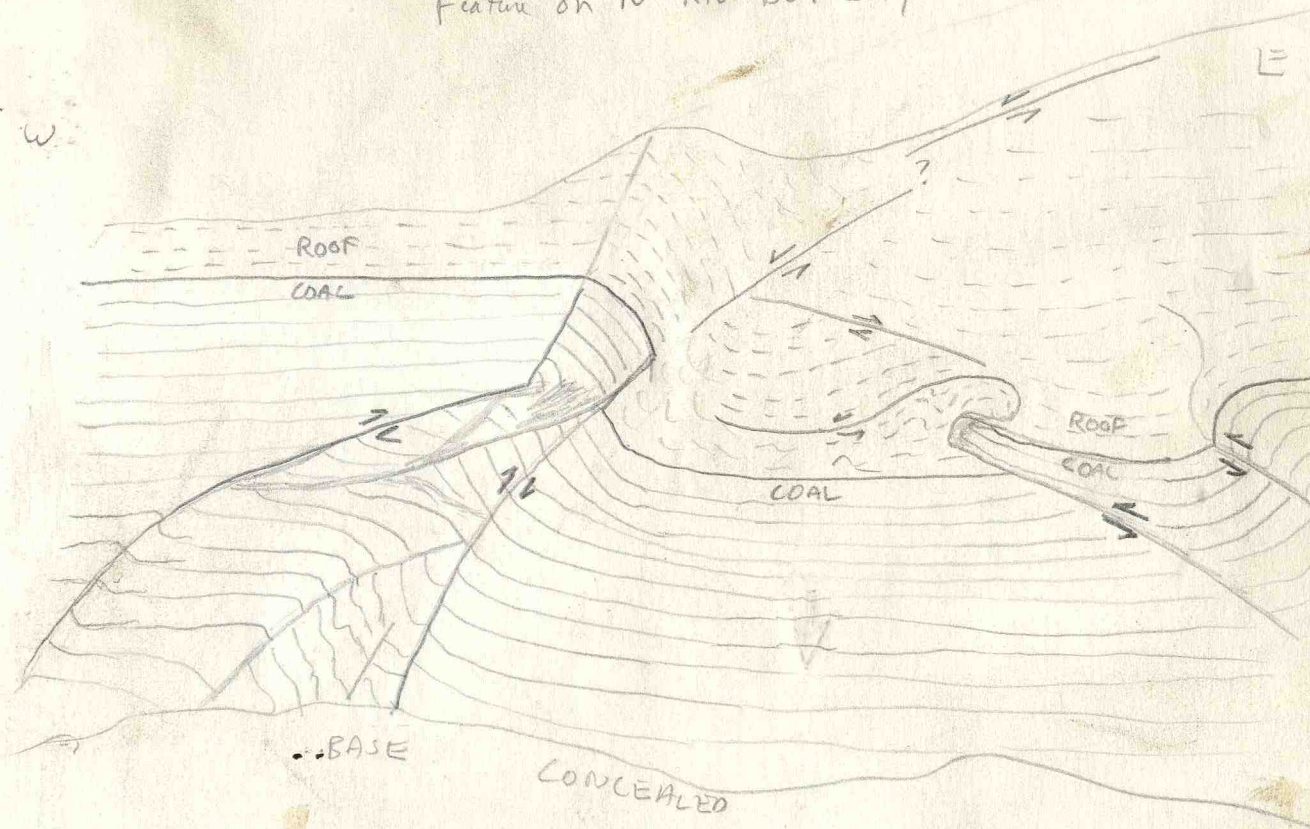
Feature on N. Rib Belt Entry

In the belt entry, the main structures visible are a series of low-angle reverse faults and flexures. Roof and coal are badly crushed and disturbed. Some movement has occurred along bedding planes. See sketch (over).

This structure clearly is due to compressional forces. We have seen similar structures in Freeman Orient No. 4 and in Zeigler No. 4, but there only in association with larger faults. There are no large faults in this part of Sahara No. 21.

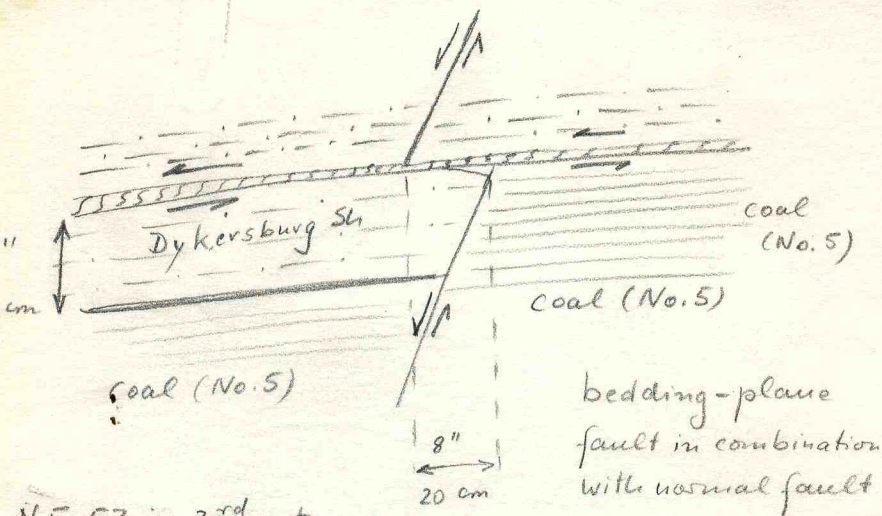
N.E. 57 in 3rd entry
 2 crosscuts out by face
 Sahara 21

bedding-plane
 fault in combination
 with normal fault

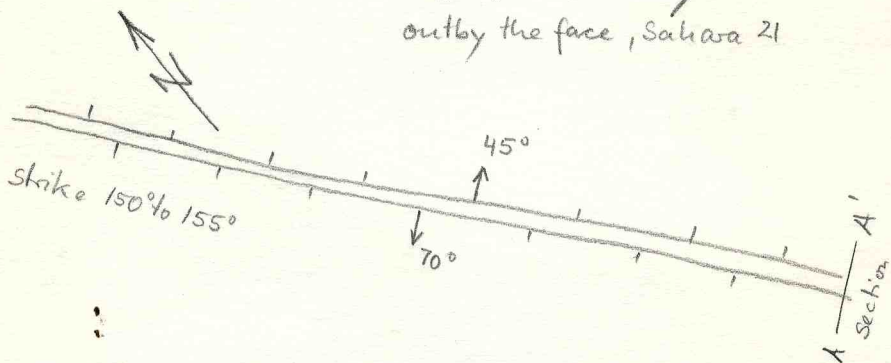
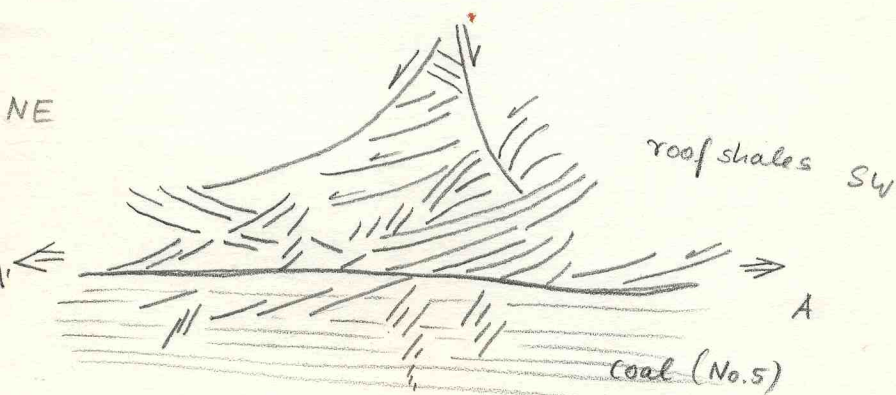
subsidiary faults in roof
 N.E. 57 in 5th entry 45 to 55'
 outby the face, Sahara 21

laterally sheared roof rock, coal only little affected.
 (all sw/aces are shear-sw/aces except coal-shale
 int/ace)

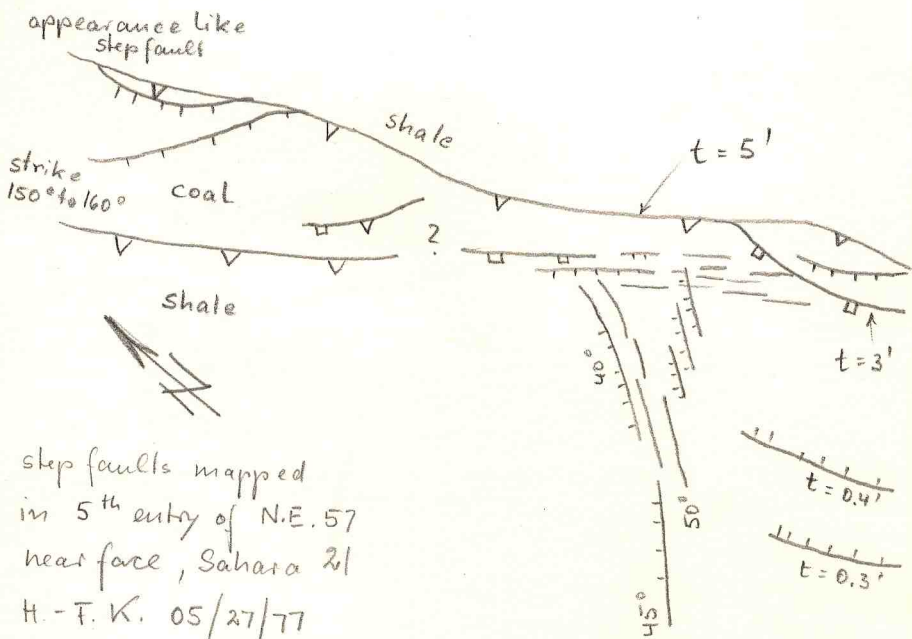
step faults mapped
in 5th entry of N.E. 57
near face, Sahara 21
H.-T. K. 05/27/77

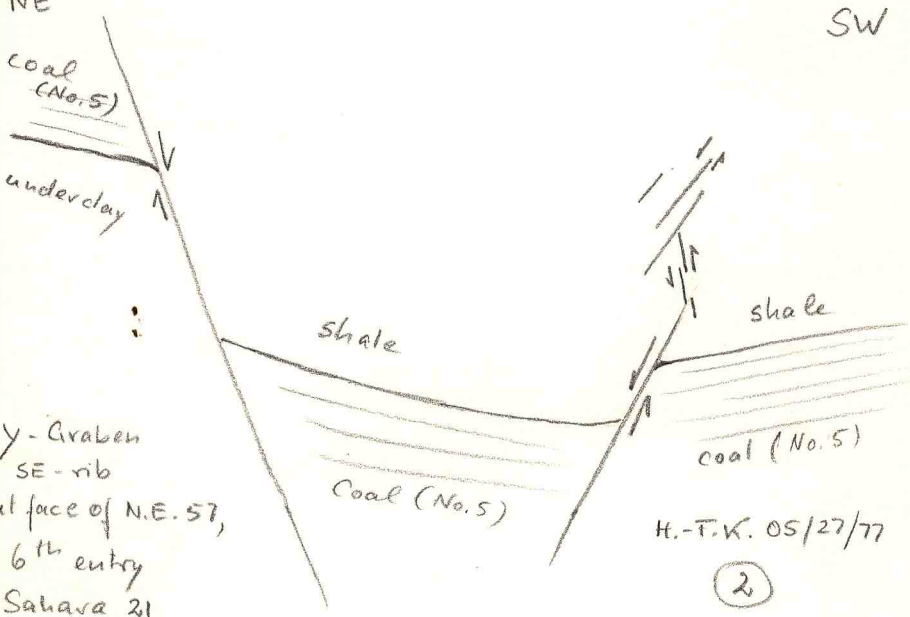
y-Graben
SE-rib
at face of N.E. 57,
6th entry
Sahara 21

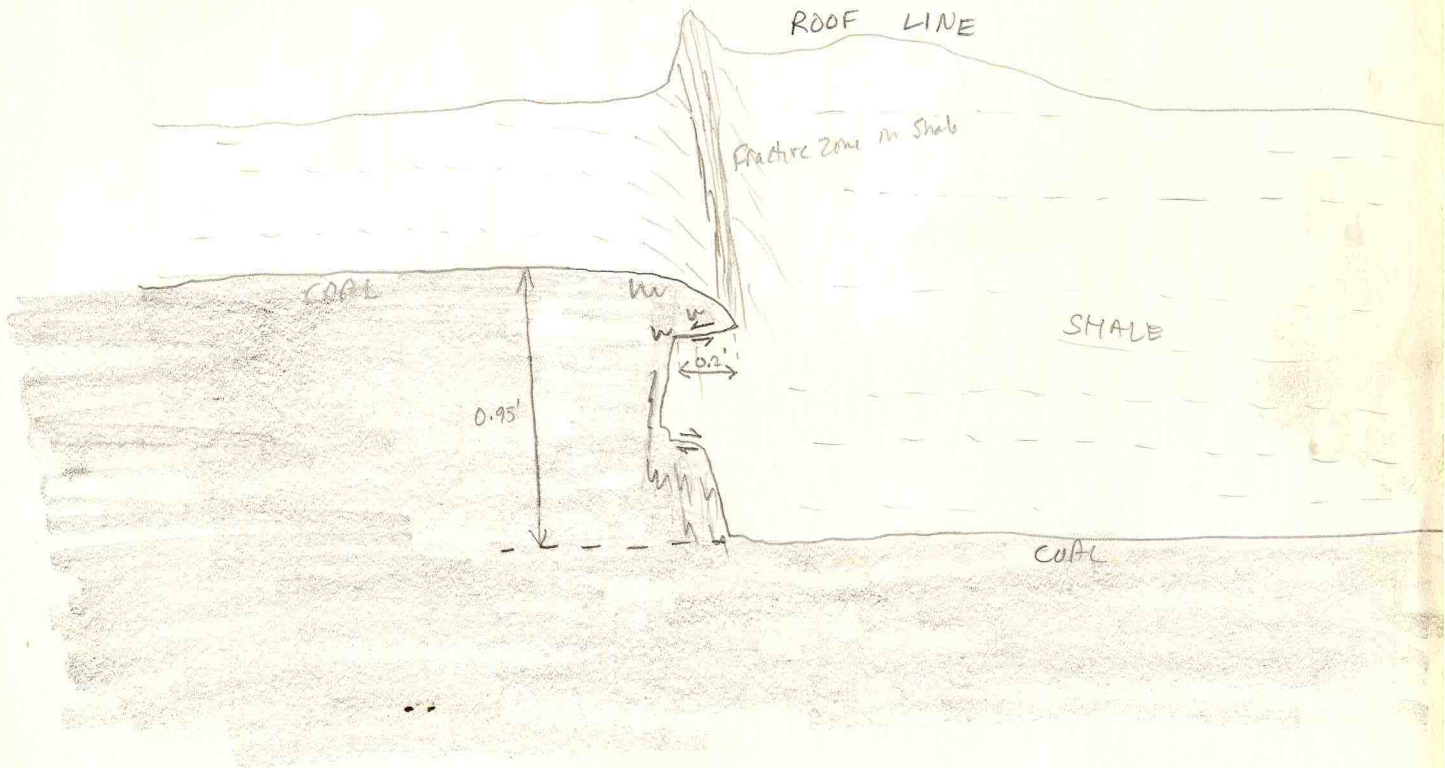
Stop 4- View of South Rib

8. Fault on south rib (photo) does not show a single clean break, but the coal is closely fractured and dragged downward along a set of downward-fanning fractures. Displacement decreases to north and the feature becomes a clean fault. This structure not noted in track entry.

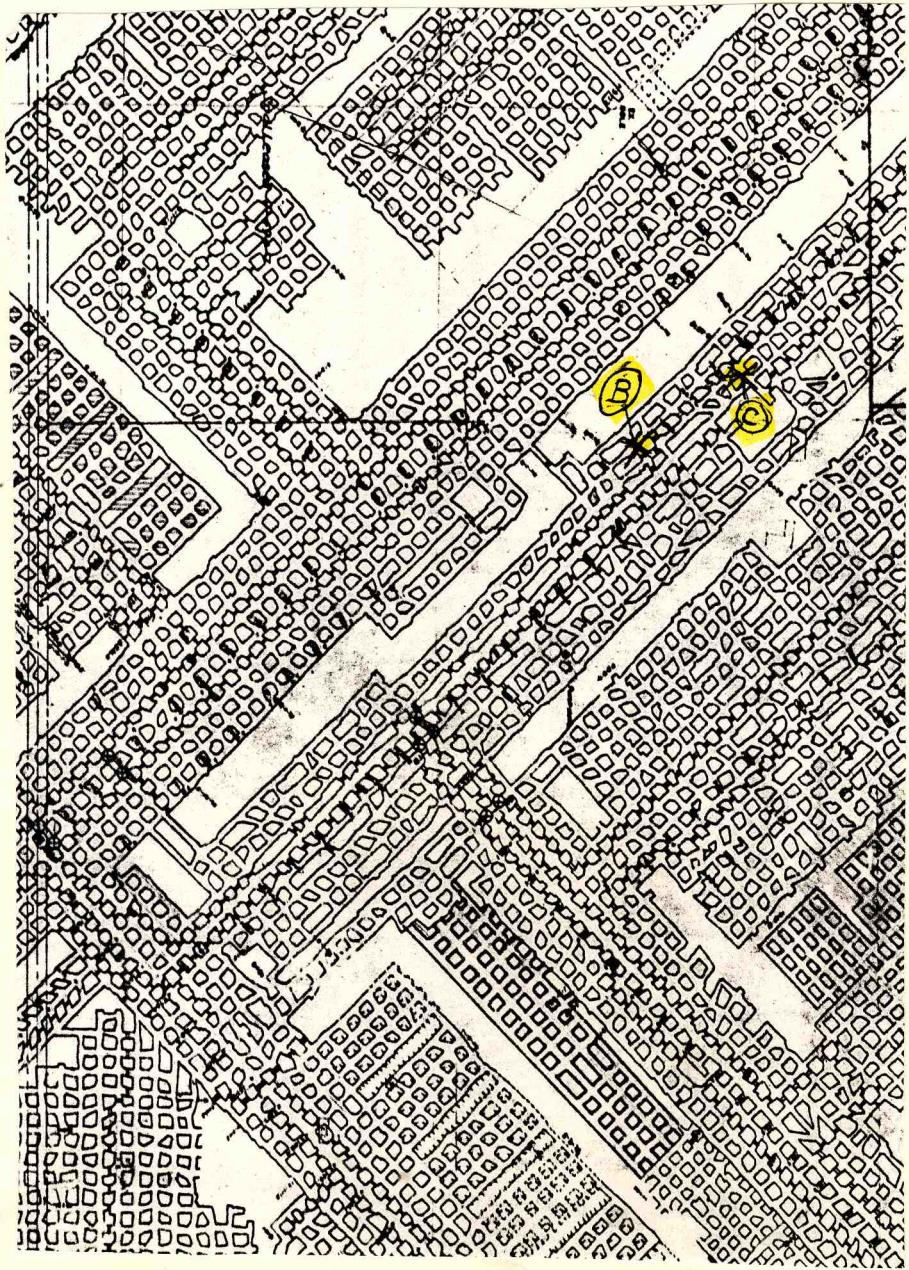
Map A

B. Fall 1 (see map A) is about 23-4' wide and ranges 10-14' high in Dykersburg Shale. Exposure shows 2 widely spaced weak fractures trending $N40^{\circ}E$ at the top of the fall and some weak jointing(?) at $15-20^{\circ}$ off that trend (see Mark's notes). Water drips from fracture planes at 10'-14' level. Shale is fairly homogeneous and has no major plant debris zones/planes, but does have some fine siderite banding in the range 2-3' above the coal.

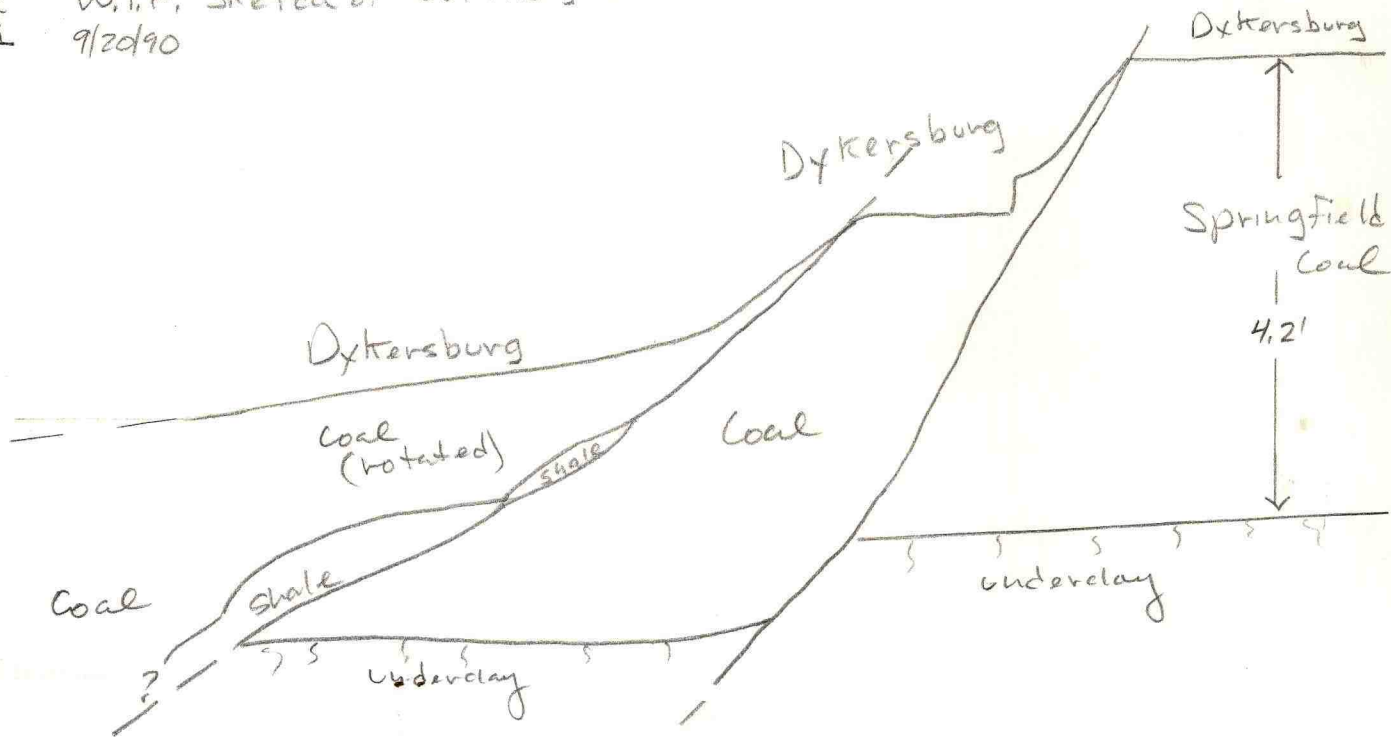
W.T.F. sketch of Wirrib Site F
9/20/90

F. We then went north into Unit 3, which is only ca. 30 c/c in, to look at small fault. Springfield is 4.24' thick on travelway at c/c 14. Area cut with entries on 80' centers + cross-cut at 150' interval (submain layout?): they hit fault 1700' N. of Main's vic 28 c/c. Here at western exposure there is about 5' net throw down to SW on 3 fault plane plus splinter-faults. We are told strike varies from N.30-45° W. across the entries. At one(?) c/c to East we examined a 6' fall at the fault (Fall 3) where entry is 18' wide. 5' and 6' bolts used in top of fall. Wayne made sketch of W. rib exposure and argued some slumping had occurred. E rib shows single fault plane with roughly 50° dip down to SW.
