Freeman United Coal Mining Company Orient # 4

Mine Index No. 688
County No. 1671
Coal Report No. S-99

Coal Slope 750' S, 650' W
of NE cor. NE $\frac{1}{4}$ SE $\frac{1}{4}$, Sect. 28

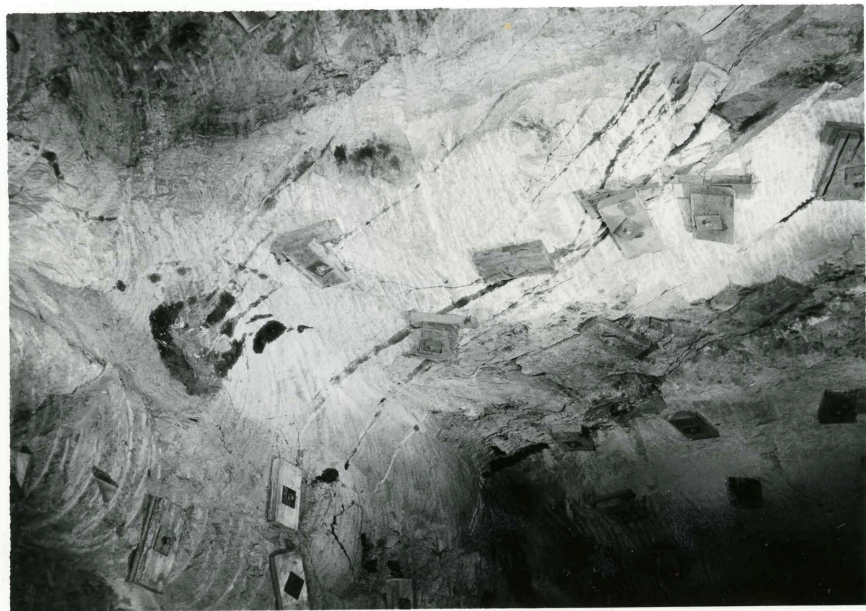
Oil seep in Piasa Limestone roof, travelway of
6th North off 2nd SE Mains, about 2300' inby.

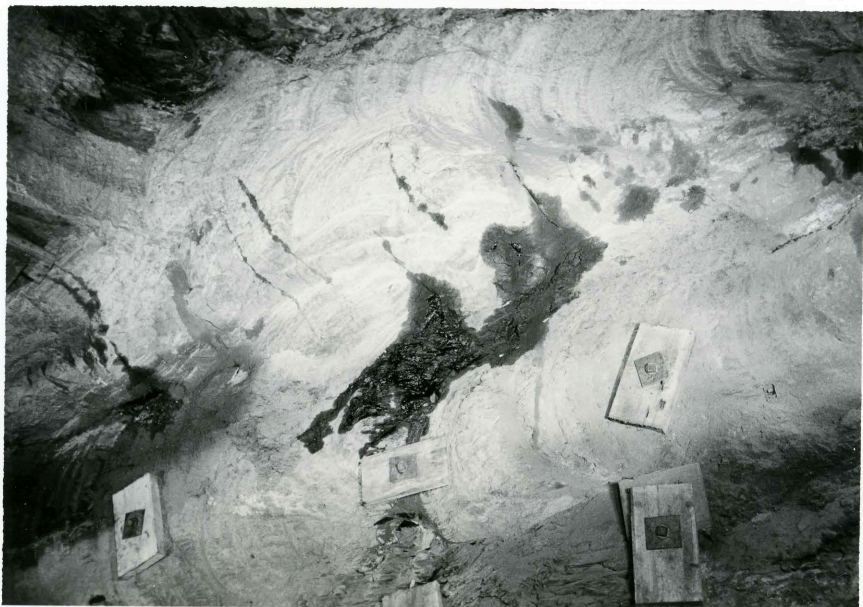
Same as previous photo.

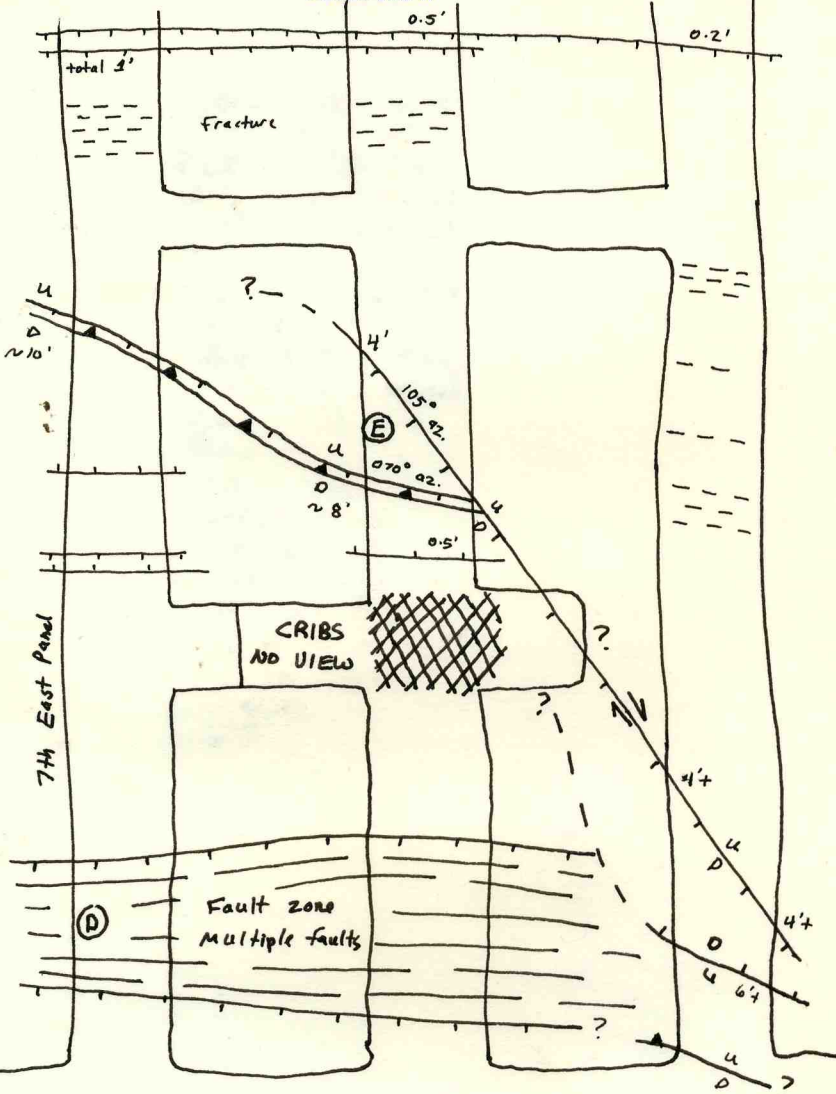
Sketch map - Stops D and E.

In the middle entry I believe there are three large faults (see sketch map). On the northwest are two parallel faults a foot or two apart and striking 070. Both dip steeply to the northwest, and have an overall throw of about 8 feet down to the northwest. Between the two faults a slice of Energy Shale appears to have been dropped lower than its level on either side of the faults; i.e. a narrow, inclined graben with a normal fault on the southeast and a high-angle reverse fault on the northwest.

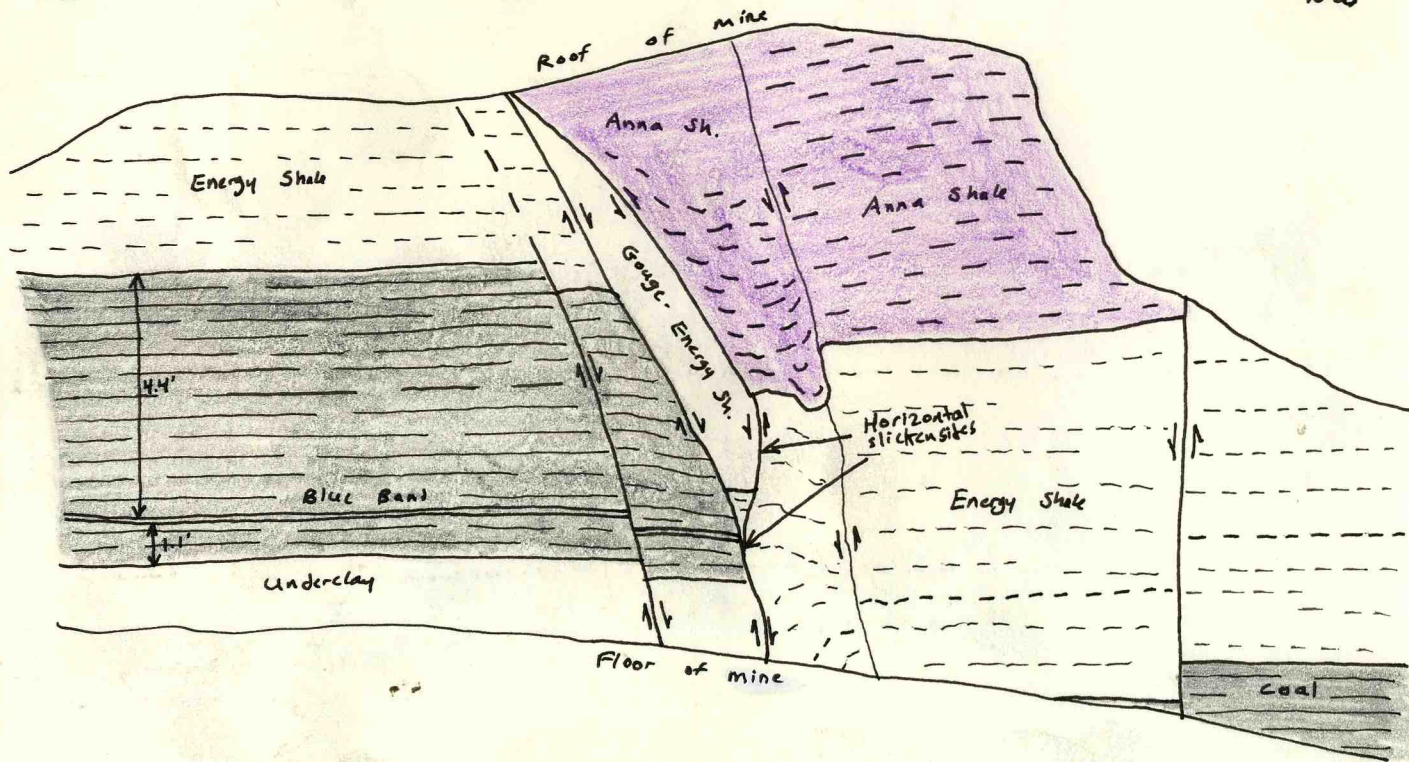
Stop E- sketch of
northeast rib

The surfaces of the faults show conspicuous horizontal or obliquely-dipping grooves and striations.

A third large fault trending 105° crosses the entry and appears to join the other two faults near the southwest rib. This fault is nearly vertical although its plane is S-shaped so that near the top of the coal on the northeast rib, it is a reverse fault. Higher up the Energy Shale and Anna Shale are very sharply folded, and the apparent drag indicates a right lateral movement along the fault.

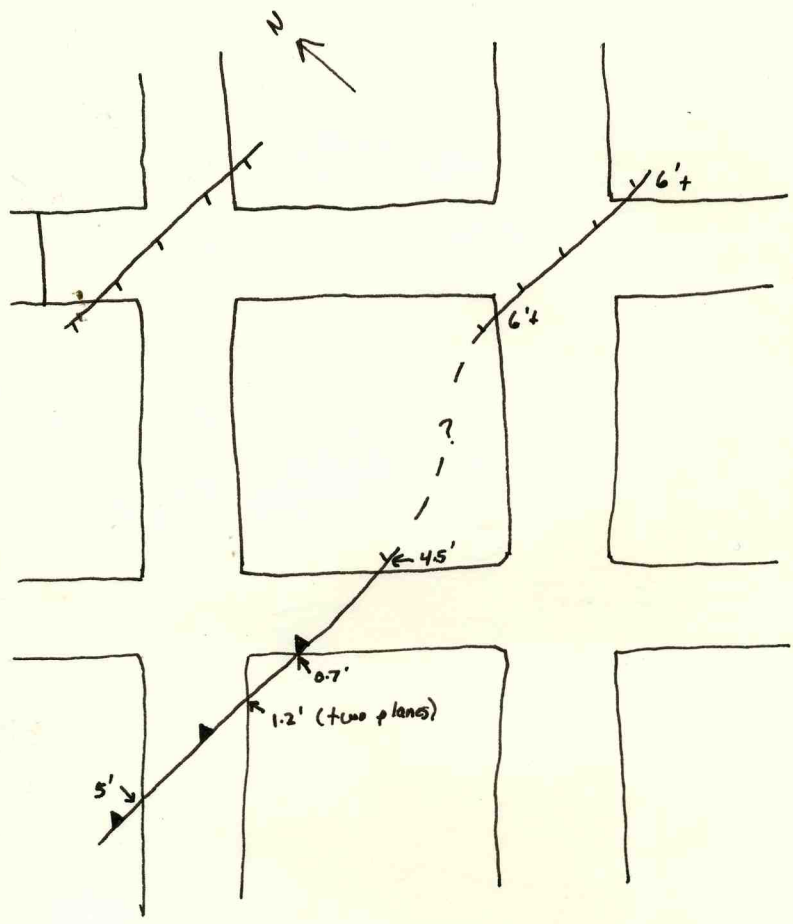
Sketch map of Stop F
 showing fault "scissoring" from
 normal to reverse

F). Continuation of fault zone from Stop E. Multiple faults are present, in a zone about 60 feet wide, and trending roughly east-west. The most interesting feature is one of the faults which changes from a normal fault to a reverse fault. As shown on the sketch map, the change is quite abrupt. On one side of the crosscut this north-dipping fault is a normal fault with 4.5 feet of offset. On the opposite side of the crosscut the same fault is reverse with the north side upthrown 0.7 feet. Farther west, diagonally across the entry, the reverse throw increases to roughly 5 feet. There is no doubt that the fault has truly "Scissored". Its trace is very well-marked in the roof.

Other structures of the fault zone are less easy to see because the thick gray shale has fallen and the entries "gobbed in" so that the coal is largely buried. Some faults have vertical offsets up to about 6 feet, but most are smaller. Within the fault zone two sets of obliquely-crossing fractures are seen. One set trends east-west and includes all the large offsets; these fractures are widely and irregularly spaced. Most dip about 45° and appear to be normal faults with possible strike-slip components. The other main set of fractures trend 045° and are spaced less than an inch apart, but show no discernable offsets.

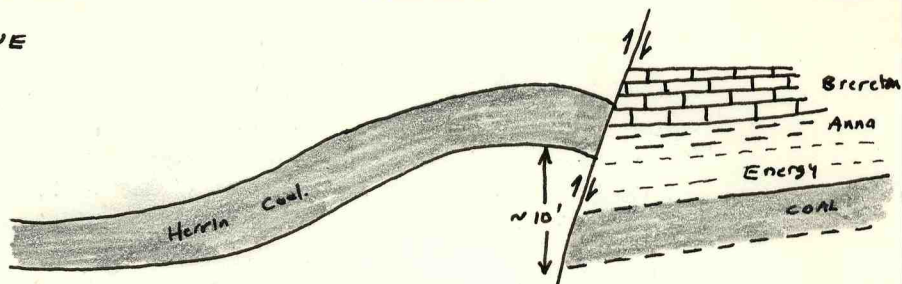
Profile at Stop G

The northeast fault, a reverse fault with less than a foot of throw, probably is the same fault from Stop G. The main displacement is along the southwestern fault which appeared at Stop H. This fault has a very complex structure and its zone of gouge and broken rock is several feet wide. Overall the zone dips steeply northward and the strata north of the fault are downthrown roughly 15 feet.

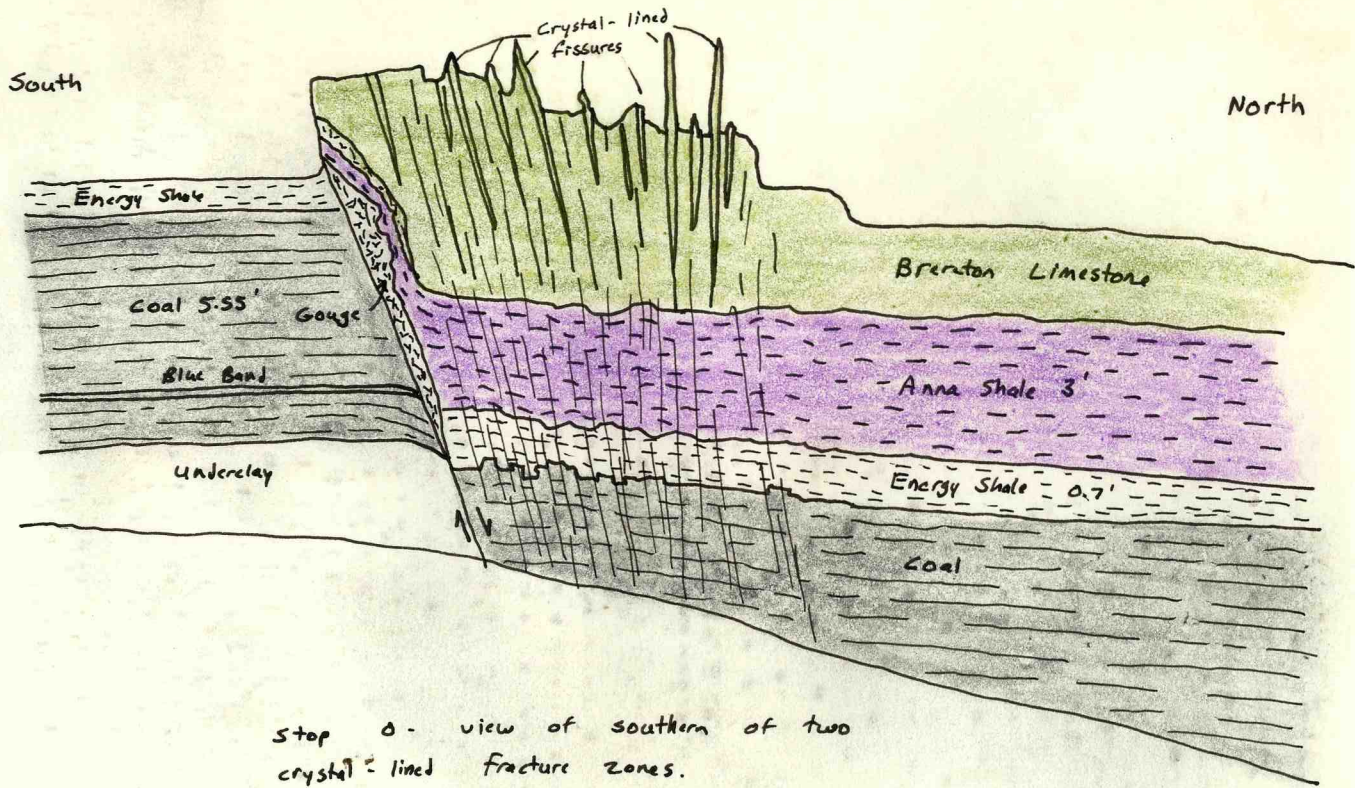
Stop 0 - view of southern of two
 crystal-lined fracture zones.

There are two faults with crystals. The southern one (see sketch) is a fairly simple high-angle normal

fault with the north side downdropped about 6 feet. The rocks on the downthrown side, in a zone approximately 10 feet wide, are intensely fractured parallel with the faults. The fractured rock shows numerous tiny offsets and the coal, in particular, has a "smeared" appearance. The limestone behaved in more brittle fashion, with large extensional fractures being opened; it is these that contain the crystals. Some of the fractures in the limestone are several inches wide and extend several feet upward. The fractures dip steeply and most are parallel with the main fault, although some dip backwards toward it.

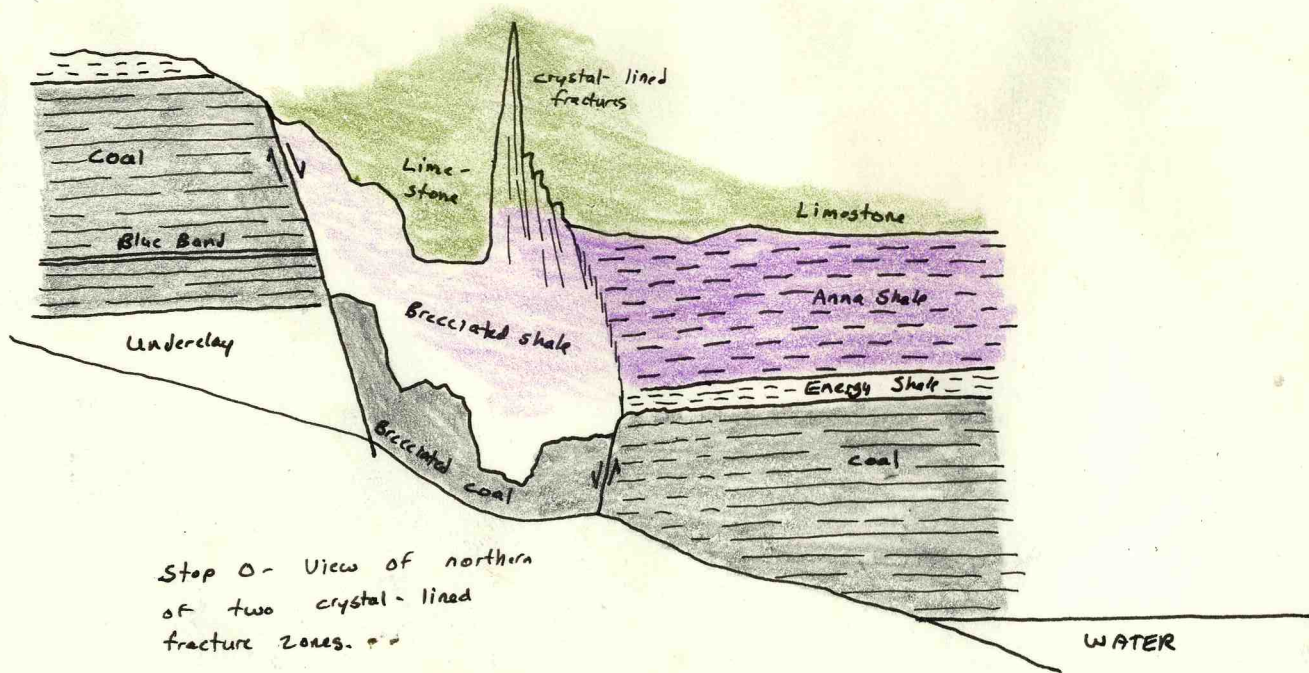
Stop 0 - View of northern
of two crystal-lined
fracture zones. = =

The northern fault zone is about 10 feet wide and its structure is harder to see, and more complex. The north side has been dropped about 8 feet relative to the south side, but in the middle of the fault zone the rock is highly broken and some of it has dropped below its level on either side of the zone. That is, I believe that the walls of the fault pulled away from each other enough to allow masses of rock to slide downward into fissures along the fault plane. The coal and shale are brecciated, with large angular blocks showing all orientations, and caught in a matrix of more finely pulverized material. The limestone again behaved more competently but broke into large blocks; the fractures again are lined with coarse crystals of white calcite.

Most likely some of the fractures in the limestone were actually opened due to extensional forces, allowing water to move along them, and this water dissolved the limestone along the cracks, then re-precipitated the crystals.

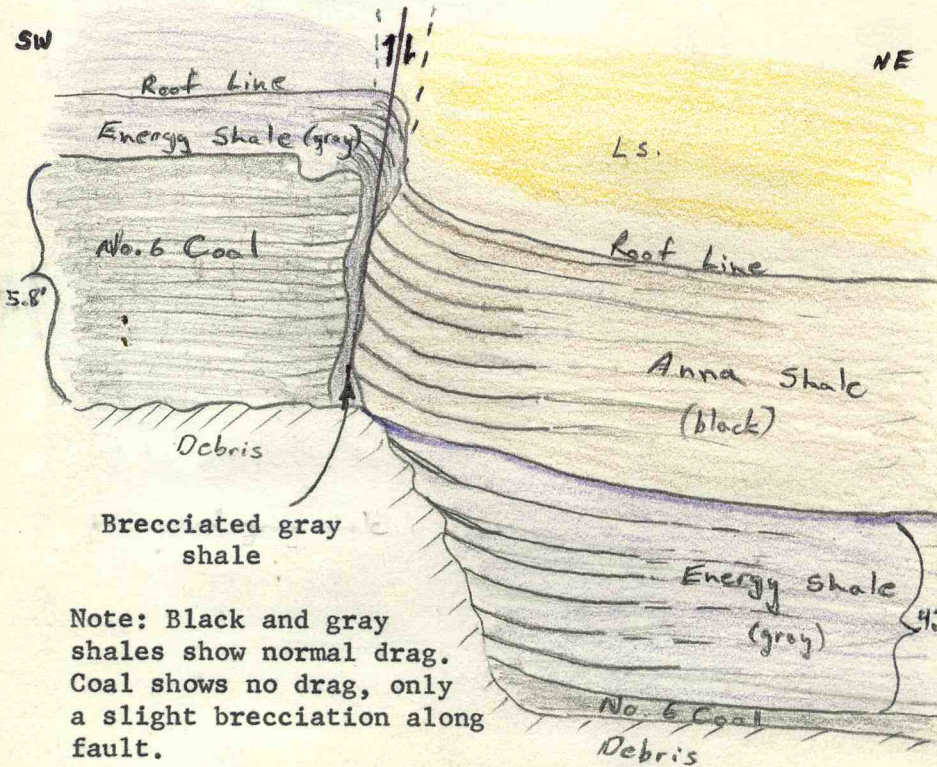
Location J: northwest rib of entry

Two major faults trending N85W. The fault to the southwest shows the greatest displacement with almost 15' of vertical offset. Fault plane is nearly vertical. See sketch.

Note: Black and gray shales show normal drag. Coal shows no drag, only a slight brecciation along fault.

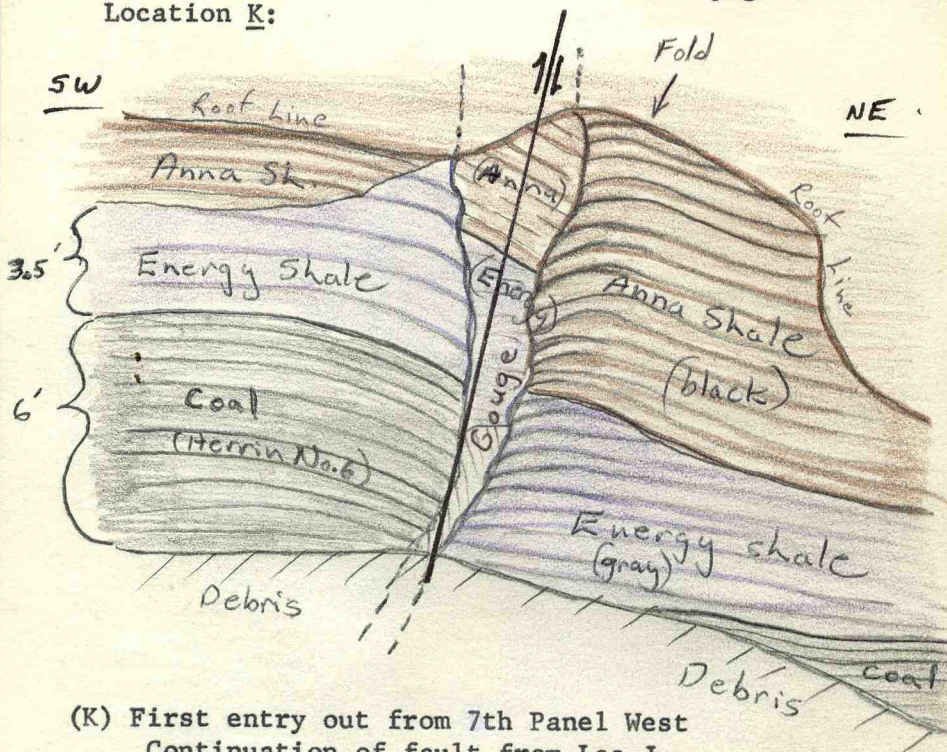
Location K:

(K) First entry out from 7th Panel West

Continuation of fault from Loc. J.

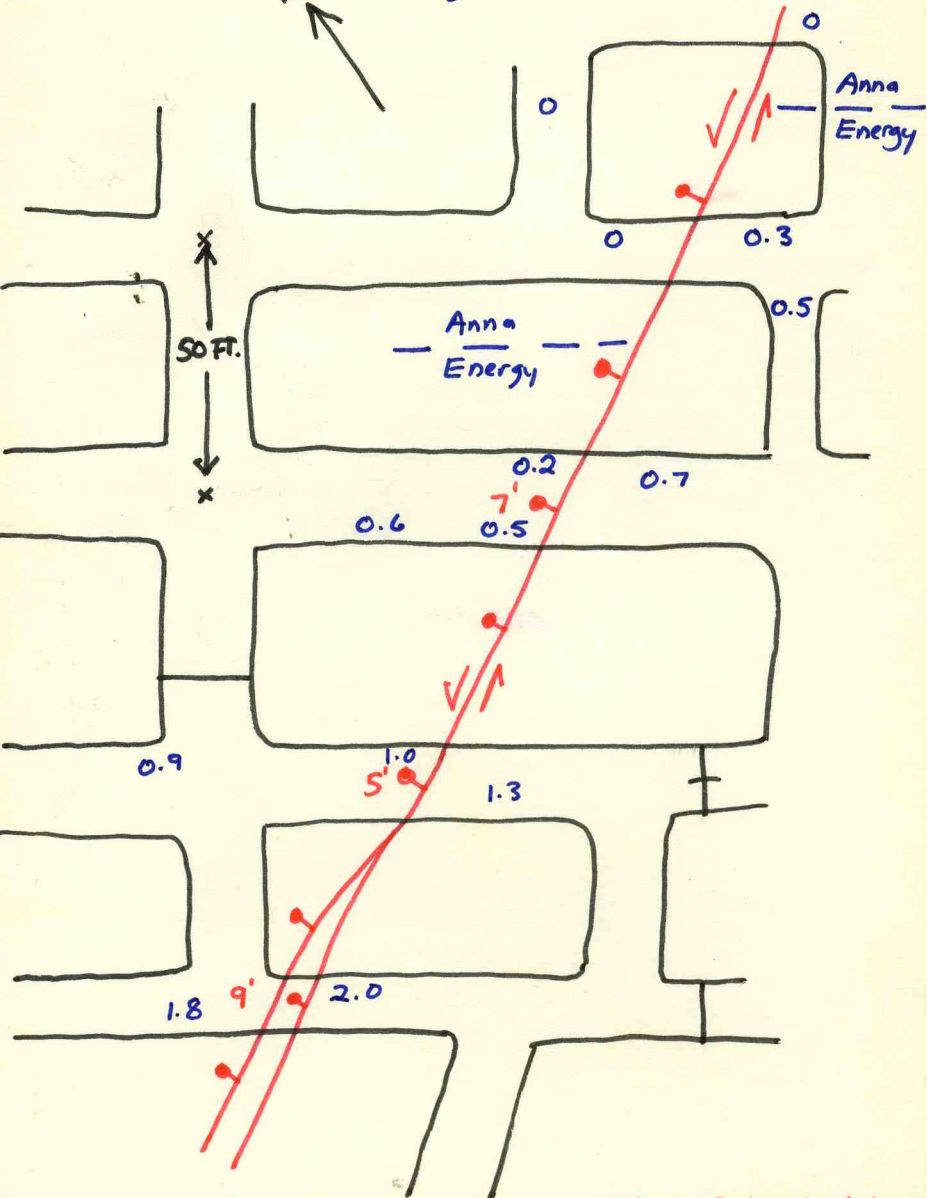
STOP 11 (SKETCH MAP)

11.) See sketch map (over). Strike-slip fault offsets lateral boundary between Anna Shale in the roof. The offset is roughly 50 feet in a left-lateral direction. Precise measurement is not possible because the changes in thickness of the Energy Shale are very gradual and the edge of the Energy Shale cannot be picked with precision. This is the lower, dark member of the Energy Shale. The difference between Anna and Energy Shales is subtle and may be gradational. Nevertheless there is no doubt about the left-lateral offset.

Map demonstrates left-lateral offset of roof shales

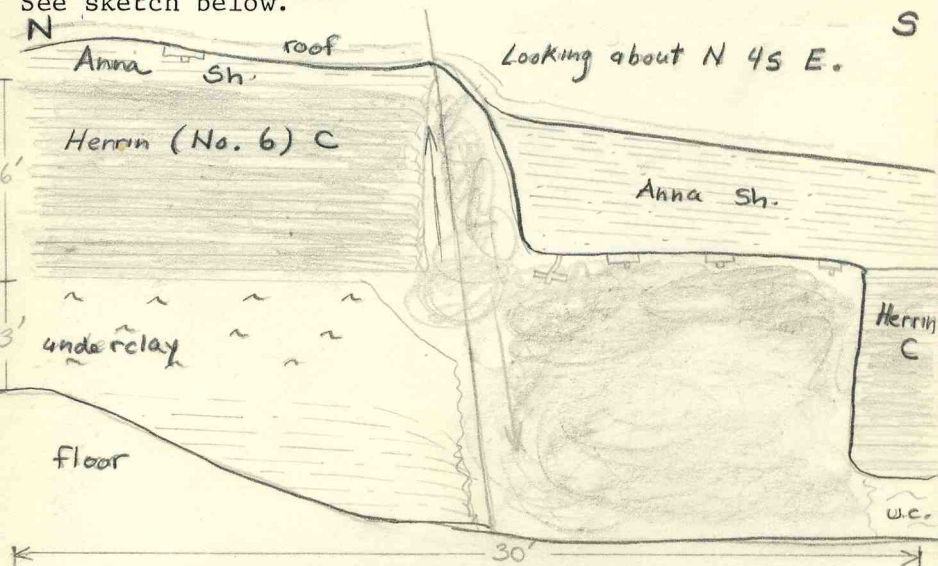
Stop 1. Intersection in return entry connecting with 2nd SE, 340' S.L., 960' E.L., SW SE SE Sec. 30, 8 S., 4 E.

High angle normal fault is exposed at 4-way intersection. The fault is nearly parallel to the strike of the entry and trends N 40-45 E. It cuts very near to the rib/roof contact on the N side of the NE entry. See sketch below.

I was not able to accurately determine the trend or dip of the fault because of the lack of a smooth planar dip surface. Face cleats and butt cleats are given below.

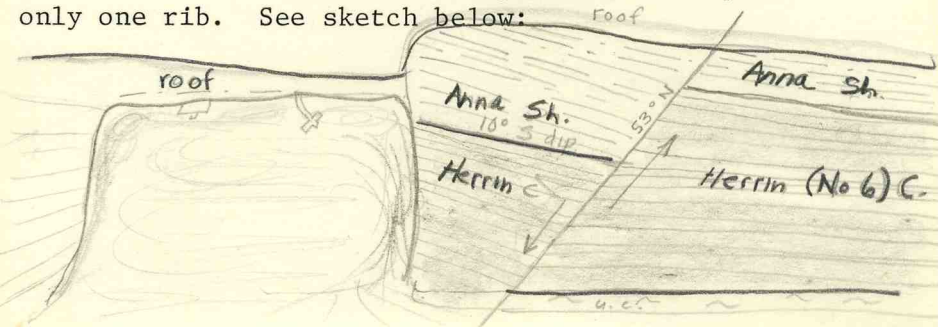
Stop 2. SW corner of rib at 3-way intersection of return entries off of 2nd SE; 310' S.L., 1070' E.L.; SW SE SE Sec. 30, 8 S., 4 E.

A normal fault occurs on SW rib at 3-way intersection. Fault plane dips 53° N. Trend cannot be determined accurately; fault is exposed on only one rib. See sketch below:

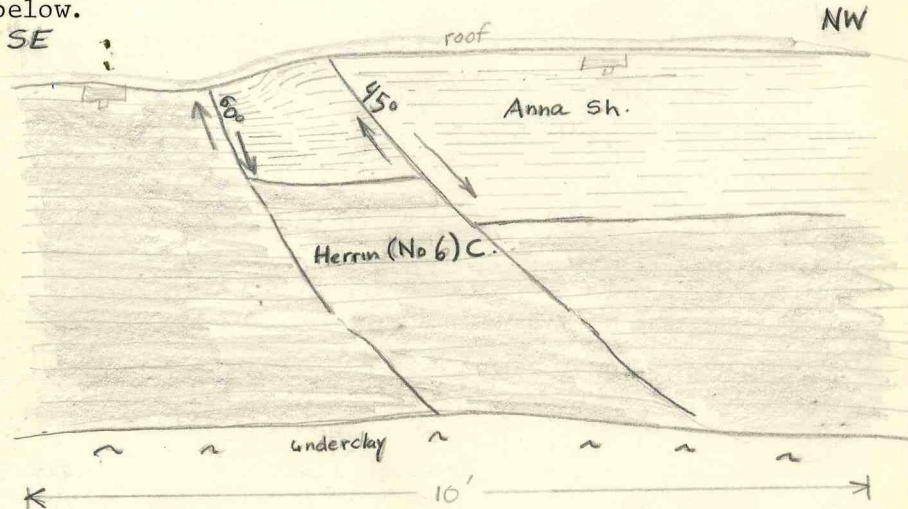
Stop 3. Middle of NE facing rib in 2st crosscut connecting intake and return entries; 0' S.L., 1440' E.L.; SE SW SE Sec. 30, 8 S., 4 E.

En echelon normal faults are located in crosscut. Faults trend approximately N 50 E. Some normal drag and fault gauge present. See sketch below.

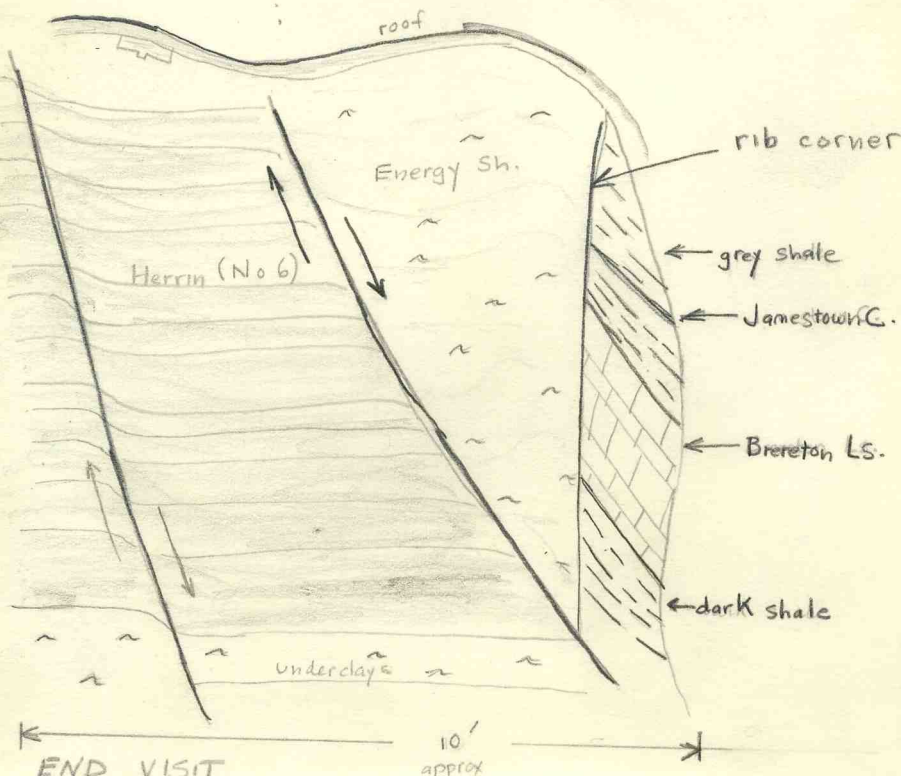
Oblique view of oblique-slip fault.

Oblique slip faulting can be detected on the SW facing rib. The amount of vertical displacement is estimated to be approximately 10'-15' feet, based on the juxtaposition of a hard, dense limestone (Brereton Limestone) downdropped against the No. 6 Coal. The amount or direction of horizontal offset cannot be determined. This shearing is marked by a prominent fracture in the roof trending N 38 E. The length of the fault is probably no more than 70' as the trace does

En echelon high angle normal faults having a component of strike-slip can be seen on crosscut rib which makes a right angle bend to become an entry. See sketch below.

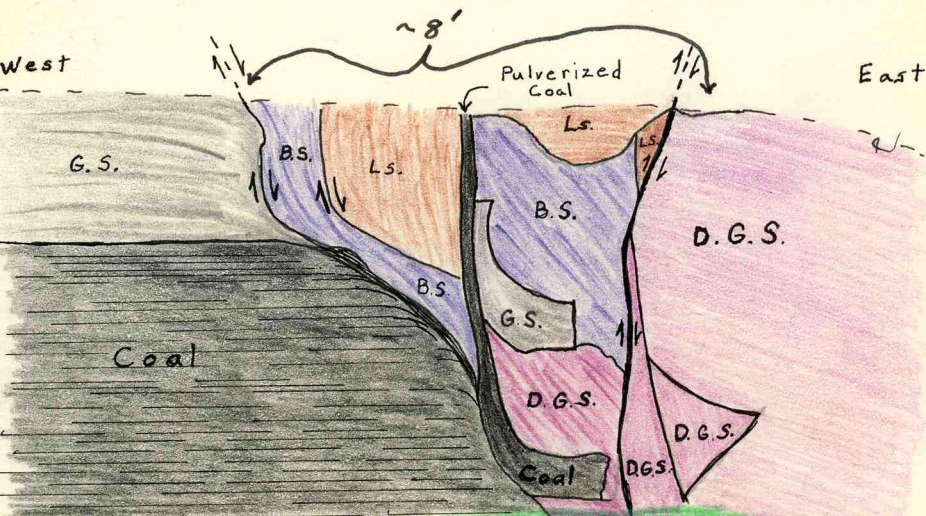
North Rib

The new fault was encountered just a day or two prior to our arrival. It is located about 400 to 500 feet east of the 1st Main North off the 8th Main East (600' from SL, 1300' from WL, SW $\frac{1}{4}$ Sec. 32, T.8S., R.4E., Williamson County). It is a high-angle normal fault that is down-dropped to the east. It trends about N20-30°W. The fault has been encountered in the four northernmost entries of the 8th Main East, but can be seen in only the 1st and 4th entries because of caving at the face of the 2nd and 3rd entries. The sketch on page 2 shows the fault in the 1st entry. The miners abandoned the face as soon as they hit the fault.

The sketch below shows the fault in the north rib of the 4th entry. The miners have advanced the

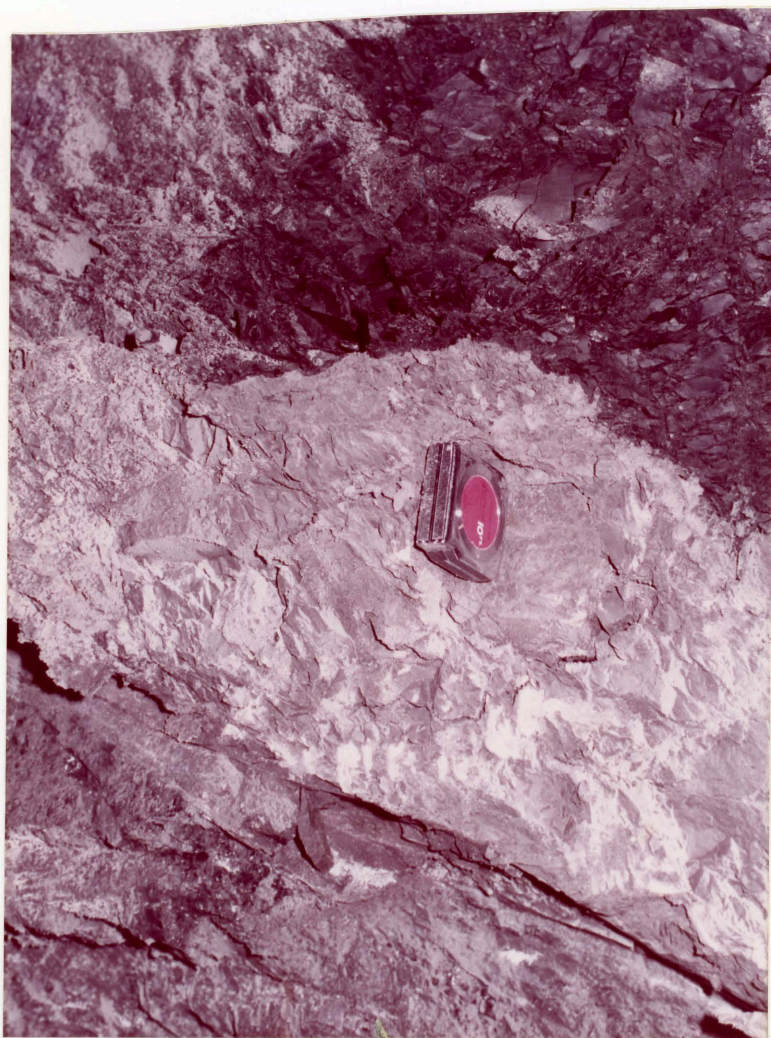
Series of photos by Eugene Robertson, showing fault zone in 8th Main East near 1st Main North, Orient No. 4 Mine.

This view shows dragged and brecciated rock along normal fault. Tape measure rests on light gray Energy Shale on downthrown block; black Anna Shale overlies Energy Shale to left. Fault plane about 6 inches to right (west) of tape); Herrin Coal to right of fault.

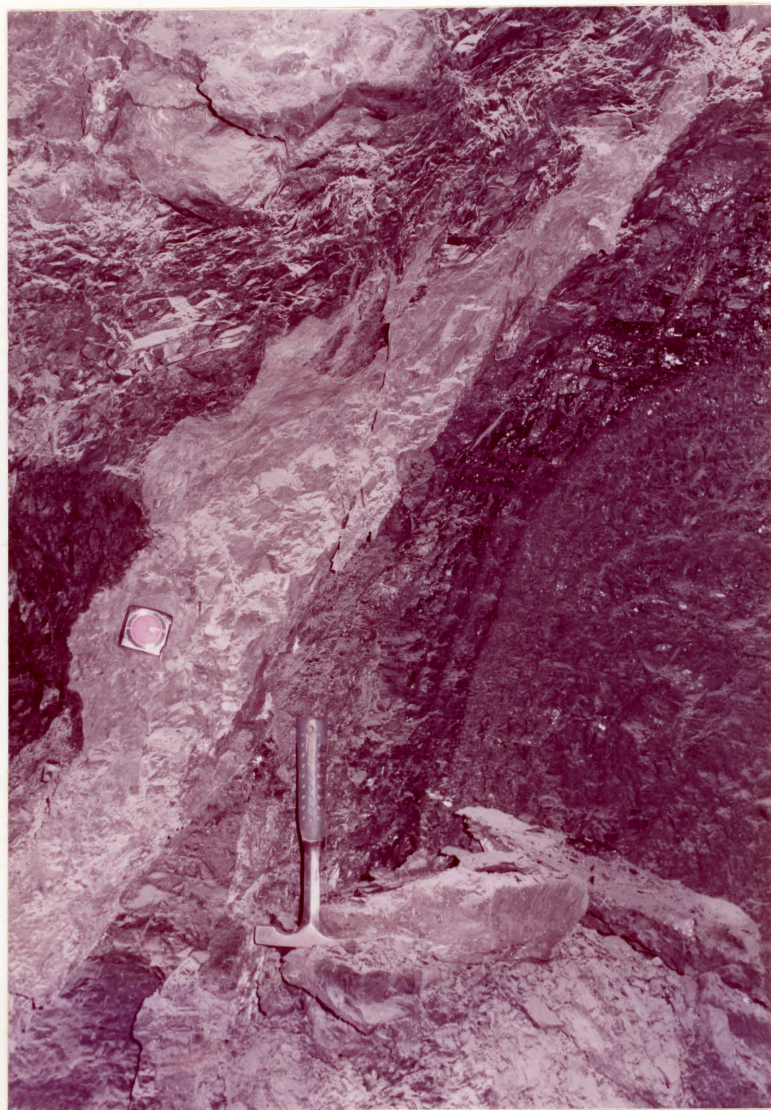
A more complete view of the fault zone, same site.

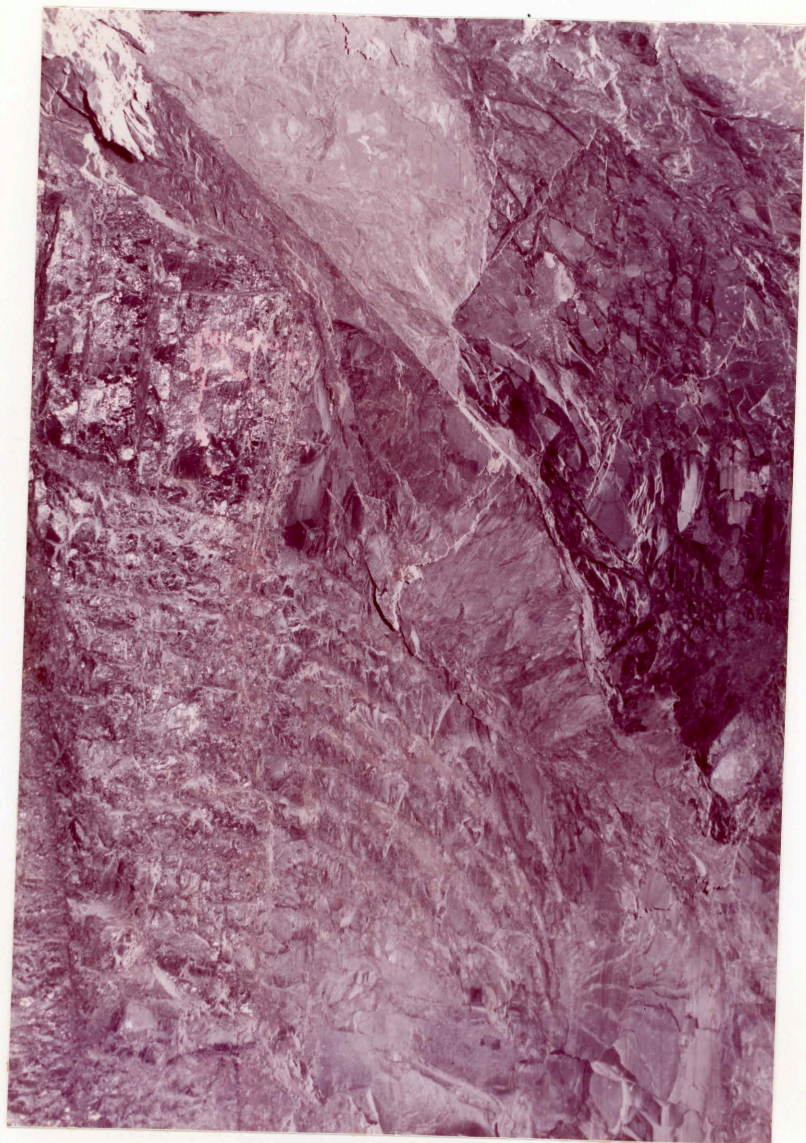
View above and to right of last (top is to right).
Note variation in width of fault zone; a lenticular
slice of relatively unfractured Energy Shale between
two gouge-filled planes.

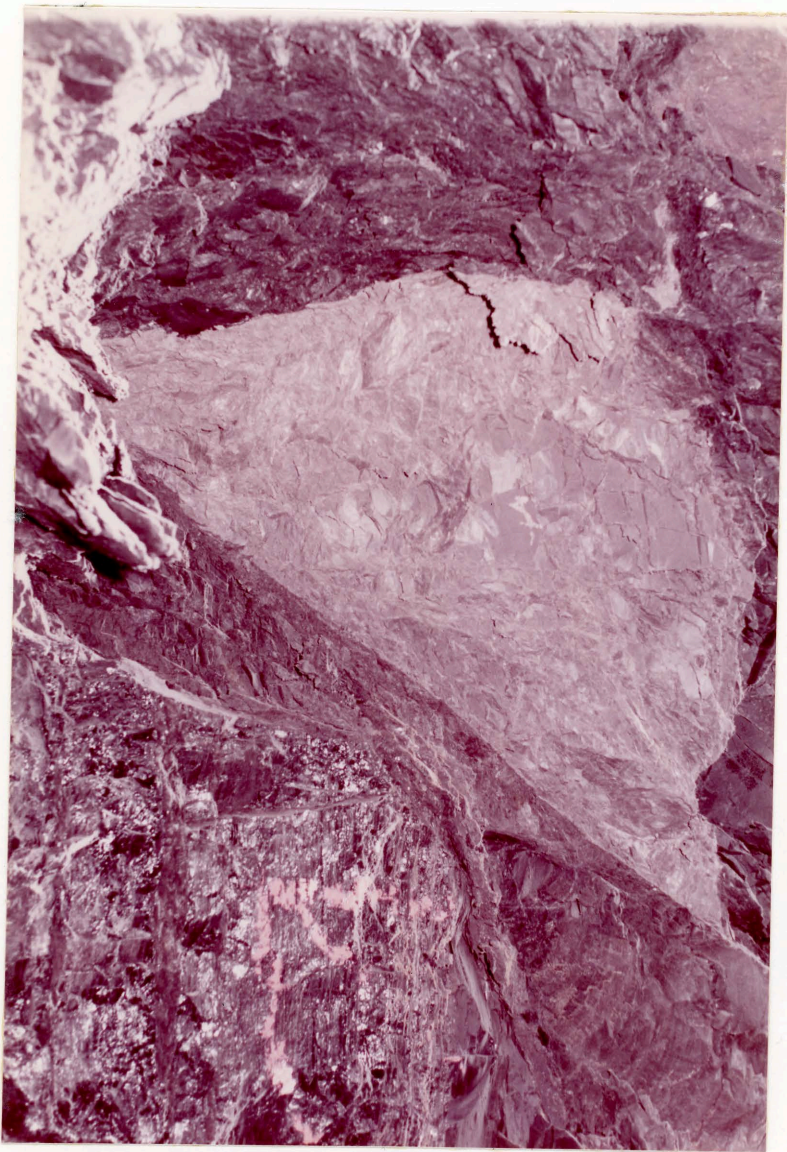
Same location: another slice of Energy Shale along
fault zone.

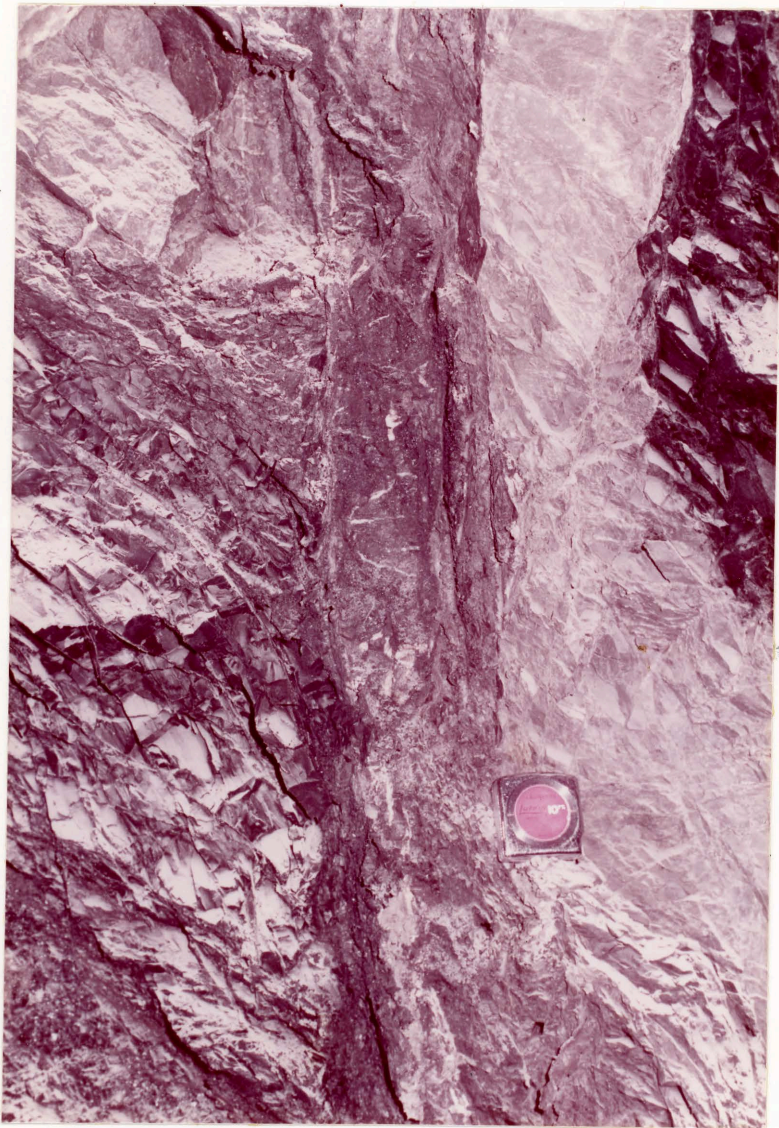
View of fault on north rib of same entry. Energy and Anna Shale on right, downthrown block dragged to nearly vertical position; coal and shale left of fault are dragged and heavily sheared.

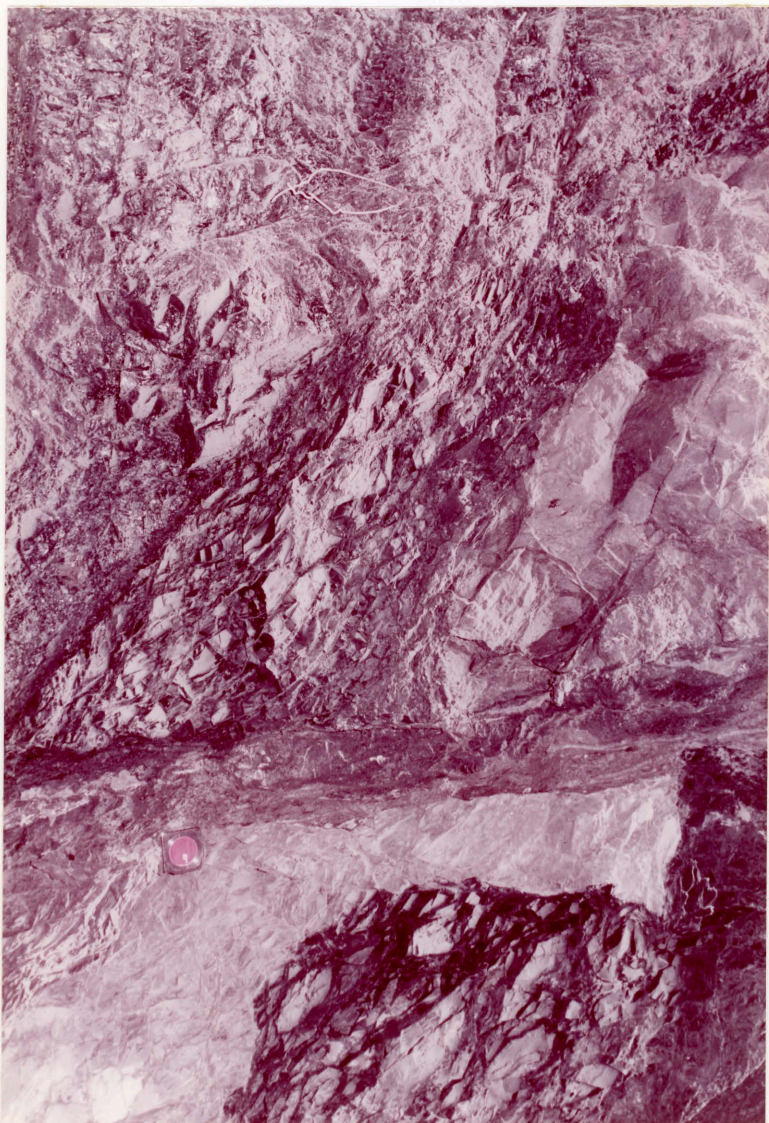
North rib, view from farther back. Top to right.

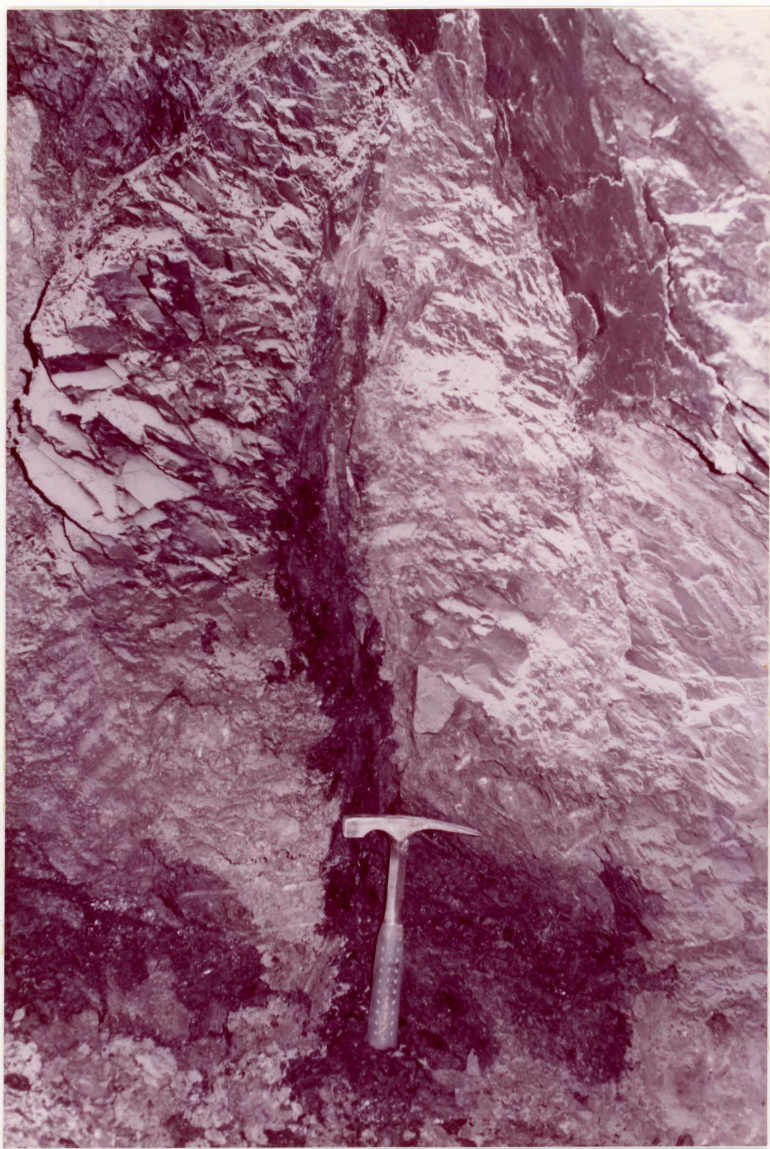
Another view; gouge along fault plane.

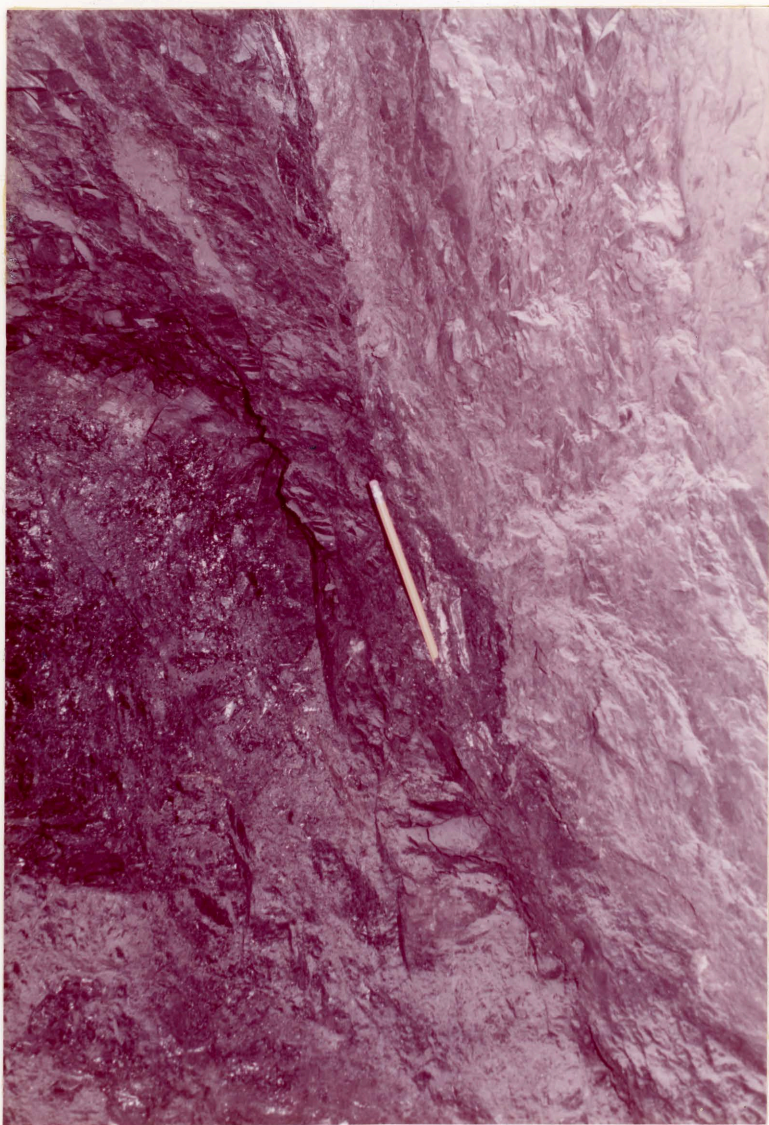
Same place, rock dust cleared off for a better view.

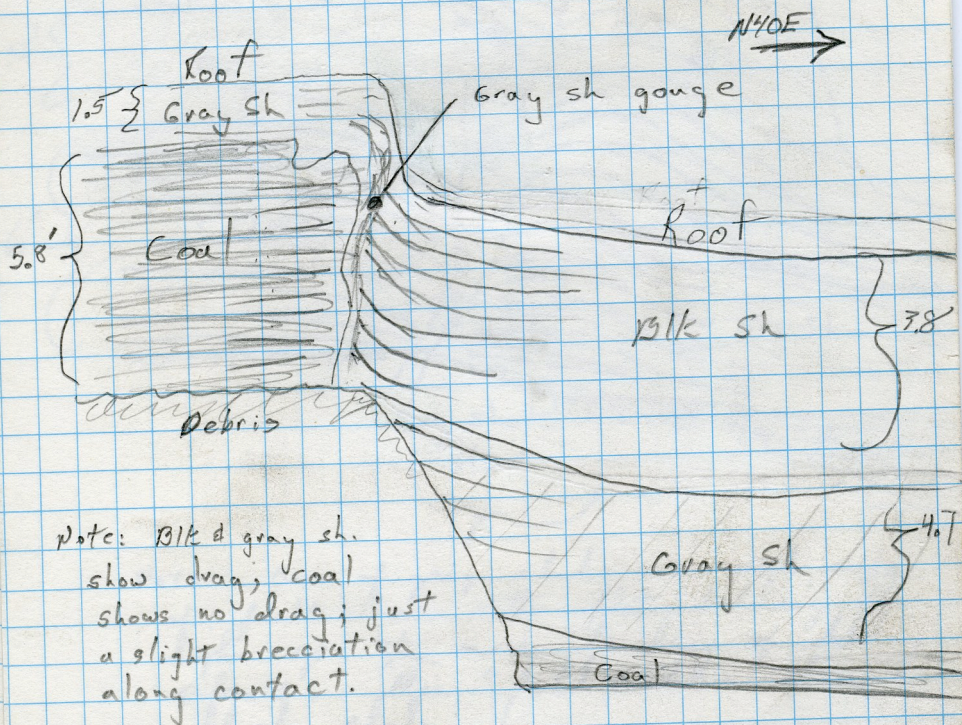
North side of northern most fault is dundred
~ 15'

Note: Blk & gray sh.
show drag; coal
shows no drag; just
a slight brecciation
along contact.

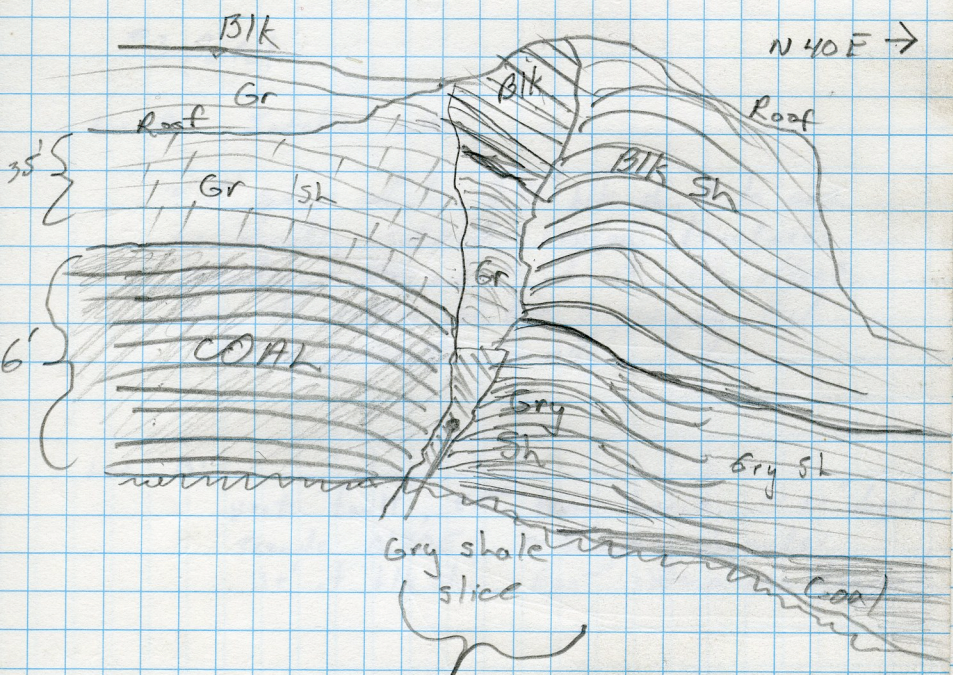
Stop K: Continuation of north-south fault.
 from stop J. Trend $N 85 W$; Horizontal
 slicks on fault

Note: Base of gray shale on north side
 of fault has rather flat bedding. The
 higher up the more bending of bedding
 planes. This "fold" contains three
 black shale.
