Sahara Coal Co. Mine # 20

SAHARA COAL CO.
MINE # 20

ISGS - Mine Index No. 909
Coal Report No. S-56

SALINE COUNTY

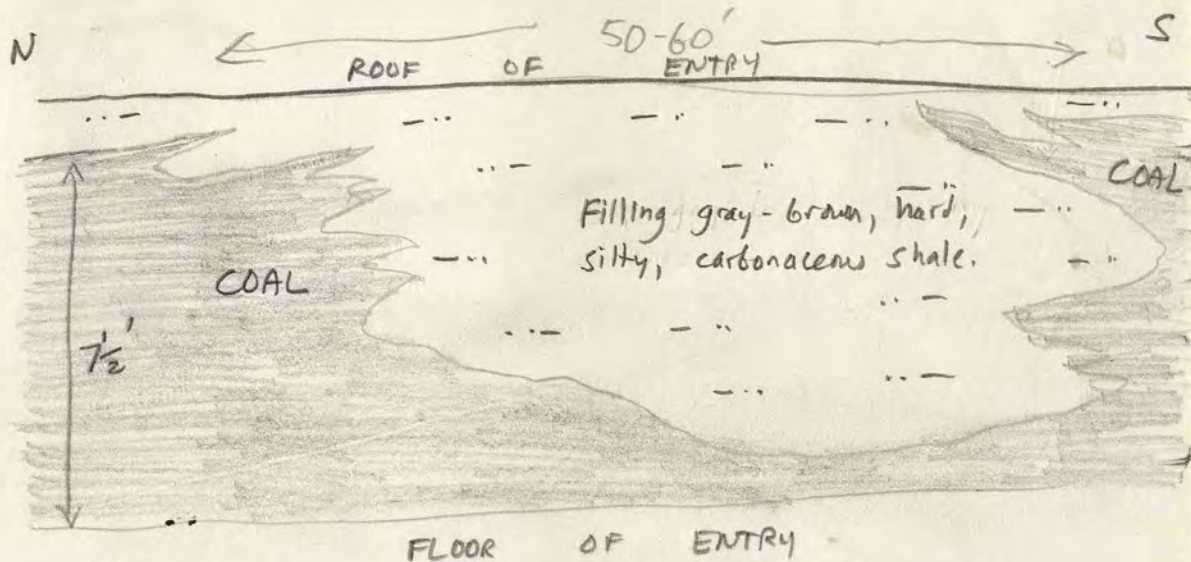
Near Face of 4th Entry.

Note vertical exaggeration.

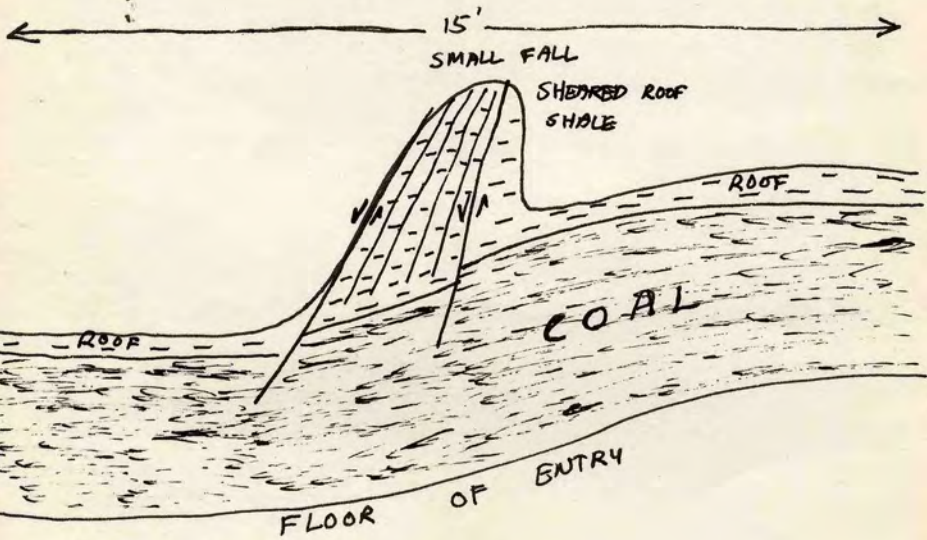
Stop 8
structure on north rib of
track entry.

Sheared flexures of this type are fairly common in the Cottage Grove Fault Zone in other mines we have visited.

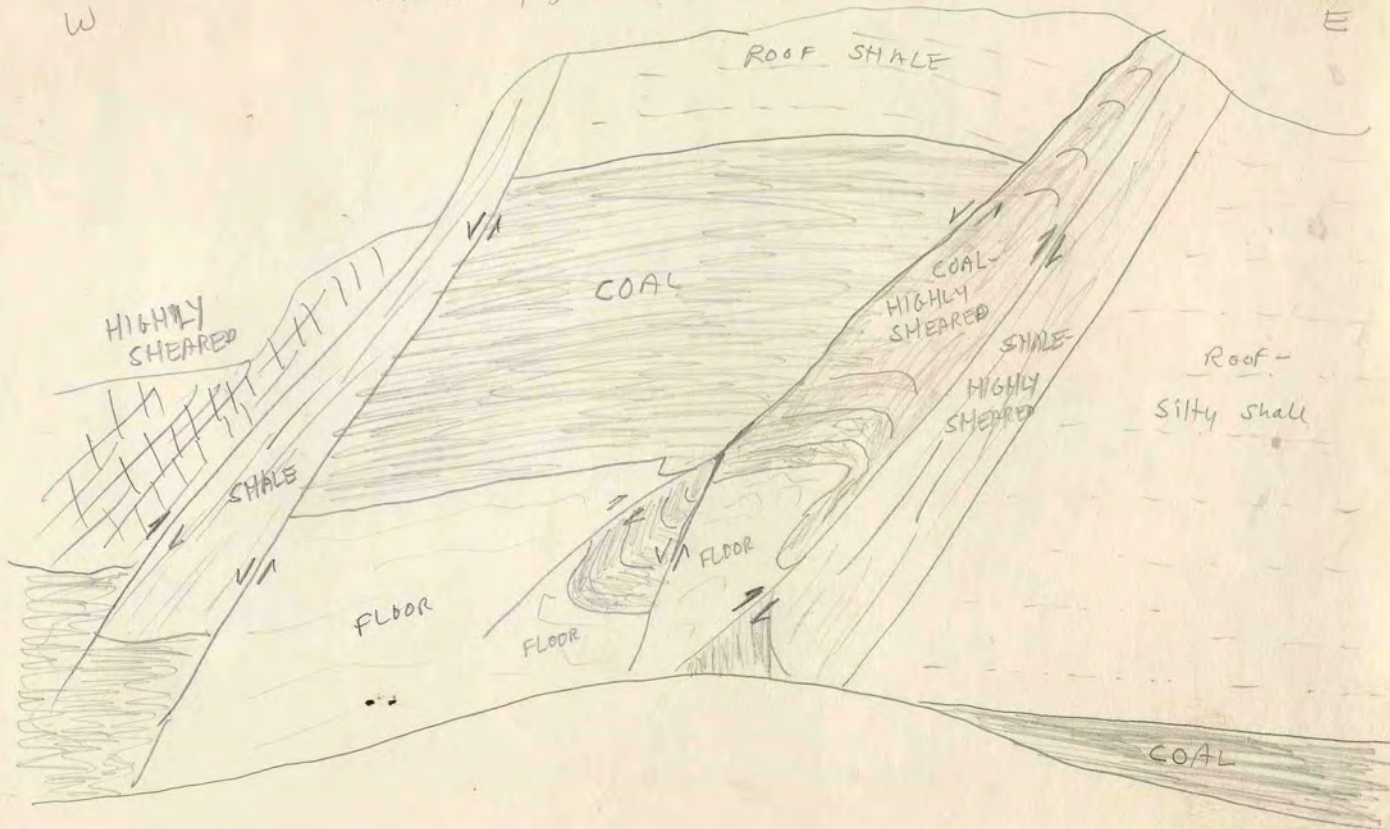
STOP 2 - VIEW OF NORTH RIB

Not a very good view due to rock dust and high ribs

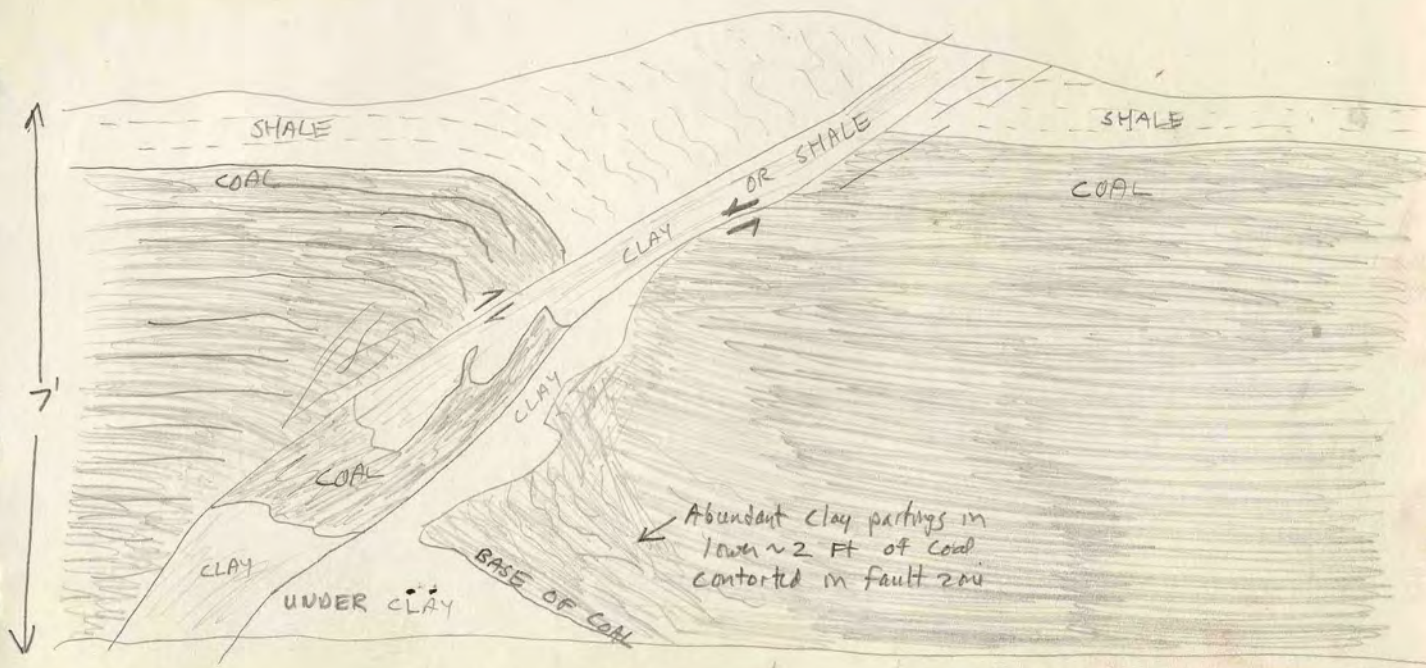
Stop 8 - View of North Rib

8. Main fault zone abruptly narrows to south, here only 1-2 ft. wide. Trend of fault is roughly 135/55 SW. Overall displacement of coal seam is only about 3 ft. down to SW, but actual deformation pattern is very complex (see sketch). Both normal and reverse faults and undoubtedly horizontal movement, have taken place. On the south rib essentially only one fault plane is present.

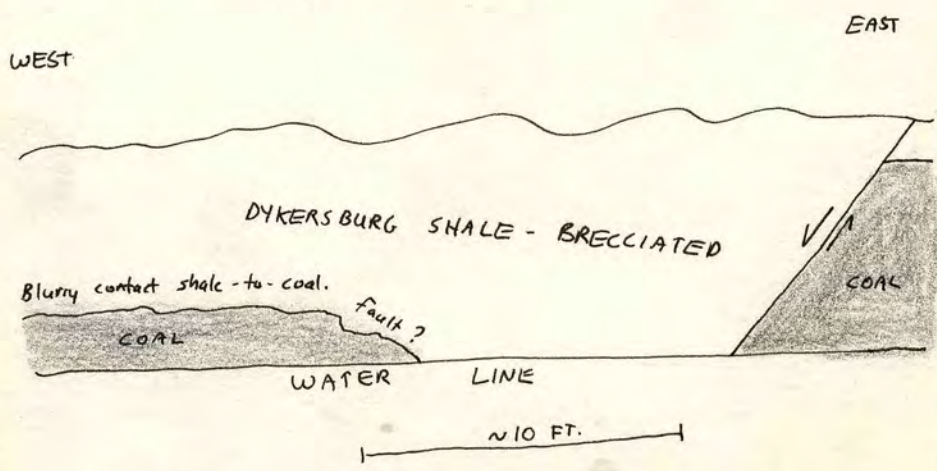
STOP 2
VIEW OF NORTH RIB

The normal fault from Stop 1 is diminishing in displacement toward the northeast; here we can see the top of the coal on the downthrown side. Again the shale on the hanging wall is fractured to brecciated, with most bedding obliterated. The coal visible on the north rib, above the water line, is cut by a fault with very blurry plane-see sketch (over).

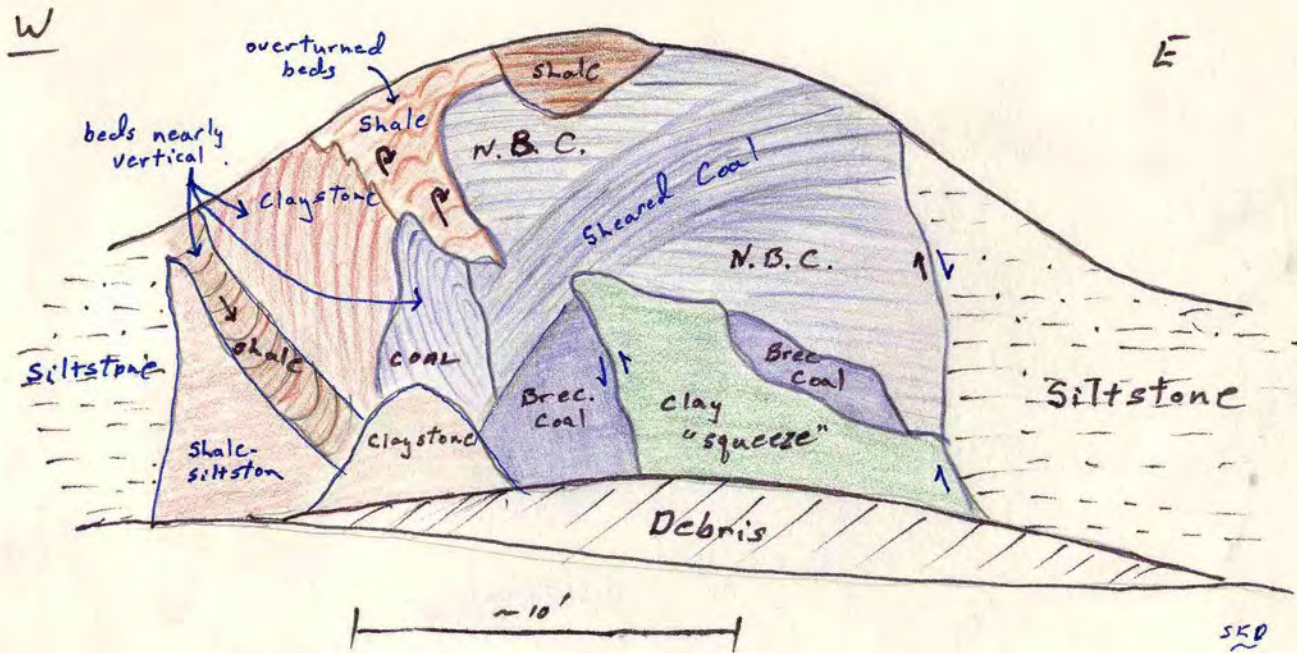
Stop 9... view of south rib

Steve sketched the faults on the south rib; the structure there is even more complicated.

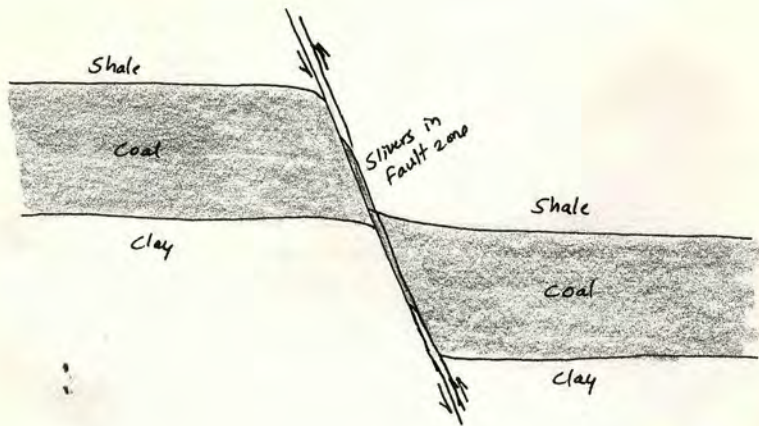
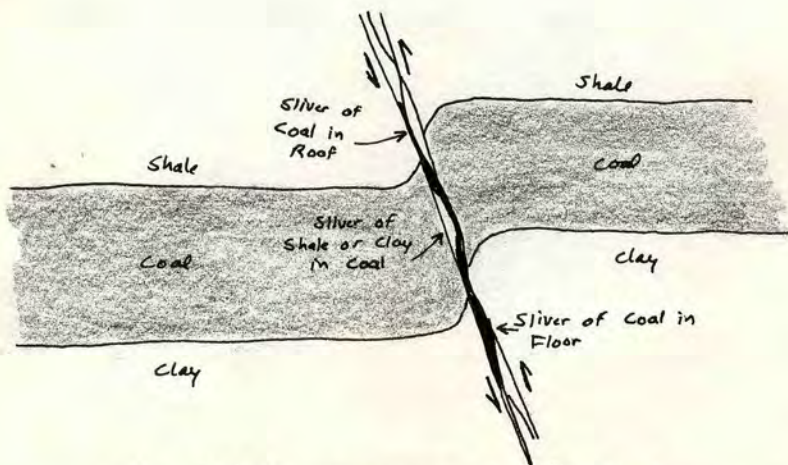
Hypothetical sequence of faulting:

Two-stage faulting results in slivers of coal being left in the roof and floor, while slivers of shale or clay are left within the coal. First slippage was normal, second slippage was reverse along the same fault.

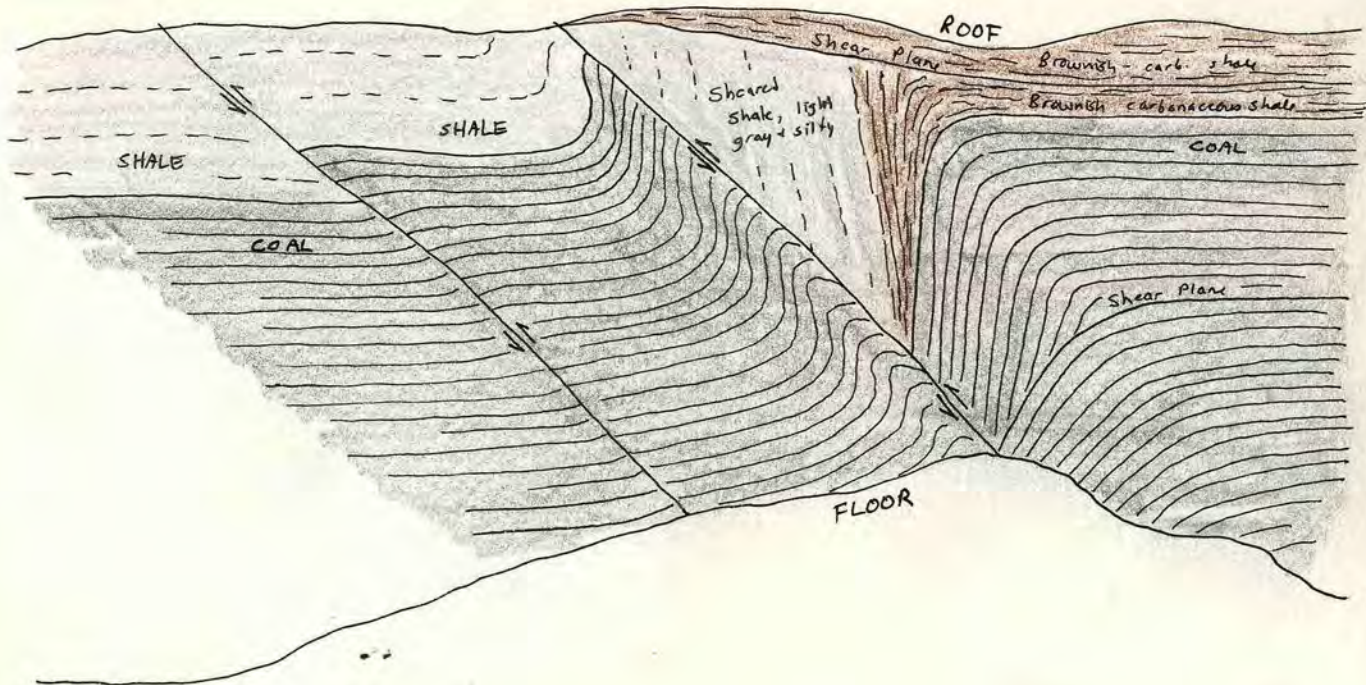
STOP 12
VIEW OF EAST RIB

12.) Fault zone in 3rd entry from west; good exposure on east rib (sketch). The west rib is so heavily dusted that little can be seen.

The zone as a whole has almost no offset in the coal. The larger fault has very strong drag on both footwall and hanging wall; beds are overturned in

places. The drag indicates that many feet of dip-slip movement occurred. Again the first movement must have been normal and the second movement reverse, both movements with approximately the same dip-slip restoring the coal bed to its original position on opposite sides of the fault. Note that on the footwall there is a small "kink" in the drag-fold close to the fault plane, suggesting that a third stage of minor normal movement took place.

An additional feature to note is the horizontal shear plane above the right-hand side of the fault. It truncates the drag fold and brings horizontal layers above in contact with vertically-dipping layers below. Cannot tell whether this horizontal fault offsets the main reverse fault or not.

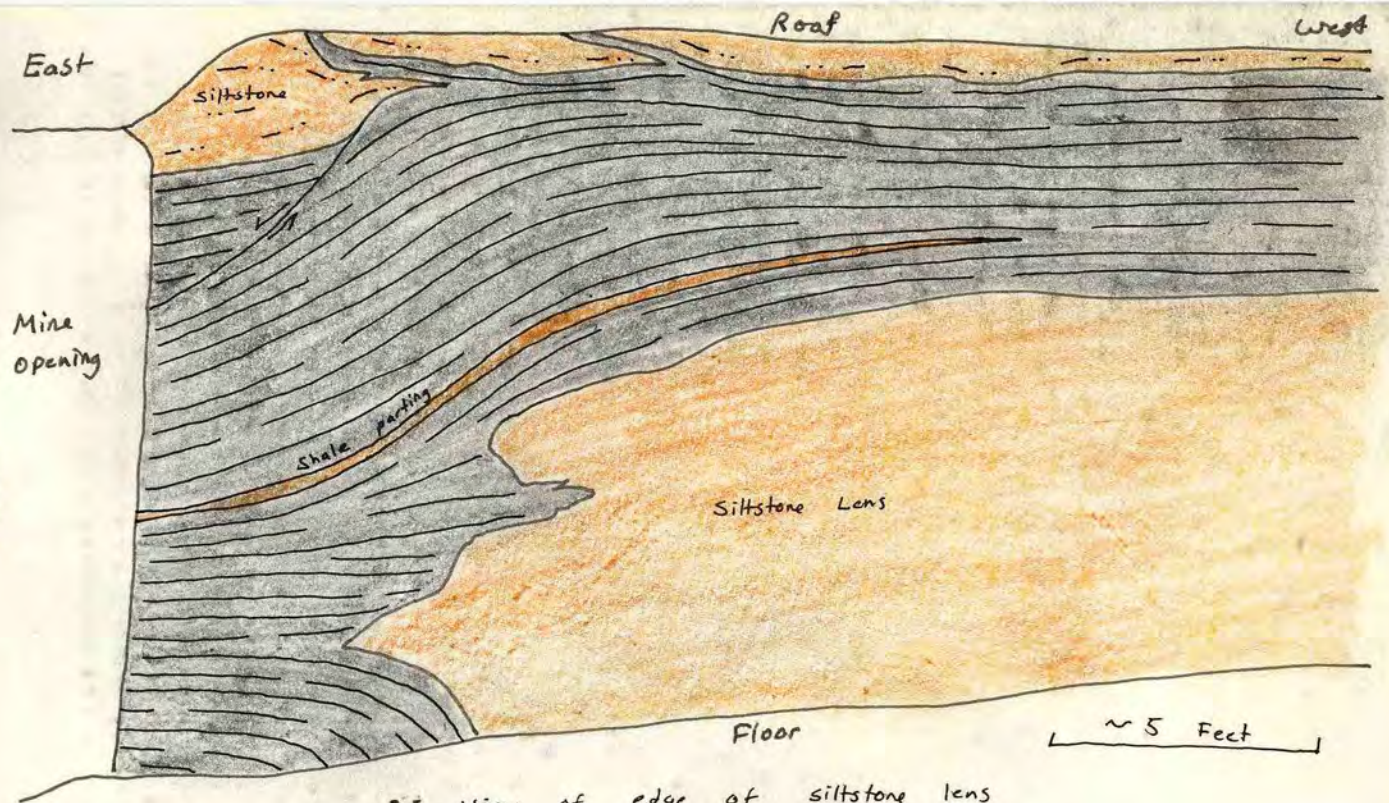
-- View of edge of siltstone lens
 Exact location unknown

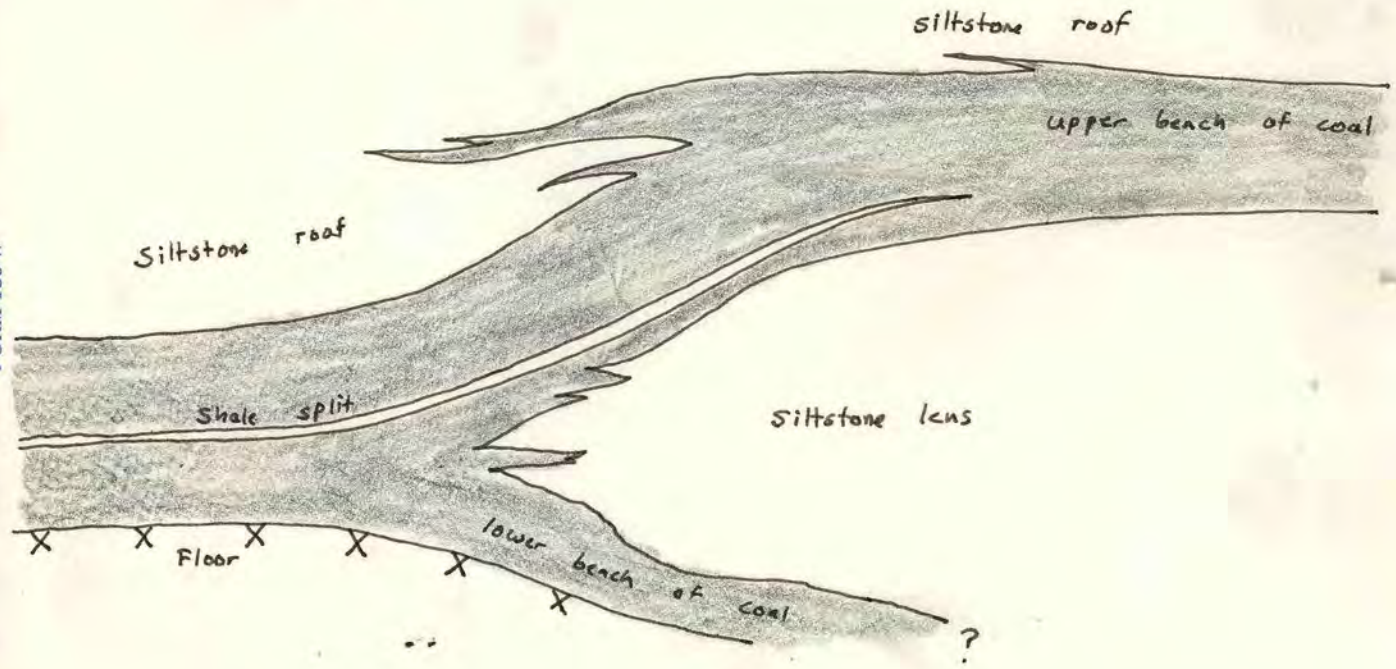
Idealized cross-section of coal when split by lens of siltstone
Saham No. 20.

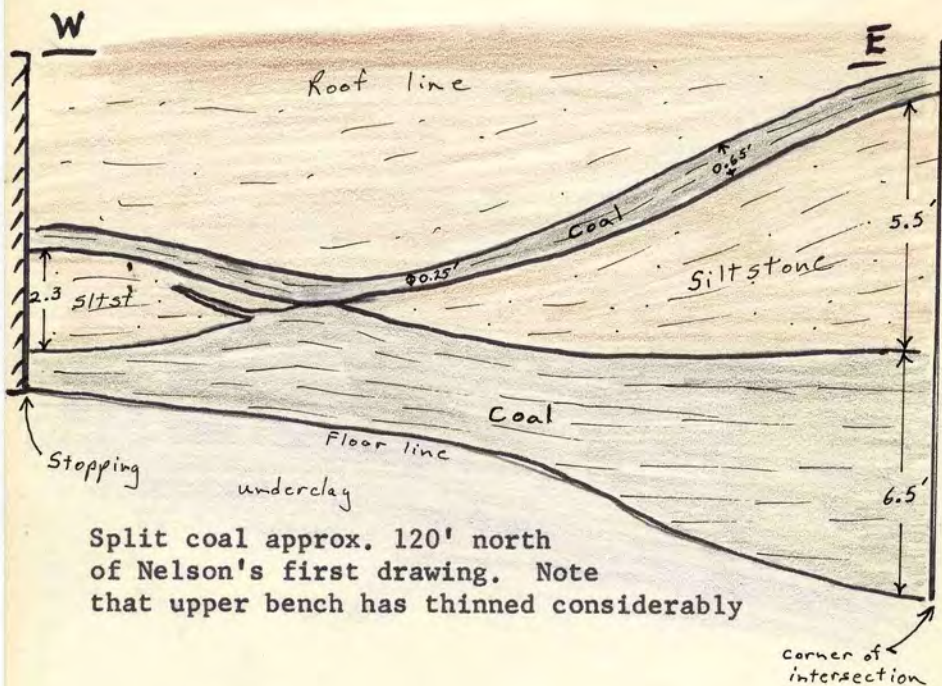
Split coal approx. 120' north of Nelson's first drawing. Note that upper bench has thinned considerably
