INLAND STEEL CO.
MINE # 1

Mine Index No. 877
Coal Report No. S-5

JEFFERSON COUNTY

Field Map
Inland Steel Co. Mine No. 1
John Nelson - 12/15/76

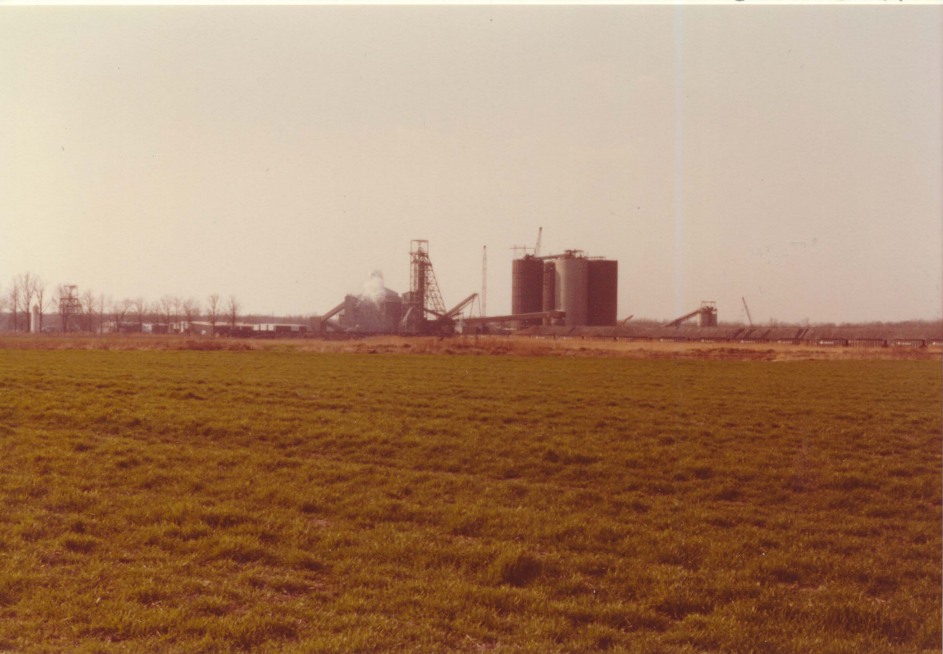
Surface works of Inland Steel Co. Mine No. 1, Jefferson County; as viewed from southeast. Photo by John Nelson, March 1981.

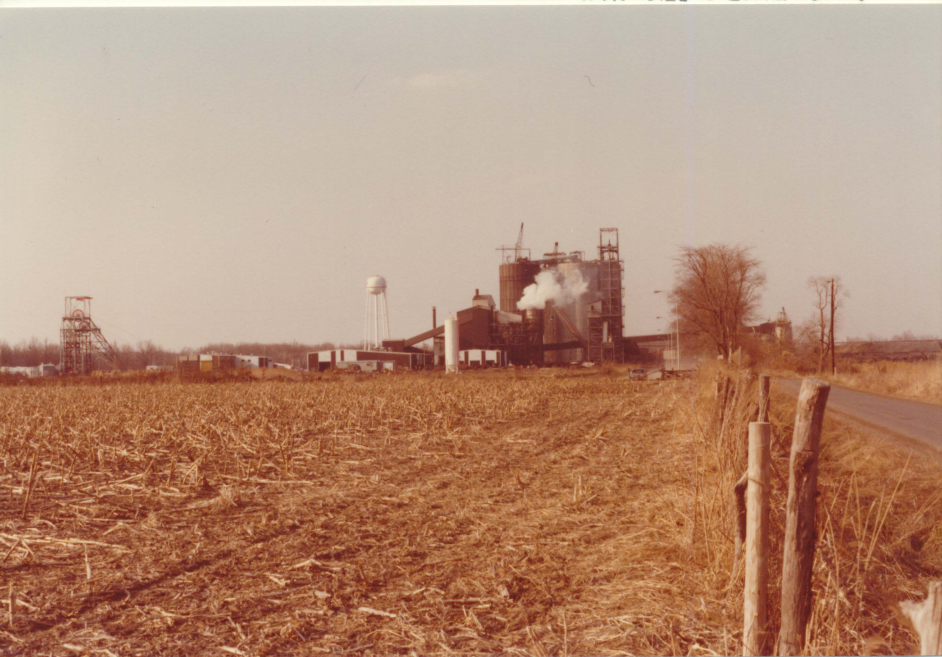
View of Inland Steel's tipple from the south.

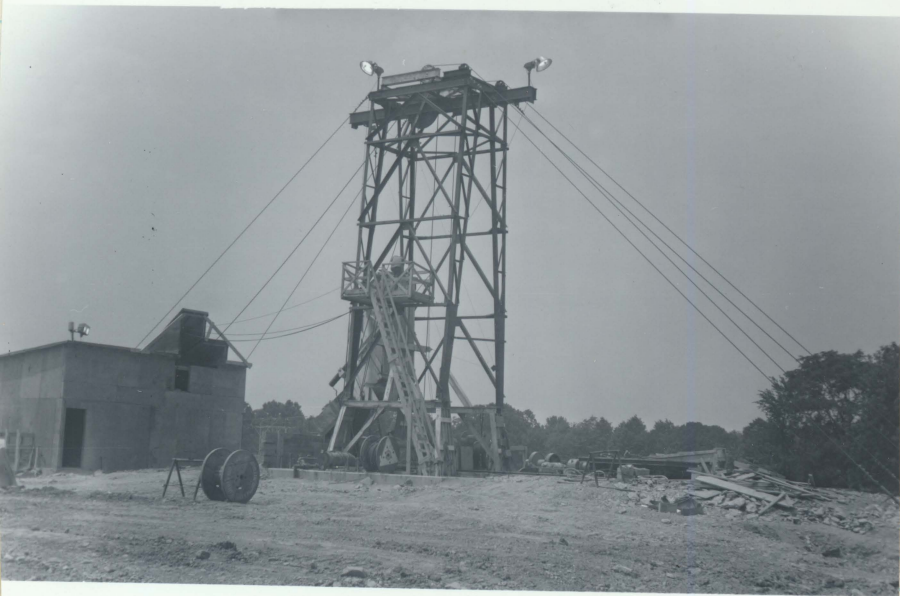
Sinking of Inland Steels
Coal hoist shaft.

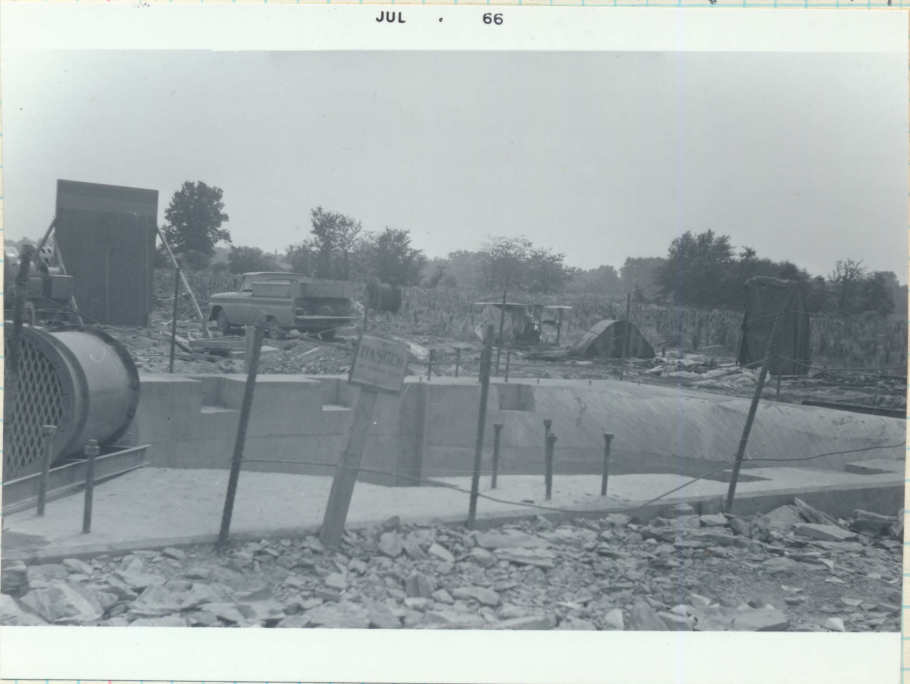
Sinking of Inland Steels' man and material shaft.

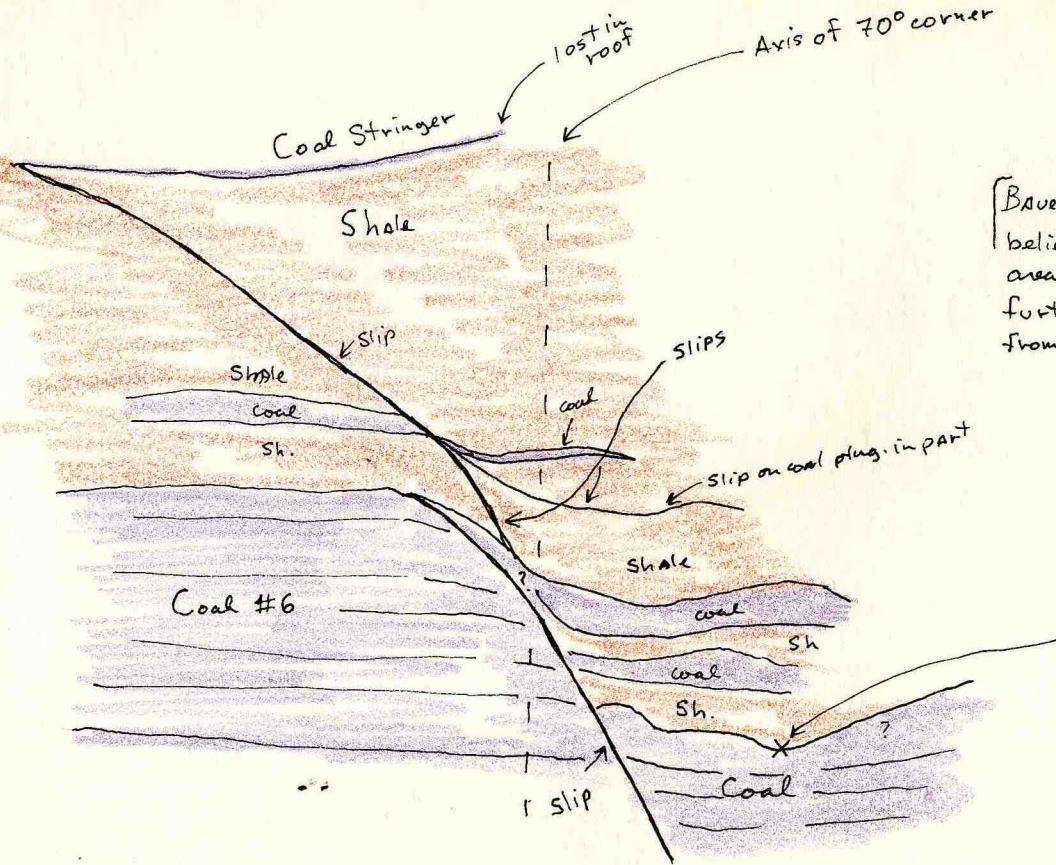
p. 3 of 6. plus 1 p. of
 Channel deepens to SE; on NW rib maps
 corner is as pictured:

{ Better sketch at (K)
 believed to cover
 area just to N. -
 further "right"
 from this sketch. }

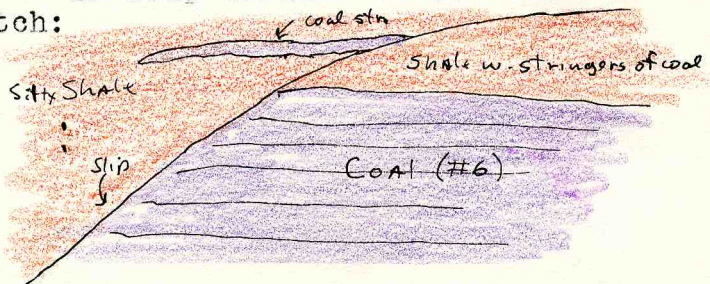
(L) In "deepest" area; coal/shale contact is slip defined on SW flank of "roll"

Coal sampled (Note; can find no CP # and I received no chem data) - contains wide lustreless bands - vitrain appears only 30-40% max. Channel nearly to floor (not cutting under it enough; coal depressed 6-8' from 100' West)

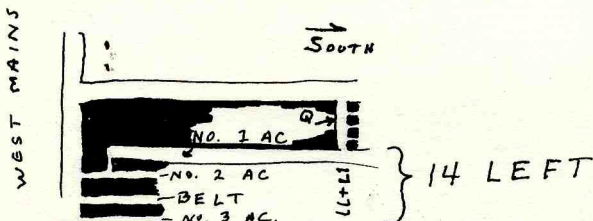
14 Left off West Mains - entry at 17+77.
Point Q on map which is the 3rd Pillar east
of 14 left, on north rib.

Appears as if a log was some how replaced by a laminated sandstone, which is identical to the sandstone filled rolls encountered in the mine.

Round finely laminated body of sandstone and shale is exposed in the rib. The round sandstone body is completely surrounded by shale. Sandstone disc has a carboniferous layer all around it about 1/16 of an inch thick. The carboniferous layer shows wood material.

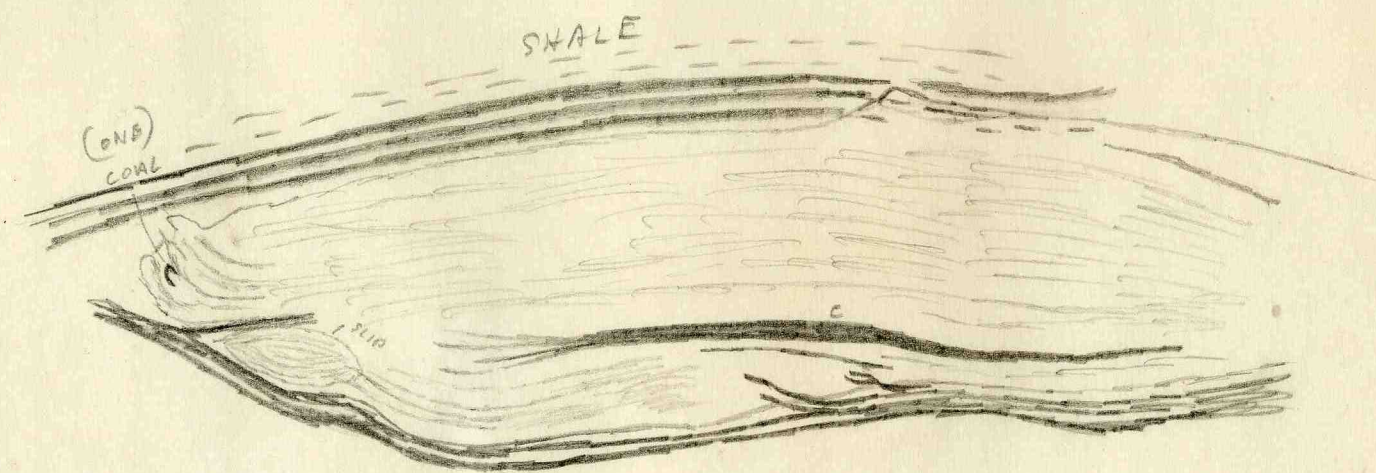
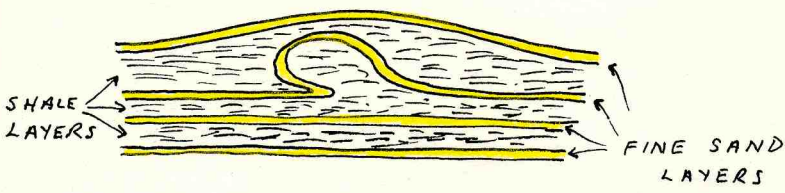
LOCATION K

In the rolls with sand and shale laminations, there are folds in some of the fine sand layers. The beds above and below the folded layer are unaffected. The sand bed above the folded one rides up and over the area of the folded one. See figure next page.

NOT TO SCALE - SAND LAYERS ~ .5 MM

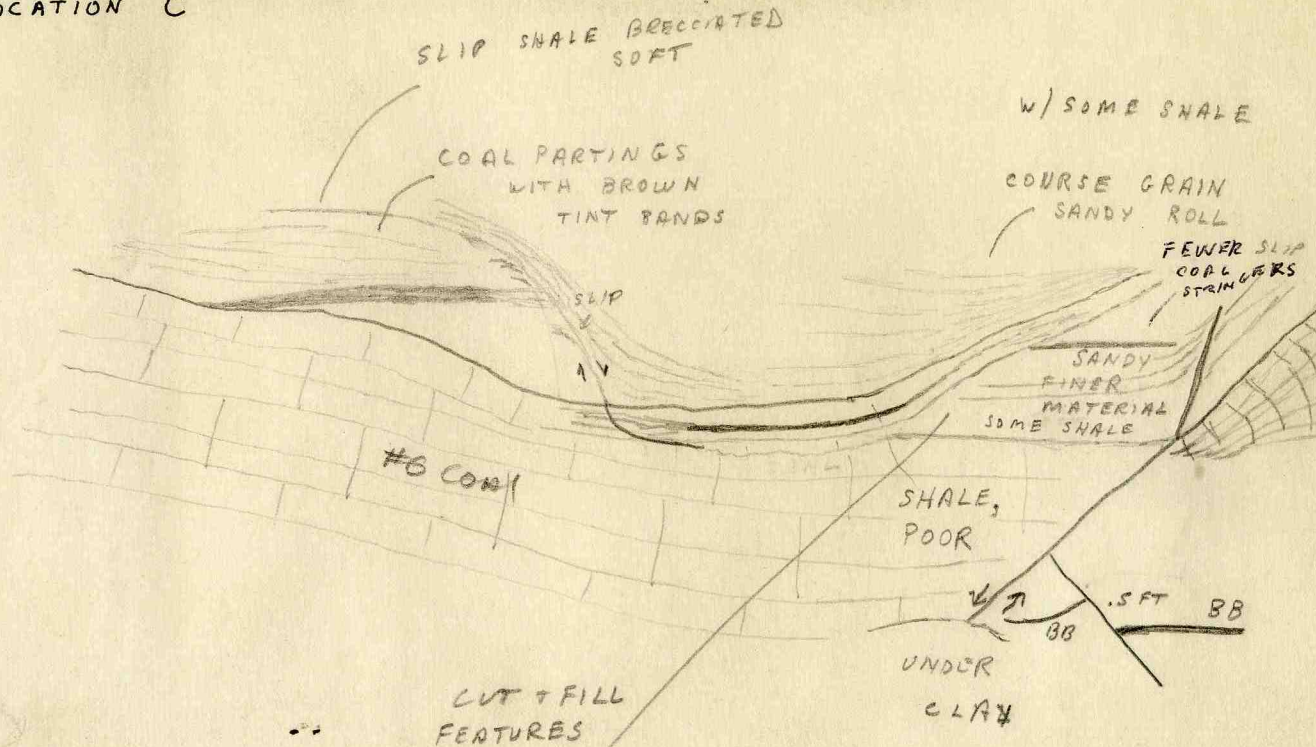
LOCATION C

DIFFERENT THAN
 ROLL - VERY FEW COAL SEAMS
 CO 1 SAMPLE #1

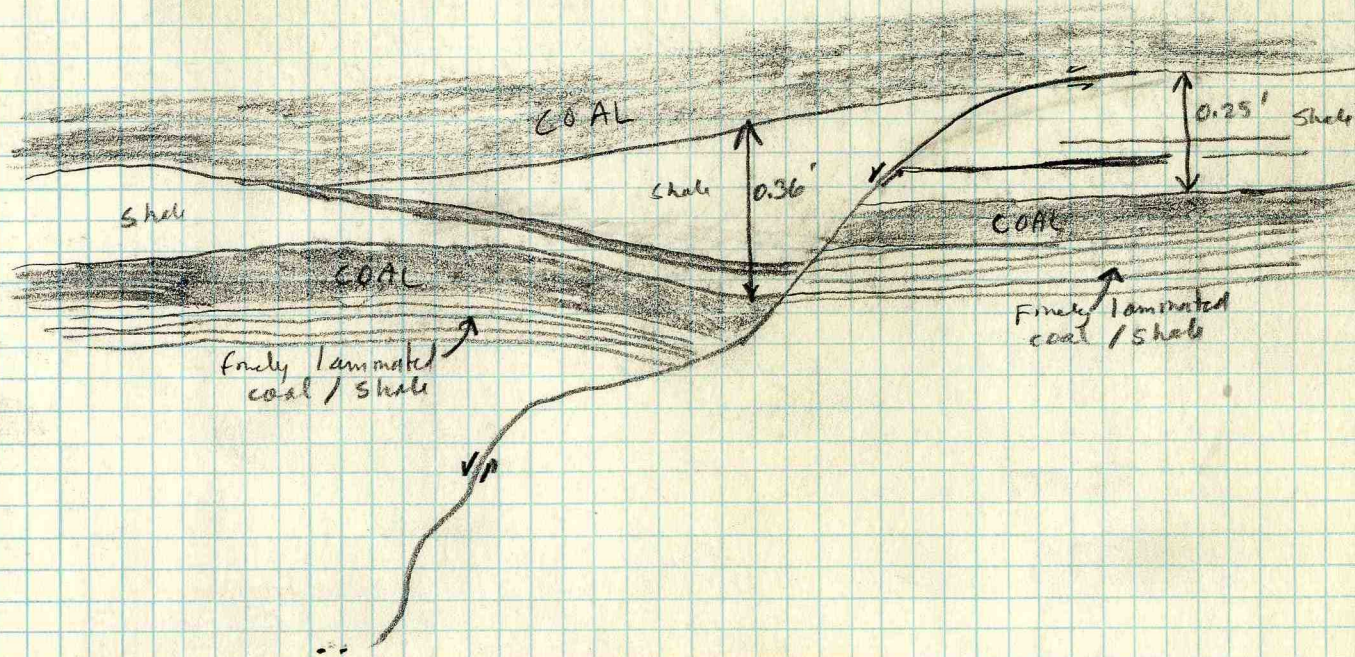
Several slips or slickensided surfaces noted in coal, mostly at large shale bands. One (see sketch, over) is in the big split and the layering is different on opposite sides of the slip. The shale on the footwall side is 0.25' thick but that on the hanging wall is 0.36' thick and the numerous coaly splits in the shale on the footwall do not trace across the slip. The slip changes from nearly horizontal to steeply inclined and its strike meanders. It appears that either the slip was formed during coal deposition or else later squeezing during compaction changed the thickness of the shale on opposite sides of the slip.

Stop 1 - Slip displacing the big split.

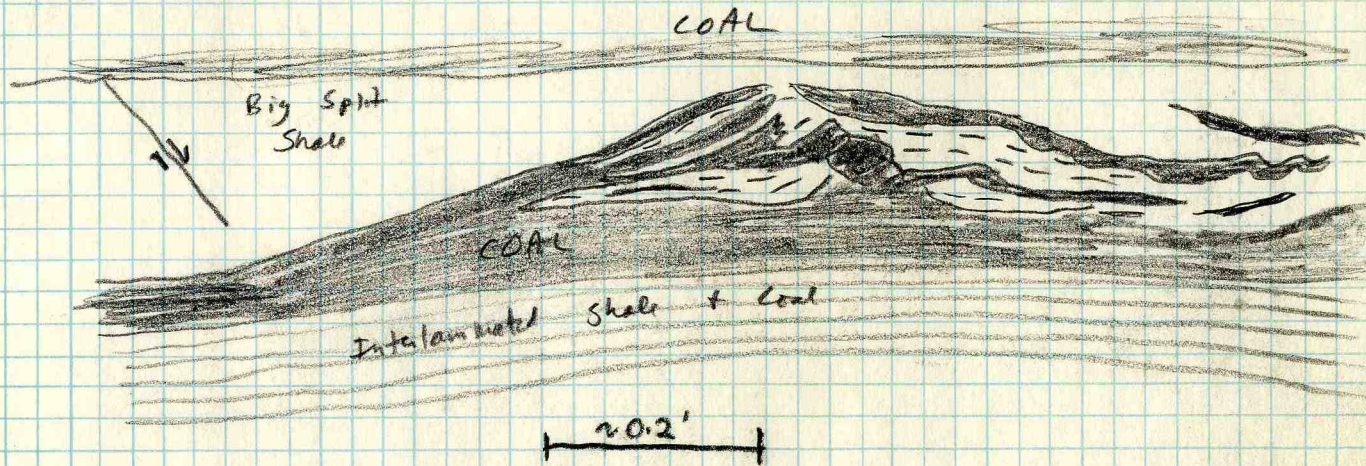
Stop 3 - Pinch out of big split

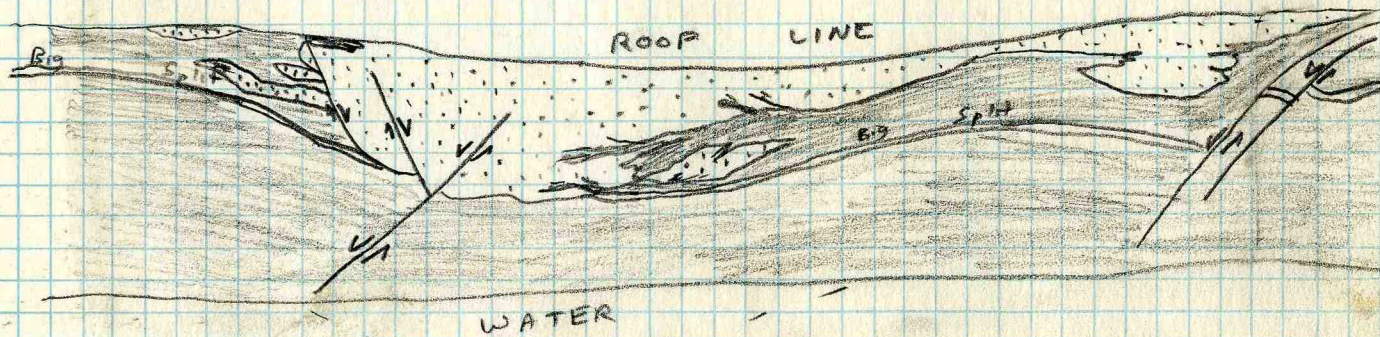
Generalized View of North Rib

Stop 18 - Large Sandstone-filled Roll.

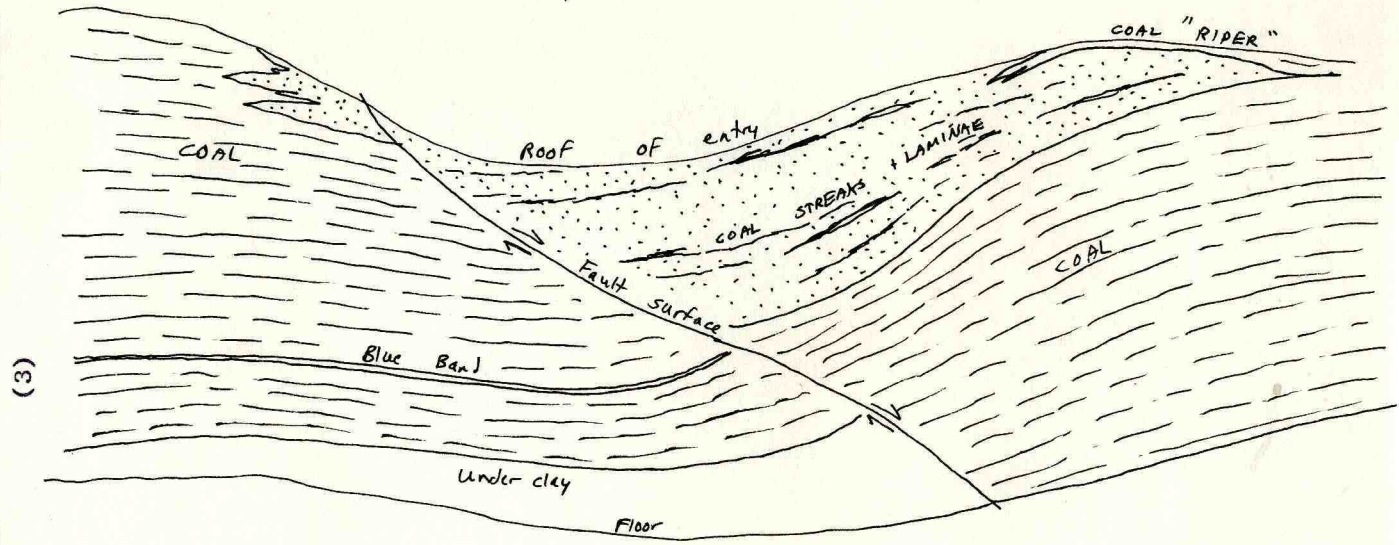
The roll trends in a northwesterly or west-northwesterly direction. The southwest side is marked by a low-angle compactional fault which has about six feet of throw and cuts through the underclay. The coal on the northeast side dips as steeply as 45 degrees toward the fault. Above the coal is well-laminated sandstone with abundant stringers of carbonaceous material. Though the laminations are locally disturbed they strongly rule against any interpretation of this roll as sand squeezed or injected into the coal. I believe the roll is a lens or linear body of sandstone deposited in a small channel or "washout" and bowed downward by differential compaction.

This roll extends across the belt entry and the two intake-air entries west of the travelway. The appearance of the roll changes from one place to the next but the overall trend is maintained.

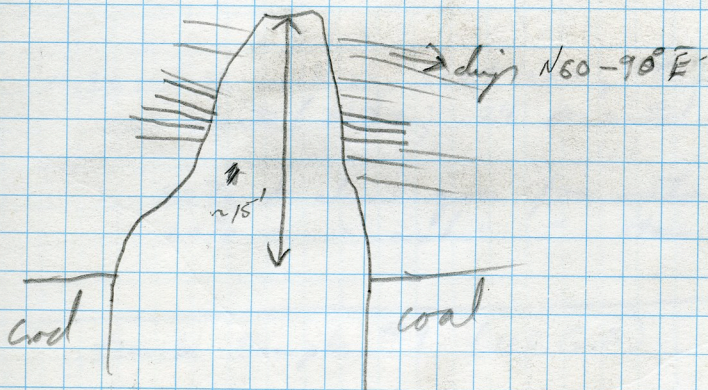
Belt entry (16 left):

15' fall of planar bedded sandstone;

Farther east on belt entry; coal ~12' thick
ripple on bedding planes of fallen
sandstone, ridges & valleys trend
S 40-50° E

15' of planar bedded sandstone has fallen along this entry. This fall, shaped like an inverted "V", has exposed numerous ripple-marked bedding planes. The ripple mark ridges and valleys trend N 40-50°W, while the bedding planes dip to the east. It should be noted that the coal in the vicinity of the fall is almost 12' thick.
