BROWN BROS. EXCAVATING
MINE # 2 (Strip)

Mine Index No. 919
Coal Report No. L-131

BROWN BROTHERS EXCAVATING CO. (Strip Mine) SALINE COUNTY

Notes by John Nelson on visit with John Popp, 9/30/77

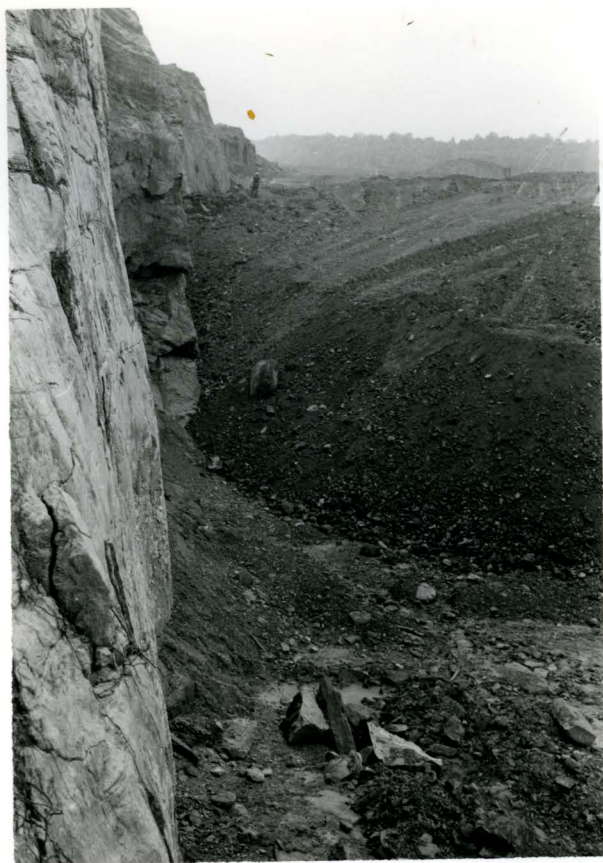
Picture 1

Southwest facing view of fault in the abandoned northeast pit. J. Nelson is standing in the background, and a dragline can be seen in the upper right hand corner. The pit is being filled for reclamation. See sketch map for the location.

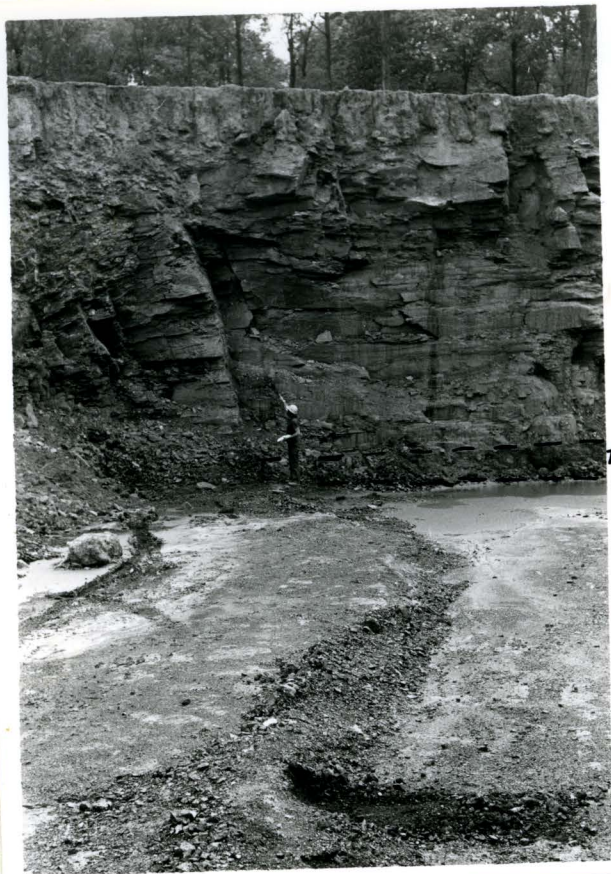
Picture 4

There are also two faults of 1-2' displacement, down to the northwest, traceable through the floor of the pit to the highwall. The strike of these faults is clearly shown as steps in the floor of the pit. The coal has been removed exposing the underclay. The faults intersect the highwall as steeply-dipping fractures. Due to lack of persistent marker beds in the highwall it is very difficult to determine displacement there.

Idle southwest pit with DeKoven Coal exposed in the highwall. Southwest facing view with J. Nelson pointing to one of the small displacement faults. In the foreground another very small fault has been uncovered; the fault displaced the underclay about 1'. See sketch map for location.

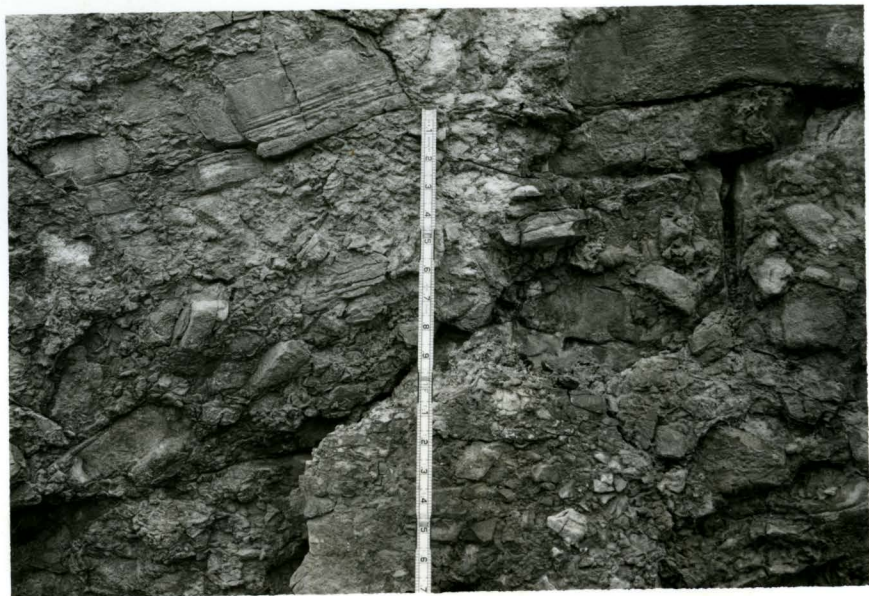
Breccia composed of angular blocks of sandstone
clinging to fault plane. Location 1, abandoned pit.

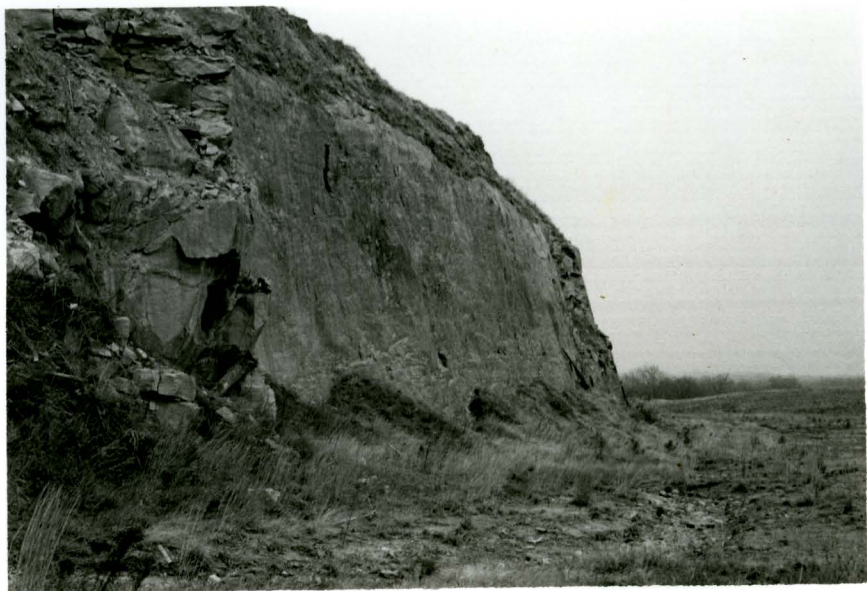
Fault scarp on abandoned strip mine highwall
(location 2). Fault plane trends roughly 055/80 SE
and shows vertical slickensides.

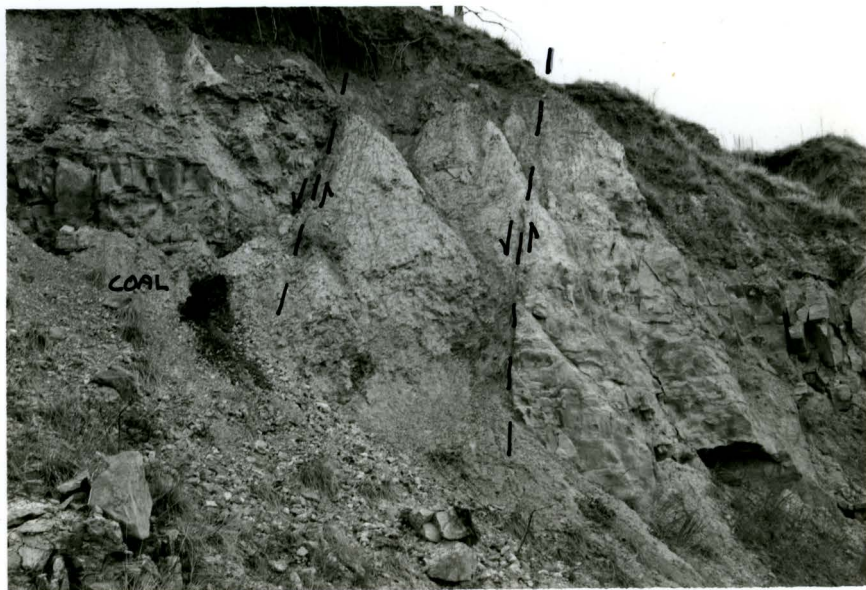
High-angle faults exposed on re-entrant of highwall (location 3 in abandoned pit). Sandstone to right contains many antithetic fractures. Shale between two faults is drag-folded, as is thin coal layer to left of faults. Compare with sketch.

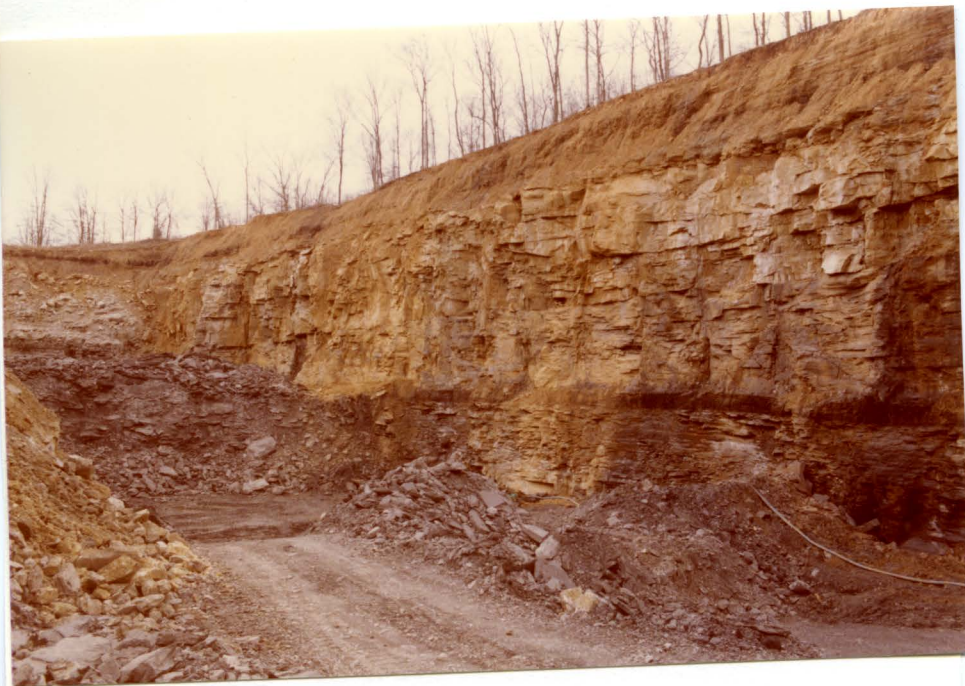
General view looking southwestward in the active pit. No. 2 Coal and Mecca Quarry Shale form dark band near top of highwall; DeKoven Coal is about 1/3 of the way above the floor of the pit. The Palzo Sandstone, about halfway between the two coals, is thick and breaks with rectangular fractures.

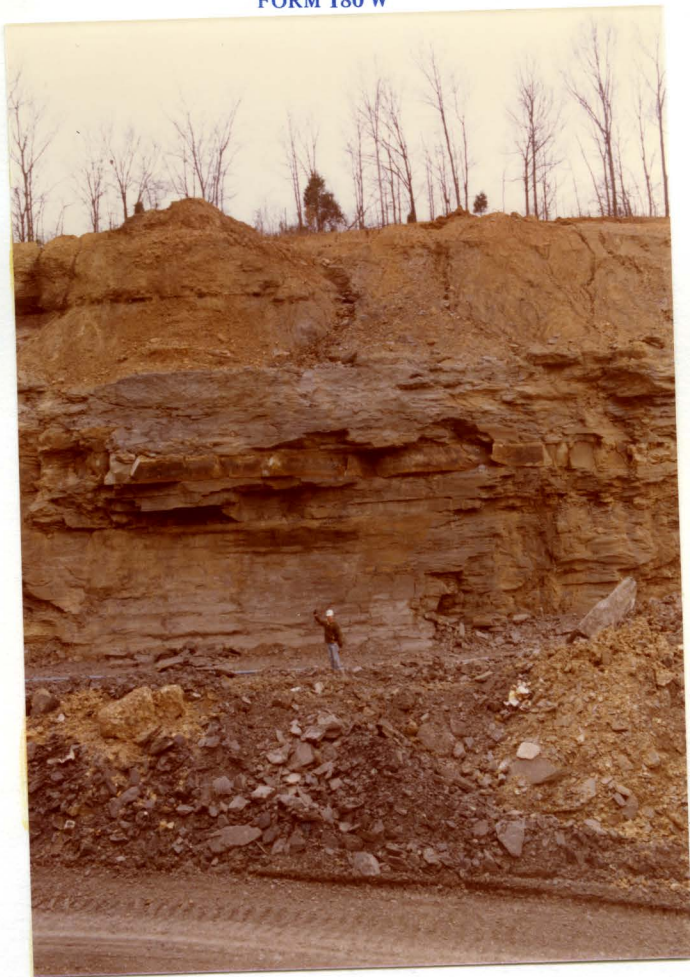
View of highwall farther north in the mine. Here the Palzo Sandstone, about 15 feet above D.K.'s head, is much thinner than in the previous shot, and is lenticular.

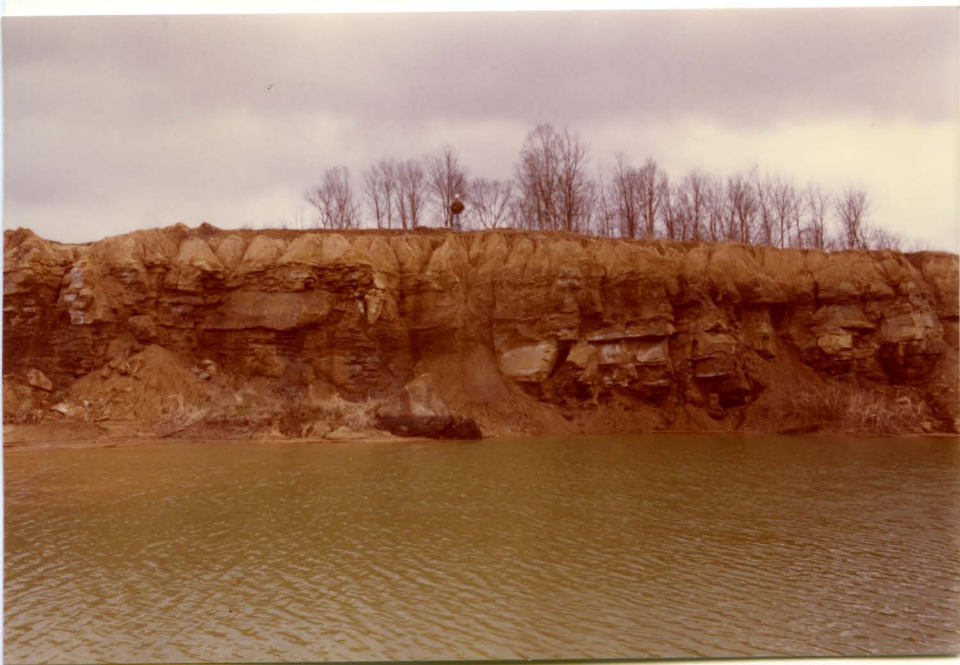
D.K. Lumm is standing directly above the 11-foot fault in the small abandoned pit. The displacement is best shown by offset of the massive Palzo Sandstone which is downthrown on the right-hand side of the photo. The loess is not affected by the fault.
