MAP OF STRIKE-SLIP FAULT
IN STH SOUTH PANEL
OFF MAIN EAST.

Mine Notes - Freeman Crown II - Macoupin County

Trip: Jan. 23-25, 1980 by Phil DeMaris and John Nelson

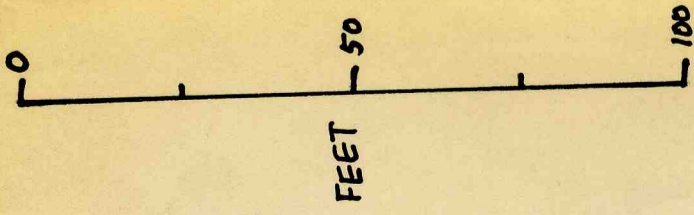
x 2.3 - Thickness of Anna Shale
Isopach lines in pencil

— Fault - tick on downthrown side
--- Fractures in roof

The isopach lines are very clearly offset along the fault in the vicinity of Stop 5. The 3.0-foot isoline, which is perpendicular to the fault, has been shifted about 60 feet in a left-lateral sense. East of the 3.0-foot line a "saddle" or belt of thin Anna Shale has similarly been offset about 70 feet. Even allowing for an error in calculations of 10 feet, this is considerably more displacement than any of our previous observations had led us to believe would be found.

so that we are able to take continuous measurements of the thickness of the Anna Shale along the pillars. Fred Krausse noticed that the shale north of the fault on the west rib is 2.1 feet thick, while the shale directly south of the fault is 3.4' thick. This suggests that considerable lateral offset of the shale has occurred. Therefore, we took many measurements of shale thickness and then constructed an isopach map of the Anna Shale (see map included with these notes).

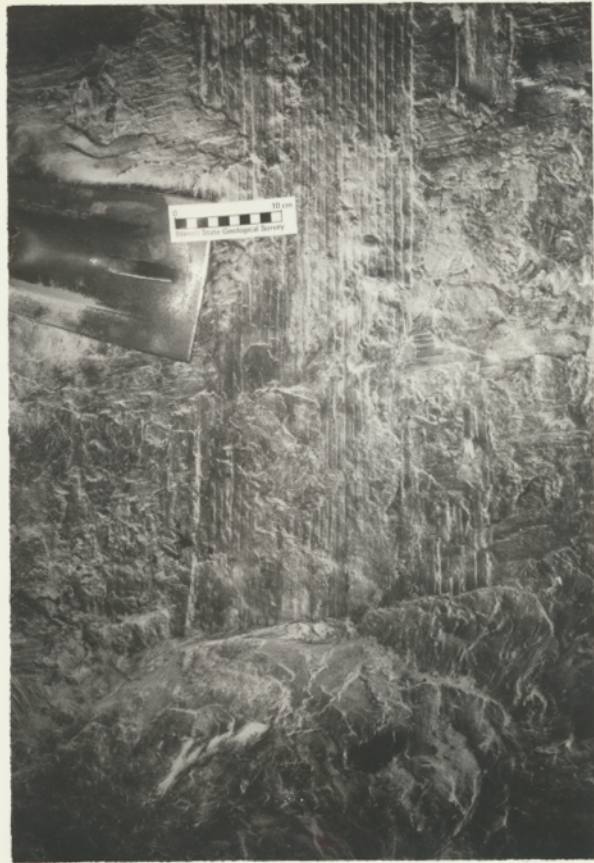
Neq. 1

1/23/80 Crown II - site "I"; Sigillaria in top
coal

I. Large Sigillaria compression in t.c. under Anna roof; 26 cm. wide; 8.6' long as exposed, but part has fallen; may be longer (+ took 2 photos)

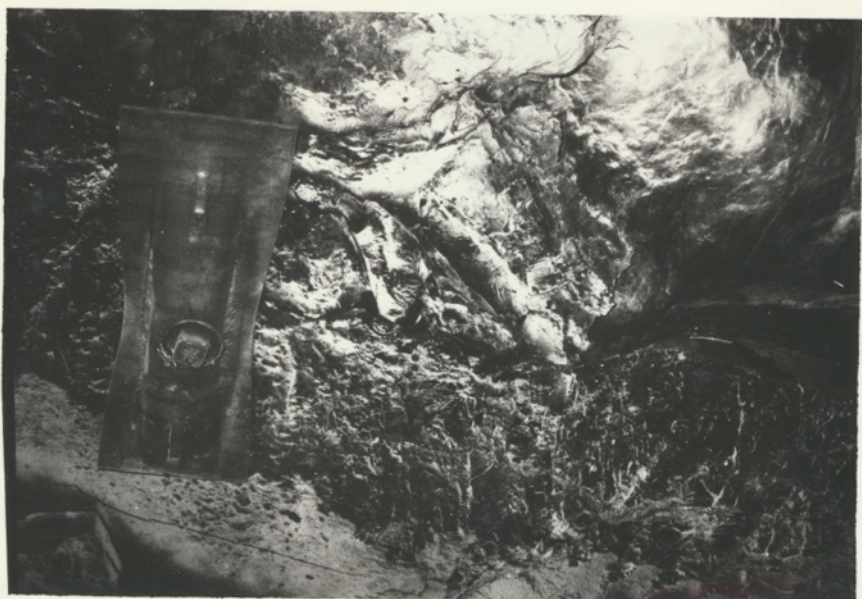
Neg.
H 1/23/80 Crown II Ls. "Boss" Prob. @ 360' N. on "E" entry, 3rd N. panel

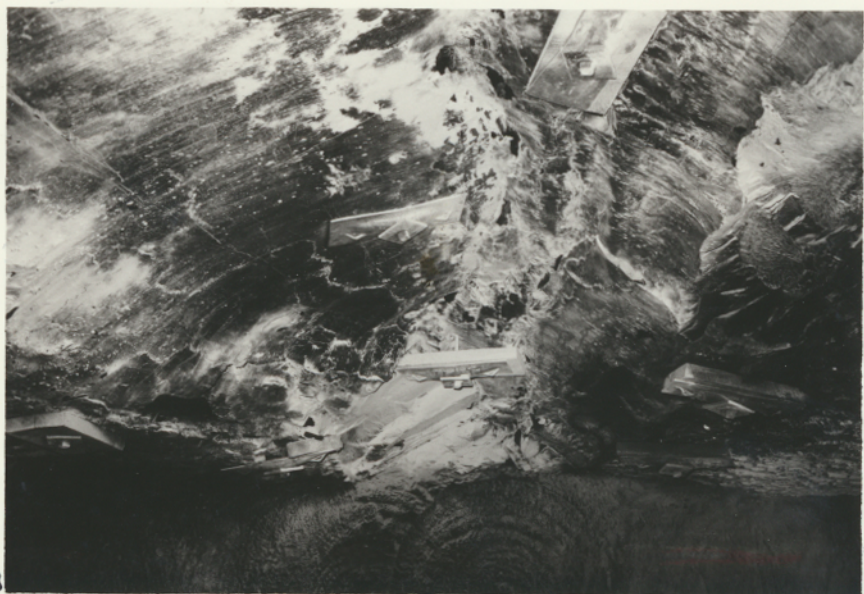
Neg
3. 1/23/80 Crown II - "Coffin cover" fall in ANNA 3rd N. @ 1880' N - "D" entry

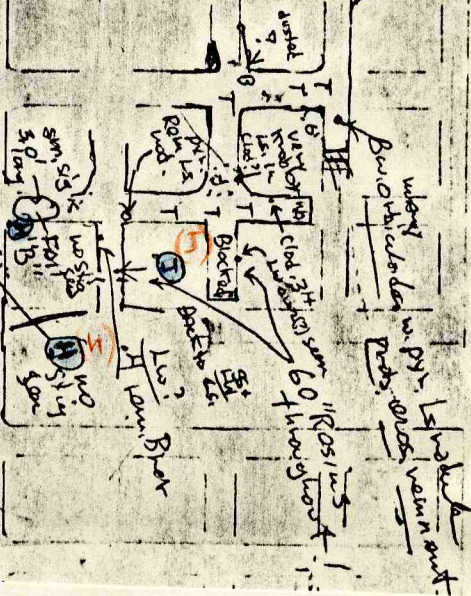
Field Map Ⓢ
 6/27/80
 3rd N. Panel

Ⓢ No Bosses, few pectins
 (want a pectins) - 3 small
 hoof falls + prob. ls. above
 "suggested" by holding
 some 36" bolts

F. Checked Energy roof area for pectins; none found. No "bosses" either; 3 small roof falls examined; prob. Ls. above suggested by 36" roof bolts; thickest Energy seen was 1'.
