Superior Coal Co., #4

COAL MINE LOCATION AND DATA

K.—ACTIVE SHIPPING OR LOCAL COAL MINE.

V-MINE LOCATION SHEET.

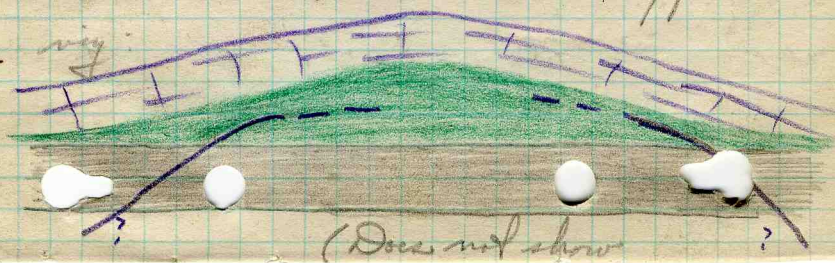
Visited 13W off 5th S.W.

In general the ^{immediate} roof is bad being impossible to hold by any timbering method used to date. However, the bad top is not thick over large areas being usually less than 18" thick. In the localities where the thickness is greater than 18" is where greatest difficulty is encountered. This change in thickness usually starts on a slip (i.e. end on a slip) and the increase ⁱⁿ thickness is very fast.

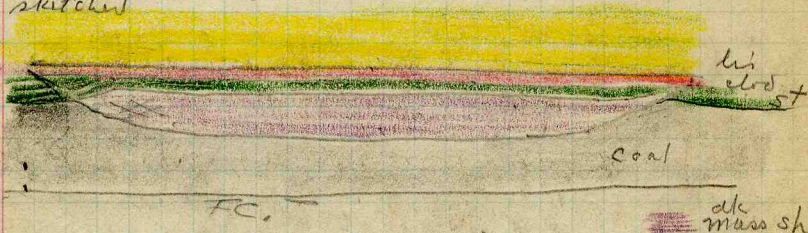
Sup No 4 Gillespie
24" sh below the slate along 3rd N. entry is
cut out by slips on North - condition as
sketch

The slips bounding the dk mass shale appear
to be fractures due to weak zones yielding
during pressure on the beds.

The deposition probably corresponded to
the present disposition of the mass. sh.

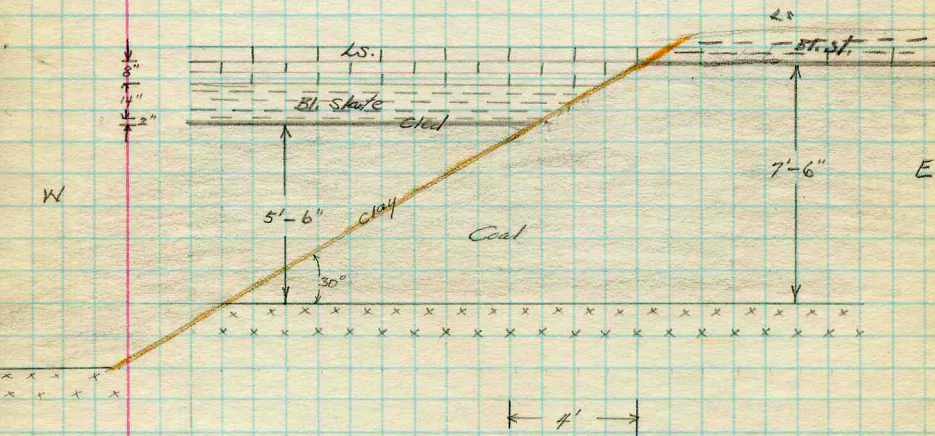
Photo 1-2

Between rooms 10 & 11, 13th W, 7th NW,
in entry, on S. rib.

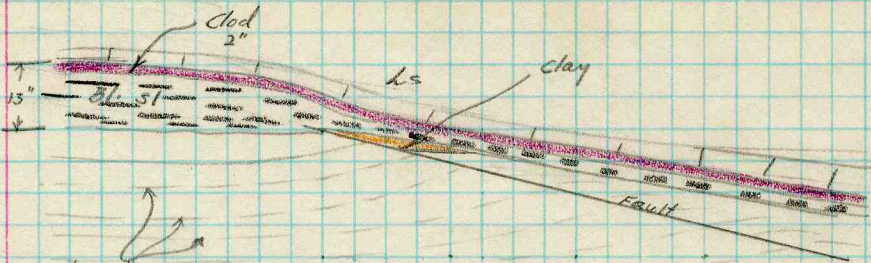
Photo 1-10

N. Rib between Rooms 4 & 5, 5th E., 5th SE.

(Caprock very rolly in this vicinity, with many faults and "slips" in the bl. sl. and coal)

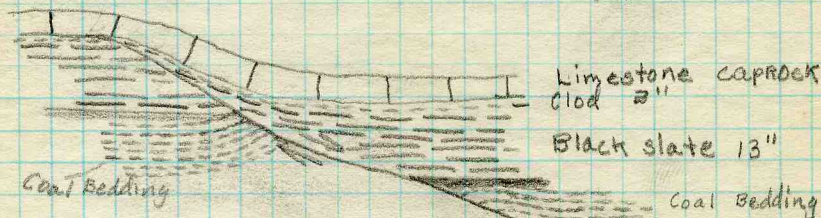
On the rib between rooms 425 or 5E off 53 on main E a fault on the west side of a large limestone roll shows an apparent reverse drag in the coal (see diagram below). The reverse drag shown in these faults may be due to reversal in movement of the fault, but it seems more likely to me that it is caused by bending of the upper layers of the coal and by the fracturing of the small arch produced. The evidence that seems to indicate this to me is that such reverse drag is commonly associated with faults surrounding limestone rolls and the fact that this apparent reversal or drag is confined generally to the upper part of the coal bed. Further one would expect more crushing to the coal along the fault plane if there were several movements. This location is occupied by a generally low area of limestone which is bounded by small faults.

Diagram of fault on west side of large limestone roll. Note reversal in drag of coal bedding.

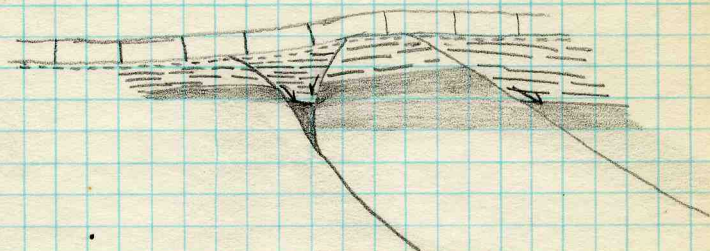
Diagram of series of faults on North side of large limestone roll, located between entry and first cross-cut in room 5.

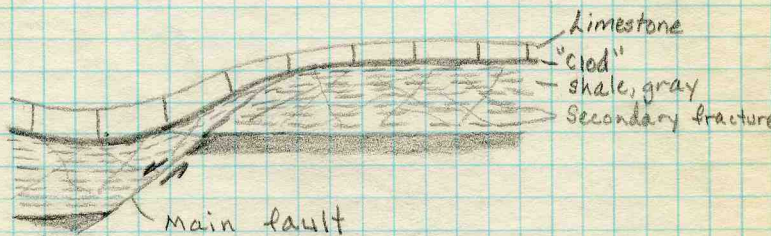
At the face of the 4th N, or 13th W off 7th N of 1st Main W is an excellent exposure of highly fractured gray shale associated with bed roll in the limestone and a small fault with a vertical displacement of 14" as diagrammed below. Here there was no black slate in the section

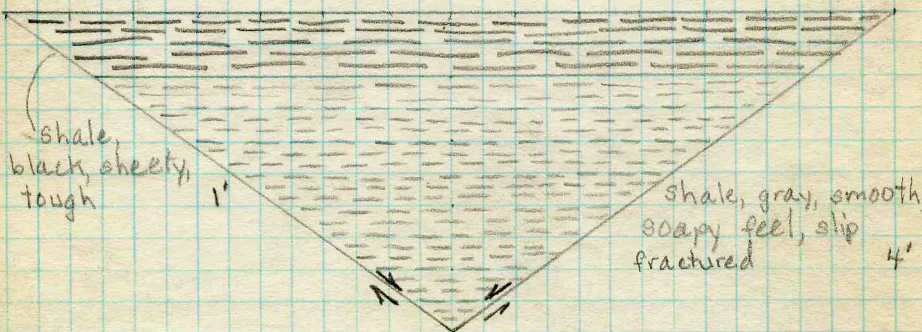
At Mouth of ROOM 16 of 5E off 5th south off Main E is a large wedge of gray shale and black slate running at an angle of 45° across the mouth of the room. The wedge is 5 feet deep (1 foot black "slate" + 4 ft. gray shale), and is 14 feet across the top. The wedge is faulted on both sides (see diagram below) and the roof material on both sides of the wedge falls badly. In the main entry a wedge of limestone runs into this and the faults apparently continue into the limestone at least a short distance.

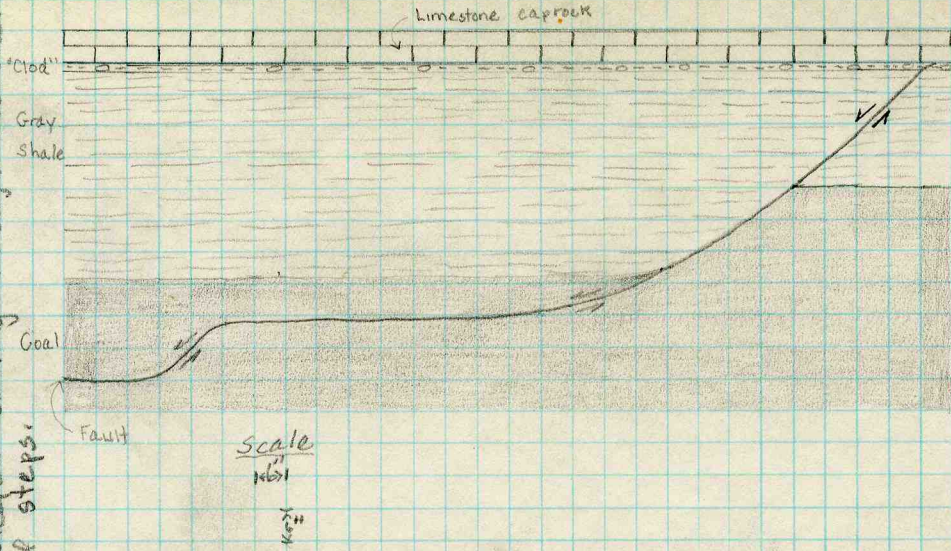
A peculiar fault was noted on the east rib near room 8 2nd s. off 6E off 7S-E in which there was a pronounced flattening of the fault within the coal bed (see diagram below). The fault would flatten for a few feet then steepen cutting through the coal in a series of steps.

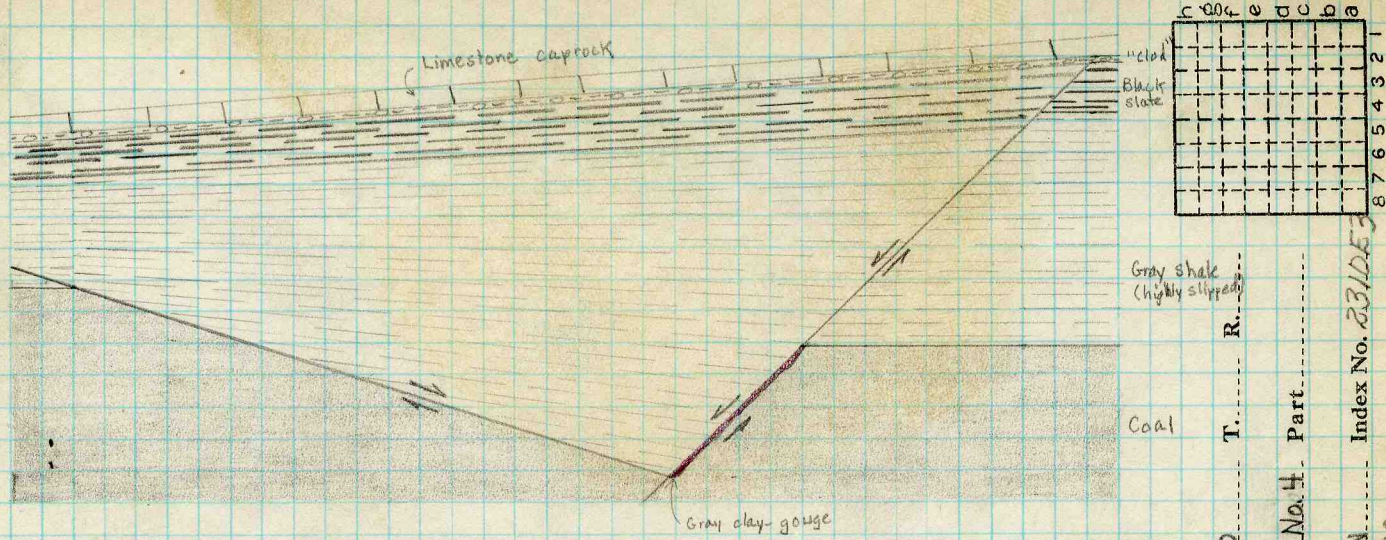
Diagram of intersecting faults in gray shale lense under limestone roll in Room 1 off 2nd S off 8'E off 5S-E on North rib.

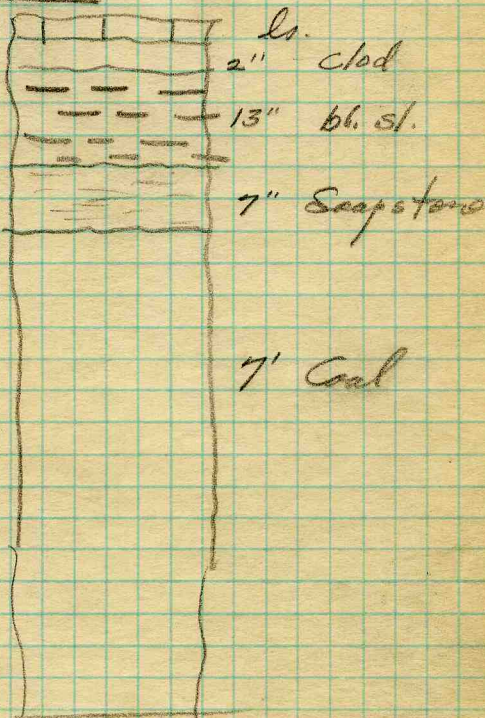
1-11 Photo showing lenticular
structure of soapstone, and
contact between the soapstone
and the bl. sl.

at hammer.

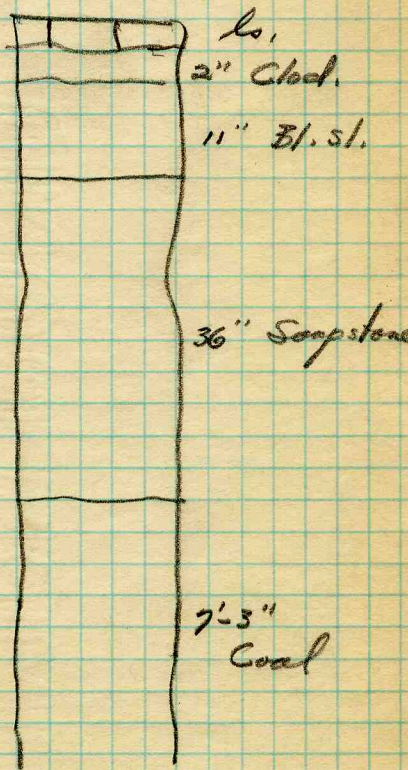
1-12 - Photo showing bl. sl. and soapstone at hammer:

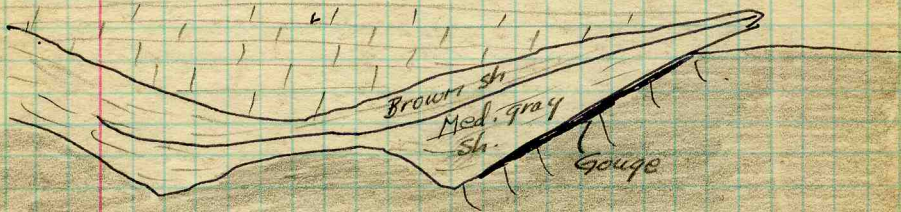
Immediate roof — sh.

- 1) Thickness — 0-5'
- 2) Contact with coal
- 3) Hor. variation — varies considerably in character

Track level

2500' from bottom in ~~the~~ Main E

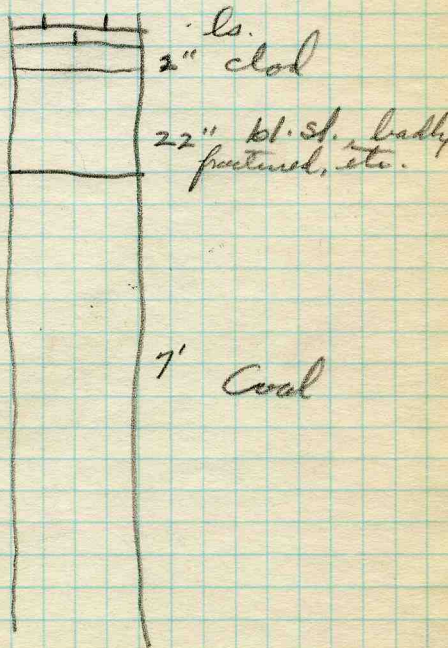
3-3 Bl. sl., badly slipped & fractured.
