EQUALITY MINING CO. NO. 1
MINE INDEX NO. 983

COAL MINE—PRODUCTION

ILLINOIS GEOLOGICAL SURVEY, URBANA

Notes by John Nelson on visit with John Popp.

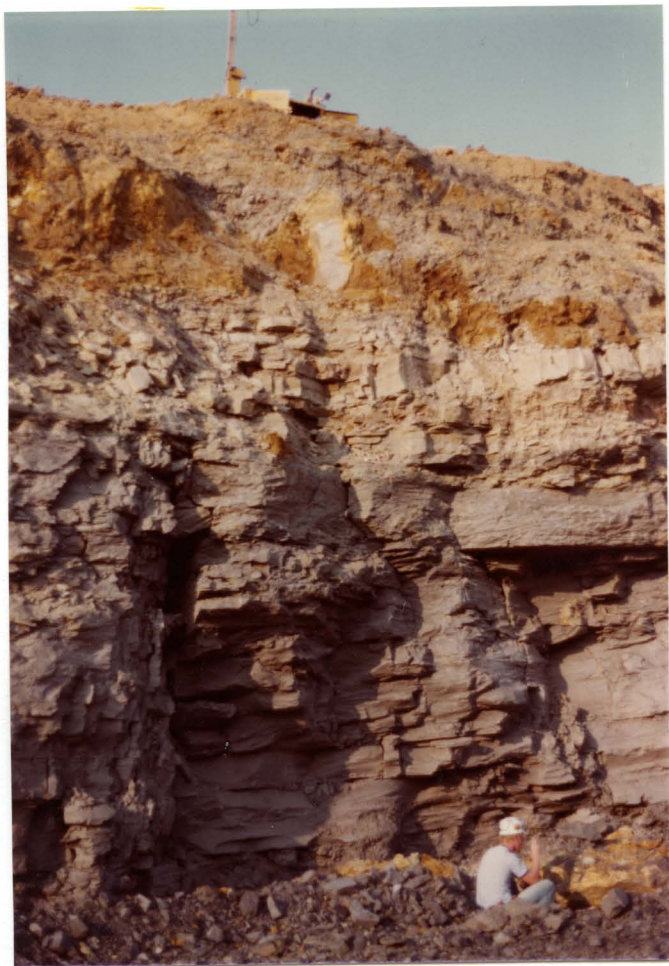
View of highwall in active (west) pit of Equality Mining Company. Notice large white boulder, turned up on end, in orange-brown clay just above top of bedrock. This is possible evidence of glaciation here, south of the generally-accepted limit of glaciation.
