OXFORD MINING COMPANY

OXFORD MINING COMPANY (Strip Mine) WILLIAMSON COUNTY

Visit by John Nelson 8/25/77

Oxford Construction Co. Mine No. 4 June 6, 1978 Notes by John Nelson on visit with John Popp

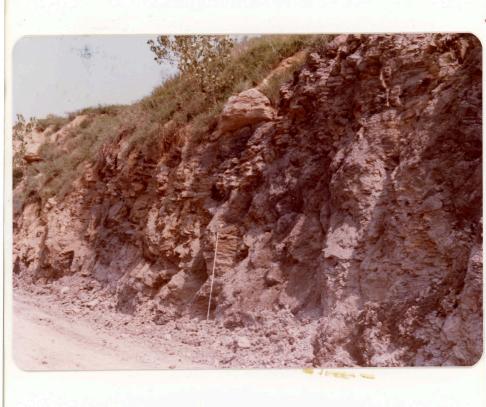
General view of abandoned highwall along access road to Oxford pit. Highest rock unit is the Brereton Limestone, which is seen as isolated boulders. One such is seen just right of the bush above the ruler (ruler is 6 feet long). Below the limestone is closely jointed, black Anna Shale 3-4' thick. The remainder of the highwall is composed of the gray, sideritic Energy Shale. The coal seam (Herrin- No. 6) is not exposed. Slumped appearance of highwall is probably due to the collapse of abandoned underground coal workings.

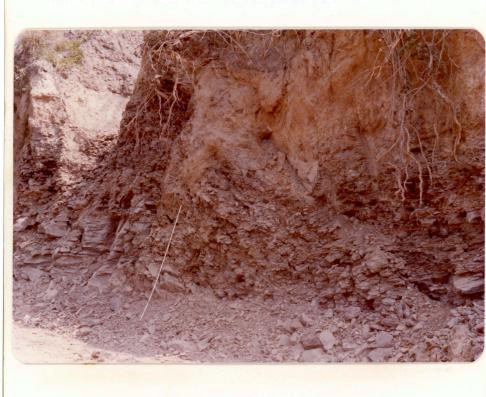
This fall has extended all the way to the surface and glacial material has slumped into the hole.

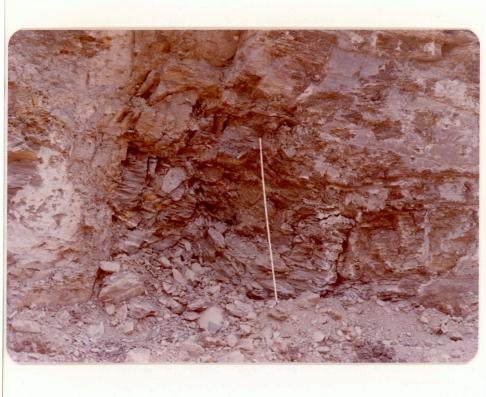
This mine entry is completely choked with fallen rock. Most of the mine openings visible along the highwall look like this.

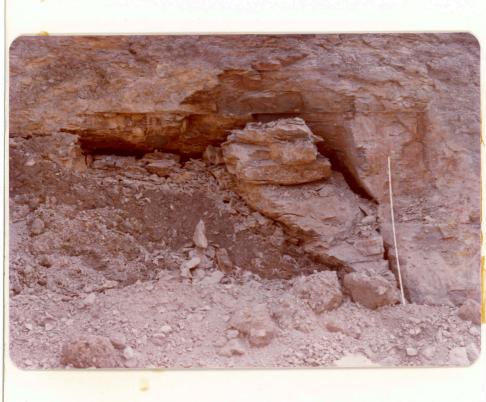
Another collapsed mine opening in the highwall. This fall has domed out in the Energy Shale, a gray, silty, sideritic shale. Ruler is 6 feet long.
