MAP (A) Feb 27/8, 1979

Mar. 30, 79
 Crown II
 1st N. Panel

John Nelson
April 19-20, 1979

MAP B4 JOHN NELSON
JUNE 26-27, 1979

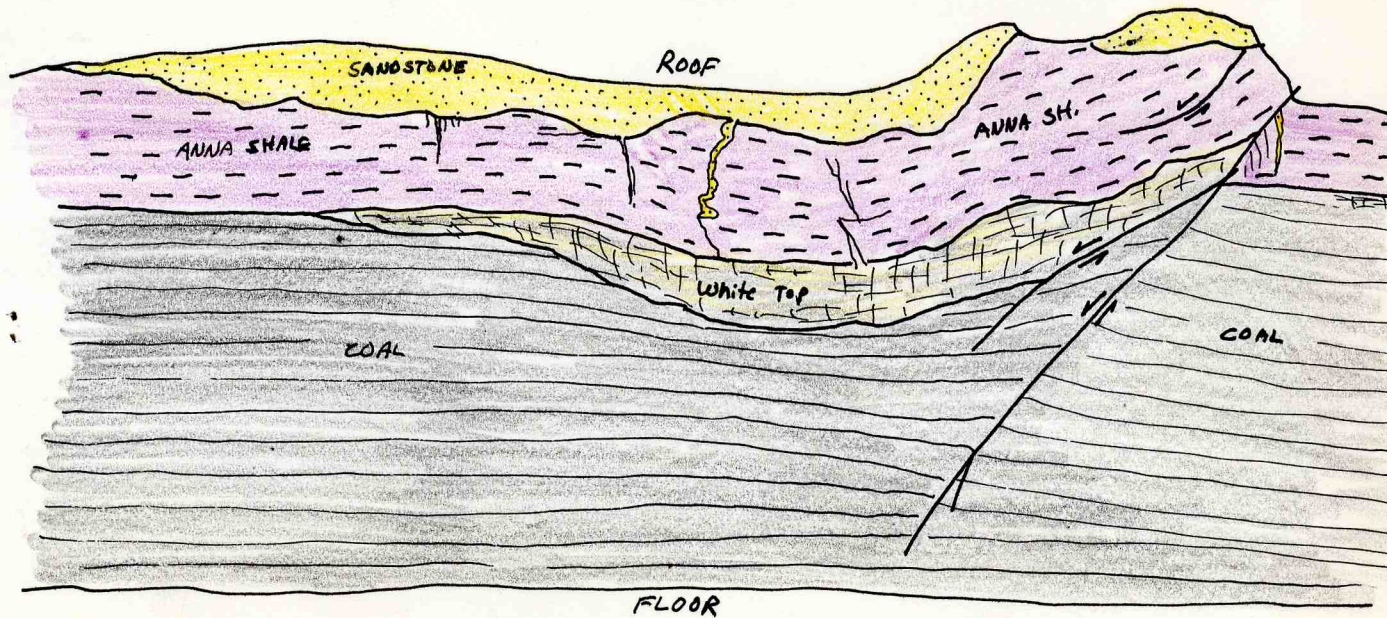
VIEW LOOKING WEST

1.) Roof fall exposes erosional contact at base of channel. North of the fall, along the east rib, the immediate roof is black, fissile Anna Shale, grading upward to mottled, dark gray olive or greenish silty shale; poorly bedded, containing numerous marine fossils including brachiopods and coiled cephalopods. The highest exposed stratum (about 1 foot above the top of the coal) is a hard layer, probably the base of the Brereton Limestone. Water is dripping from the roof nearby. The rest of the area has top coal in place, so the transitional zone cannot be observed.

In the fall itself the Anna Shale is 2 to 3 feet thick. The lower portion is "slaty" with occasional large concretions. About 2 feet above the base is a prominent horizon of light brown phosphatic lenses. Above this the shale is darkly mottled, poorly bedded, appears burrowed in places and is finely micaceous, but no fossils or limestone was observed.

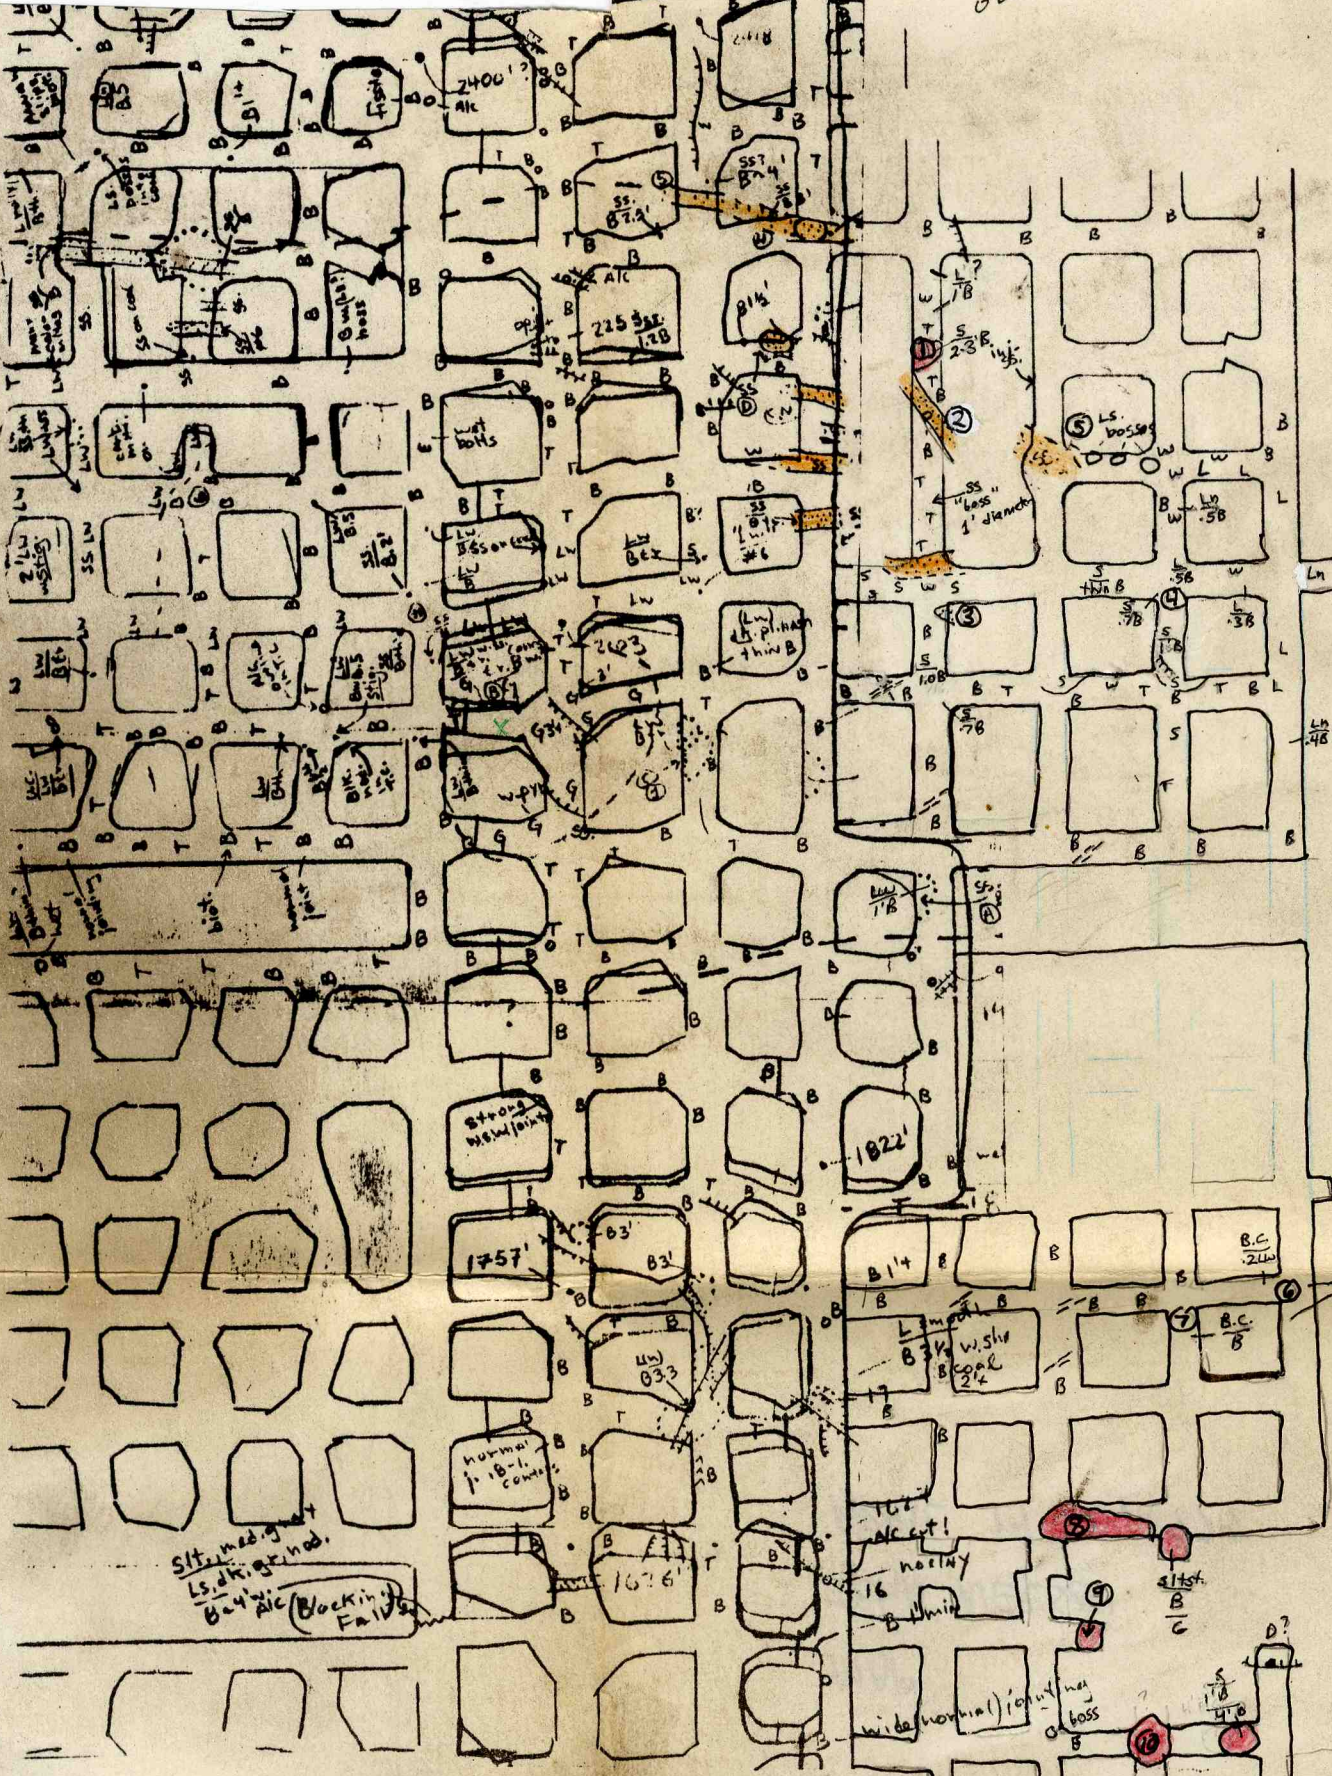
An obvious ss.
exp. was missed
on "C"

Ln
48 These pillars
are shorter.

B.C = Bony coal
in channel -
fill sequence.

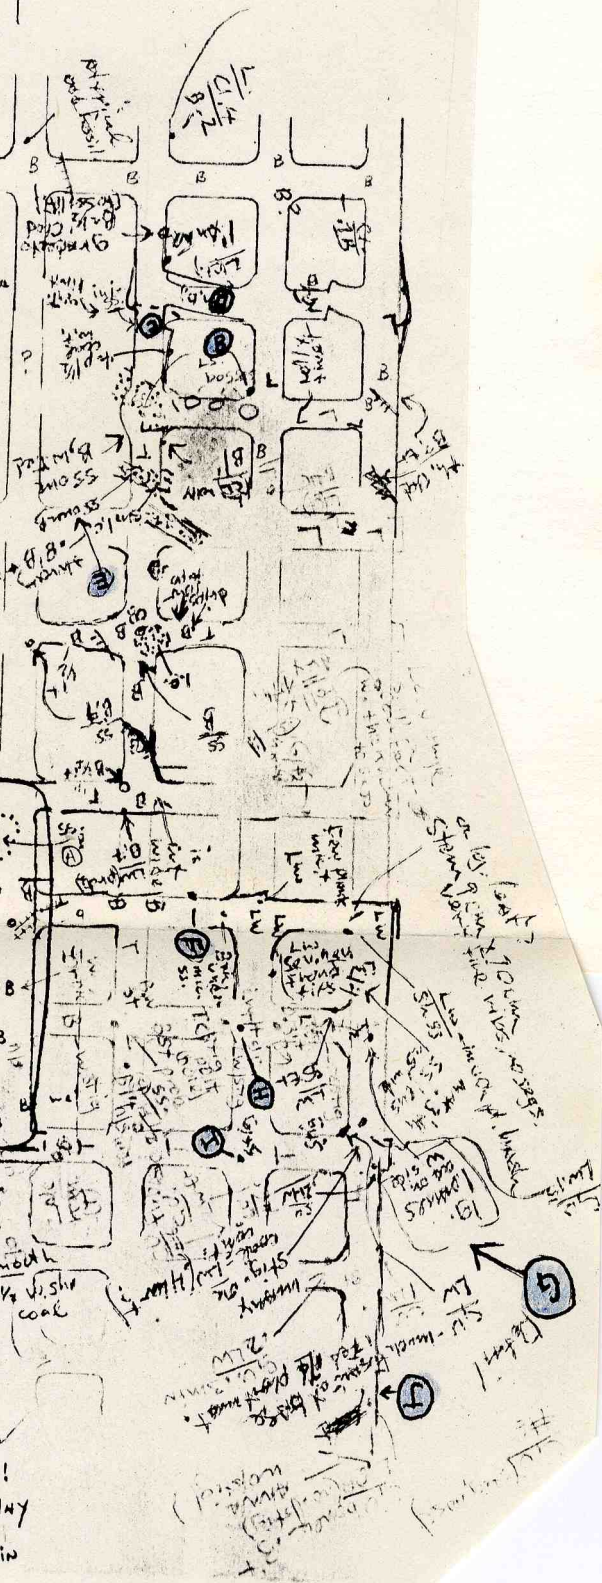
Field Map A
4/19/79

An obvious ss.
exp. was missed
on "C"

some knobs as sm. as golf balls

D. Base of Ls. is dimpled, knobby; Anna is 0.8' thick; Brere. has broken along a weak zone 0.1-0.2' up. I suspect this effect
