Freeman United Coal Mining Company
Crown III Mine

Mine Index 996

Macoupin (nr. Girard)

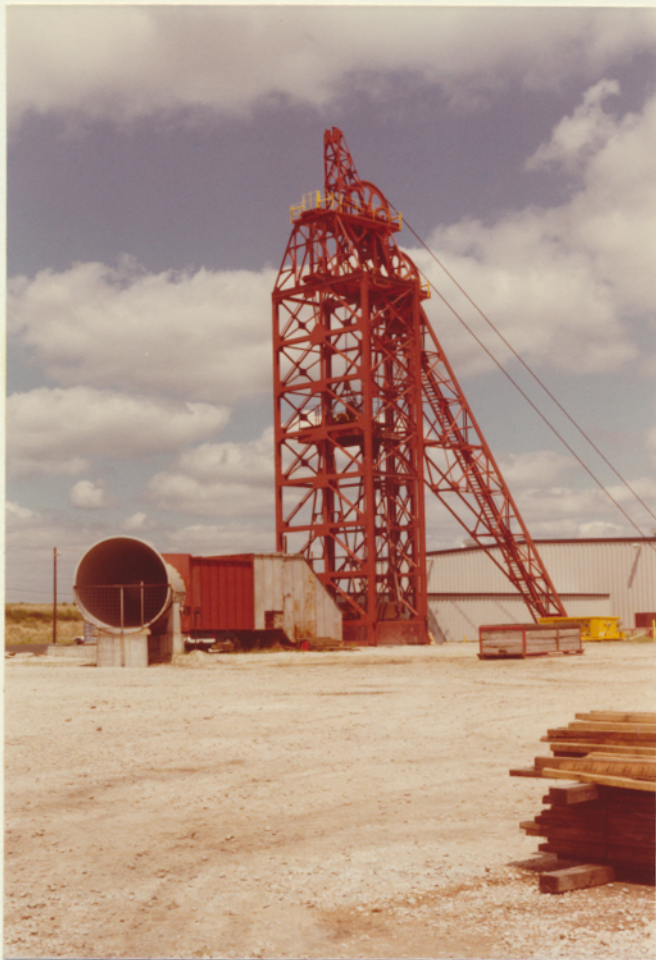
Headframe for man-and-materials
shaft, and fan, at main portal
of Crown III Mine.

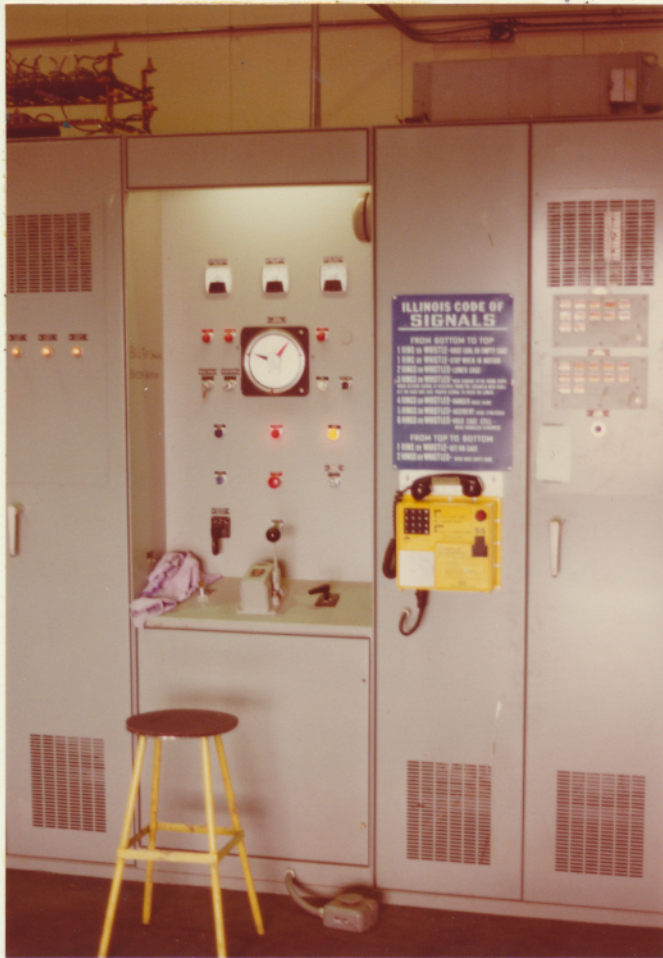
Control panel for hoist

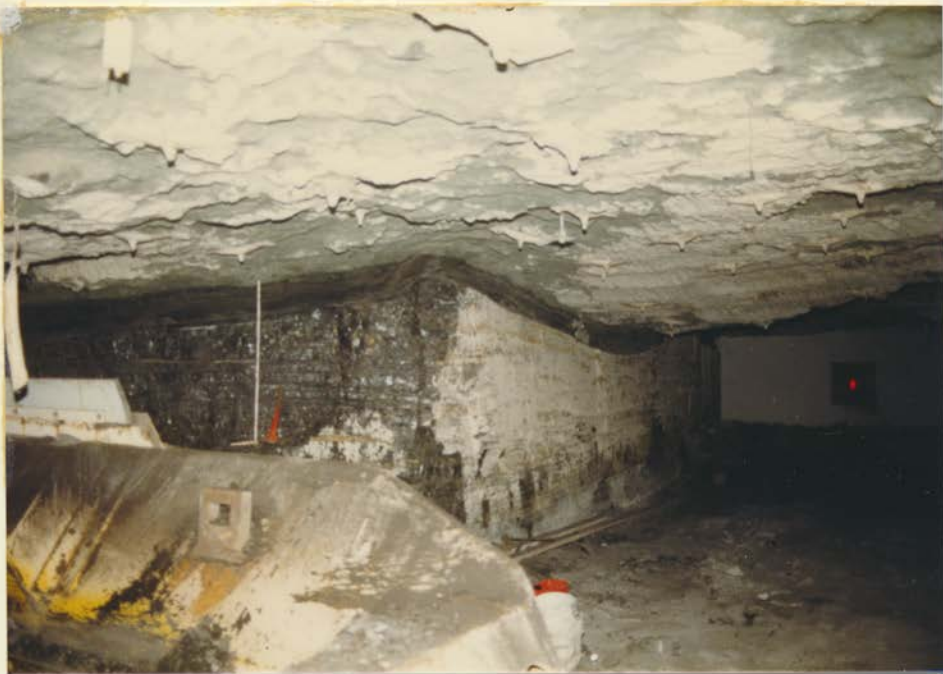
North part of mine, showing undulating contact of coal with roof shale. Note apparent truncation of coal bedding.

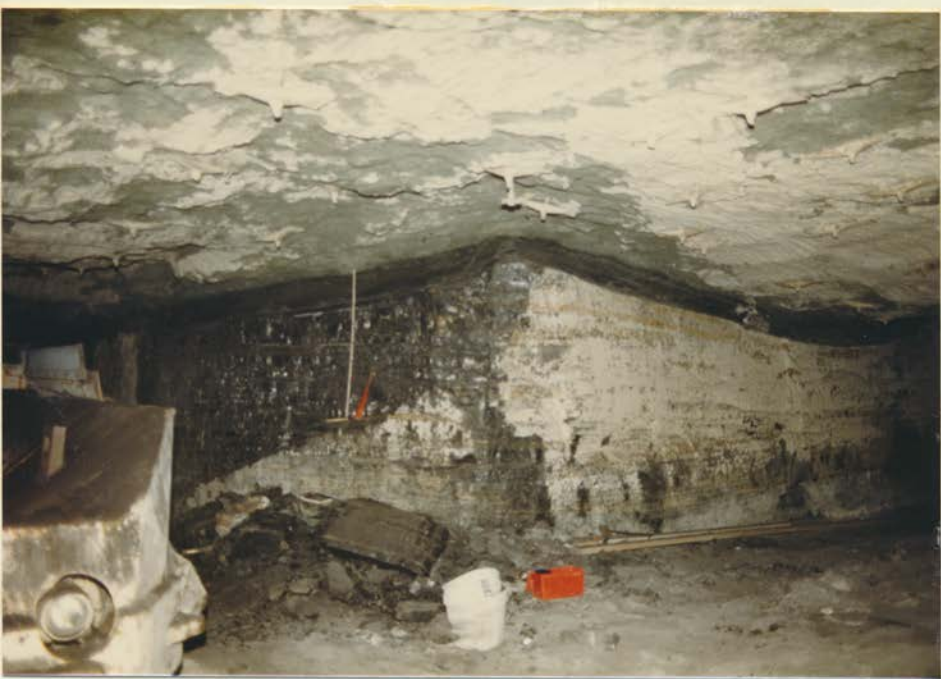
Same scene, different camera angle.

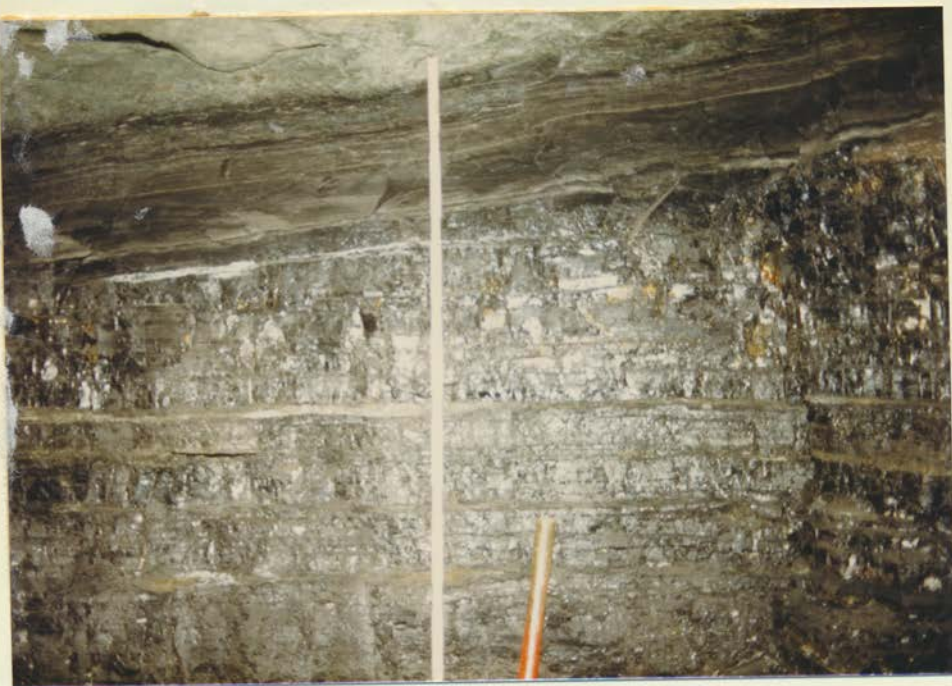
Same area. Thin layer of dull coal between bright-banded coal and roof shale. May be slight unconformity between dull coal and bright coal, suggesting that the former is transported.

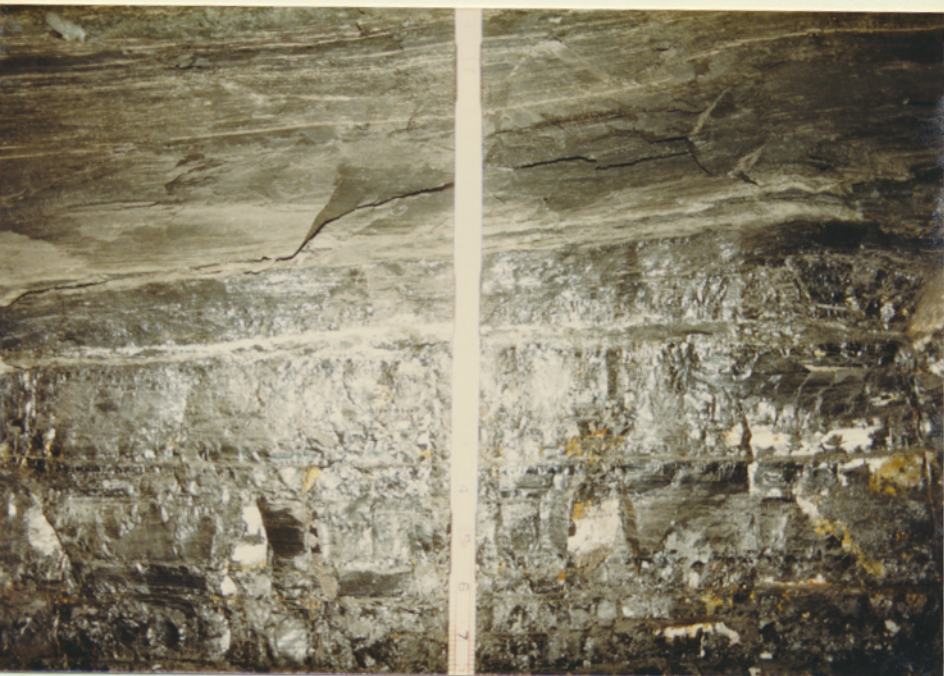
Closer view of same.

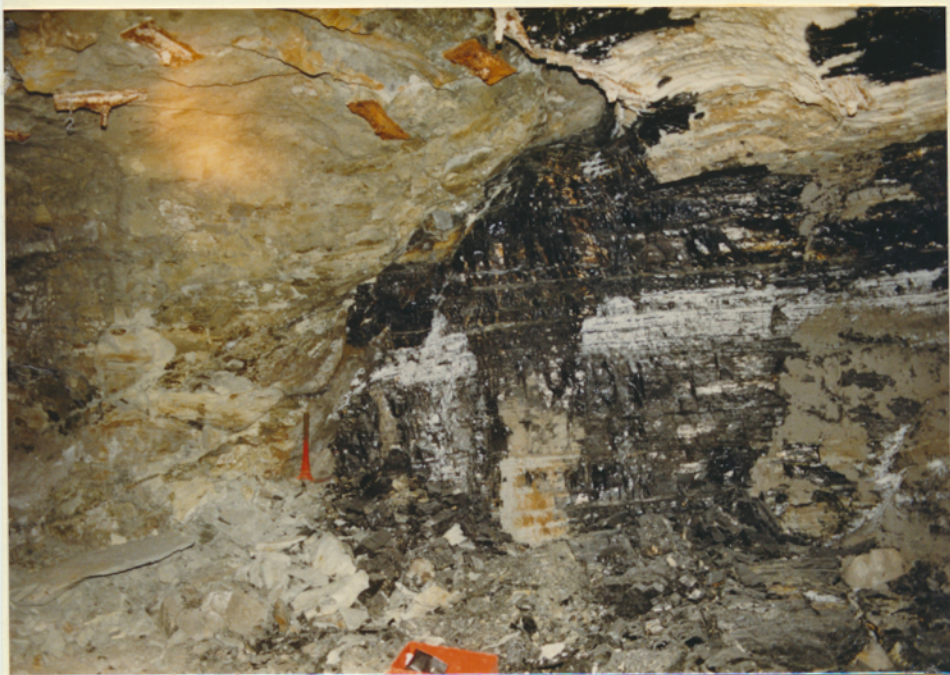
South part of mine; coal cut out in paleochannel. The cutout is steeply inclined and resembles a fault. Here the north margin of the channel is seen, in the westernmost entry that crossed it.

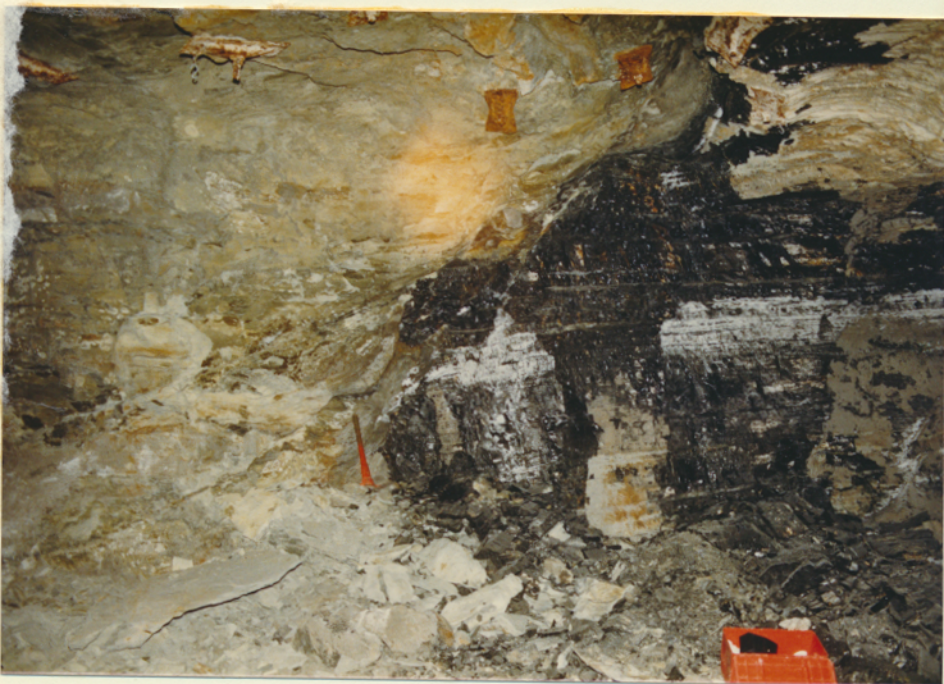
Same view. Bright spot in photo was from my cap lamp.

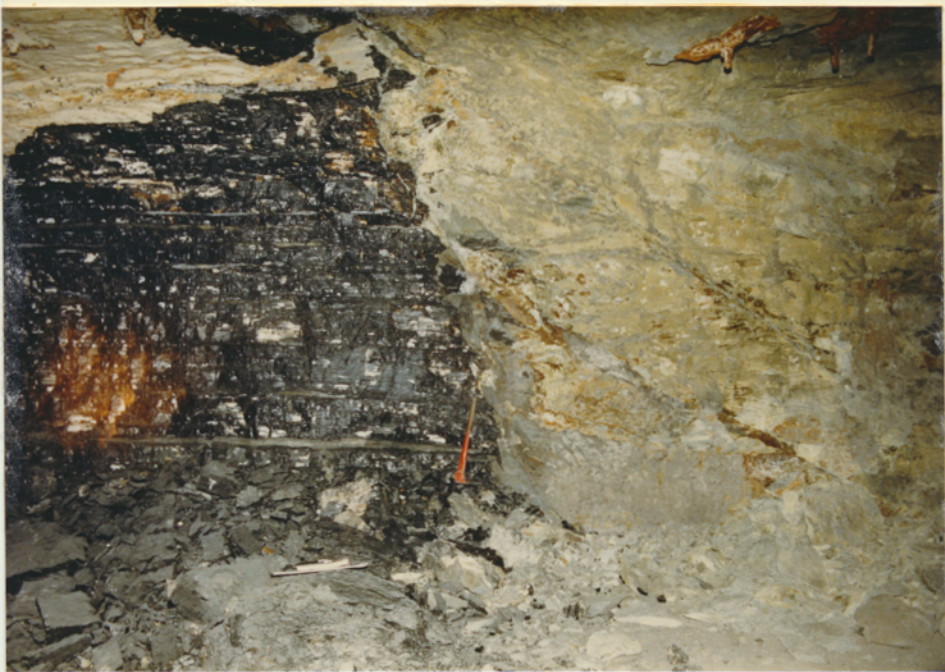
Margin of channel, opposite side of entry. Irregular contact of coal to siltstone, with fragments of coal incorporated into siltstone.

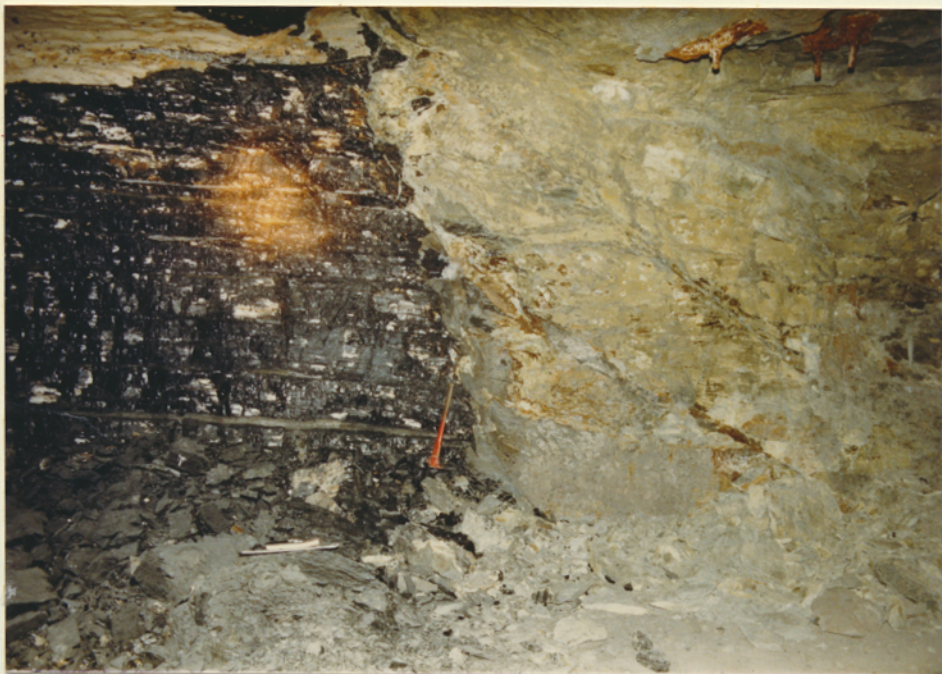
Same.

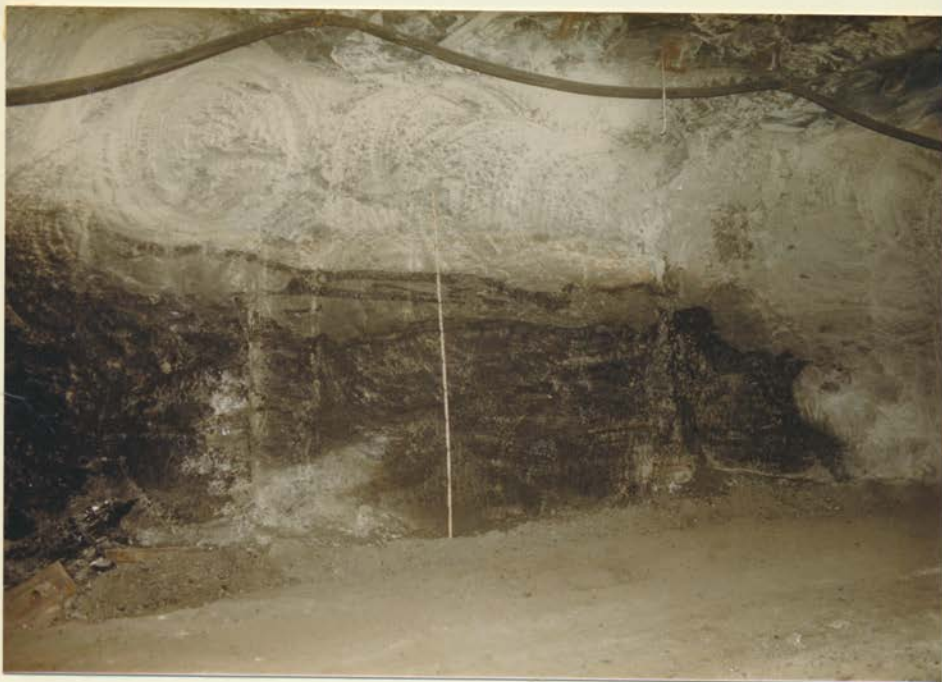
South margin of channel. Although the view is somewhat obscured by rock dust, irregular interfingering of coal and siltstone can be seen, along with lenses and stringers of coal within the siltstone. Presence of these indicates that coal was incompletely lithified when the channel was cut.

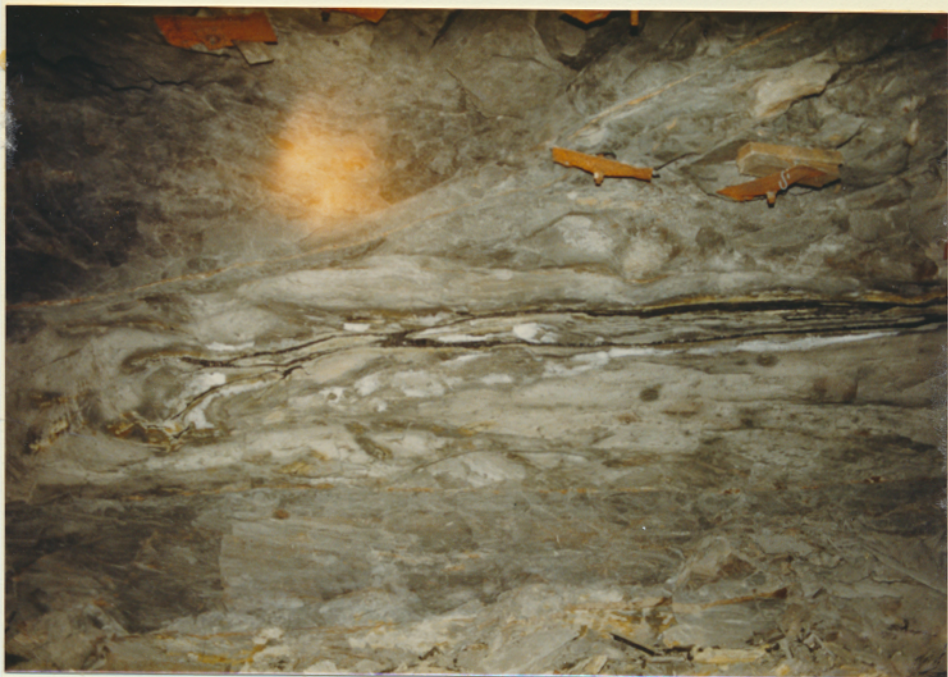
Views of channel filling. It is mainly a gray siltstone or silty mudstone containing thin laminae of sandstone and occasional siderite lenses. Here a large fossil lycopod log is found within the channel.

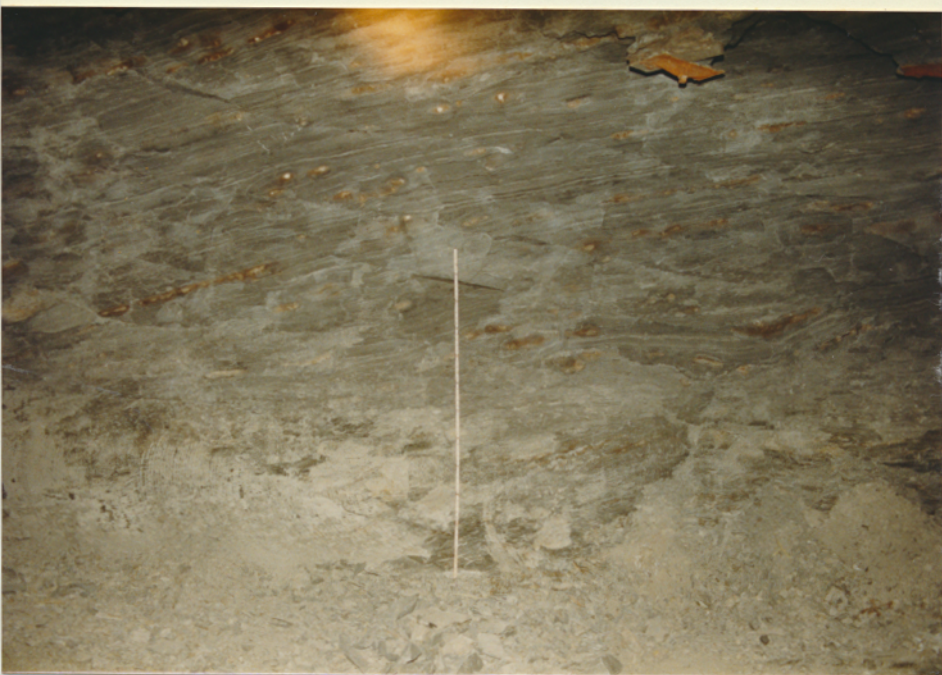
Sediments filling channel were considerably deformed; apparently they underwent slumping before lithification. Shown here, layering dips to north (left) and is offset by numerous small parallel low-angle normal faults.

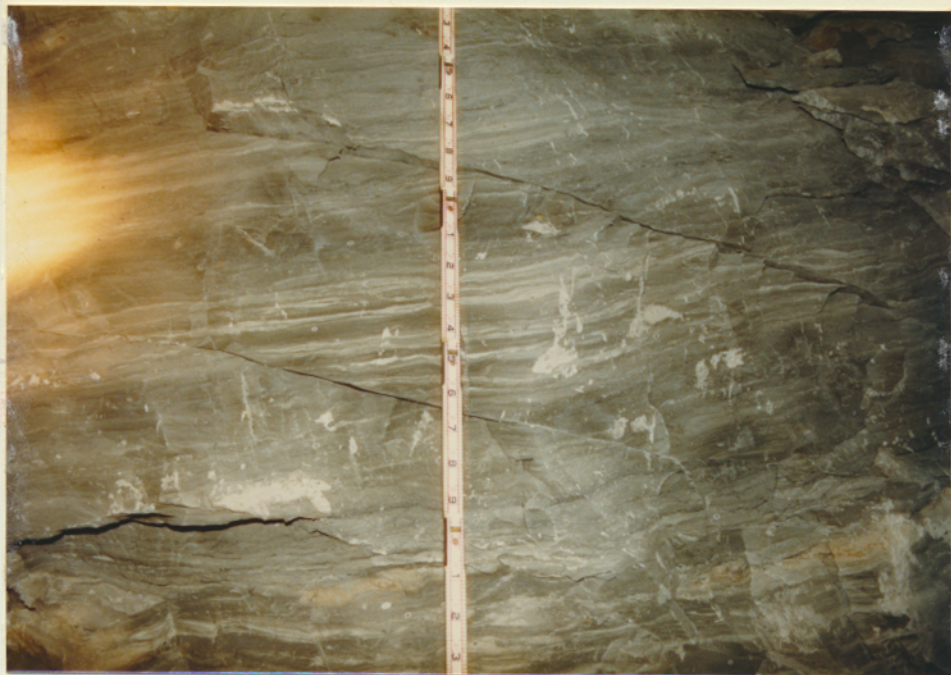
Closeup, showing faults

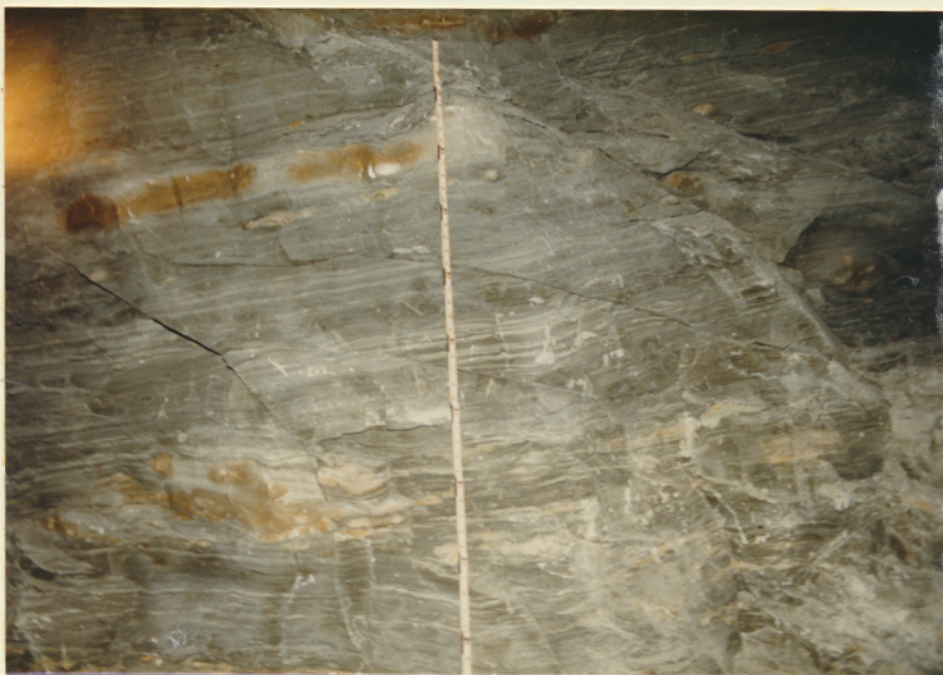
More of same

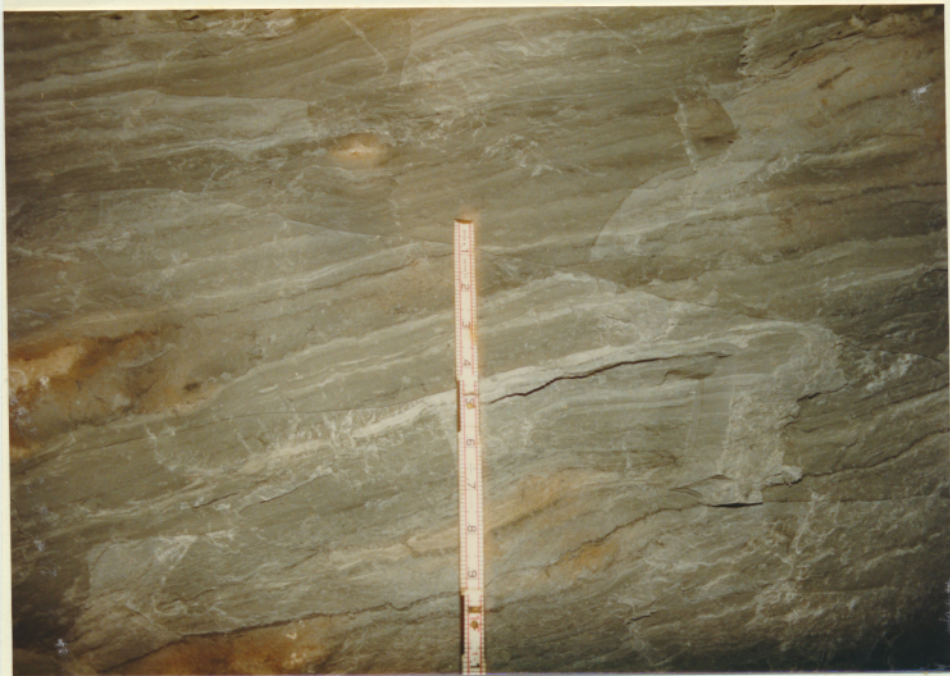
More of same
