Illinois Coal, Oil and Gas Co.

ILL. COAL, OIL + GAS CO.
(Strip Mine)

ILLINOIS COAL, OIL & GAS COMPANY MINE

Approx. center N.L., SE $\frac{1}{4}$ SE $\frac{1}{4}$ Sect. 1, T 9S, R 2E,
Williamson County. Notes by John Nelson 10/11/77.

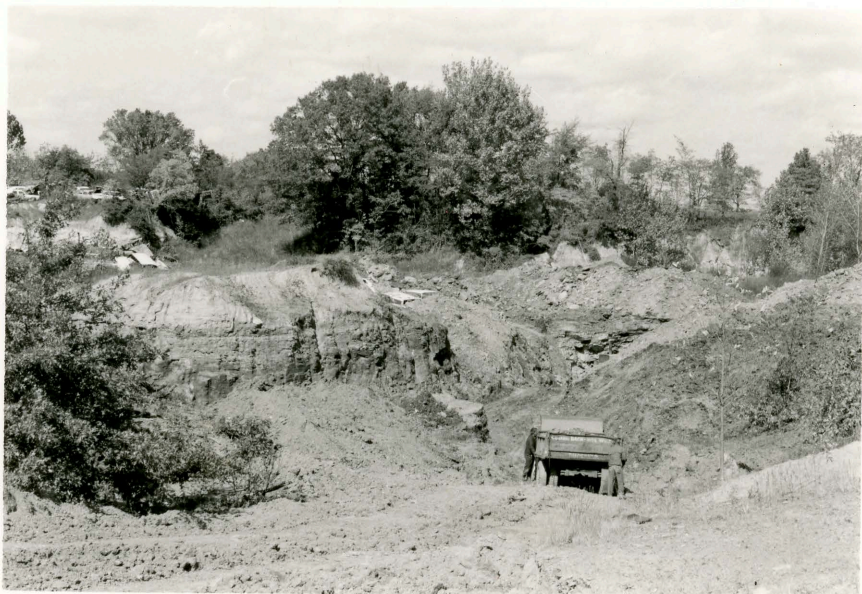
m. 46-001 tip

View looking north in Illinois Coal, Oil and Gas Co. mine. Dump truck is on incline into pit. The excavator is in the pit (out of view just above truck). Note junk cars in background.

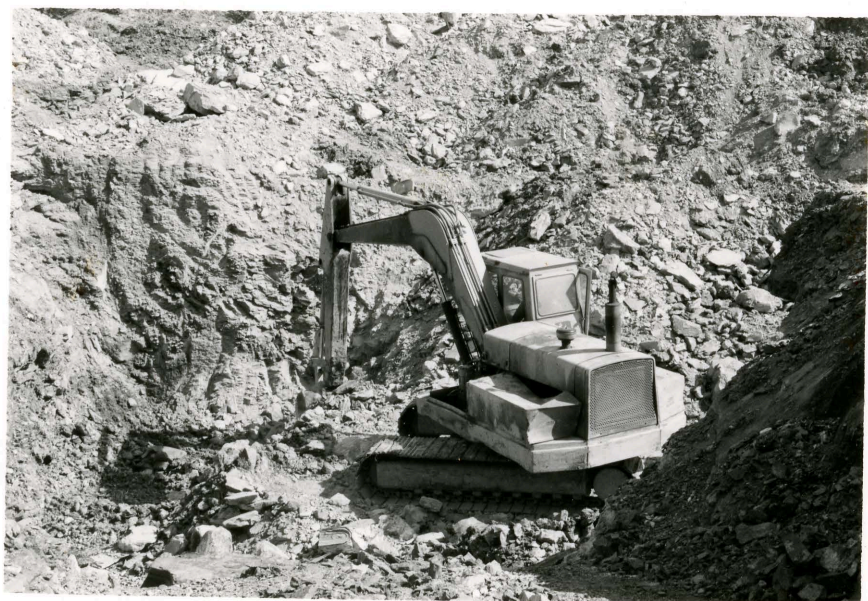
MA 46-002. P. 8

This John Deere 690-B excavator is the only piece of earth moving equipment in the mine. The top of the coal seam is just being uncovered.

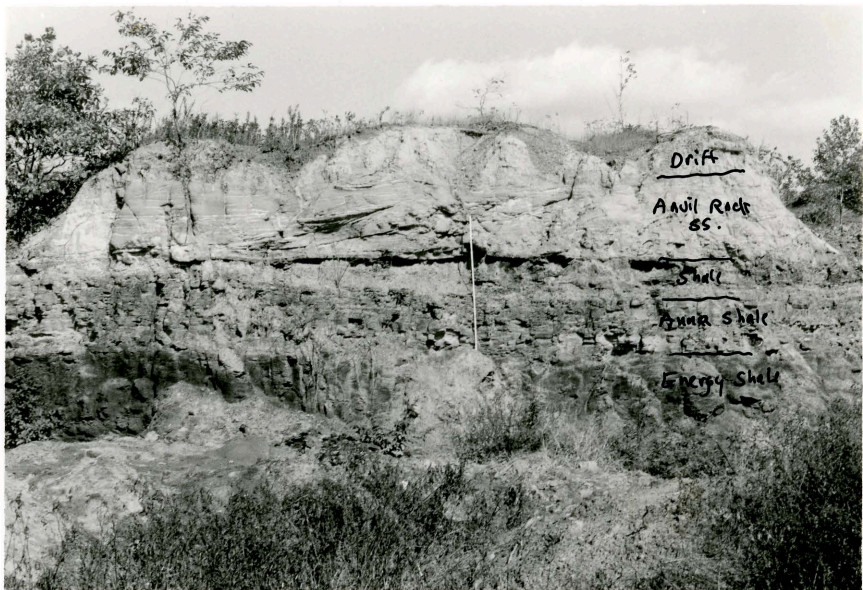
mn. 46.003.419

View of abandoned strip mine highwall just west of entrance to Ill. Coal, Oil and Gas Co. pit. Glacial drift overlies strongly cross-bedded Anvil Rock Sandstone in upper half of wall. Below the sandstone is about a foot of deeply weathered shale and 2.5 feet of black, fissile Anna Shale (base of ruler). Below this is the gray Energy Shale, which is about 17 feet thick in the active pit.

The Anvil Rock sandstone in this locality is extremely soft and friable and was quarried as sand. The quarry operation conveniently removed about half the overburden on the coal and has made coal mining possible without heavy equipment.

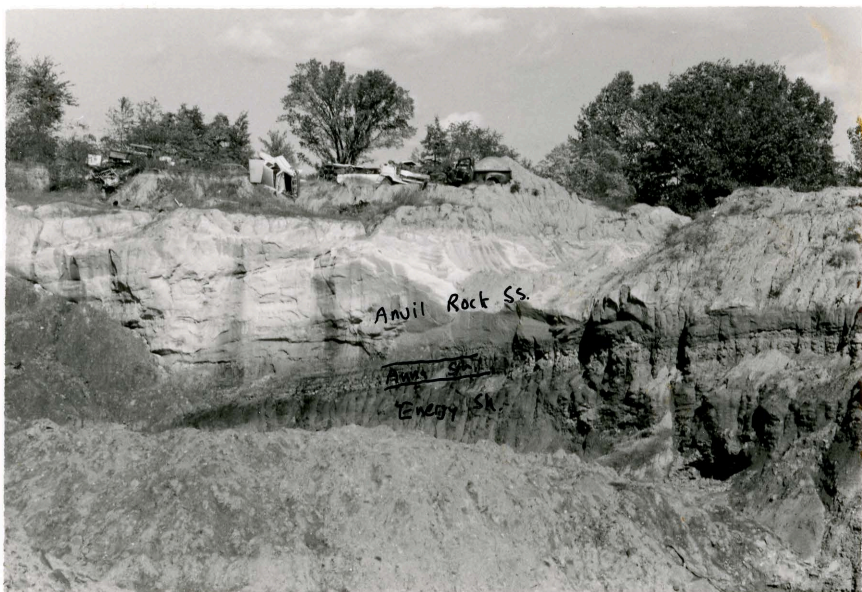
mn-48-004.119

View looking northeast in abandoned pit about 500 feet west of active pit. Top surface of Energy Shale dips to northwest (left) with corresponding thickening of light-colored Anvil Rock Sandstone above. The coal appears to lie level in the pit and the Energy Shale thins to the northwest, creating the apparent dip.

The Anna Shale appears to be continuous around the L-shaped highwall. The shale dips to the northwest at nearly a 10° angle. Below it is Energy Shale increasing from about 5' at the NE and SW corner to some 25' at the SE corner of the pit. This is only the exposed thickness and, because I cannot see the coal, I cannot tell the true thickness of the Energy Shale. However, I would guess from appearances that the coal lay roughly level and that the Energy Shale forms a wedge thickening to the southeast.

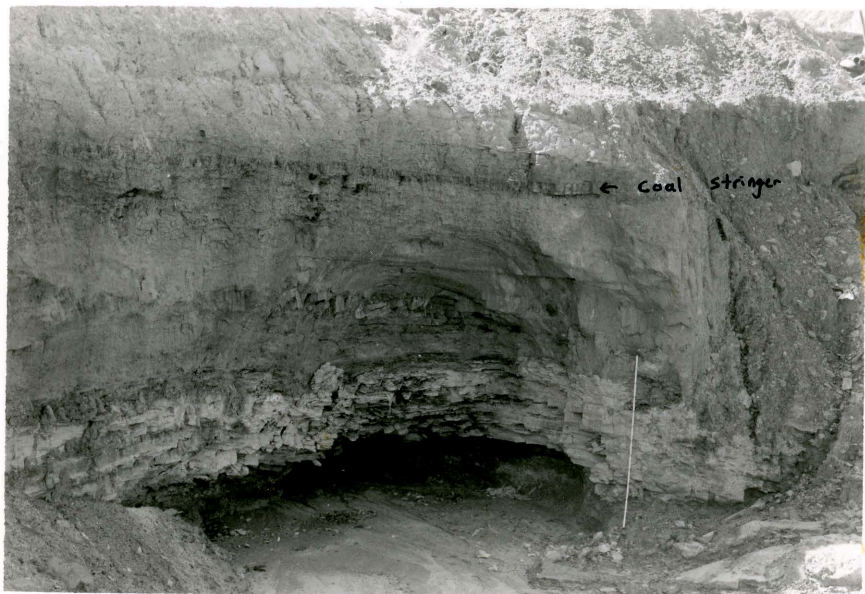
Partially caved abandoned underground mine opening in southwest part of old pit. In lower part of photo (ruler) are Energy and Anna Shales (weathered to light color and blocky appearance. Above the Anna Shale is some 12 feet of unconsolidated Pennsylvanian clay, silt, and sand, with stringers of coal. It is an unusual type of channel-fill deposit, from what I can see.

In several places around the highwall collapsed underground mine openings are clearly visible. The falls have generally stayed within the Energy Shale.

The layer of unconsolidated mud and clay, with coal, below the sandstone is most unusual. As noted above, were it not for the presence of the coal this could easily be Pleistocene deposits. It is hard to imagine conditions under which this could have been protected from lithification. Apparently it was deposited in a quiet water regime. This is especially indicated by the fine varvelike laminations seen in the clay.
