V-DAY COAL CO.

Mine Index No. ⁶⁹⁴ 1730
County No. 600
Coal Report No. L-220

VERMILLION COUNTY

CHAIN AND COMPASS MAP OF THE
V-DAY COAL MINE, Near DANVILLE, ILL.

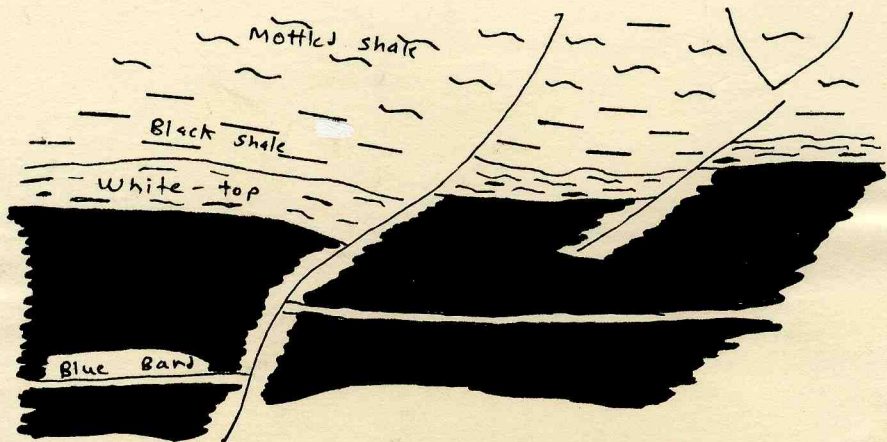
Prominent slips on North face of stub-crosscut 4, heading north off Entry 3.

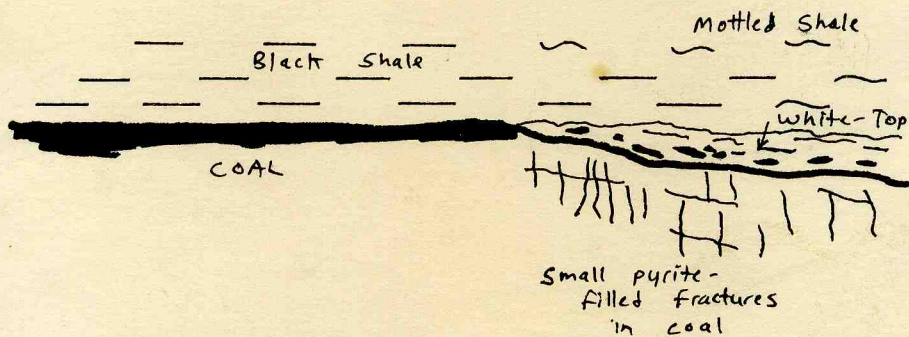
White-top in working face of Entry 2, showing how the normal straight, level upper contact of coal was eroded before White-top deposition, and showing pyrite-filled vertical fractures in coal below White-top.

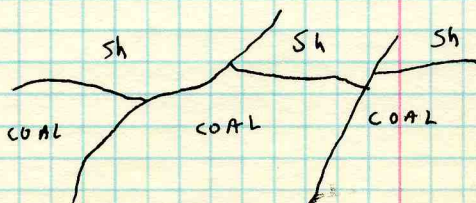
FIG 2

very thin 3.0'. Fault noted right on face. 1.5' displacement. See Fig. 2.

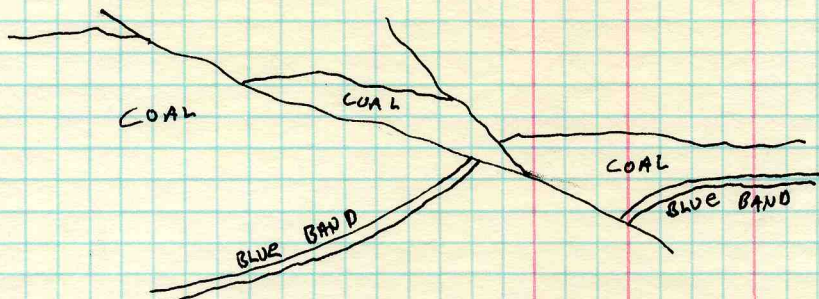
FIG 3

20. Here in the end of No. 3 entry, we have mottled shale roof as usual with numerous kettle bottoms. Coal as in 19 is overlain by weak carbonaceous shale then black shale and usual sequence. Fault noted: Maybe some fault is over in cross cut to 4. See Fig. 3.

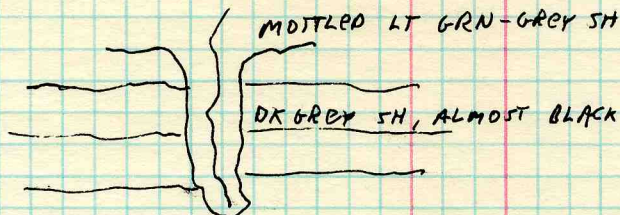
FIG 2.

5. See Fig. 2. Roof

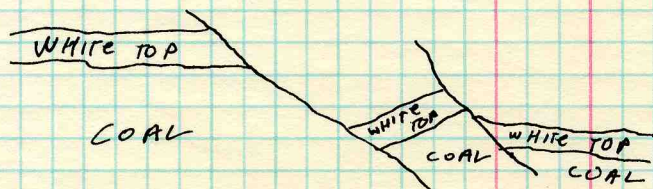
FIG 7 WHITE TOP W/SLIP

Big slip running from point 18 out into crosscut.

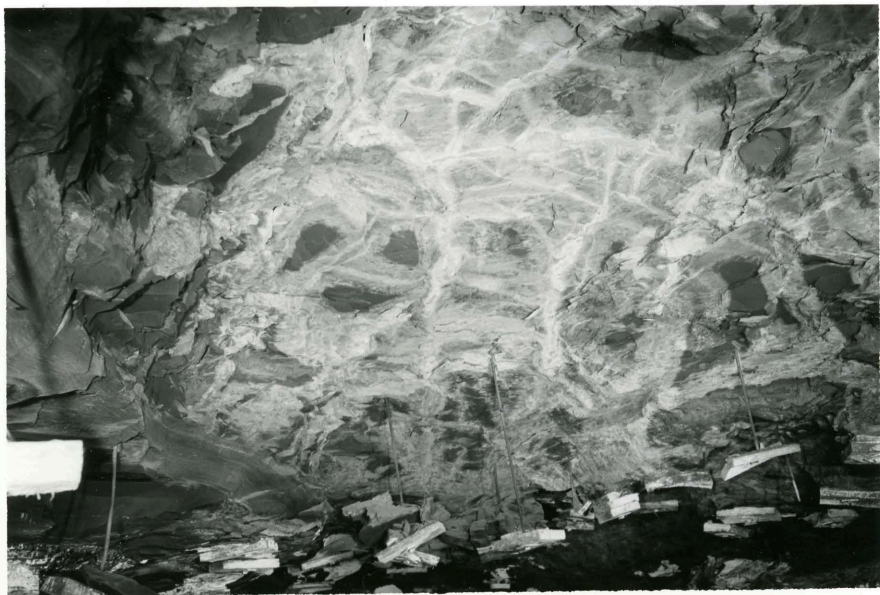
Photo 3 ↑

- 3) Fall, showing patchwork mottling of shale and synaeresis cracks. Probably in Entry 1.
- 4) Fall, showing synaeresis cracks in side view, and calcareous concretions (at level of hammer.) Probably located on slope entry just off the bottom.

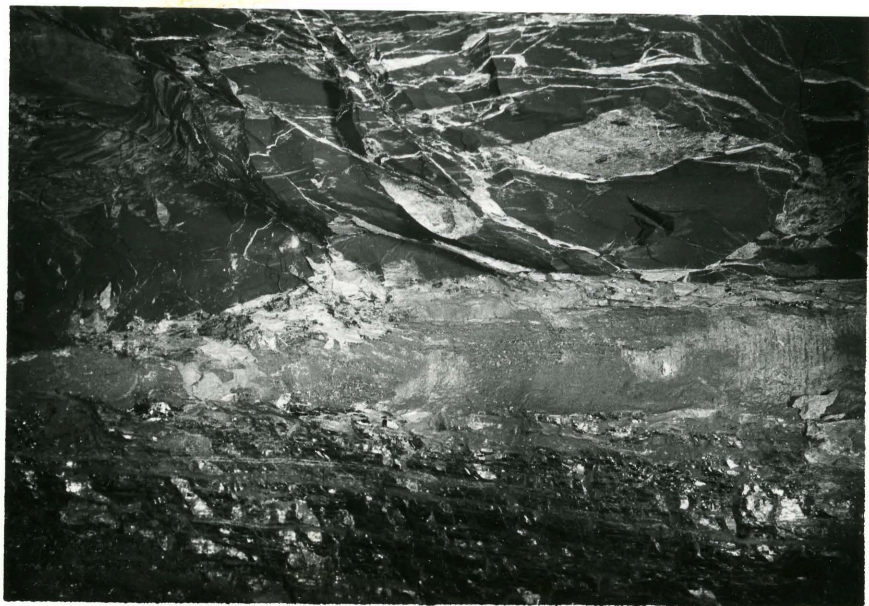
Photo 5

- 5) "White-top" above coal, and clay-filled fractures in black shale. Location unknown.
- 6) "White-top" in close-up. Somewhat out of focus.
- 7) Normal succession of roof strata. From coal upwards; black smooth shale, then gray or greenish shale, then weak, mottled shale with synaeresis cracks and calcareous concretions and inclusions.

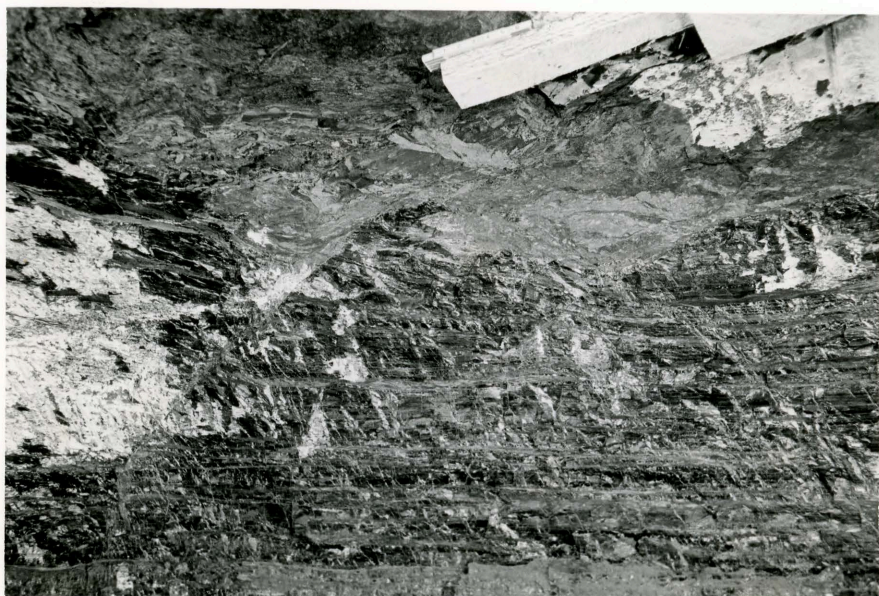
Photo 8

- 8) "White-top" and small faults displacing the coal. Clay intruded along bedding planes. Location not known.
- 9) Close-up of above photo.
