CRENSHAW COAL CO. MINE NO. 1

MINE INDEX NO. 972

CRENSHAW COAL CO. MINE NO. 1 November 9. 1978

Notes by John Nelson on visit with John Popp.

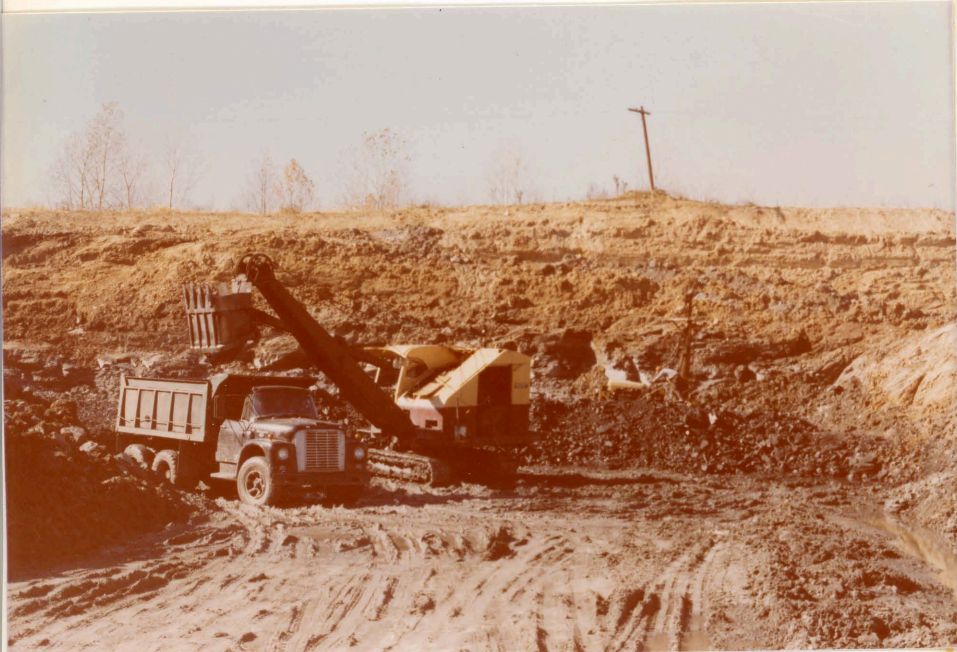
mn\_44-001.tif

Small shovel loading Harrisburg (No. 5) Coal into dump truck at Crenshaw Coal Co. No. 1 Mine. Highwall in background includes about 10 feet of gray shale overlain by glacial drift. Photo by. J.N., 11/9/78.

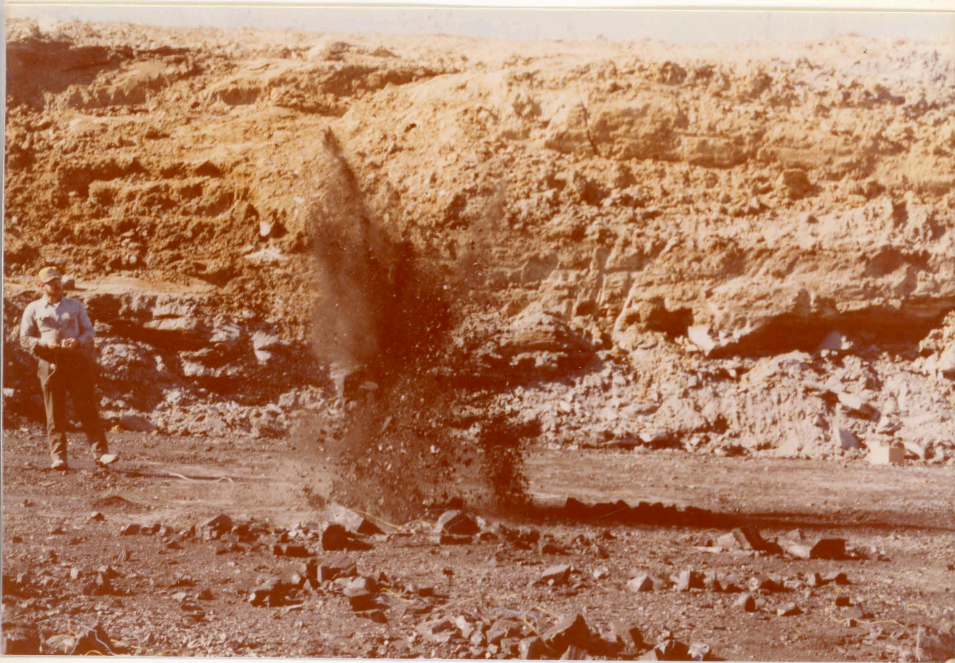
mn\_44\_002.HP

Firing a charge of powder to break up the coal at  
Crenshaw No. 1. Photo by J.N., 11/9/78.

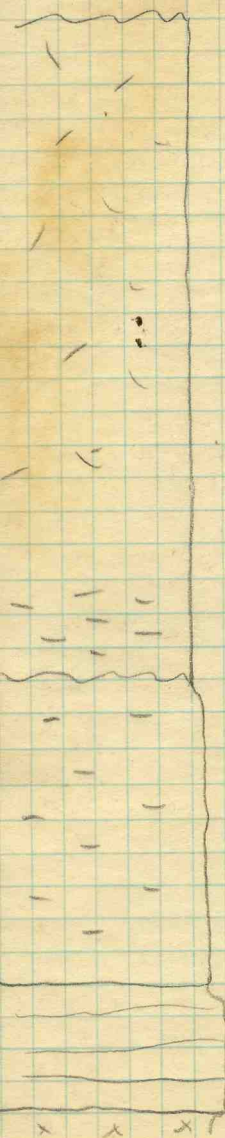
Surface, ~20' weathered shale at bottom,  
clay and unconsolidated material,  
undifferentiated

Shale, 10', med. gray, smooth, loaded with  
pyritized siderite nodules, in firm, slabby,  
incompetent, well jointed

Coal, Harrisburg (No. 5), rib, cleat 158 (face)  
and 030 (butt) is well developed and  
blocky, calcite and some pyrite on surfaces.

The mine is working in the Harrisburg (No. 5) Coal, which is about 4' thick and is overlain by about 10' of gray shale and another 20' of weathered shale. See columnar description on the next page. The gray shale overlying the coal reminds me of the medium gray shale facies of the Energy Shale, although this shale isn't as silty.

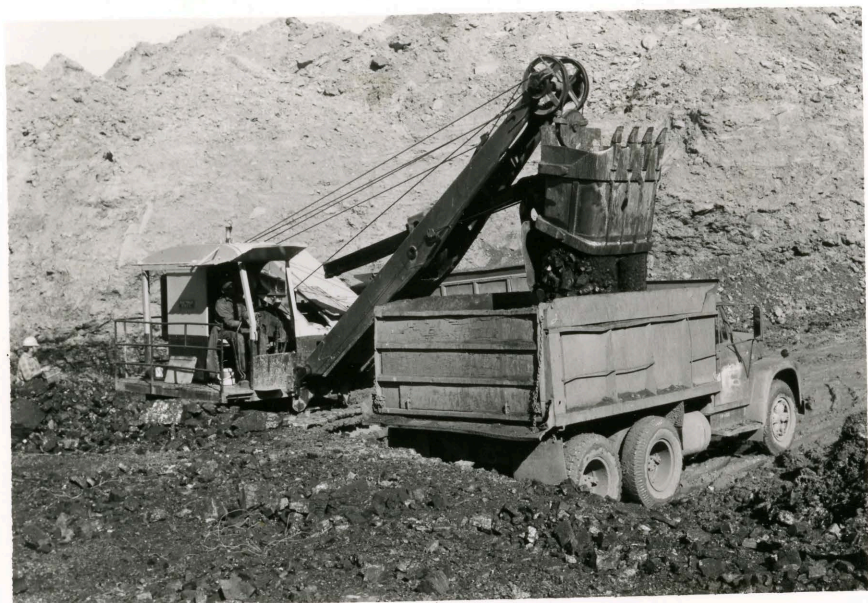
m-44-003.tif

Cronshaw Coal Company, Mine No. 1  
Williamson County  
November 9, 1978

Modern mining equipment in action! Russians,  
take note!!

This is a very small operation, and their equipment includes one dragline, several dozers, one old coal shovel (see picture), and several dump trucks.
