PEABODY COAL CO.
MINE # 10

County No. 238
Mine Index No. 693

COAL MINE—PRODUCTION

ILLINOIS GEOLOGICAL SURVEY, URBANA

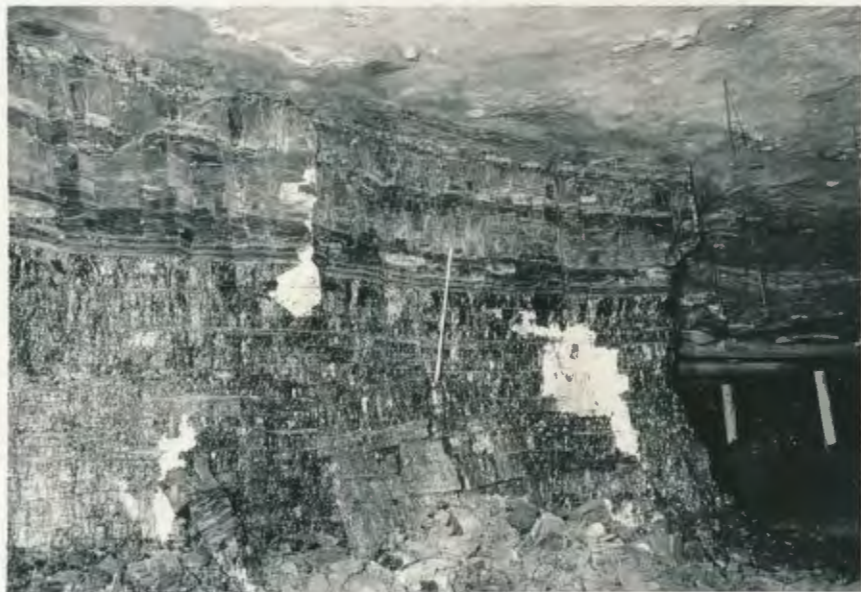
Black shale above coal, the Anna Shale Member, showing well-developed joints. Prominent joints run about 100° and are spaced 6-10" apart; subsidiary joints trend about 045° . This place was mined in 1965 (nine years prior to visit).

Note how all of shale has fallen, exposing limestone "caprock" with dangling roof bolts.

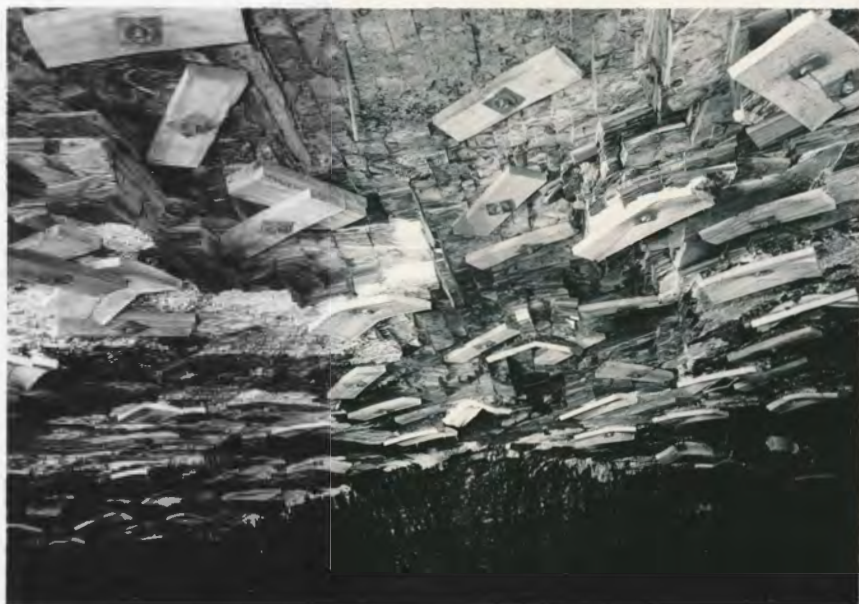
Mn-02-002.tif

Prominent jointing in black shale roof. Trend of joints about 100 . Minor slabbing of roof along joints between header boards.

Location: # 3 Entry, about 750' from shaft. Looking NW.

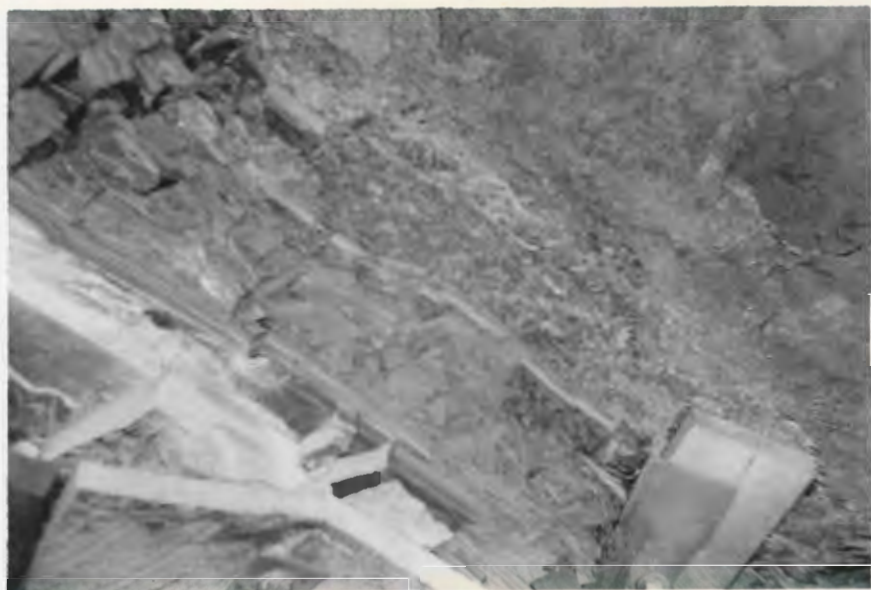
M7-02-003.tif

Anna Shale, about 1.5' thick, with 0.5' heavily burrowed zone near top. Shale with burrows is weak.
Location: About 850' from shaft, looking NNE.

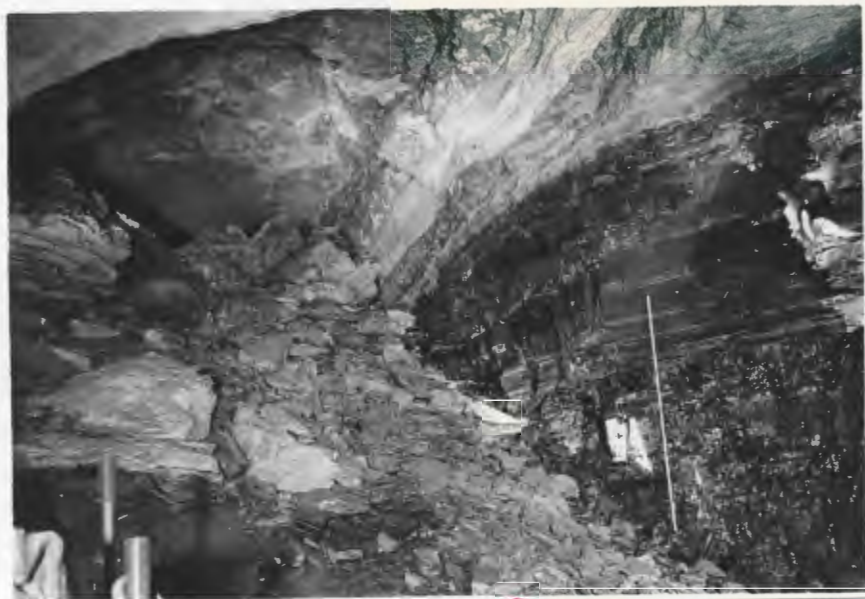
Mn-02-004, RJD

Roof fall exposing the following rock sequence:

Location: About 1000' from shaft looking north.

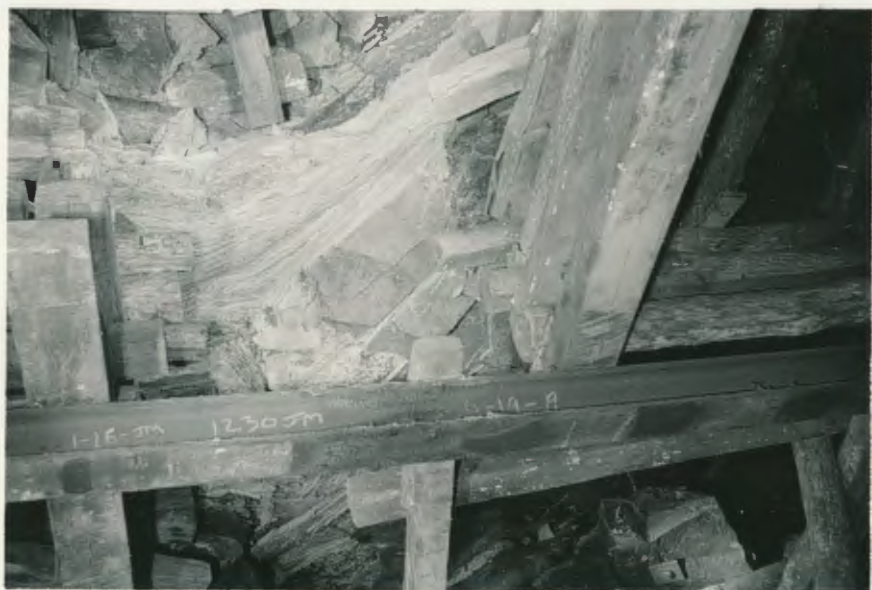
MN-02-005.HP

Roof fall exposing about 3 ft. of thin-bedded sandstone (probably Anvil Rock) with numerous shale interlamination. Bedding thickness ranges from $\frac{1}{4}$ - $\frac{1}{2}$ ". Below is about 2.5' of Anna Shale.

Location: 450' from shaft, looking SW.

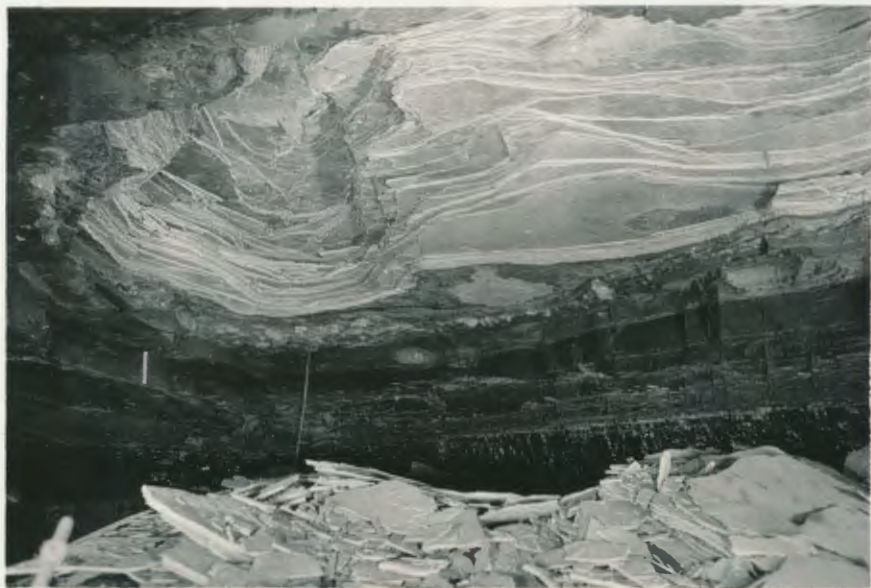
Mn 02 006.tif

Another view of fall in previous photo showing typical failure pattern in thin-bedded sandstone. Below sandstone is 6-18" of limestone with large oval concretions, and about 2' of Anna Shale. (Damberger calls the limestone Brereton, but the large oval concretions are typical of the Conant Limestone in this region. The sandstone is probably the Anvil Rock Sandstone).

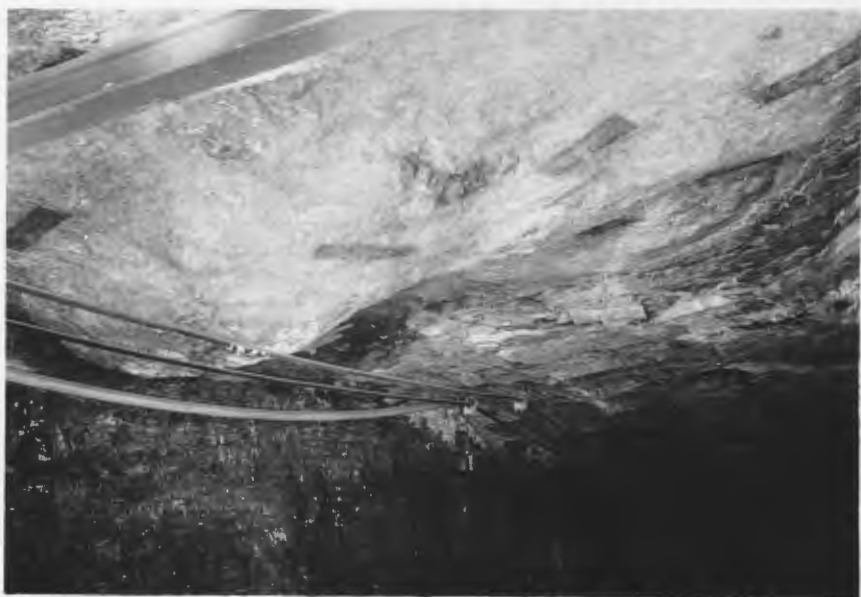
Mn-02-007.tif

Brereton Limestone "boss" protruding down into coal, and displacing Anna Shale, which varies up to a foot thick in this area.

Location: 6th Entry of 5 $\frac{1}{2}$ West, west at top of "hill."

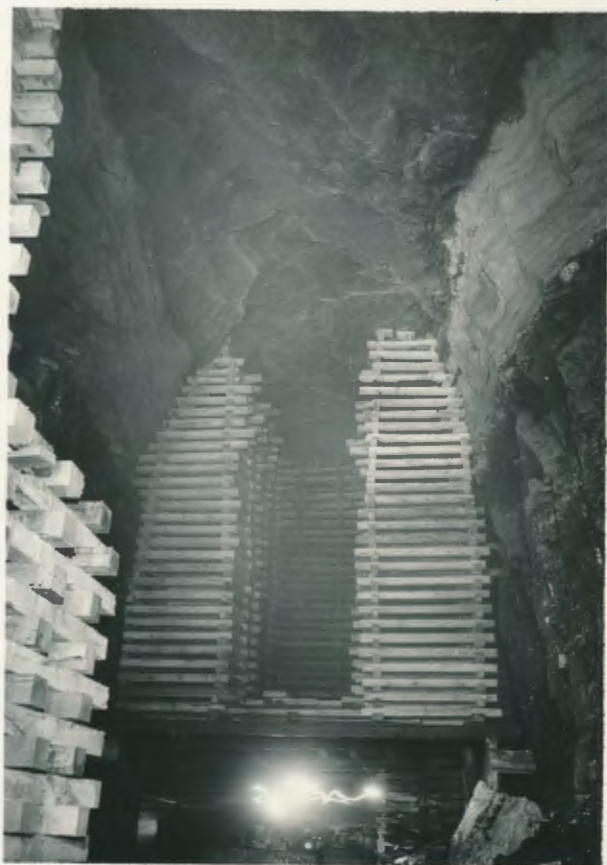
Mn 02-009.tif

Massive cribbing in the 35-foot-high roof fall at the bottom of the syncline, where the coal is up to 13 feet thick.

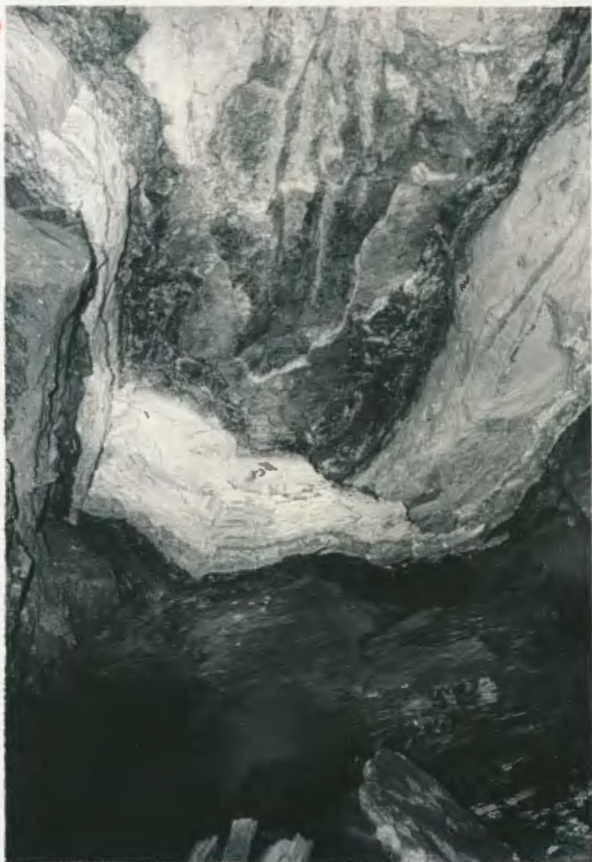
Mn_02-010.350

Another view of same fall.

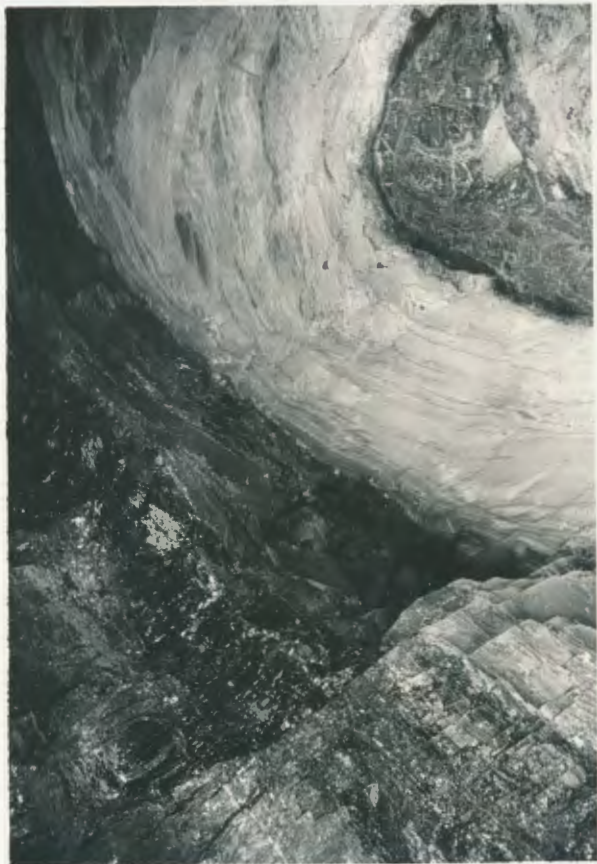
Mn-02-011.tif

Large fall exposing about 6 ft. of dark gray silty shale overlain by 10 ft. of sandstone. Camera appears to have been tilted at a 45-degree angle.

Location: 6th Entry just south of previous photos.

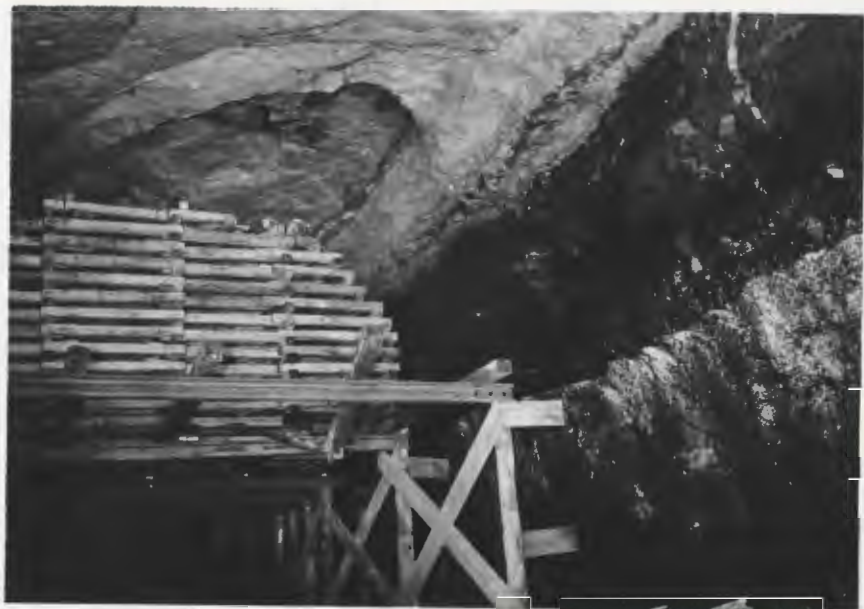
Mn-02-012.tif

Cribbing in roof fall.

Location: 5th Entry, 1st Main South off 5½ West,
1500' S of 1st E turn.

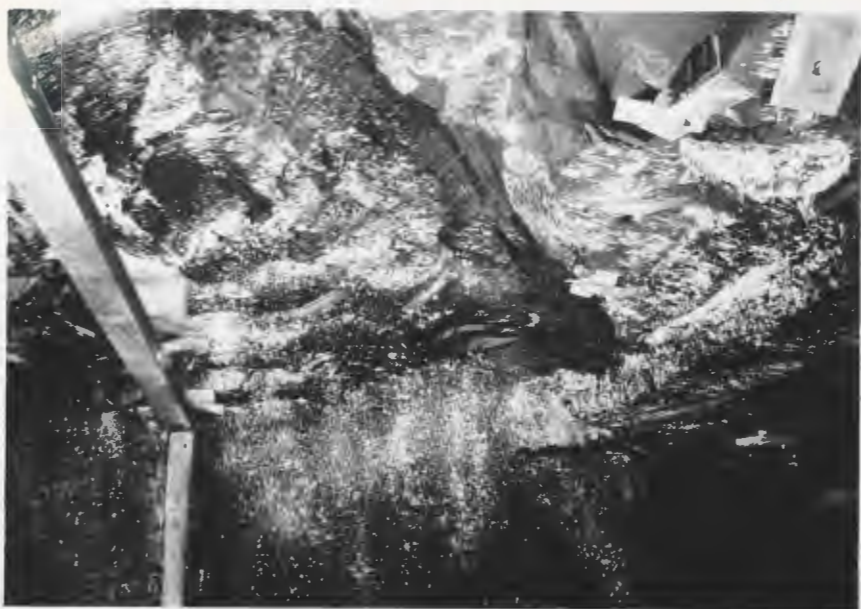
Small fall along slip trending about 100 in
black shale, which is about 5 ft. thick here.
Location: #5 Entry, S 1000' from 1st E.

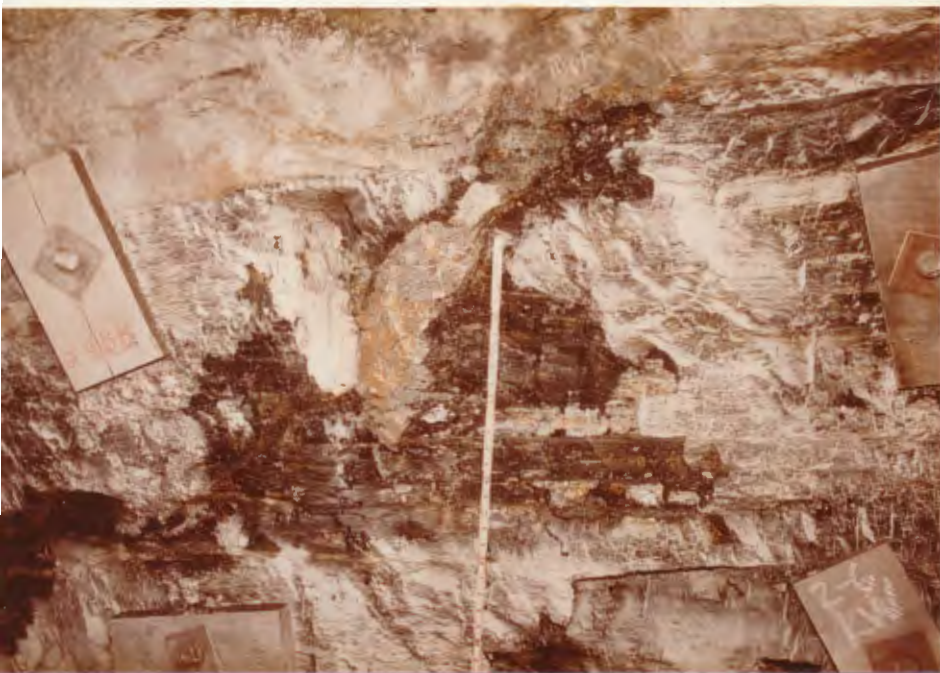
MN-02-014.t.p

Peabody Coal Company - Mine No. 10 - Photo 1- Sandstone dike in Herrin Coal.

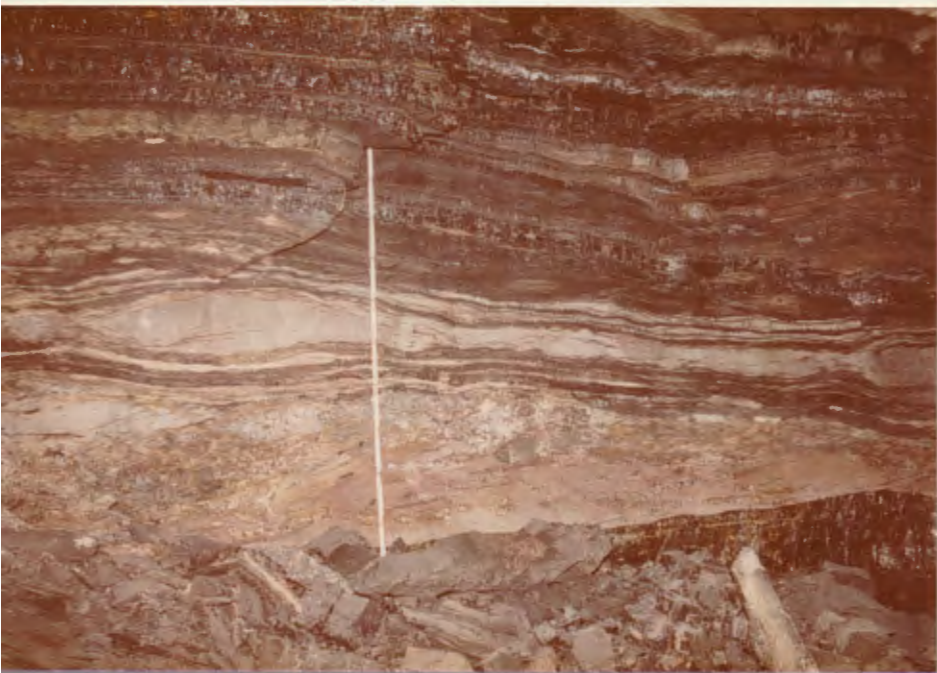
Photo 5. Channel-fill deposit.
