Old Ben Coal Company- Mine No. 27

Old Ben Mine No. 27
(Underground)

Mine Notes - Old Ben No. 27, Franklin Co., Ill.

Old Ben Coal Co. - Mine No. 27, April 15, 1982.
 Notes by John Nelson with Phil DeMaris - Jim Minton
 from Old Ben.

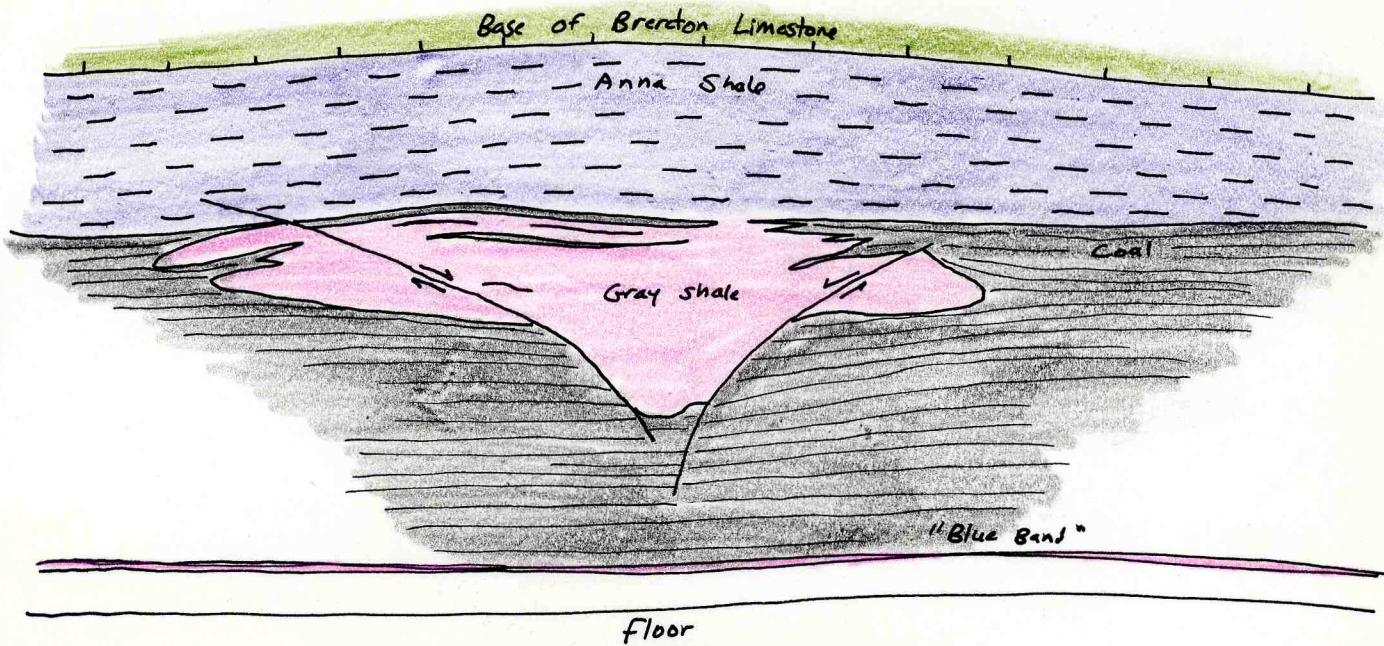
Roll is about 10 feet wide

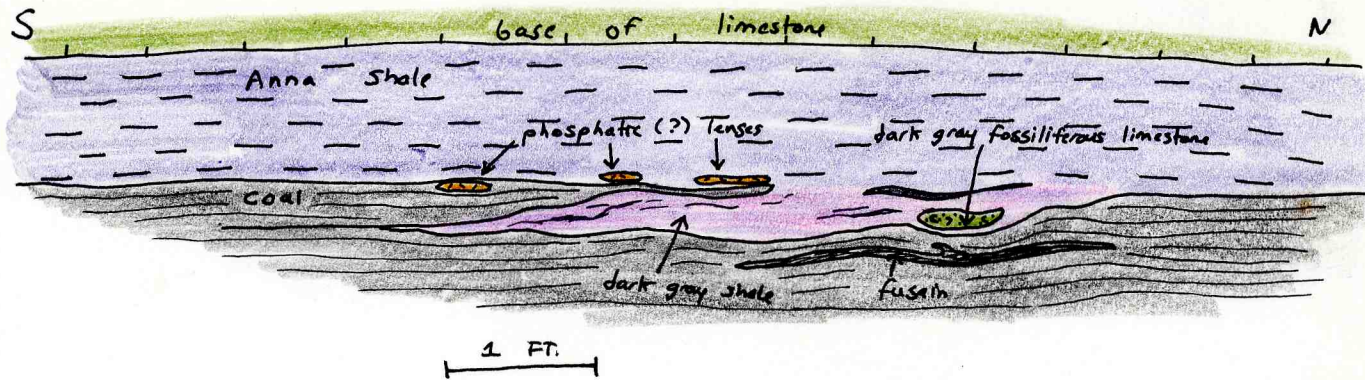
STOP 4- sketch of west rig
 where last remnant of roll
 is seen.

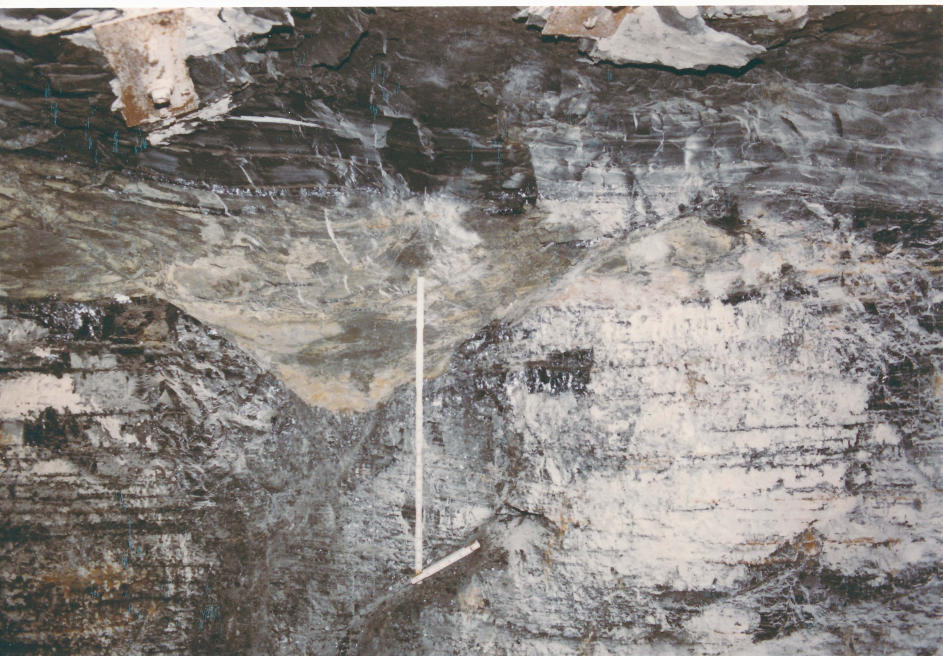
Roll at Stop 4; compare with sketch. Depression in top of coal seam, filled with yellowish-gray shale containing stringers of coal, and overlain by black fissile shale.

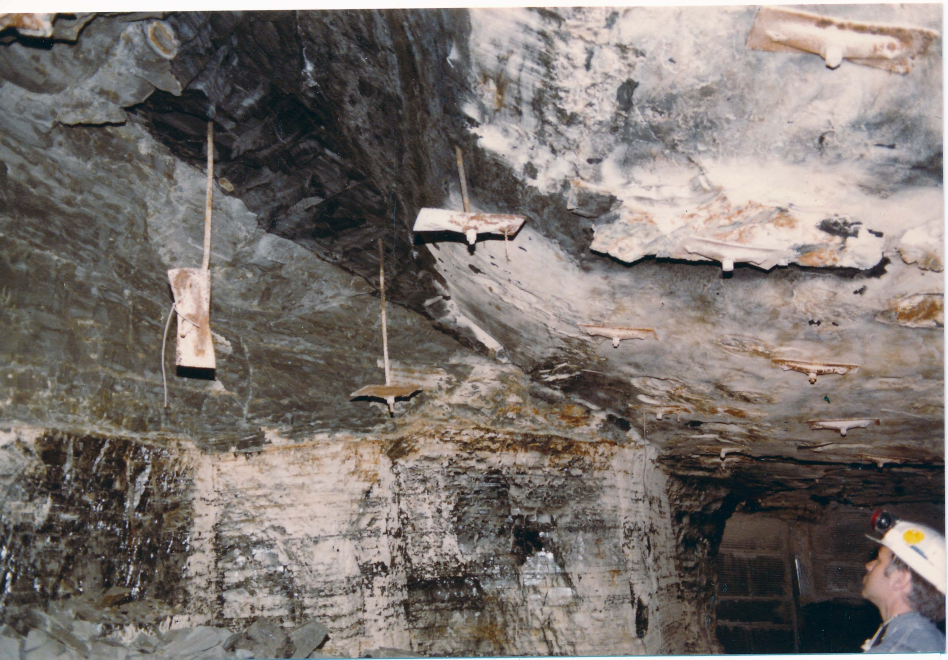
View at Stop 6, showing the angular unconformity between the black, fissile Anna Shale (right) and gray, horizontally bedded Energy Shale (left). The erosional surface dips eastward at 22 degrees.

The angular unconformity observed at Stop 6 suggests that this is an erosional remnant of Energy Shale that is preserved because it was deposited in a depression in the top of the peat. The depression in the peat in turn was due to scouring away of the top layer of peat before the gray shale was deposited - or alternatively, the gray shale is in part contemporaneous with the peat.

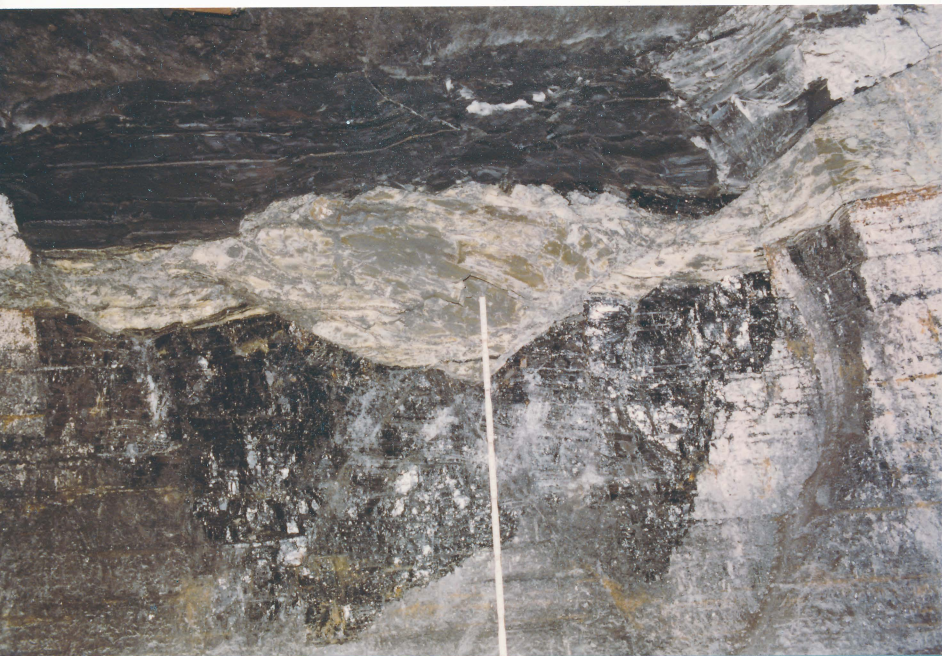
Roll at Stop 9. In the vicinity of the ruler, the bedding of the soft, yellowish-gray shale filling the roll appears to dip toward the right (west) at roughly 15 degrees. The top of the roll and the tilted edges of the beds are truncated at the base of the Anna Shale.

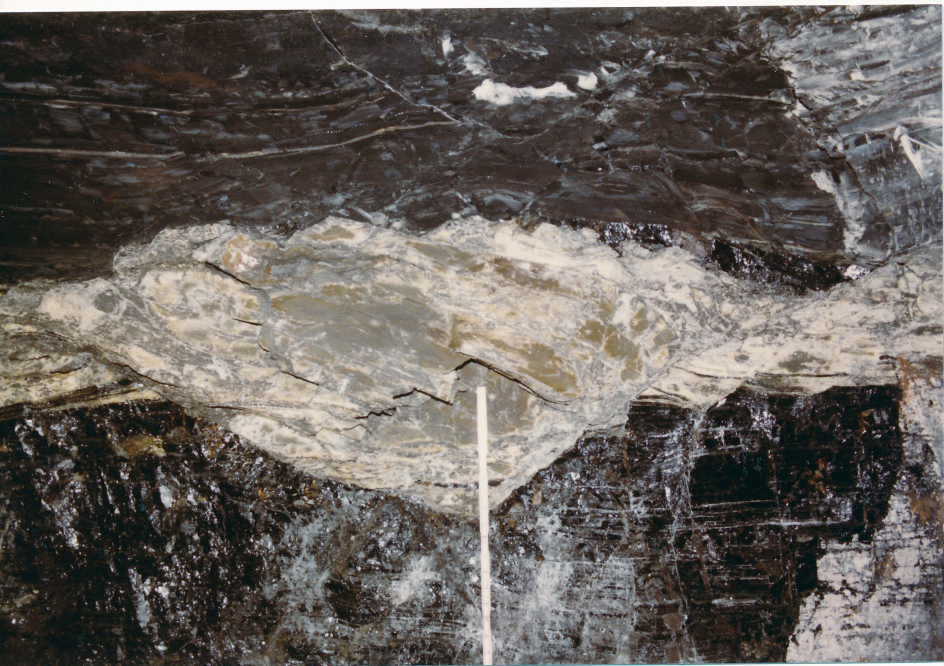
Closer view of roll at Stop 9.

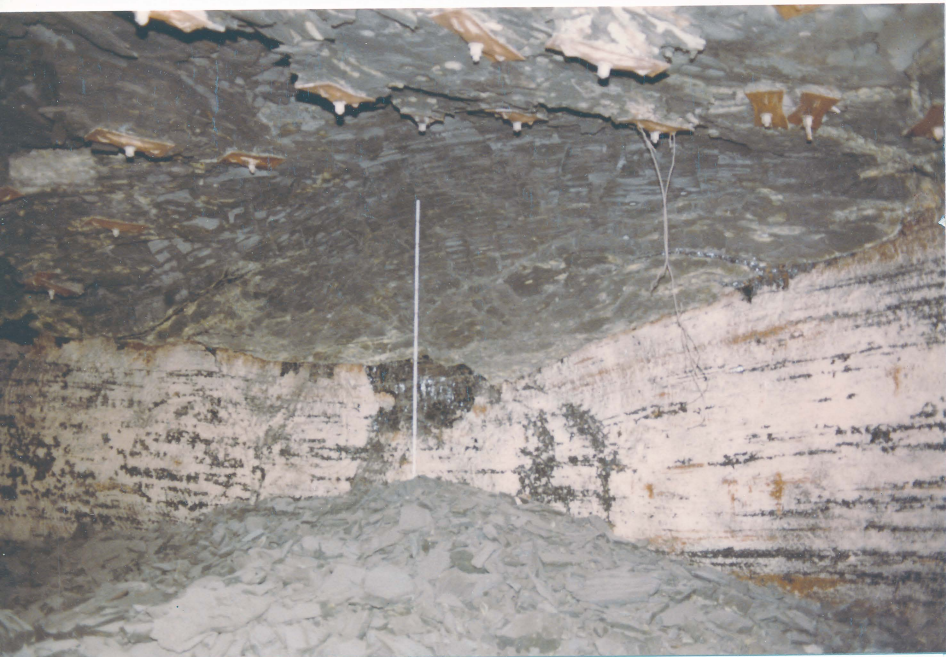
Large roll at Stop 12; compare with sketch. This roll, and the overlying rock, are entirely gray shale. The rolls shown in the other photos must have resembled this originally, but in an episode of erosion most of the gray shale was removed. Only the shale down in the depressions escaped erosion before the next unit, the Anna Shale, was deposited.

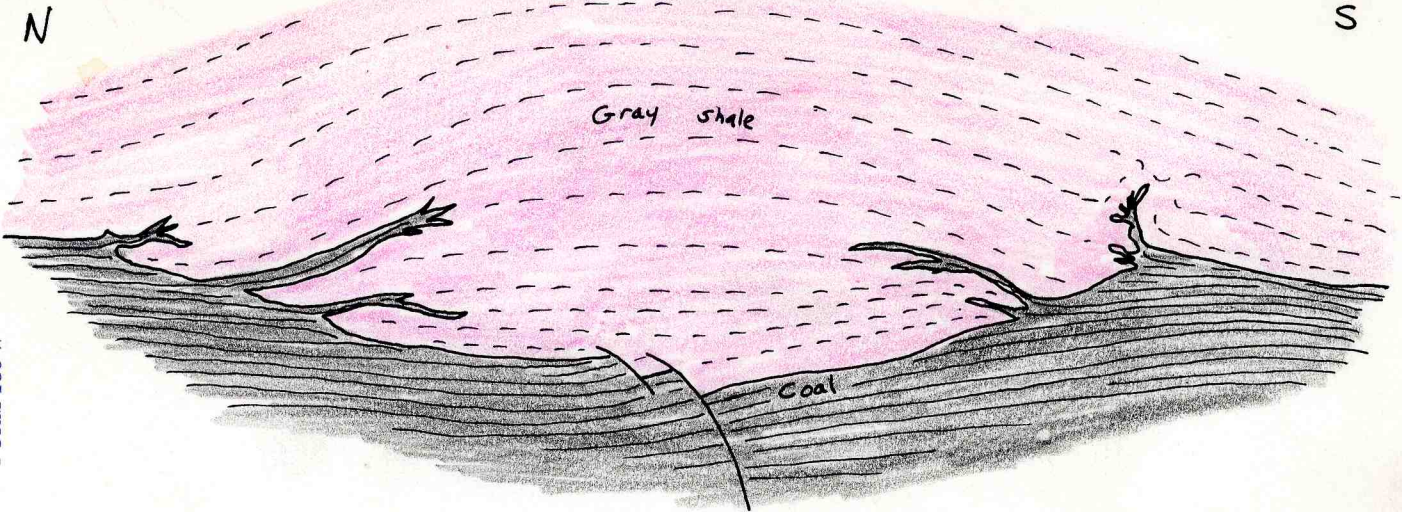
STOP 12 - EAST RIB

Width of view about 20 feet.
Depth of roll somewhat
exaggerated relative to width.

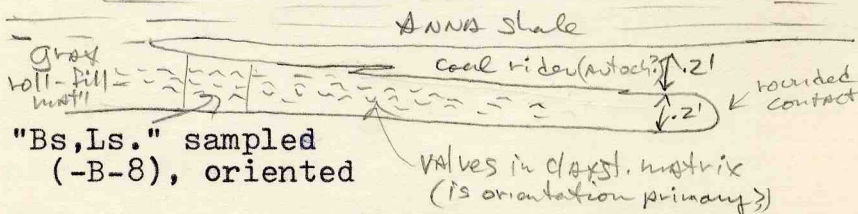
H. Edge of erosional roll seen on N. side of pillar. Fossil-rich claystone (a.k.a. "bastard limestone") appears to be injected 5 feet along peat/coal bedding plane, or at least remobilization of deposited material pressed along bedding. Key feature in diagnosis is the rounded contact to coal. Sketch:

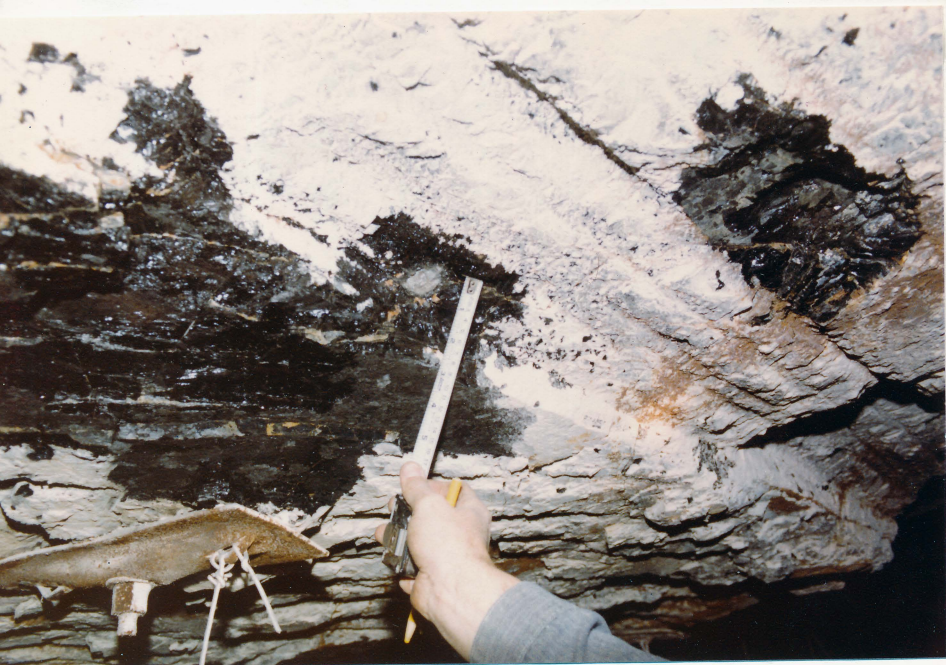
Site G₁. Bioturbation trace in top of Henric,
now heavily pyritized, but prob. began
as calciferite. About .09' down (me.).

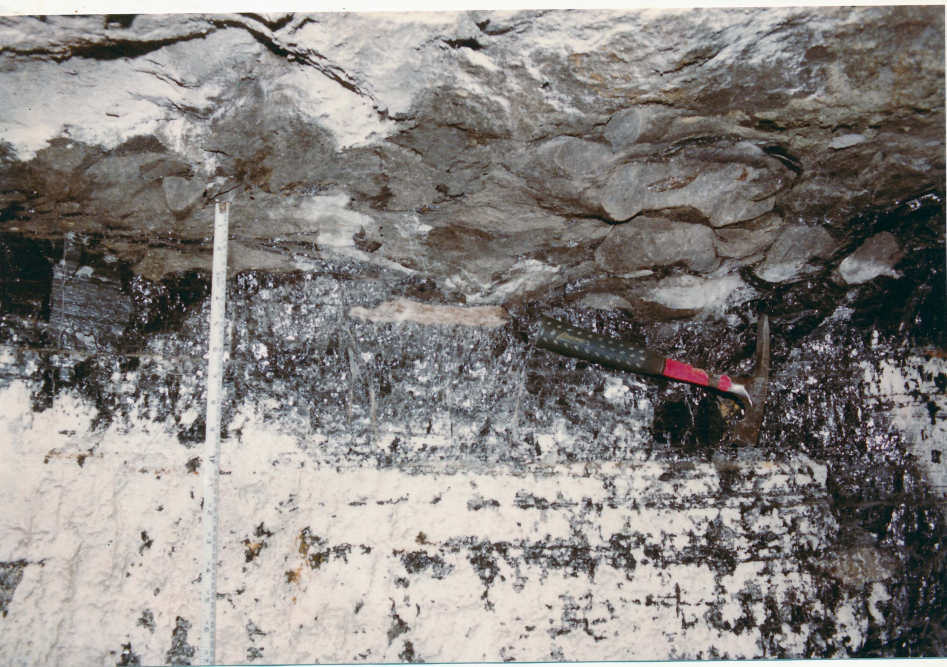
Nelson's Site 3

Tubi-Dorm masses at base of Breketon and into top coal. Believed to show mechanism that produces "mixed coal balls" by introduction of fine mud into peat. No mixed c.b.'s seen here; one at hammer head appeared to be normal. For mixed coal balls see next visit.

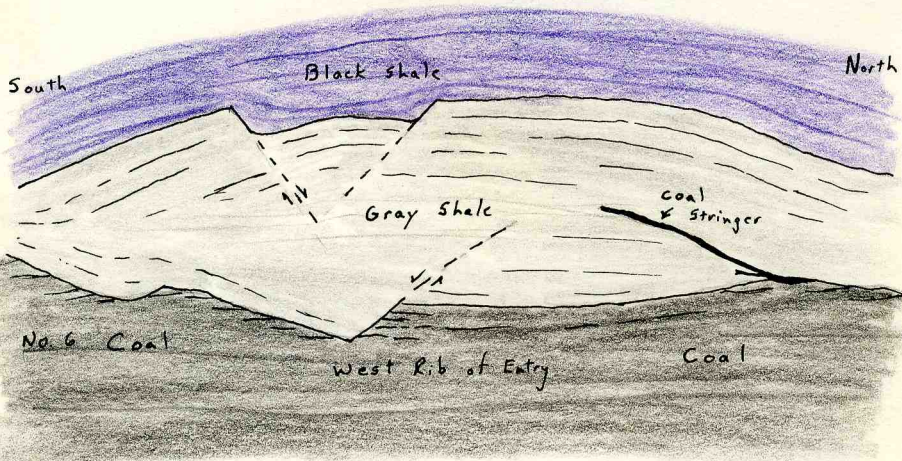
Stop #3: Mega-roll: Roll is about 40' wide, 5' thick, and displaces about 3' of coal. Roll material is gray shale, while roof is black (Anna) shale. The banding (bedding) in the top of the coal is sharply truncated by the roll. There is little or no apparent deformation. It appears that the coal was eroded in small benches, in a st

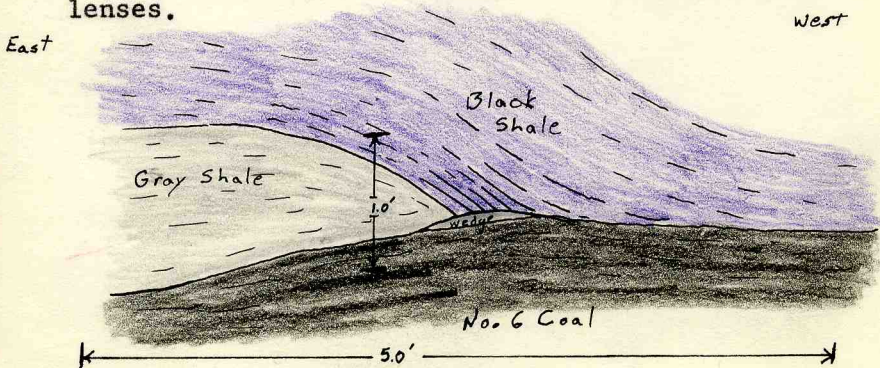
Stop #5: Terminus of gray shale lens. (see sketch) While there are numerous gray shale lenses in this area, this one has a somewhat unusual terminus. The overlying black shale tends to be conformable with most of the gray shale lens. At the terminus however, the black shale displays a sharp unconformity. Apparently a wedge of the gray shale squeezed out beyond the end of the lens before either of the shales had lithified (soft-sediment deformation). This wedge truncated the bedding in the black shale, giving the appearance of an unconformity. The gray shale has fallen out of the roof of the entry at this site, which attests to the fact that transition zones such as this cause roof control problems. The interface between the gray and black shales is often slickensided near the termini of these gray shale lenses.

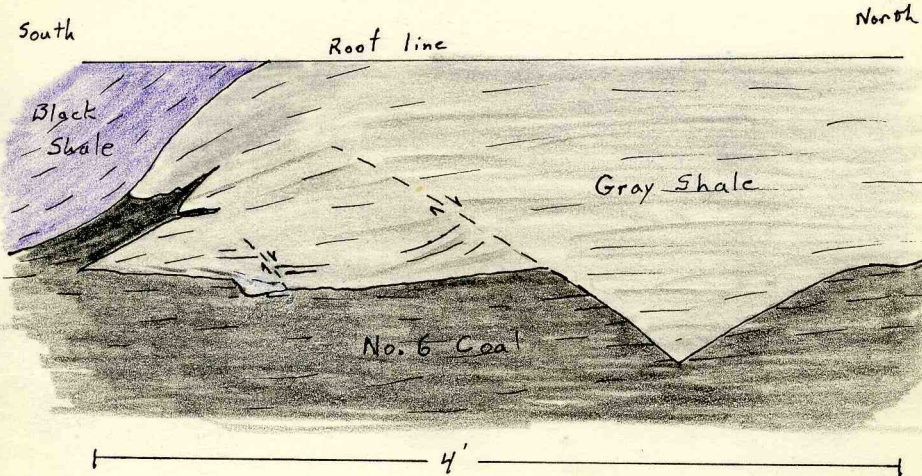
The following sketch is of the gray shale roll I encountered in the longwall face. It was located in front of shield #53. DeMaris's notes should indicate the position of the face at the time of our visit.

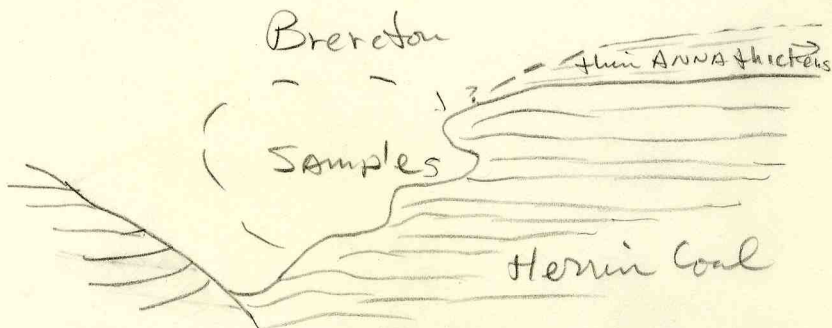
- A. Thickness at 835'N. under thin Anna roof: 5.22' above b.b., .08' blue band, .79' below b.b., T = 6.09'
- B. Weak show of a wide erosional roll on southeast intersection corner; 0.5' claystone and impure coal with relatively conformable appearance. No slips here; thickens to 1' gray claystone to south along rib. Is 2½' on opposite corner.
- C. A trace of light gray shale/claystone here - probable roll-fill material.
- D. Brereton locally pushed into (bioturbation?) top of the Herrin coal. Fault formed under Brereton mass. Anna generally displaced (soft-sedimentary deformation) or mixed in, but is present away from center of feature.

Feature looks like a "boss" (à la Crown II), but bioturbation traces are present in feature. May be bioturbation-induced flow, or unusual area of intense bioturbation in limited area. Something similar once seen on longwall traverse in O.B. 24. Samples of Brereton (C-1, -2, -3) collected.

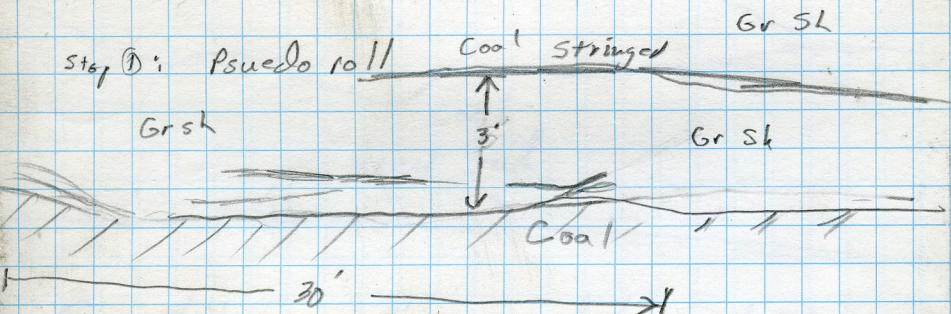
This phenomenon appears to be the
long profile of a half ass roll.
It dips into the coal about 0.5'
Top is rather unstable; several cicles
in entry

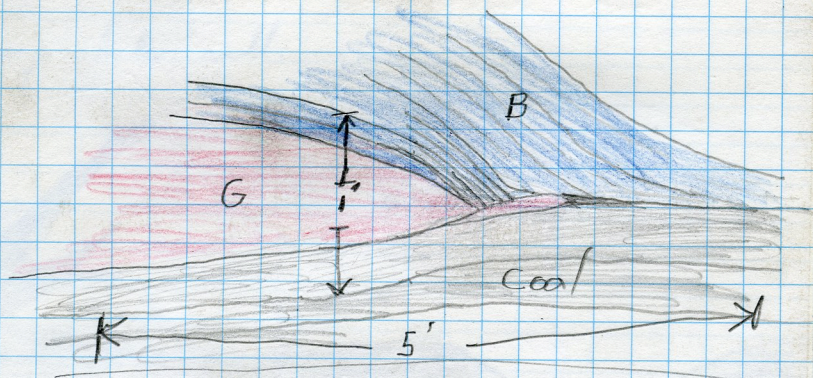
Step 5: Transition zone - B to G

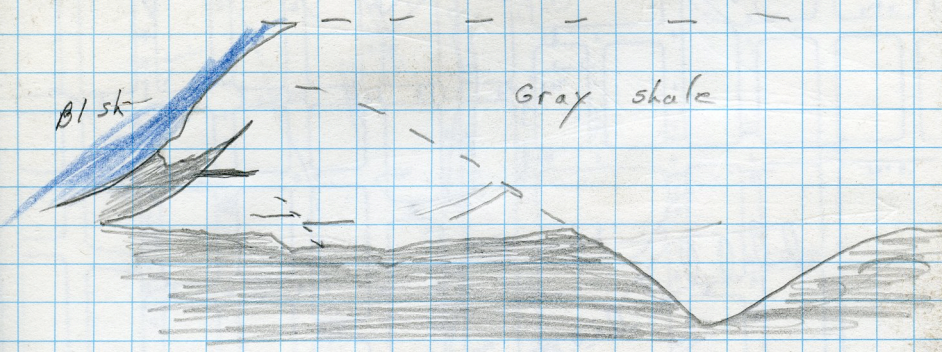
Shield #53:

Gray shale roll:

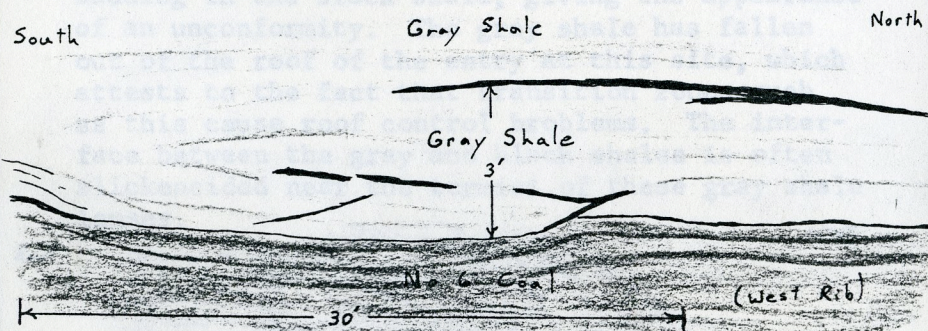
Stop #1: Pseudo-roll in pillar rib. This is not what I would call a classic roll. A maximum of only 0.5' of coal is displaced at the top of the seam. The material in the roll appears identical to the roof rock which is the gray Energy Shale. The coal stringers extend another 15-20' beyond the end of the roll structure. (see sketch below) The roof in this entry is rather unstable and slabby, and requires cribbing. A large fracture near the south end of the roll is probably contributing to the ragged roof.

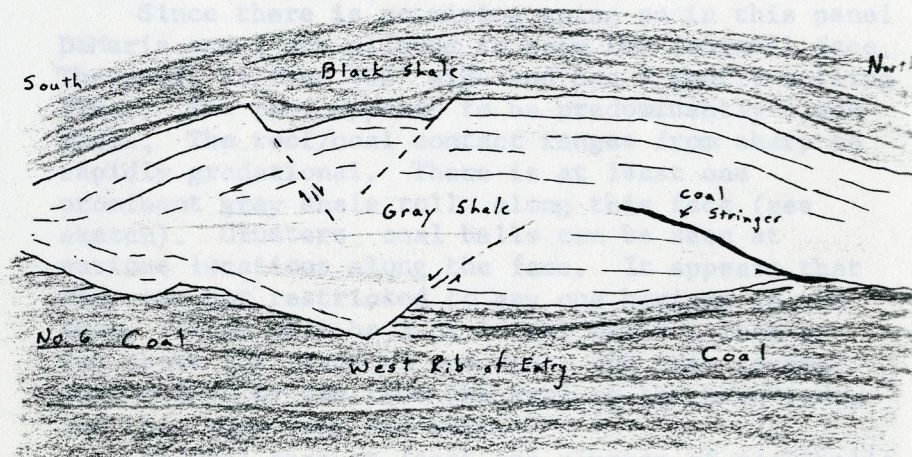
Stop #3: Mega-roll: Roll is about 40' wide, 5' thick, and displaces about 3' of coal. Roll material is gray shale, while roof is black (Anna) shale. The banding (bedding) in the top of the coal is sharply truncated by the roll. There is little or no apparent deformation. It appears that the coal was eroded in small benches.

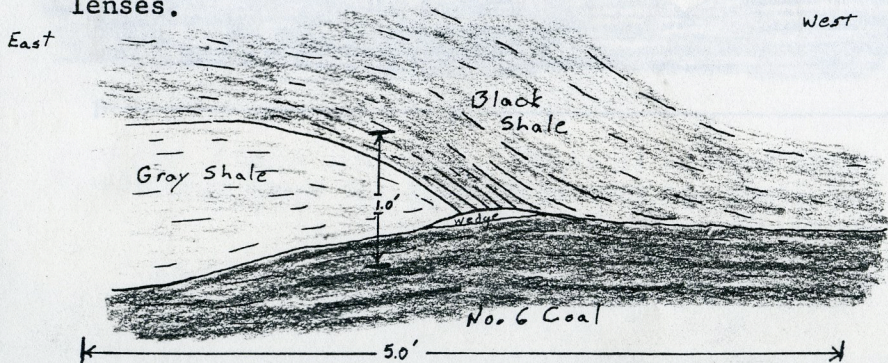
Stop #5: Terminus of gray shale lens. (see sketch) While there are numerous gray shale lenses in this area, this one has a somewhat unusual terminus. The overlying black shale tends to be conformable with most of the gray shale lens. At the terminus however, the black shale displays a sharp unconformity. Apparently a wedge of the gray shale squeezed out beyond the end of the lens before either of the shales had lithified (soft-sediment deformation). This wedge truncated the bedding in the black shale, giving the appearance of an unconformity. The gray shale has fallen out of the roof of the entry at this site, which attests to the fact that transition zones such as this cause roof control problems. The interface between the gray and black shales is often slickensided near the termini of these gray shale lenses.

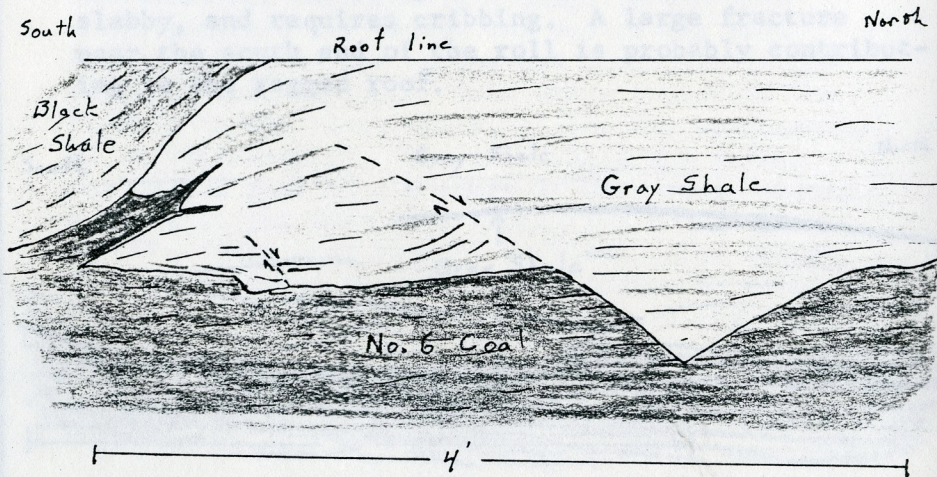
The following sketch is of the gray shale roll I encountered in the longwall face. It was located in front of shield #53. DeMaris's notes should indicate the position of the face at the time of our visit.
