OLD BEN COAL CO.
MINE # 26

Mine Index No. 879 S-26

COAL MINE—PRODUCTION

ILLINOIS GEOLOGICAL SURVEY, URBANA

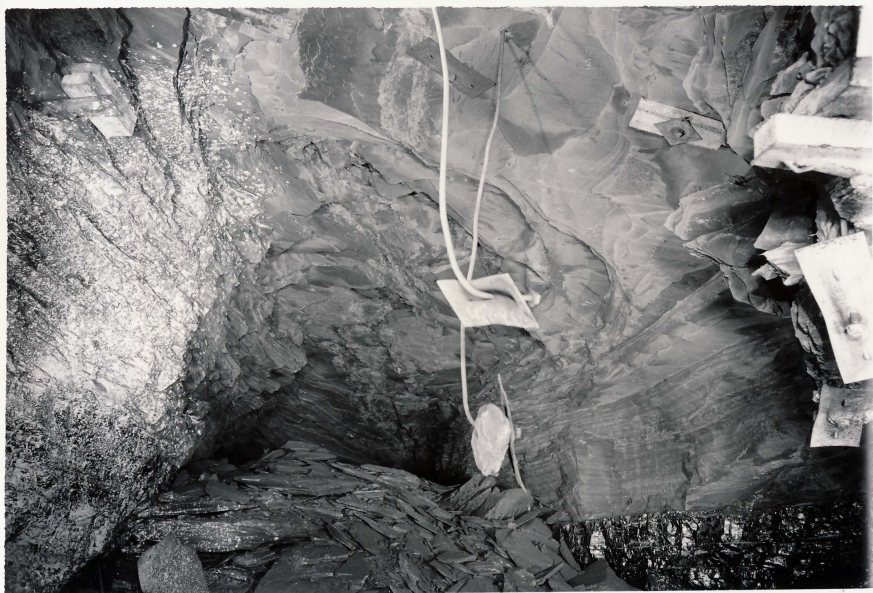
Photo 5 mn-03A-045

Photo 5 Looking into roof fall, due almost south 150° (sic). They turned from E-W to 45° ; that's when it fell. This is only one entry farther south from photo 4, same zone of weakness, fell where it hit intersection, shows pressure (powdered rock) in ceiling, trending 160° on west side it followed 140 main cleat and joint tried? to do this several places (sic), gray shale with brownish bands. Fell before March; that is, maybe two months after mining. 9' bolts still hanging from roof. 10th entry E, 8650' in.

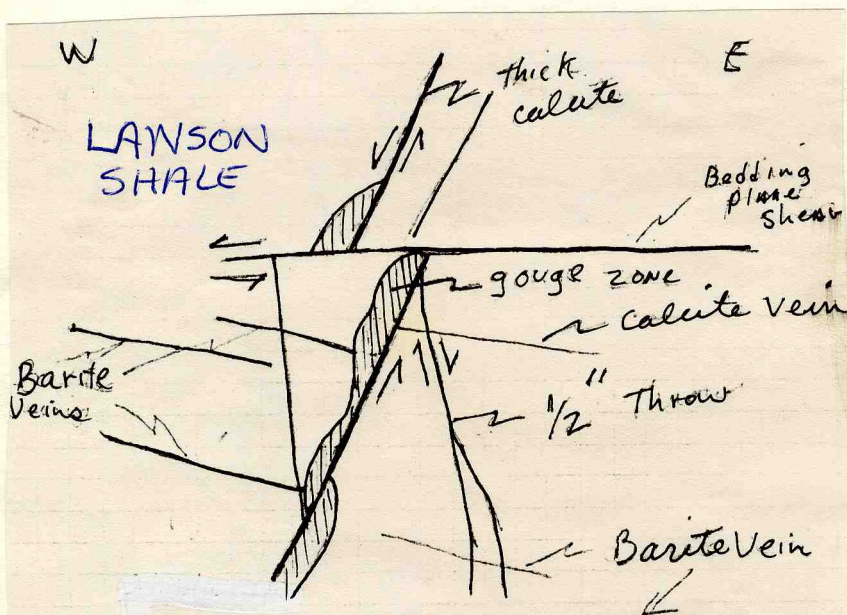
Barite vein on small E-dipping slip is offset $\frac{1}{16}$ of an inch whereas the strata are offset $\frac{1}{2}$ inch.

Also Barite veins do not enter gouge zone. Also not slickensided.

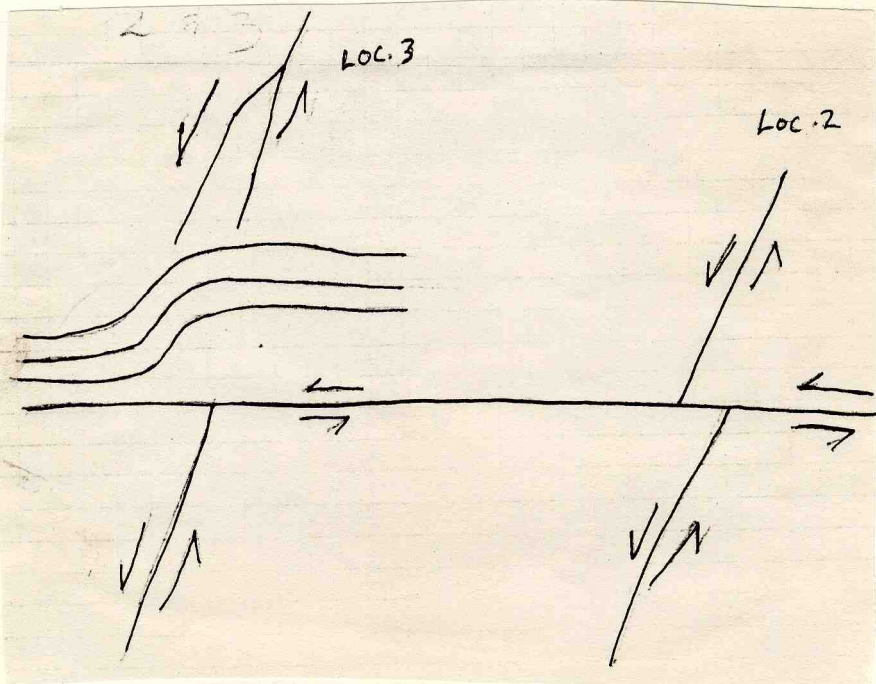
Summary drawing of locations 2+3:

4. E dipping thrust fault. Probably same as bedding plane slip shown above. Apparent dip: 13° E continues as far as arrow on map.
5. Goat beards predominantly dip to W.
6. Last shear fractures seen at 2nd Man door west of map.
7. Last shears E of fault (off map) is at the 2nd overcast where there are 2 together.

8. Major fault is composed of 2 faults 5' apart, striking due North and with a 67° dip to East. Can't tell which fault is bigger. Coal exhibits very little drag. Throw can't be measured, but Lawson Shale and perhaps Bankston Fork exposed on downthrown side.
9. Faulting here more complex. At least 4 different fault planes. X-section next page.

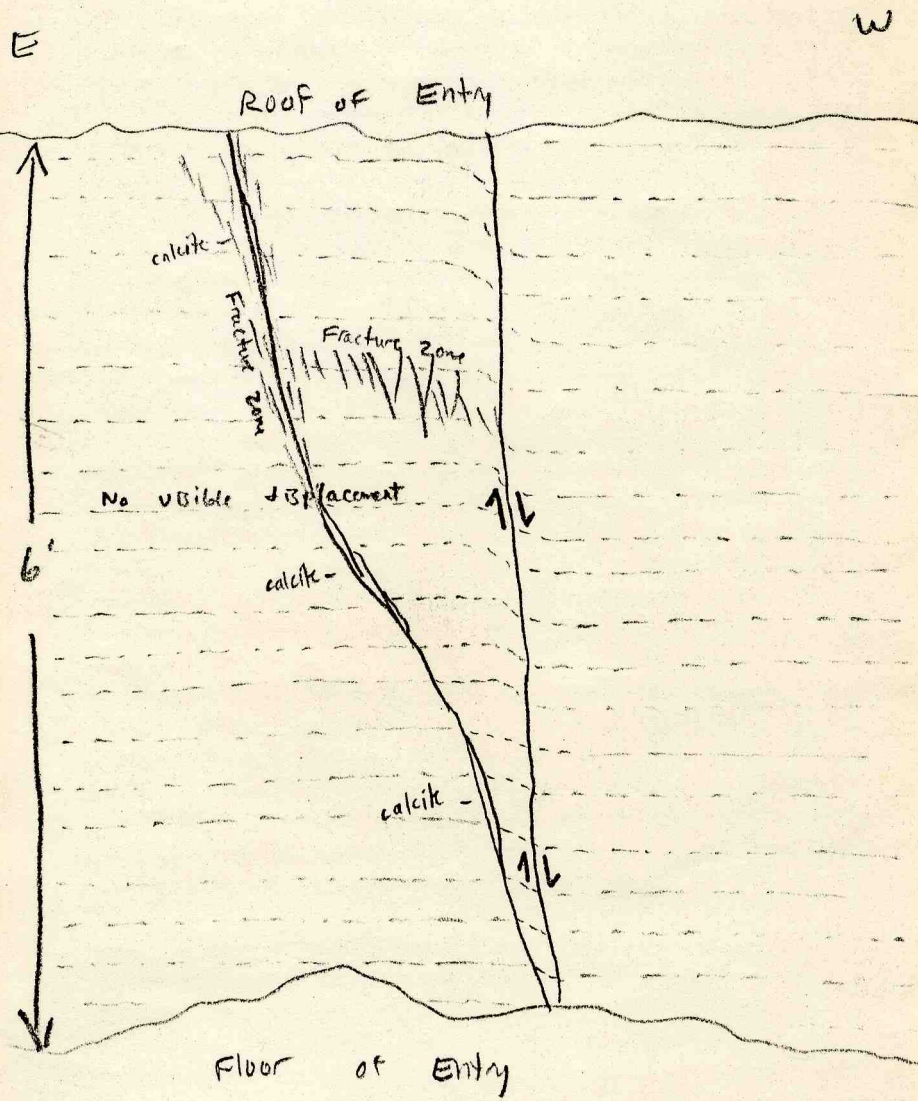
Stop 1
South side of entry

The flexural fault looks about the same on both sides of the entry. It trends N-S and dips steeply westward. Near the floor it is a single fault, but it branches upward into two separate fractures. Total displacement is less than a foot, accomplished mostly by folding of the shale rather than by offset. There is calcite filling on the fault plane. See sketch (over).

Only one set of small faults with displacement is seen. These trend N-S, dip steeply west, and contain calcite filling. Both shearing offset and flexural folding are seen; mostly the former. There are numerous vertical fractures and low-angle slick-

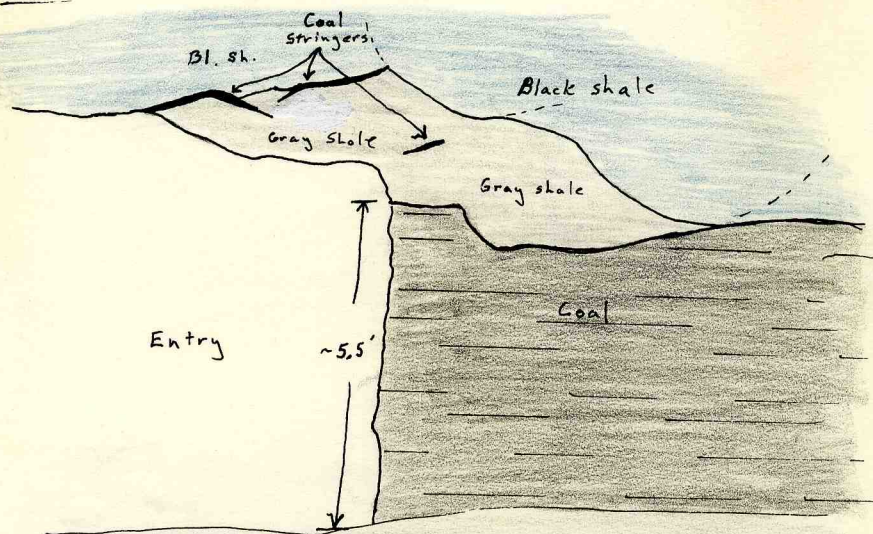
Gray shale roll under black(Anna) shale roof. The roll material is a medium gray shale/claystone that has weathered to a sulfur yellow color. It is mod soft, and appears prone to slaking. It contains several stringers or small coal riders. Numerous signs of soft sediment deformation. Top of coal appears eroded. The contact between the black

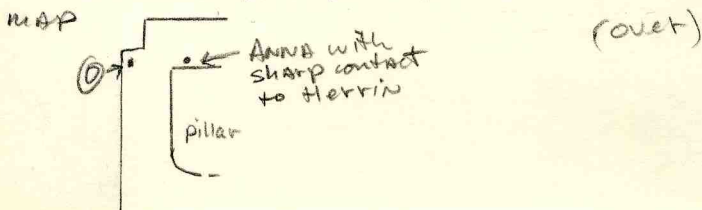
O. At corner about 360' N. on 40th N. there is Anna Shale roof with a sharp, level contact to the Herrin. On the west rib there is a limited exposure of an unusual sequence of units. "Bs. Limestone" has been bolted up under top coal with coal balls (Rich takes picture) Anna sampled (-A-15). Section:
