February 15, 1978

Notes by John Nelson in mapping with John Popp, Bob Bauer, and Roger Nance.

FREEMAN UNITED COAL MINING CO. CROWN MINE II

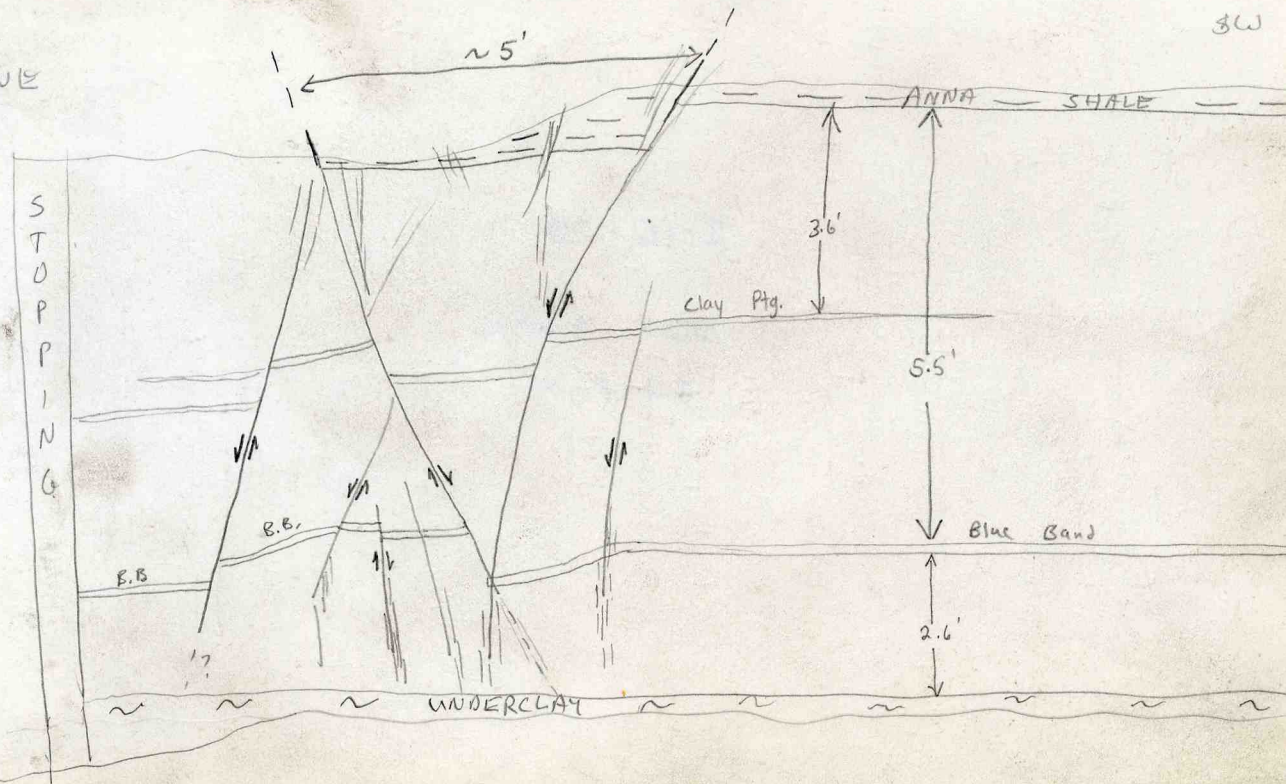
North a very large clay dike appears on almost a direct line with the fracturing, and possibly represents a continuation.

A puzzling feature of the fractures is that they bear marks both of tectonic faults and of soft-sediment features. Perhaps this is best summarized in list form:

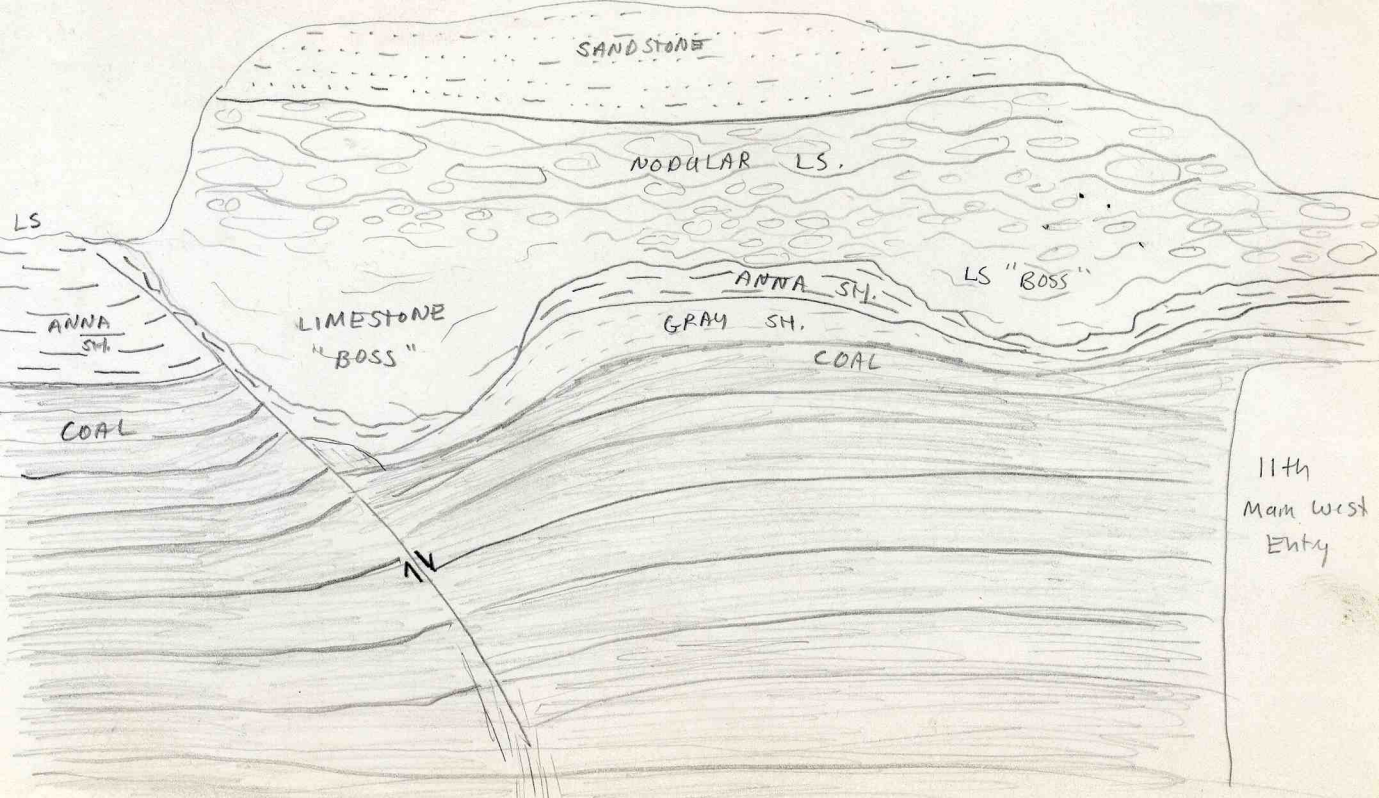
TOP OF FALL

On the east rib (see sketch, over) two "bosses" are present. The larger one, to the north, is about 10 feet in diameter and protrudes about 2 feet into the coal. It may have connected with a similar "boss" exposed on the west rib.

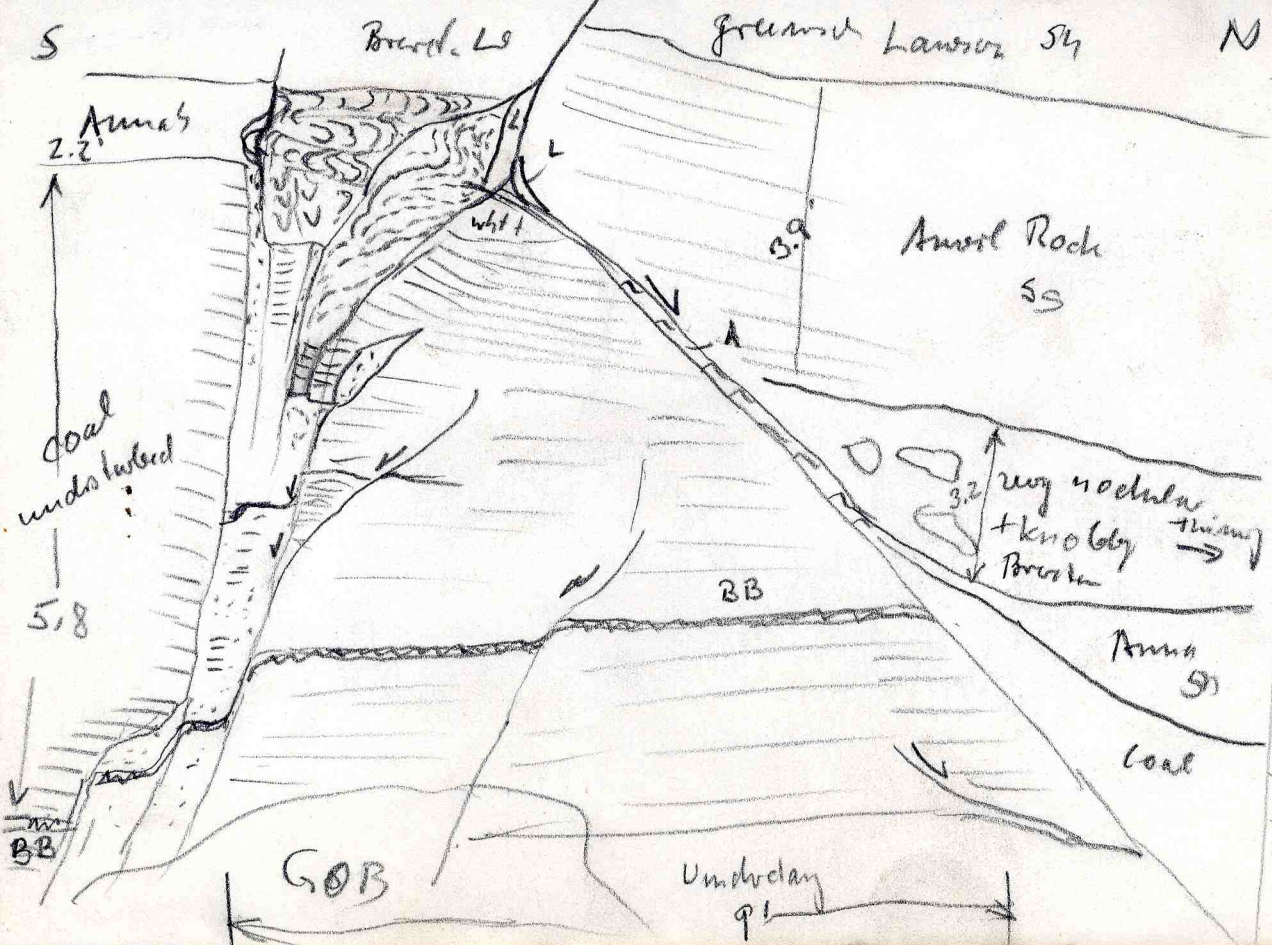
The sandstone sharply overlies the Anna Shale and its bedding is roughly parallel with the contact. Some erosion appears to have taken place but it is not certain. The condition of the roof does not encourage close detailed study. Locally lenses or concretions of limestone lie along the sandstone/Anna contact.

Many large clay dike type faults cross the roof fall. Most trend N-S and so roughly parallel the local lithologic trends.

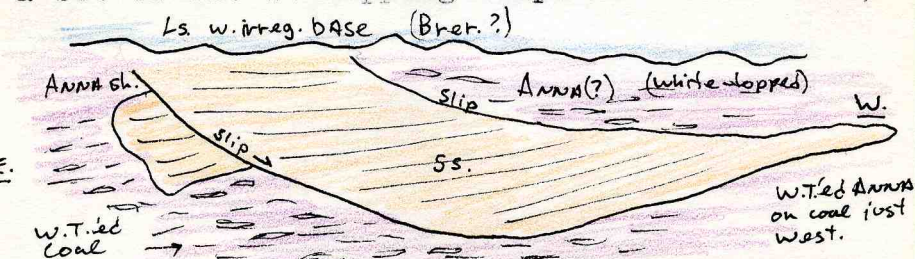
D. The small, ^rcourse sand cut-out on the S. rib is even more perplexing than the sudden appearance of Ss. roof. To the E. this is a simple case of thin Anna overlain by Knobby Brereton. Here the top of the coal is "white-topped" (irreg. interlaminated by a lt. gray shaley material) with an apparent downcutting relationship between the Ss. lense and the "w.t.ed" coal. The Ss. is faintly banded with bands dipping slightly E. w. a set of sm. W.-dipping slips on the E. side;

I interpret the Bk. "w.t.ed" ^{coal} shale to be the Anna (0.3') and the Ls. above to be Brereton. The micaceous "clod" beneath knobby Ls. is one of the few hints that the exposure is unusual (outside of known stratigraphy). The incongruous Ss. apparently has been injected into the Anna along the edge of the Ss. channel feature on the otherside of the crosscut, even though the Anna appears to rest conformably on the S.S. lense.

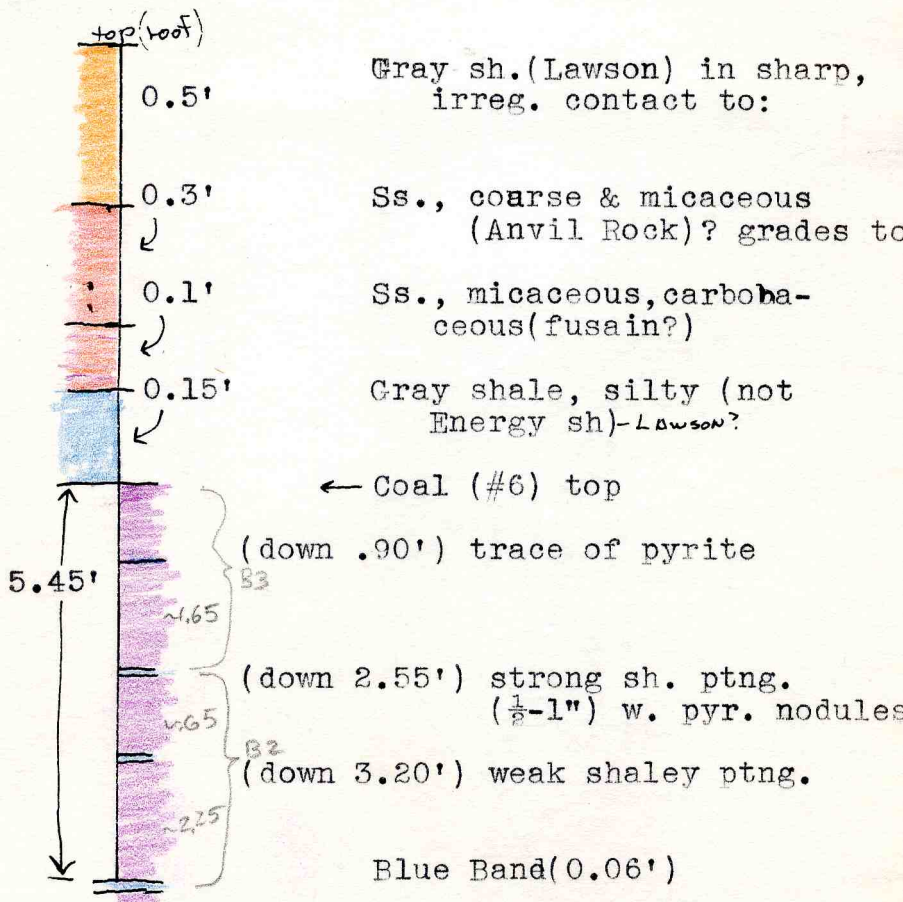
Section:

I. Section showing details of the Lawson-Anvil Rock interval & the #6 coal. (over) This seems to a typical coal thickness under (former) Anna roof, so there is not likely very much if any missing coal. (over)

Later analysis suggests as much as 1/2' could reasonably be missing. Having BB → etc thickness would help. ASD 12/81

Laterally (to W.) there is a dull 2" coal at the "top" position marked here. Sample B-7 taken there. (see text map, over)

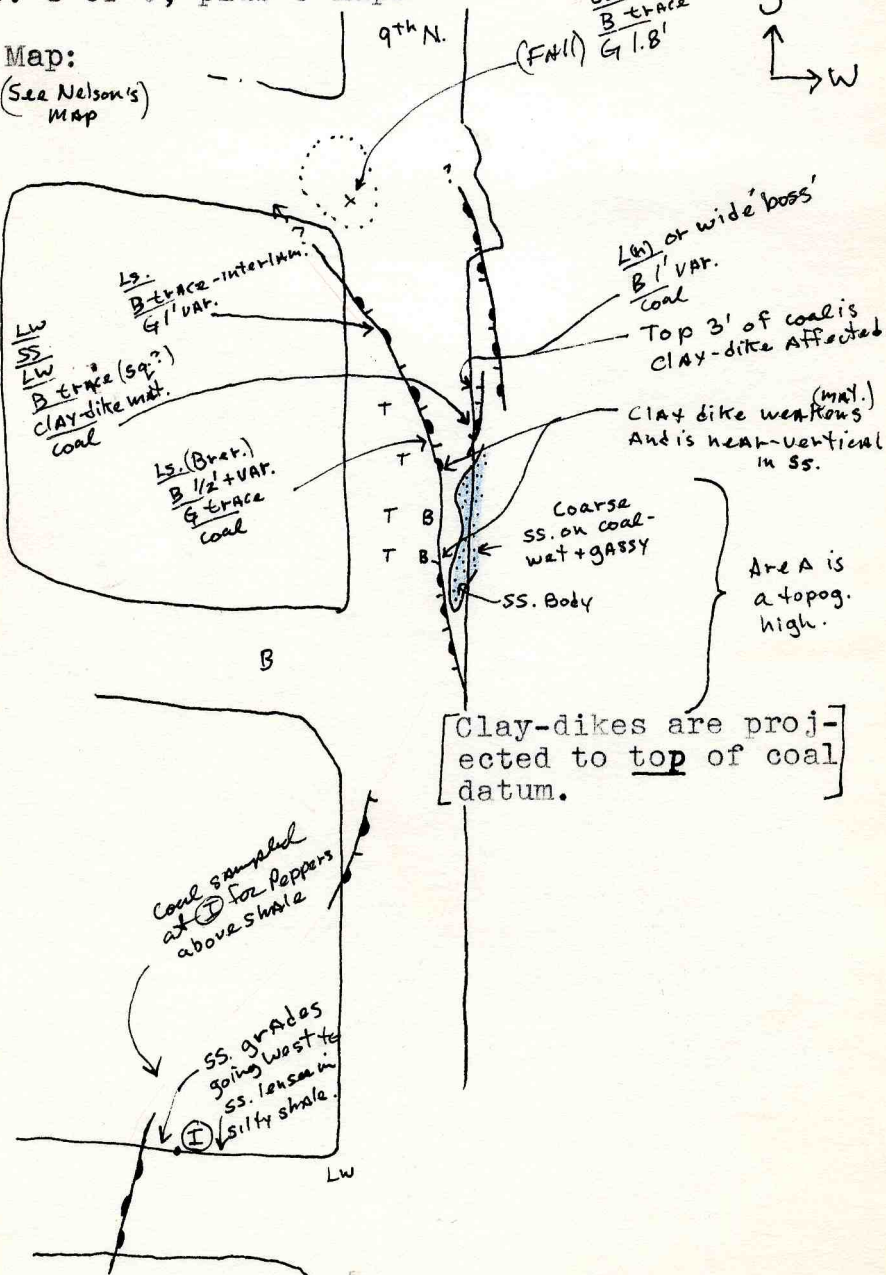
Map:
(See Nelson's Map)

J. Complex area of clay dikes and with? Ss. body. Mapping done on the 10th N, by Nance was found to be inadequate & will have to be adjusted. The two gray shales were not differentiated & thus some of this may need remapping. (text map over)

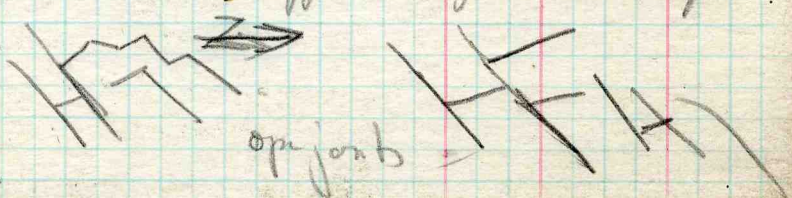
(50) Roof fall through Anna Shale to Bottom
of Broctor Limestone. Anna Shale is 2.7 to 3.9' thick
intensely jointed by a set of joints ^N45° to 50° E/
dipping 50 to 80 NW (mainly dipping 70° NW) in places
these joints develop into minor slips and faults with
slite sided surfaces. The base surface of the
Broctor Limestone is smooth slightly dipping
to the west locally up to 18° incline.

The Broctor Ls is intensely jointed / spacy
about 1 joint/foot locally denser. These joints
draw water into the mine. There are two
sets N 40 E (water); N 135 E (bunk joints) all
are open fractures, fissures open up to 1" at
places. Some sagging of - probably not too
thick Broctor has occurred along these open
fractures but was supported by cribs and kept
up.
