ZEIGLER COAL CO.
 MINE # 4

Mine Index No. ~~0210~~ 0662
 County No. 1604
 Coal Report No. S-83

WILLIAMSON COUNTY

Zeigler Coal Co. U. G. Mine No. 4, Williamson County/
Ill.

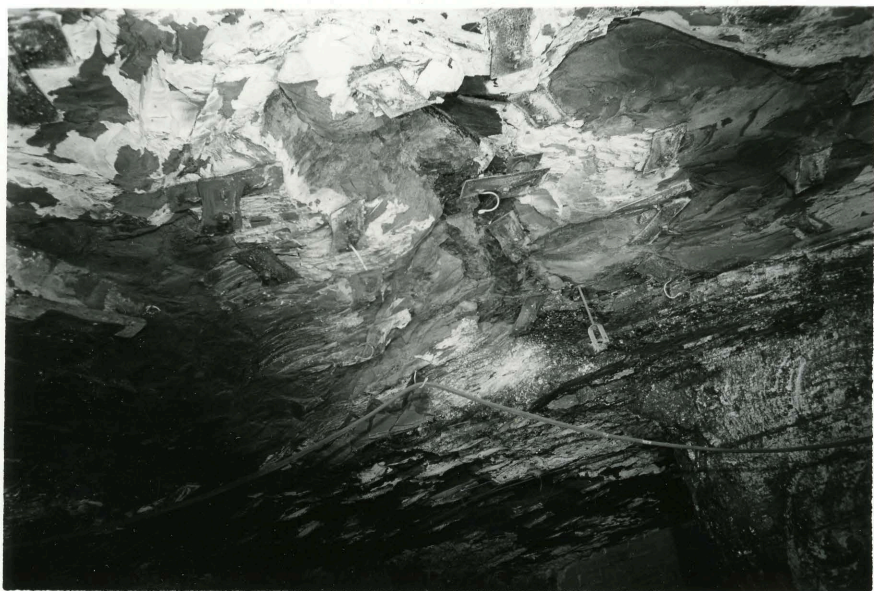
PHOTO 2

Photo #2: About 2-4" top layer of coal taking off (sic) into roof shale and causing roof falls. Loc. in 1st SE Panel one crosscut inby overcast, 1st S. off Main East. 2200' from S.L., 450' from W.L., Sect. 10. Looking on a 220-degree heading.

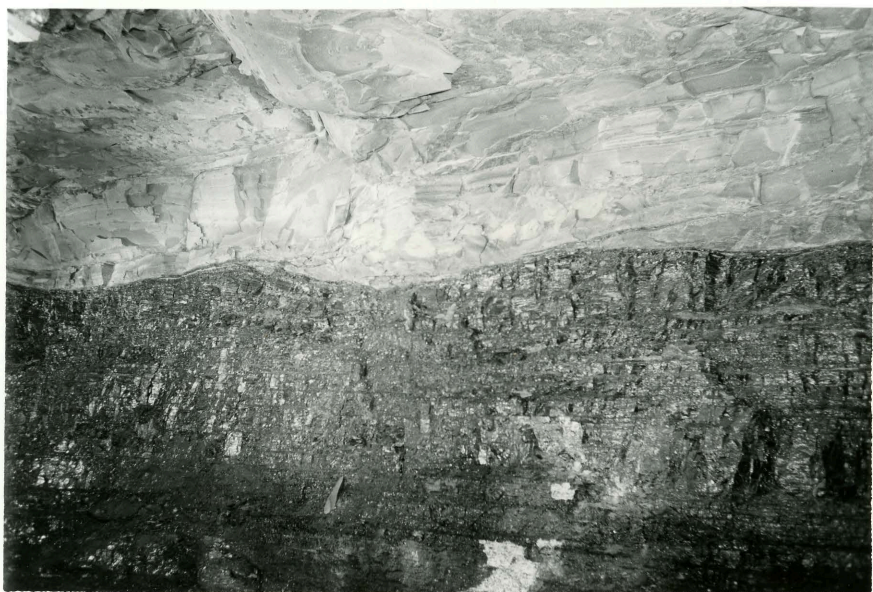
PHOTO # 5

Photos 5 and 6: Two crosscuts inby rock hopper, 1800' W, 1800' S of center Sect. 9. Shows irregularities at top of seam and stringers taking off, causing roof problems. Also shows structure of shale in this area near bottom, with synaeresis etc. Views looking NW.

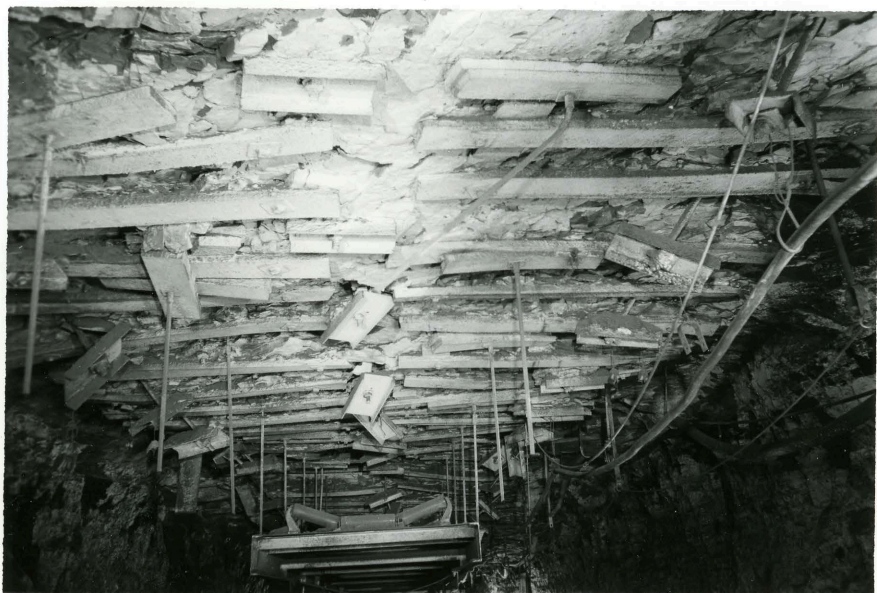
PHOTO # 7

Photo #7: First roof bolts in the world, put in about 30 years ago, directly above rock hopper. 1800' W, 1700' S of center Sect. 9.

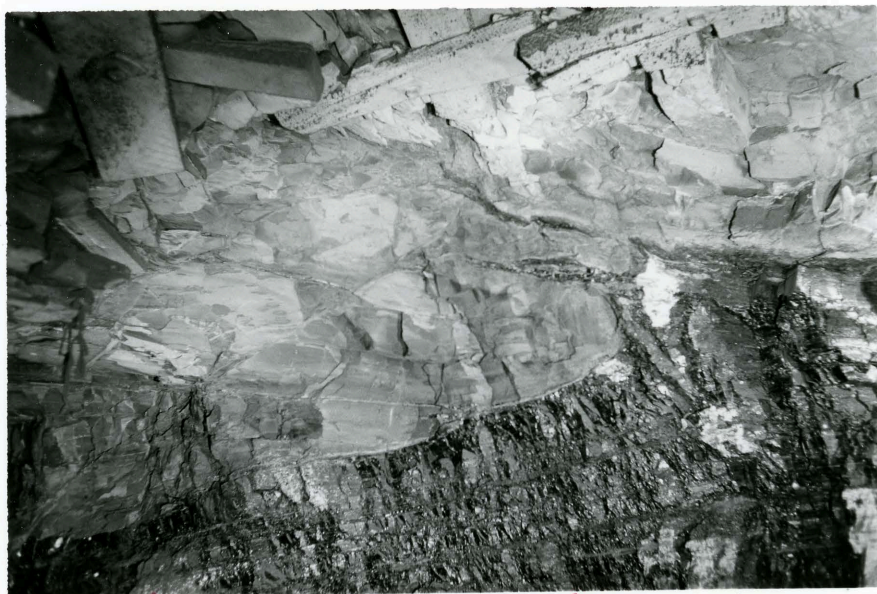
PHOTO # 8

Photo #8: 2nd Main West two crosscuts inby the coal hopper. Edge of "channel" looking appr. S. 1200' from S.L., 400' from W.L., Sect. 9.

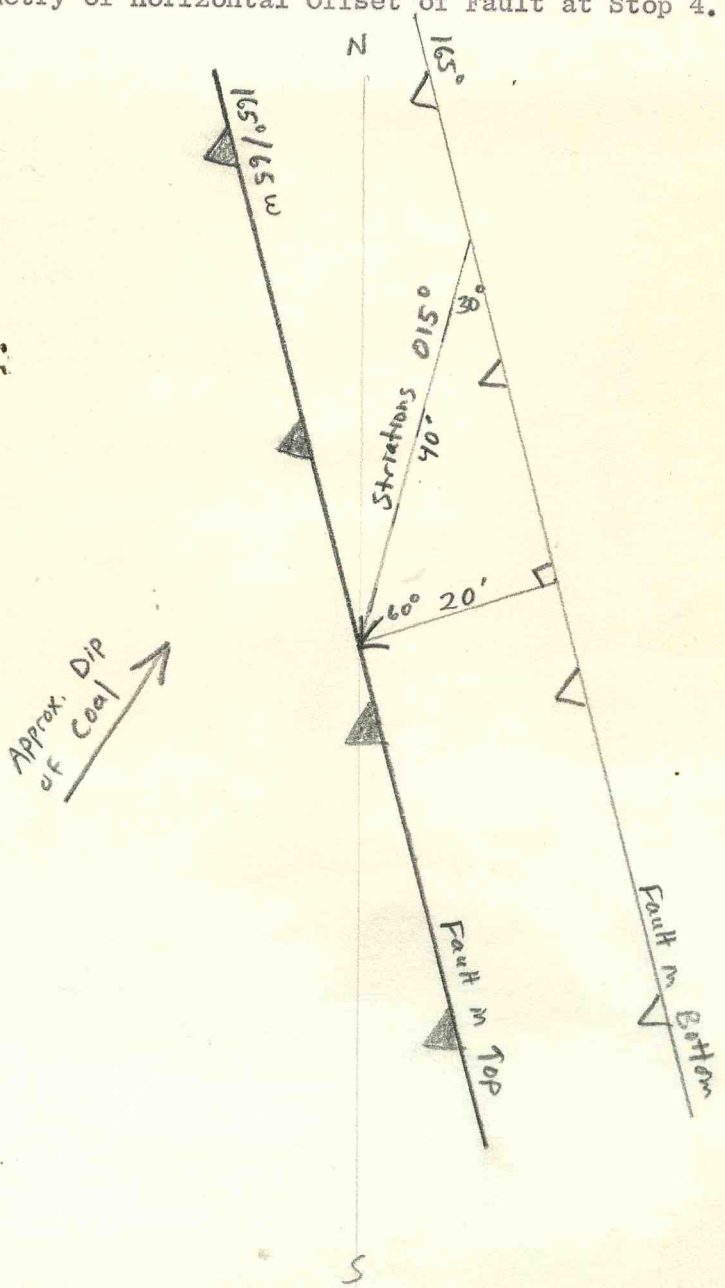
Geometry of Horizontal Offset of Fault at Stop 4.

Diagram (over) indicates that the horizontal displacement along the bedding plane is about 40 feet, and that the upper part of the coal moved "uphill" relative to the lower part of the coal. This is the same sense of movement observed in the 6th North of Freeman Orient # 4 near the large reverse fault.

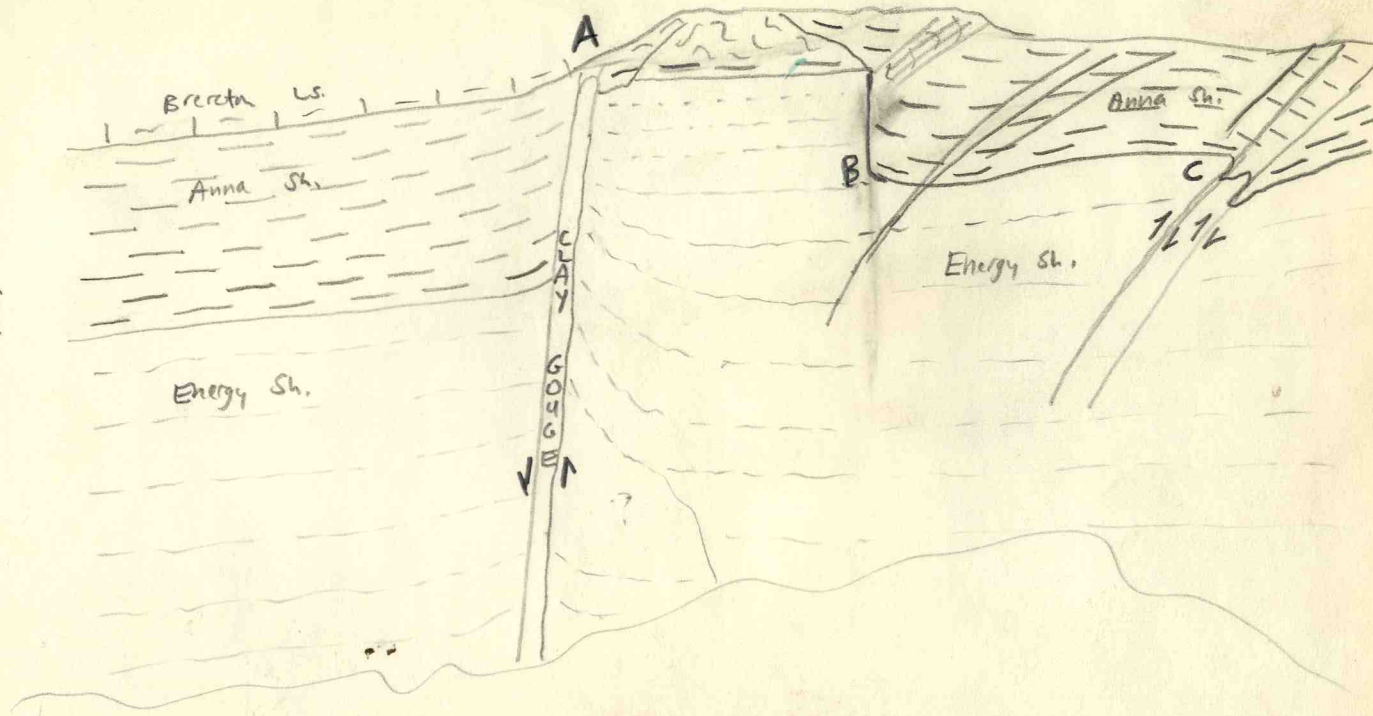
Stop 15 - View South Rd

Roof and ribs are loose and dangerous, hindering detailed study of this area.

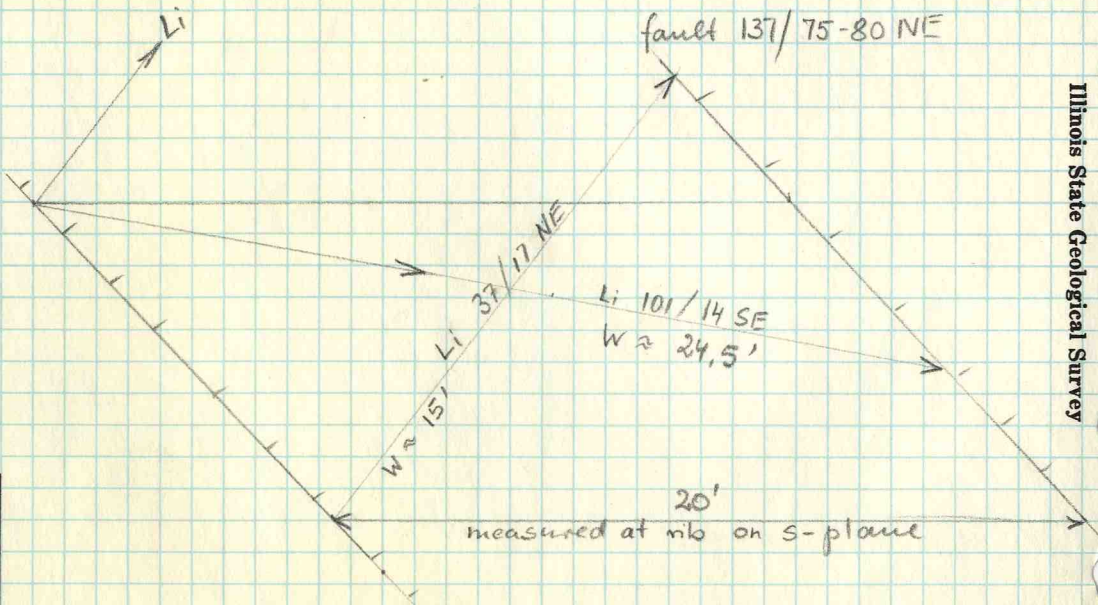
stations (11 and 12) combined.
 sketch, no scale! high angle faults displaced by ss-parallel s-plane

fault 137/75-80NE

displacement along stria on ss-parallel s-plane = between 15' and 25'

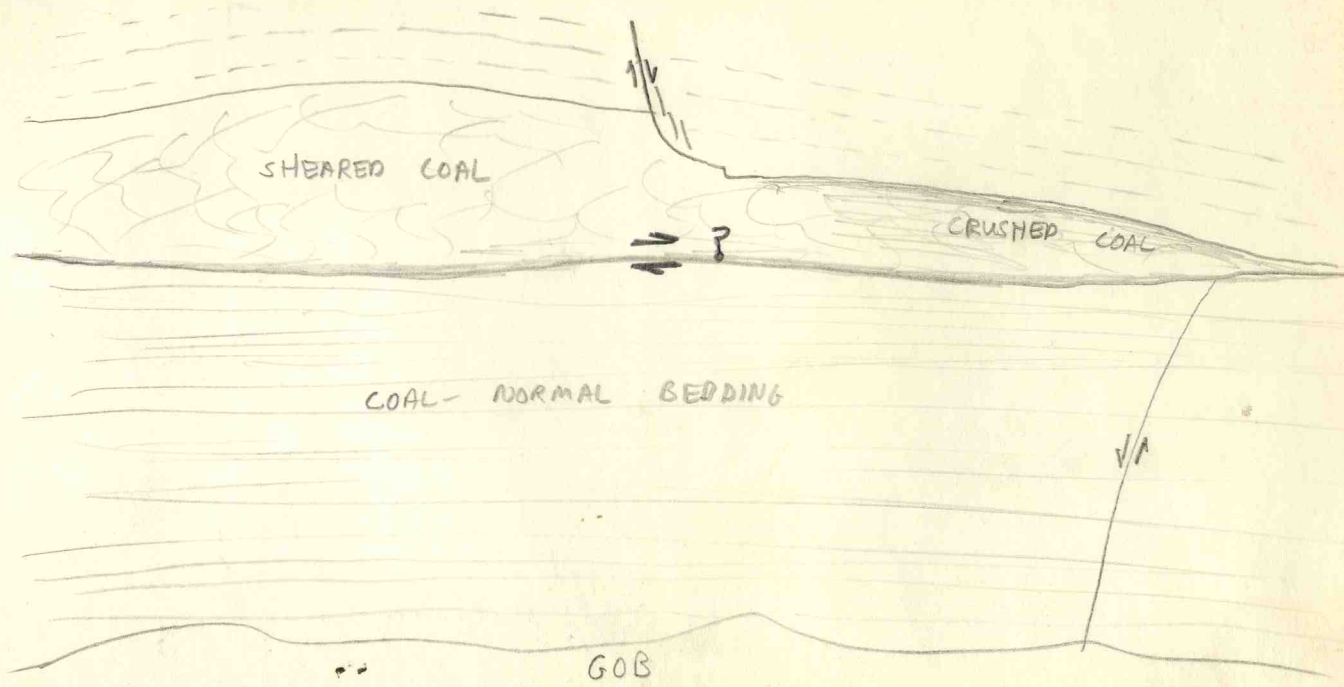
Stop 24 - view of N Rib

friable. There appear to be multiple shear planes within this wedge.

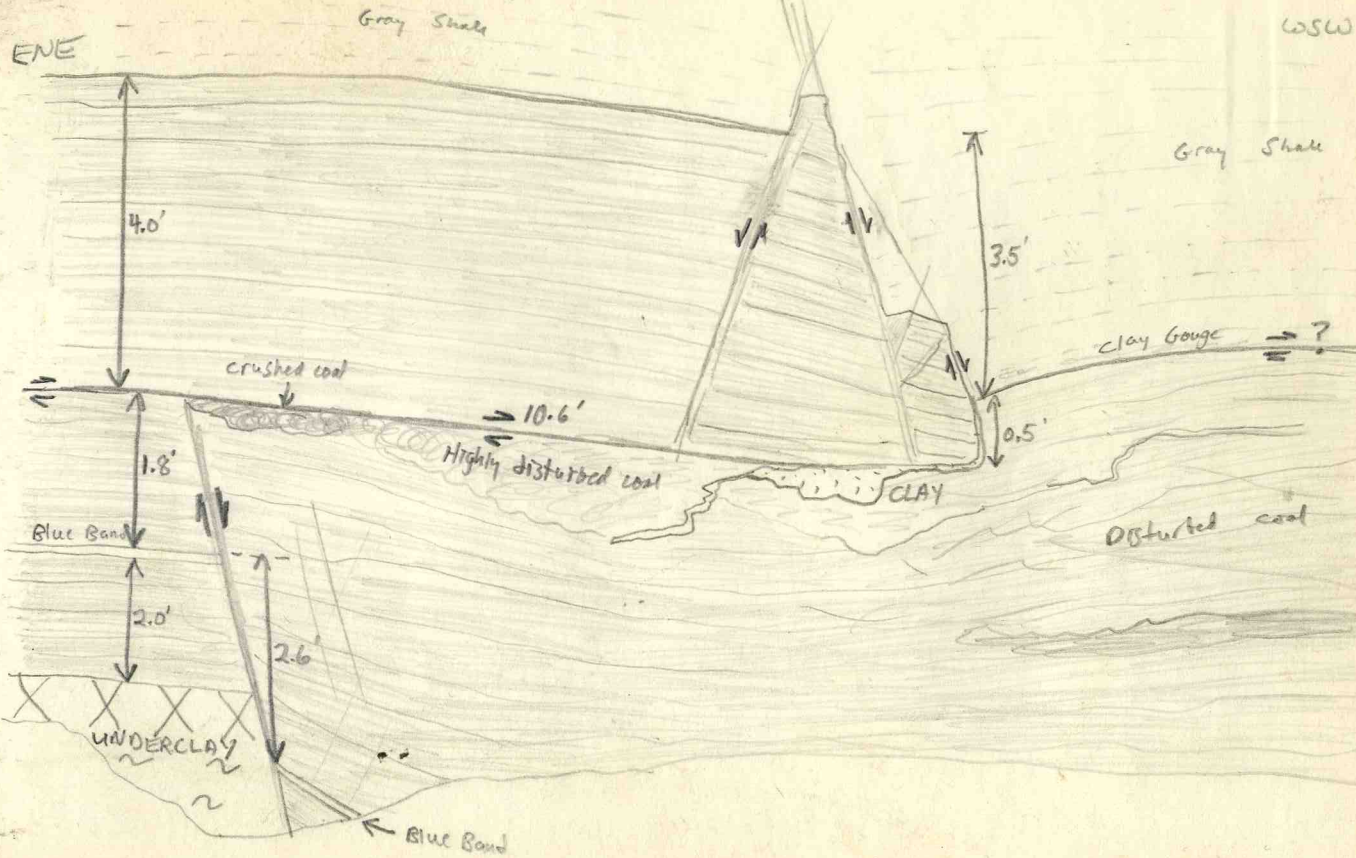
Stop 30 - View of S. Rib

A normal fault trending $150/75^{\circ}$ W with 3.5' throw on the south rib is displaced 10.6' along a horizontal shear plane. We dug out the lower half of the fault on both sides of the entry and found Blue Band and floor displaced by several feet. The

block above the shear plane moved westward relative to the block below. We could not find slickensides to indicate the actual direction and distance of offset (the 10.6' figure is measured along the rib).

There has been vertical movement after horizontal shearing as well. This is shown by a sharp 0.5' vertical offset of the horizontal shear along the main fault.

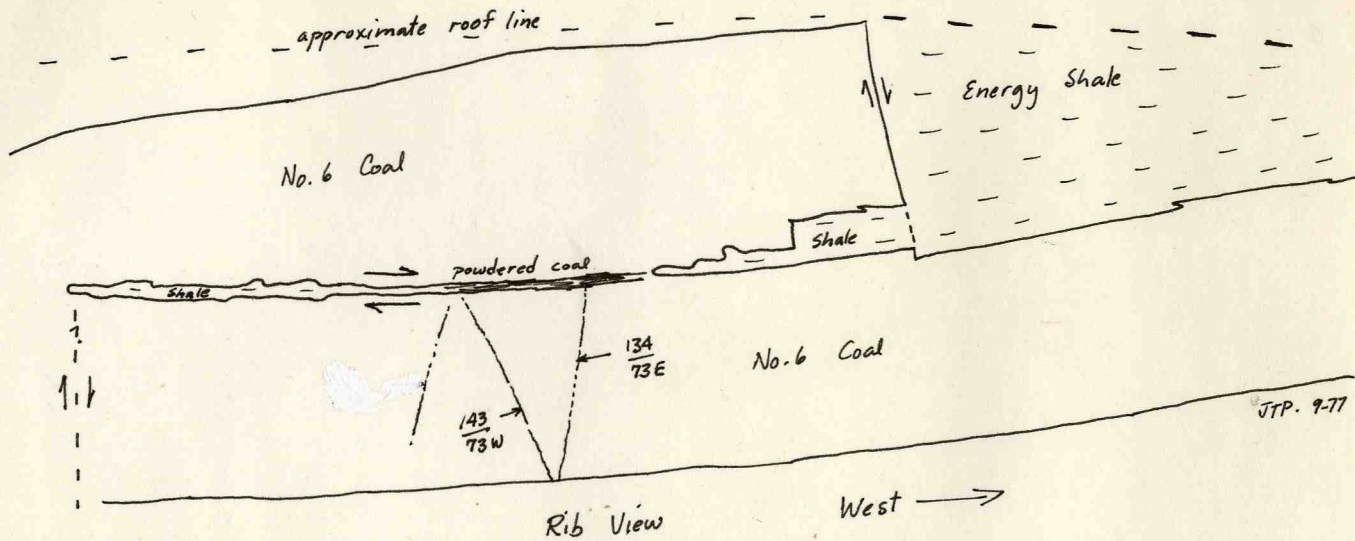
Booknote 1

In general it appears that the coal and shale have slid on one another, giving the polished, gouged, and crushed appearance. The coal still has a pronounced NE dip, and small offsets in vertical joints, or slips, support the presence of horizontal movement.

Small (discontinuous?) shears are present in the shale, and although the shale is well bedded, the combination of vertical shears and horizontal shears seem to cause it to fall.

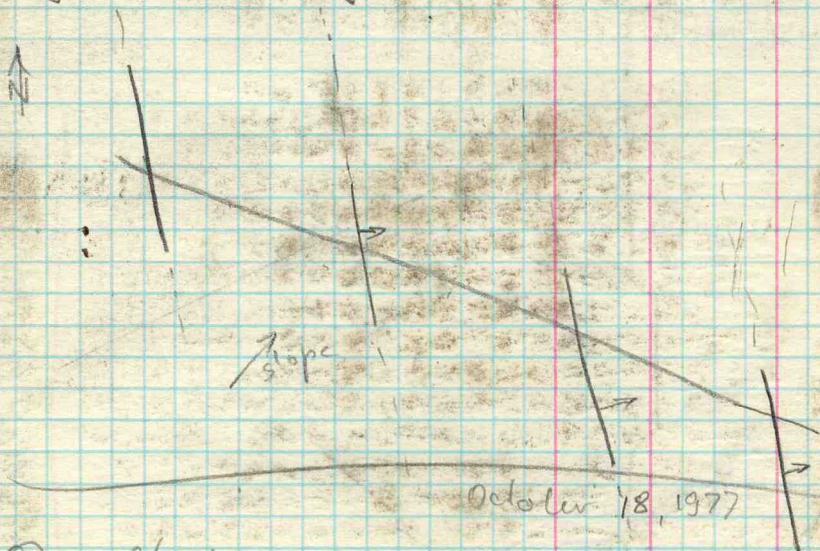
② Faults larger one $t = 0.9'$ fs: 147/71NE
accompanied by synthetic and antithetic
smaller faults.

③ Fault $t = 1.4'$ fs: 147/55-60SW
associated by many small synthetic
and few antithetic faults in coal
with displacement of only cm.

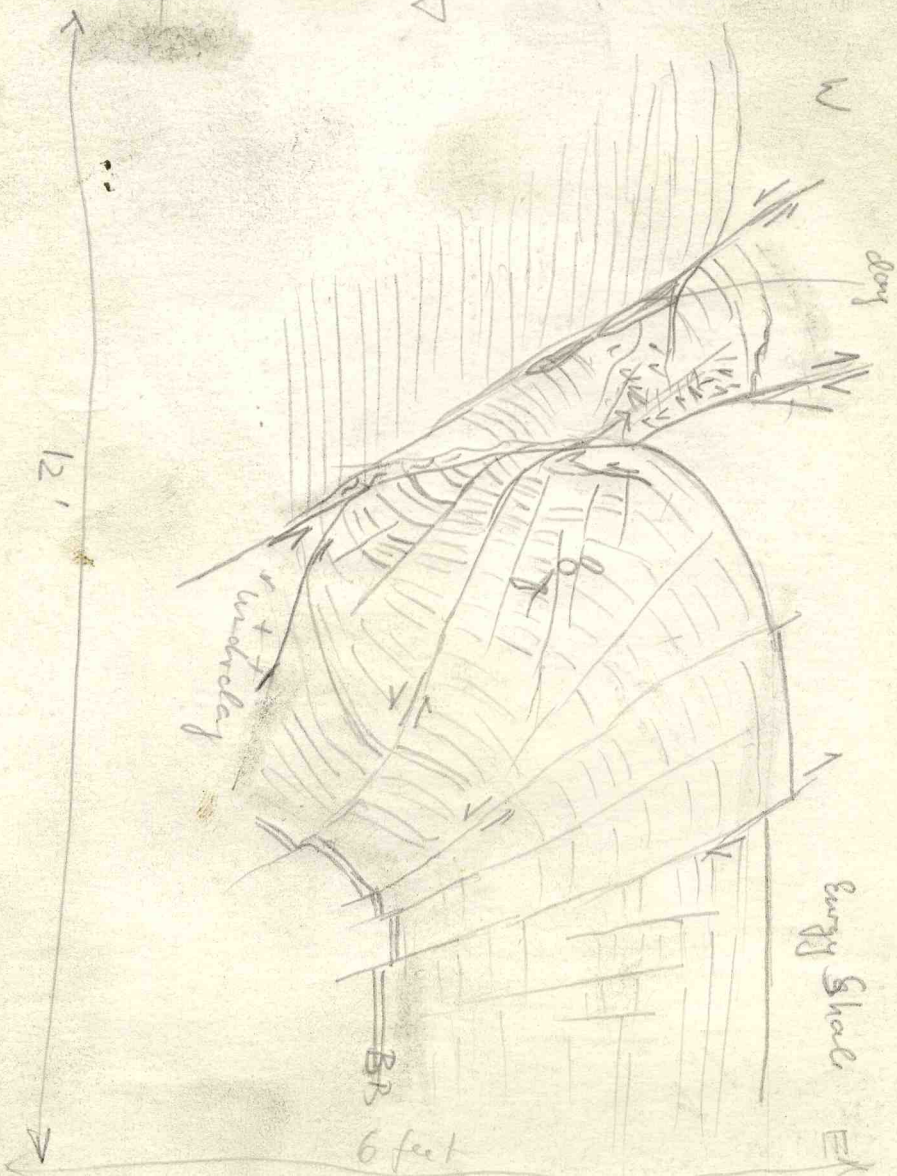
(9)

⑧ "Collapse fault" in Cottage Grove
 fault syst. "reverse fault + normal fault"
 as of station ⑧ huge wave and wave

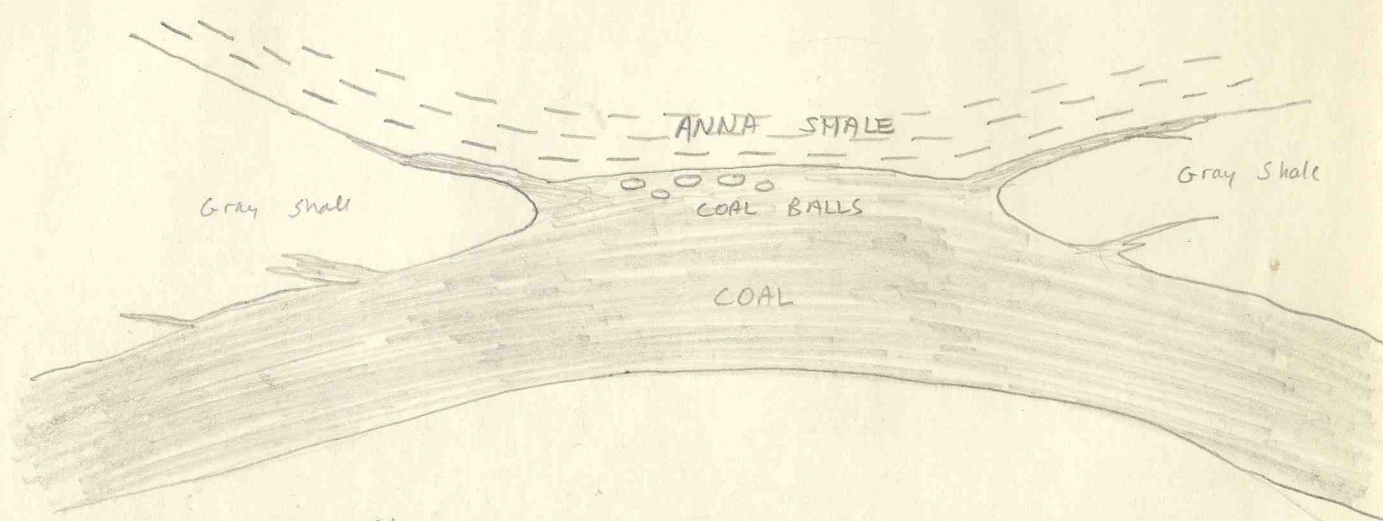
(2)

large "rolls" with coal "riders" pointing away from the ridge. Coal balls occur in the top coal along the ridge crest, under Anna Shale. See sketch (over).

This fits a pattern we have seen in other mines, including Old Ben # 24, Orient # 4, and Orient # 3. It is best developed in the northwest part of Orient # 3. Gray shale roof is found in troughs or depression in the coal seam, and black shale roof above high places.

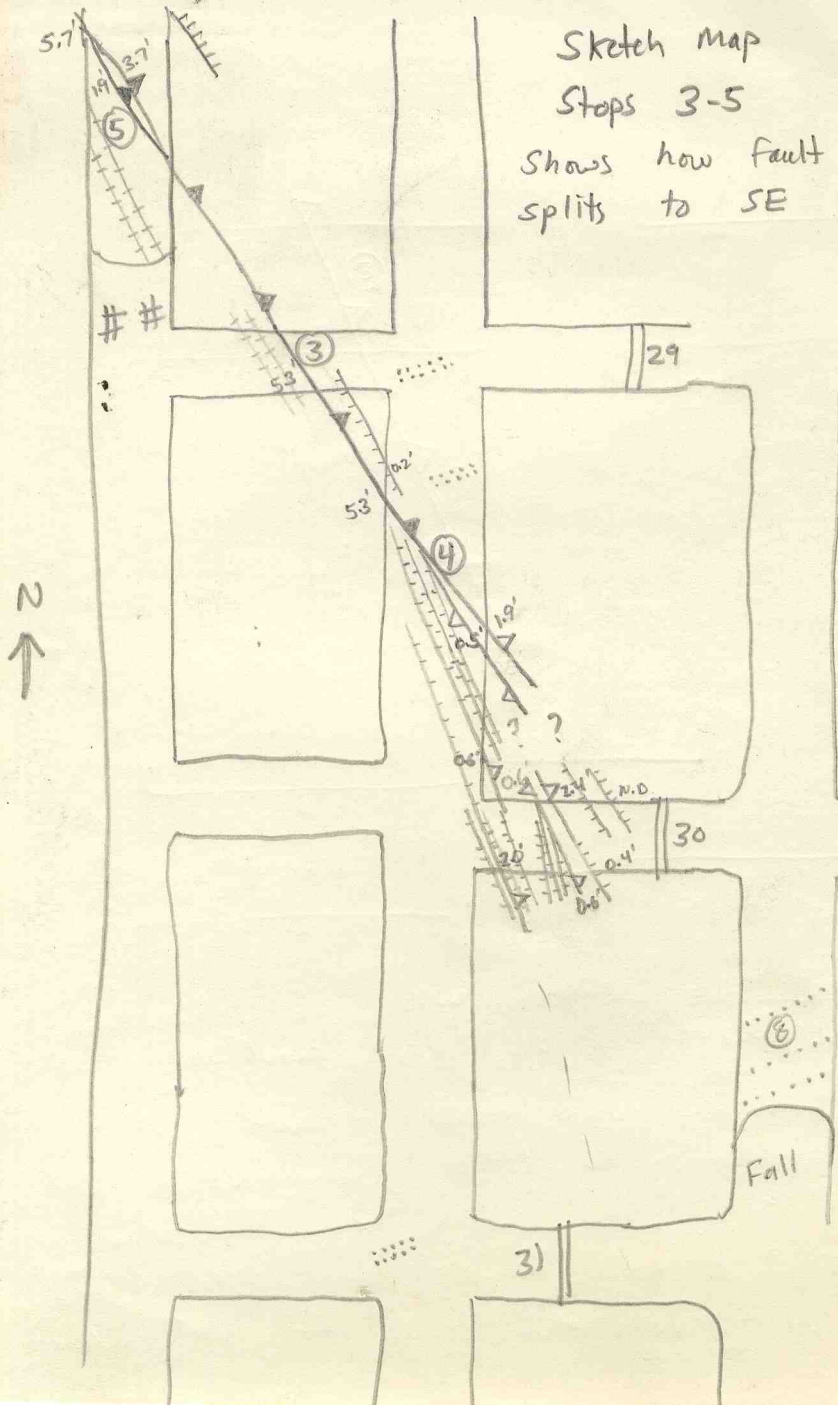
Stops 3-5

Shows how fault splits to SE

The faults fan out not only along strike but along dip. The dips range from vertical to about 35°. The largest faults are down to the northeast.

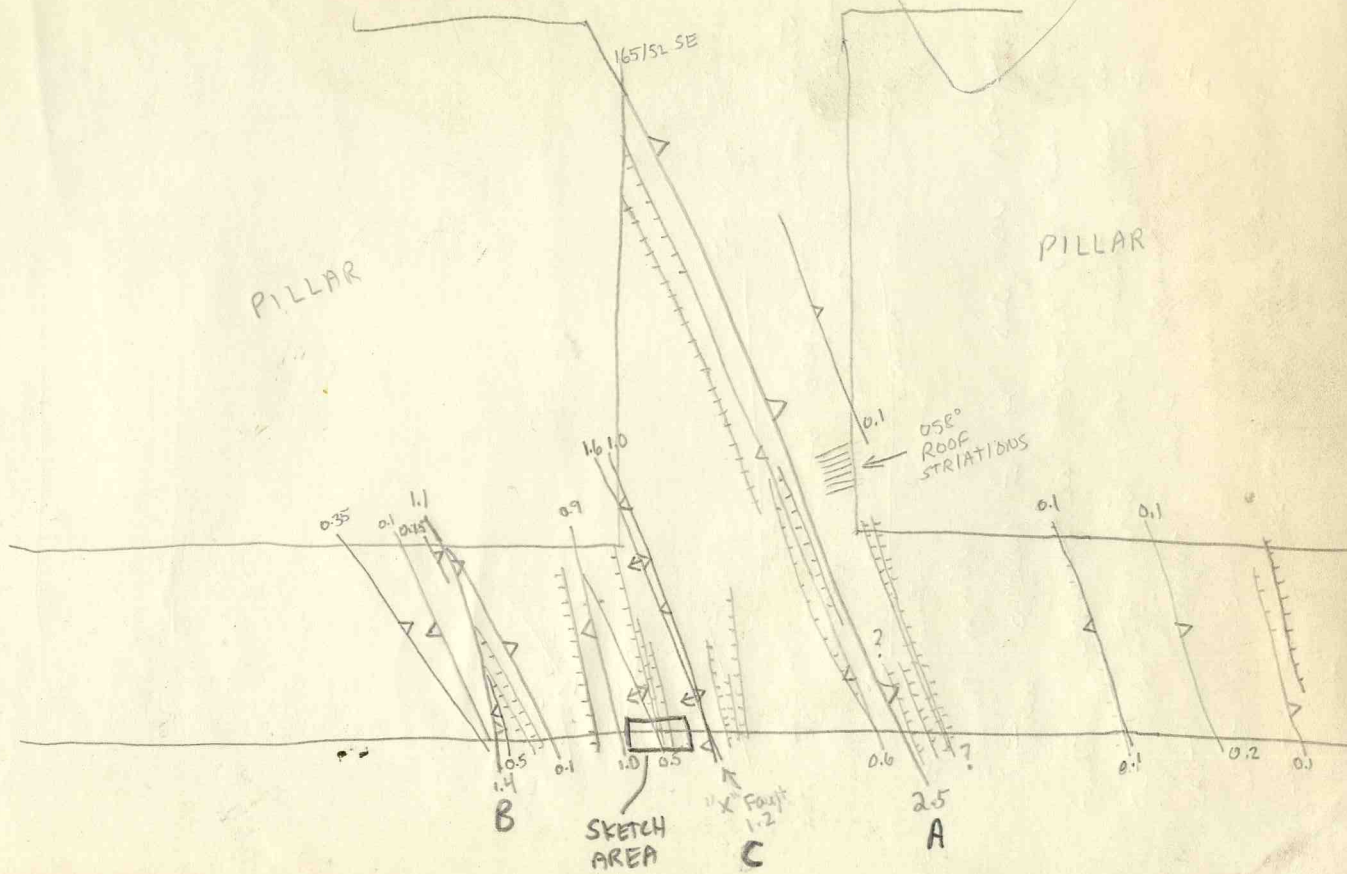
STOP 1 - SKETCH MAP

There are a great number of smaller normal faults and fractures. The easternmost of these lies about 50 feet east of Fault "A". From here to the east end of the mapping area, about 500 feet, there is not the slightest indication of tectonic movement. No fractures, "goat beards", or joints are seen in coal or roof. The only features of interest are several rather shallow, discontinuous "rolls" with associated minor compactional slips.

A few small normal faults occur directly west of Fault "B". From here to west end of the included map there are no major faults, but there are several distinct high-angle to vertical fractures in the coal, trending about 150° . Some of these connect to joints in the roof shale trending the same direction. The roof shale is otherwise not jointed. These fractures show no displacement, but I believe they are fault related. About 800 feet west of Stop 1 is another zone of faults up to about 3' throw and trending 150° . These were not studied by us today and are not shown on the map included with these notes. See notes of May 1977 visit with Fred Krausse.

"C" on sketch map). In the north rib only one reverse fault, of 1.6' displacement is seen. It extends down at least to the Blue Band and has well-developed drag in the coal on both sides of the fault plane. The coal is heavily fractured along the fault plane.

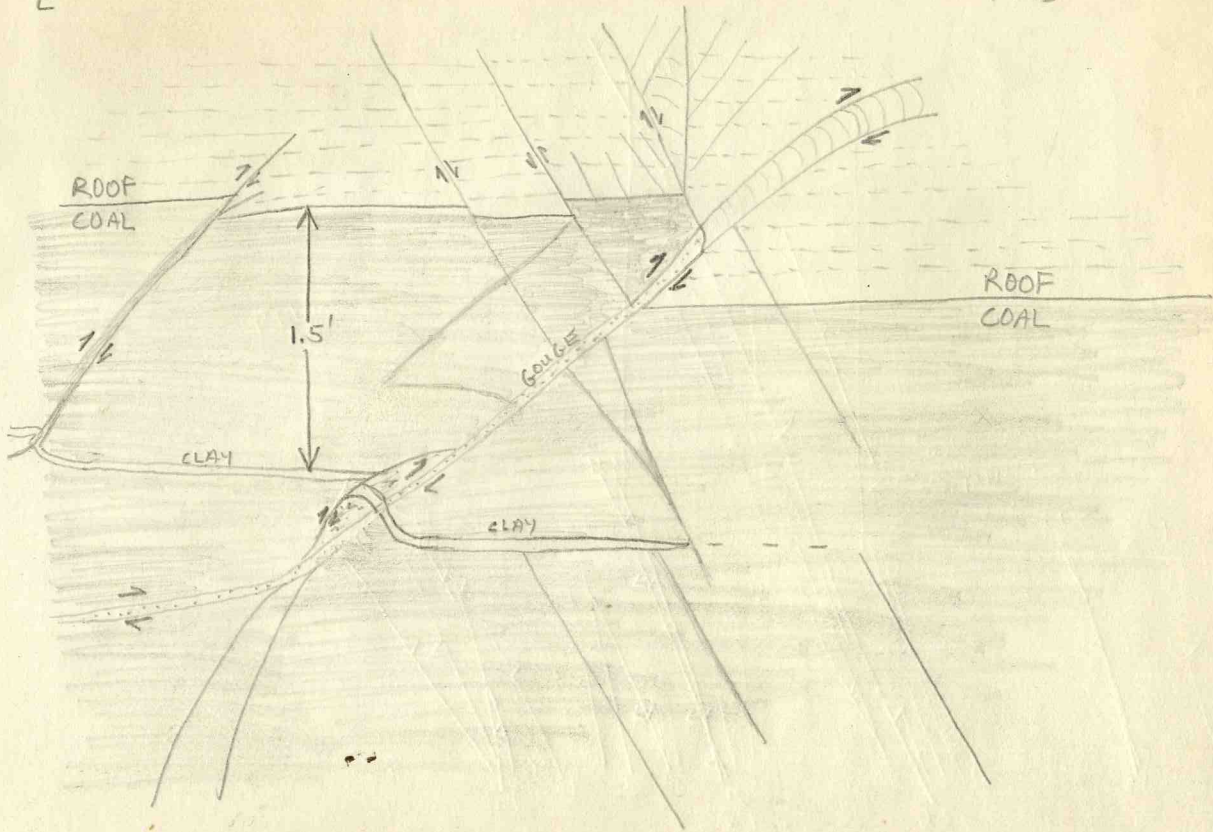
STOP 1 - SKETCH OF PORTION OF SOUTH RIB

On the south rib there are several reverse faults, but they all appear to be branches of the same fault. Part of this system is shown in the sketch (over). The main fault is the easternmost of the set; it is fairly high-angle and has 1.2' of throw. West of this are several smaller reverse faults (shown in sketch). Of these the largest is 0.5' down to the west. It is fairly high-angle at the top of the coal but turns shallow downward and appears to join the 1.2' fault near the base of the coal. Other, still smaller reverse faults also appear to branch off from the main fault.

The normal fault lies about 5 feet east of the reverse fault and the block between is upthrown forming sort of a horst. These faults probably connect with Faults A and C at Stop 1. There are no significant faults east of the 1.4' normal fault.

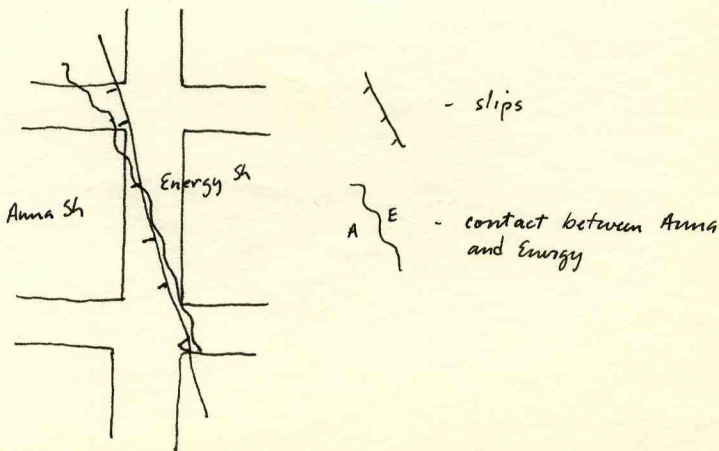
STOP 1

At this stop it appeared that the contact between the Anna Shale and Energy Shale did not coincide with a roll and set of slips. See sketch below.

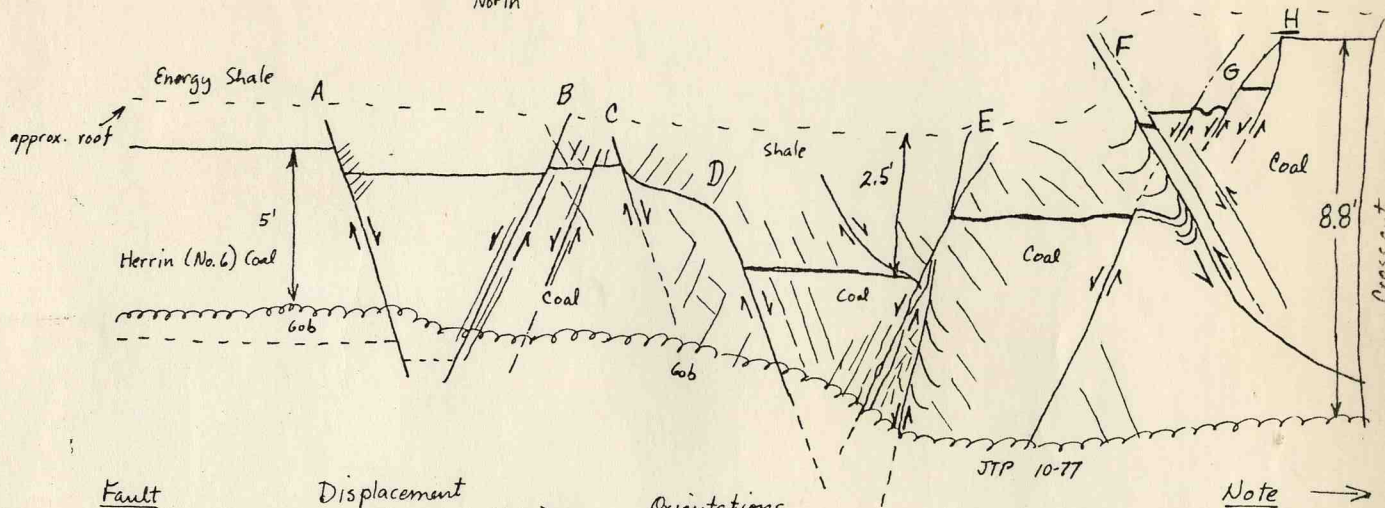
North Rib - Booknote 4

Fault

Displacement
(measured \perp to bedding)

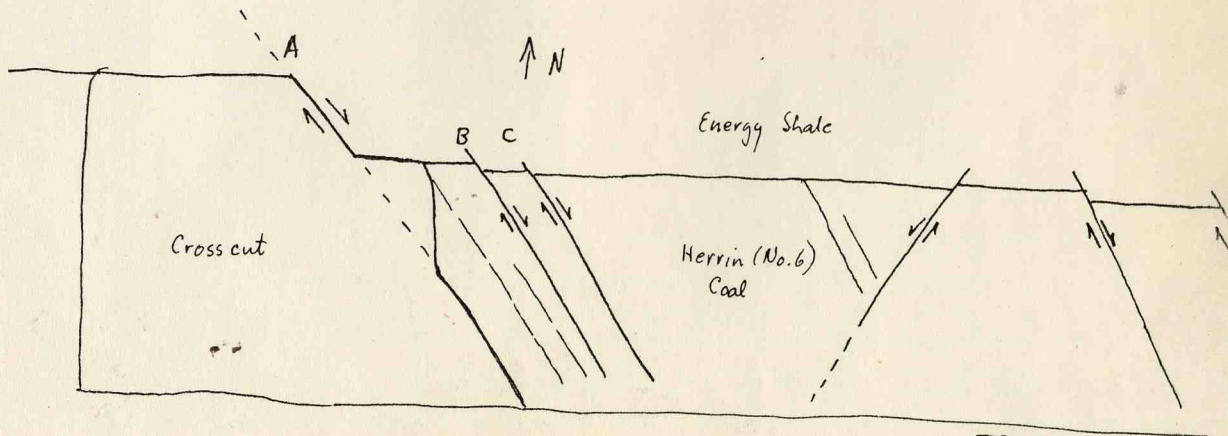
Booknote 4 - Next crosscut east

<u>Fault</u>	<u>Displacement</u>	<u>Orientation</u>
A	2.4'	150°/61°NE
B	0.1'	150°/60°NE
C	0.1'	175°/65°NE (does not continue in roof)

The drawing pretty well tells the story of this stop. My view is on the north rib; J. Nelson described the south rib and F. Krausse discussed the next entry north.

Perhaps the most striking feature of these faults is their discontinuous nature across the entry, and through the pillar. The faults change directions slightly. They are continuous from the roof into the coal, although we did not dig out the floor rock because of rib rash.

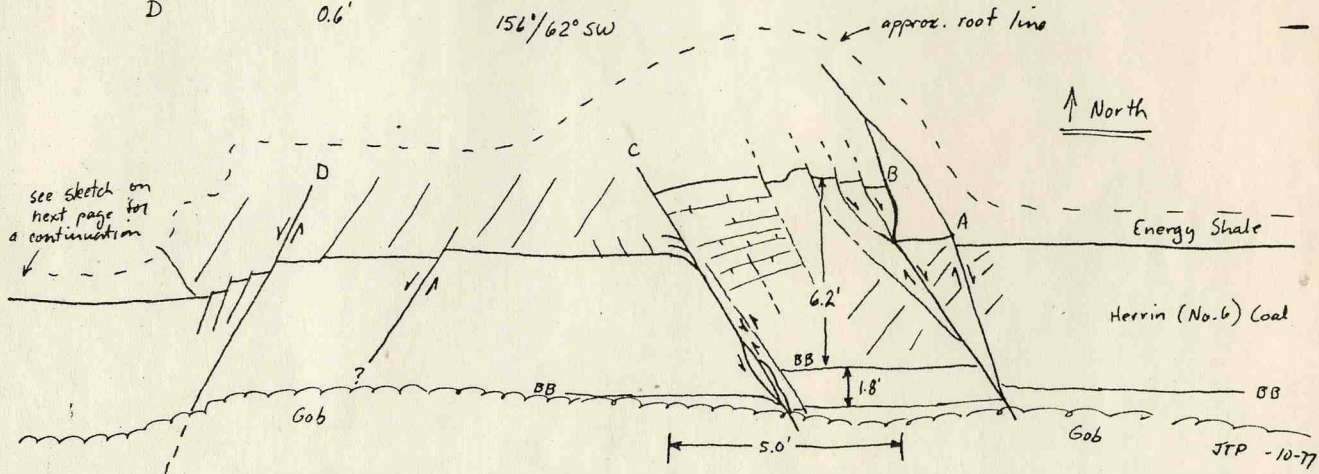
North Rebr, in the 2nd SE Panel Area

<u>Fault</u>	<u>Displacement</u>	<u>Orientation</u>
A	0.3'	170°/70° NE
B	1.4'	157°/50° NE
C	1.8'	160°/53° NE
D	0.6'	156°/62° SW

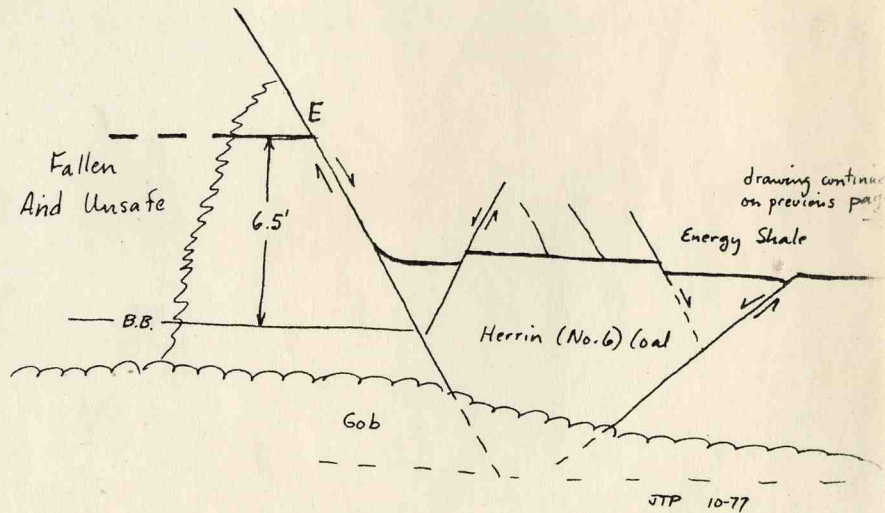
Continuation of BN 5 (to the west)

<u>Fault</u>	<u>Displacement</u>	<u>Orientation</u>
E	3.5'	155°/70°NE

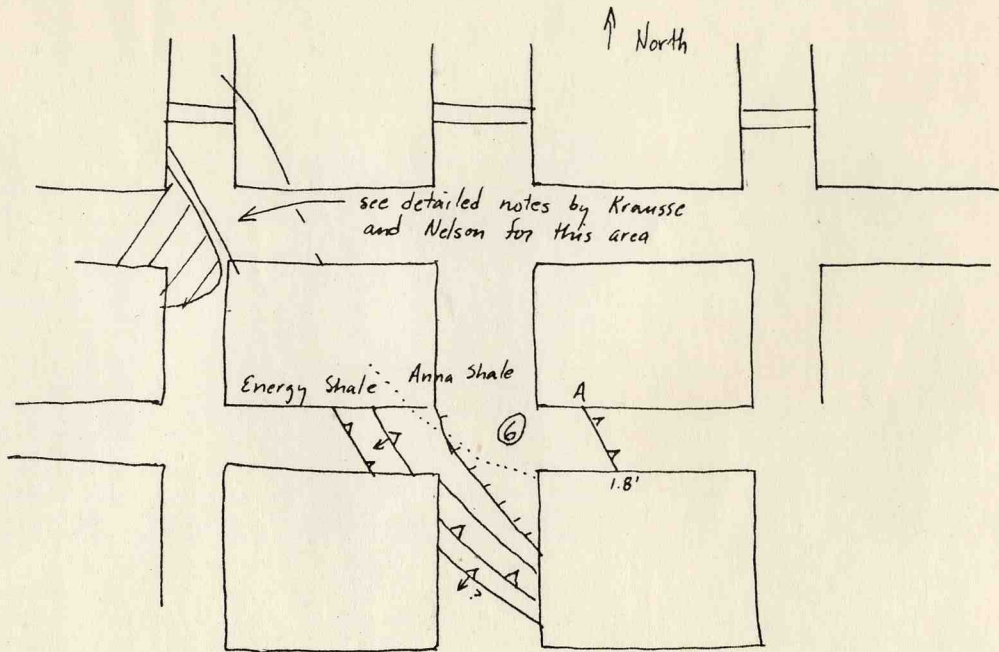
Booknote 6

The top conditions and exposures are generally bad, and rib rashing is hazardous. In the sketch map below I have incompletely begun to map the faults.

Fault A is a normal fault, 1.8' displacement, trending $150^{\circ}/54^{\circ}\text{NE}$. Lithology above the coal includes an irregular coal ball zone, 0.1-0.3' resting on the coal, 0.4-0.6' of dark gray, fossiliferous limestone above the coalballs, and 1.6'+ black, fissile shale above the limestone.
