Mine Index # 639

EL-B COAL CO. EL-BEN MINE NO. 2 LOGAN COUNTY

Heinz Damberger of the I.S.G.S. visited this mine several times in the latter part of 1968 in the course of a study of clay dikes or "horsebacks" in Illinois coal seams. He was accompanied on at least some of these trips by Ken E. Clegg of the Survey, and by Ronald Kern, at the time a graduate student in Geology at the U. of I. According to both Kern and Clegg, Damberger made numerous notes on his visits to El-Ben. These notes apparently are lost. Damberger was notoriously sloppy about filing his mine notes.

The following are photographs made by Damberger on several of his visits to El-Ben. These notes were found by Bob Ringler on 6/17/76, in a filing cabinet in Damberger's former office after Damberger had left the Survey. Also found in that cabinet was a ring binder containing more photos with captions, and notes and text relating to this and other visits. This notebook is now stored in the Coal Section Confidential Room (as of June 1976.) It is labelled "HHD, Clastic Dikes Ms."

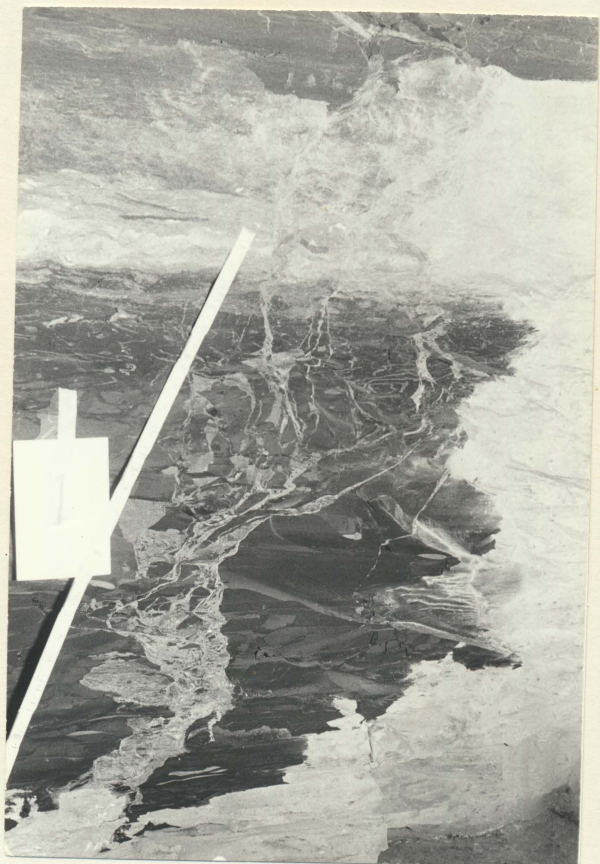
PH. 28-21 v. 4

This photo and the one following appear to be from El-Ben but cannot be matched to specific captioned photos in Damberger's notes.

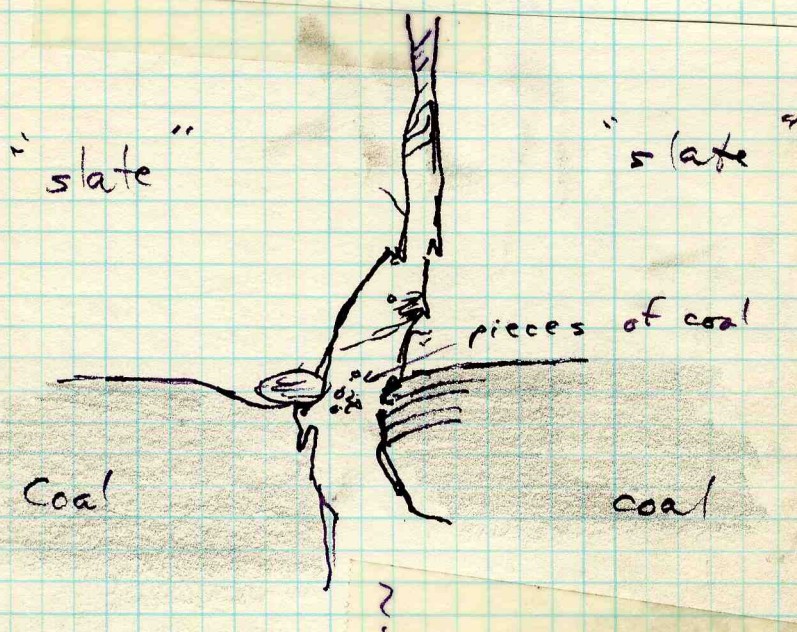
- 1. ~~At location 10~~ At location 10 in "bottom"
 - #1-2 thick "hb" with displacement of coal and splitting in roof shale
 - 3-8 thin "hb", very small displacement of coal/roof border, shearing in "bb" very nicely exhibited
 - 9-14 details of #1-2; thick "hb": 10°/vertical to 50° E; thin "hb": 10°/vertical with slip to W drag direction opp. so thick "hb"
- loc. ① photos on E side on film #1, photos on W side and roof on film #2, 1-3 trend: $N 80^{\circ} E$
dip $20^{\circ} N$ to vertical

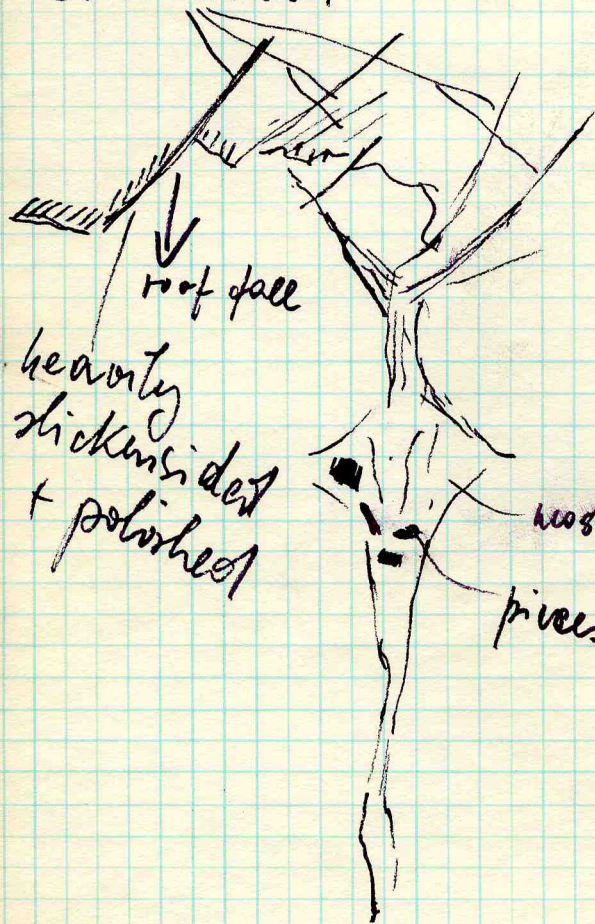
loc. #1 in sketch

photos 4 and 5 on film #2, on location (6) (old roof fall), showing slickensided planes above and in connection with "h.b.", where this big roof fall started.

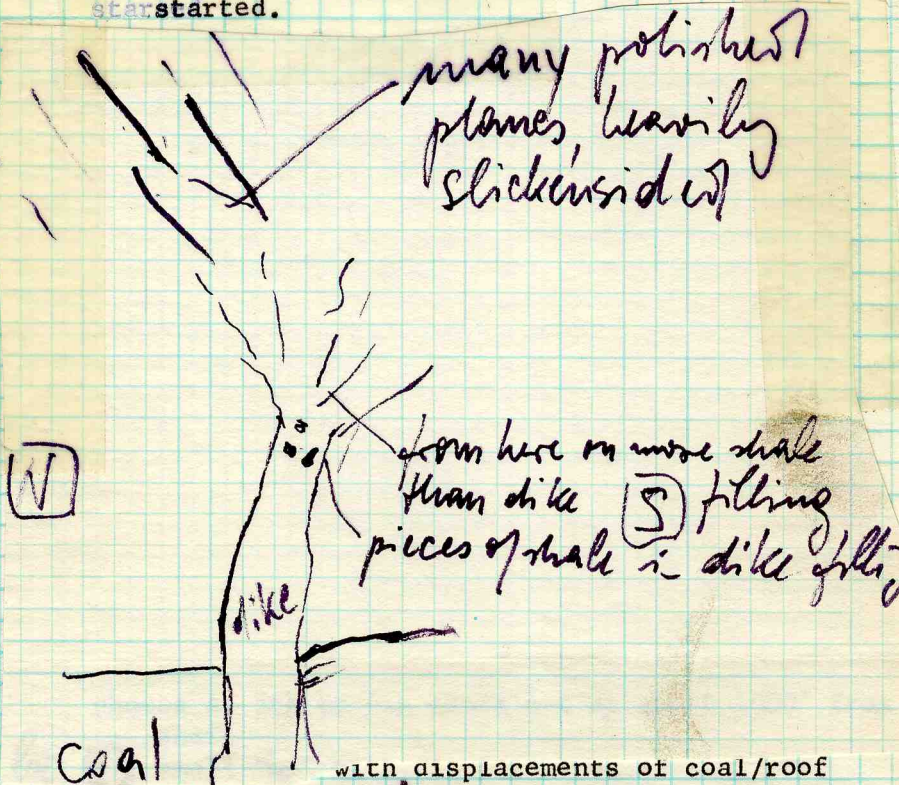
with displacements of coal/roof shale border (stick \pm parallel to top of roof) Photos #6-9; 1 the whole; 1 close up; floor not exposed; direction of "h.b": strike $N 35^{\circ} E$, dip $N 55^{\circ}$ to $N 75^{\circ}$

Note: horseback splits into several branches directly above the coal seam. The southernmost branch dipping about $N 55^{\circ}$, with tendency toward shallower dip in the upper reaches of the "h.b." and with much slickensiding. Results in a weakened roof in this vicinity (slight roof falls) shearing such as in the diagram:

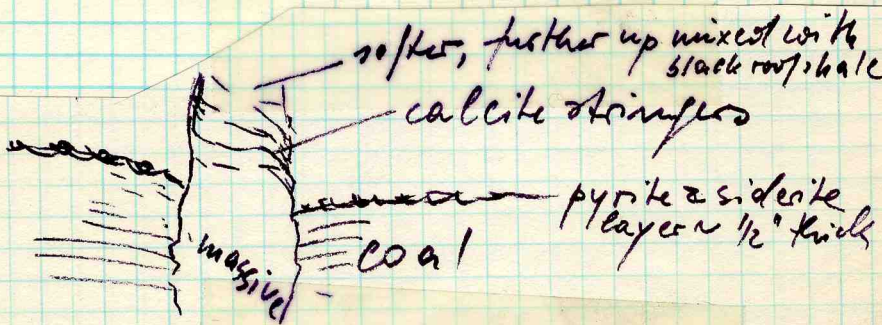
location #4 N end of 5th entry, N side of "b" moved
down 3-4"

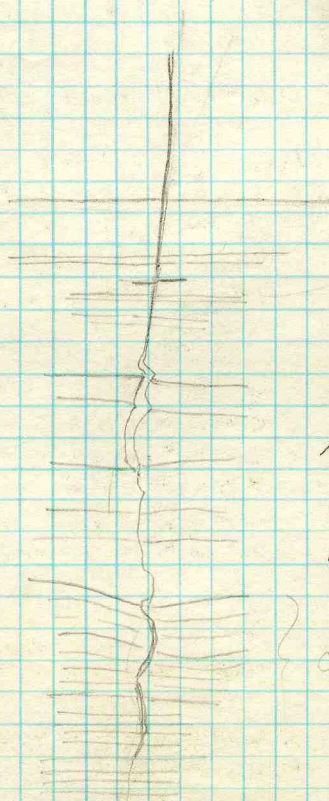
Clay dike
in roof
of #5 Coal

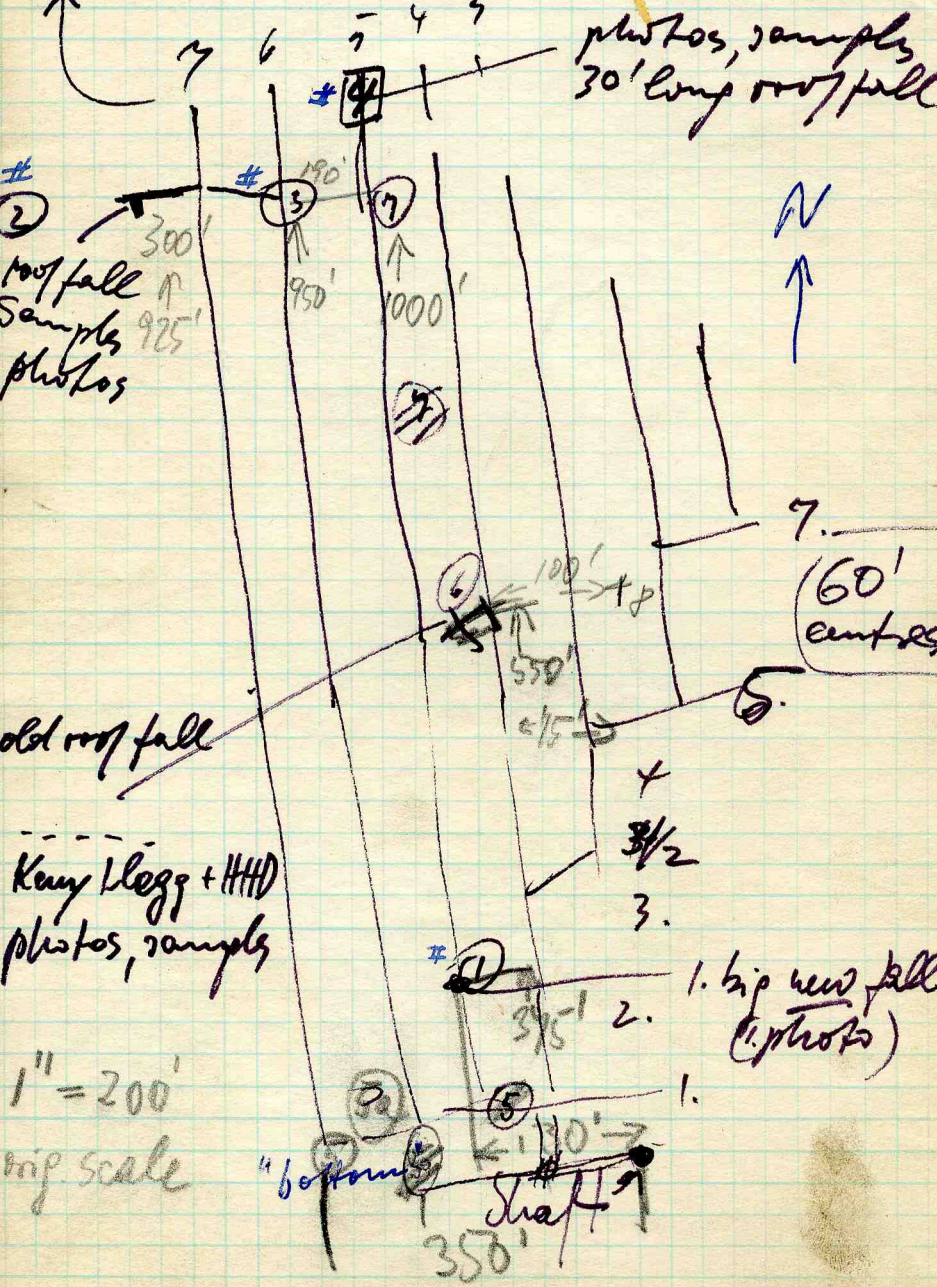
about 1160' off shaft

1. Entry #5 N, series of samples taken from above St. David Limestone, down into the coal both from adjacent rocks and clay dike which is exposed in a roof fall a few hundred feet N of "bottom"; and pictures taken both with and without samples location
