Slope Mine  
 RIOLA MINE  
 Mine Index No. 1018  
 Vermilion County

Visit to Riola Mine of Catlin Coal Co.

February 8, 1996

## Visit to Catlin Coal Company's Riola Mine

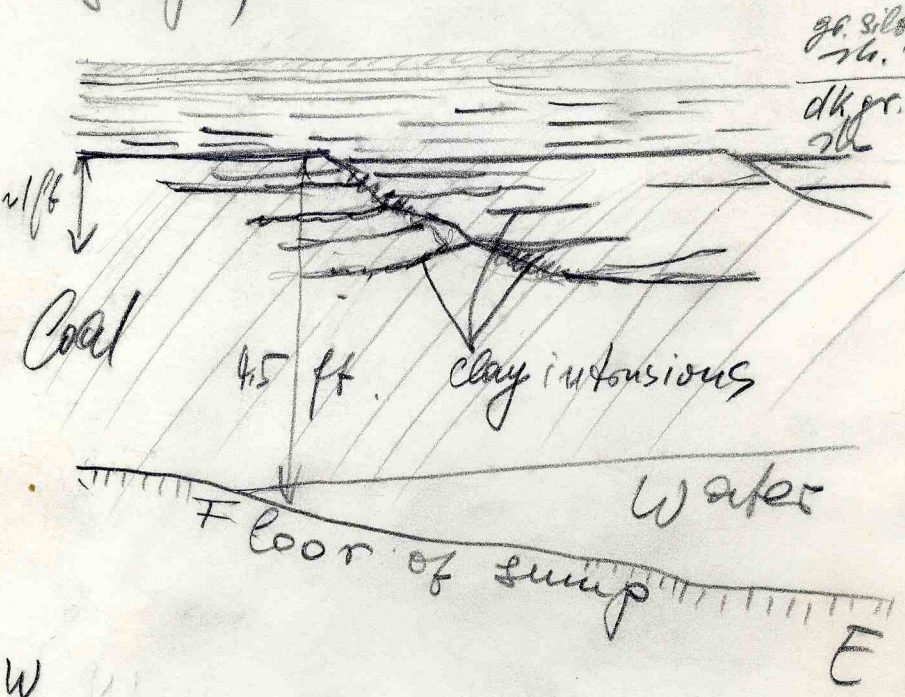
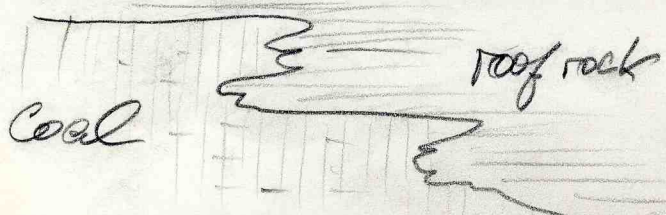
Sketch of left (W) wall of  
Sump opening, at about 45° to  
slope, close to bottom of slope

Sketch of face, looking NNE

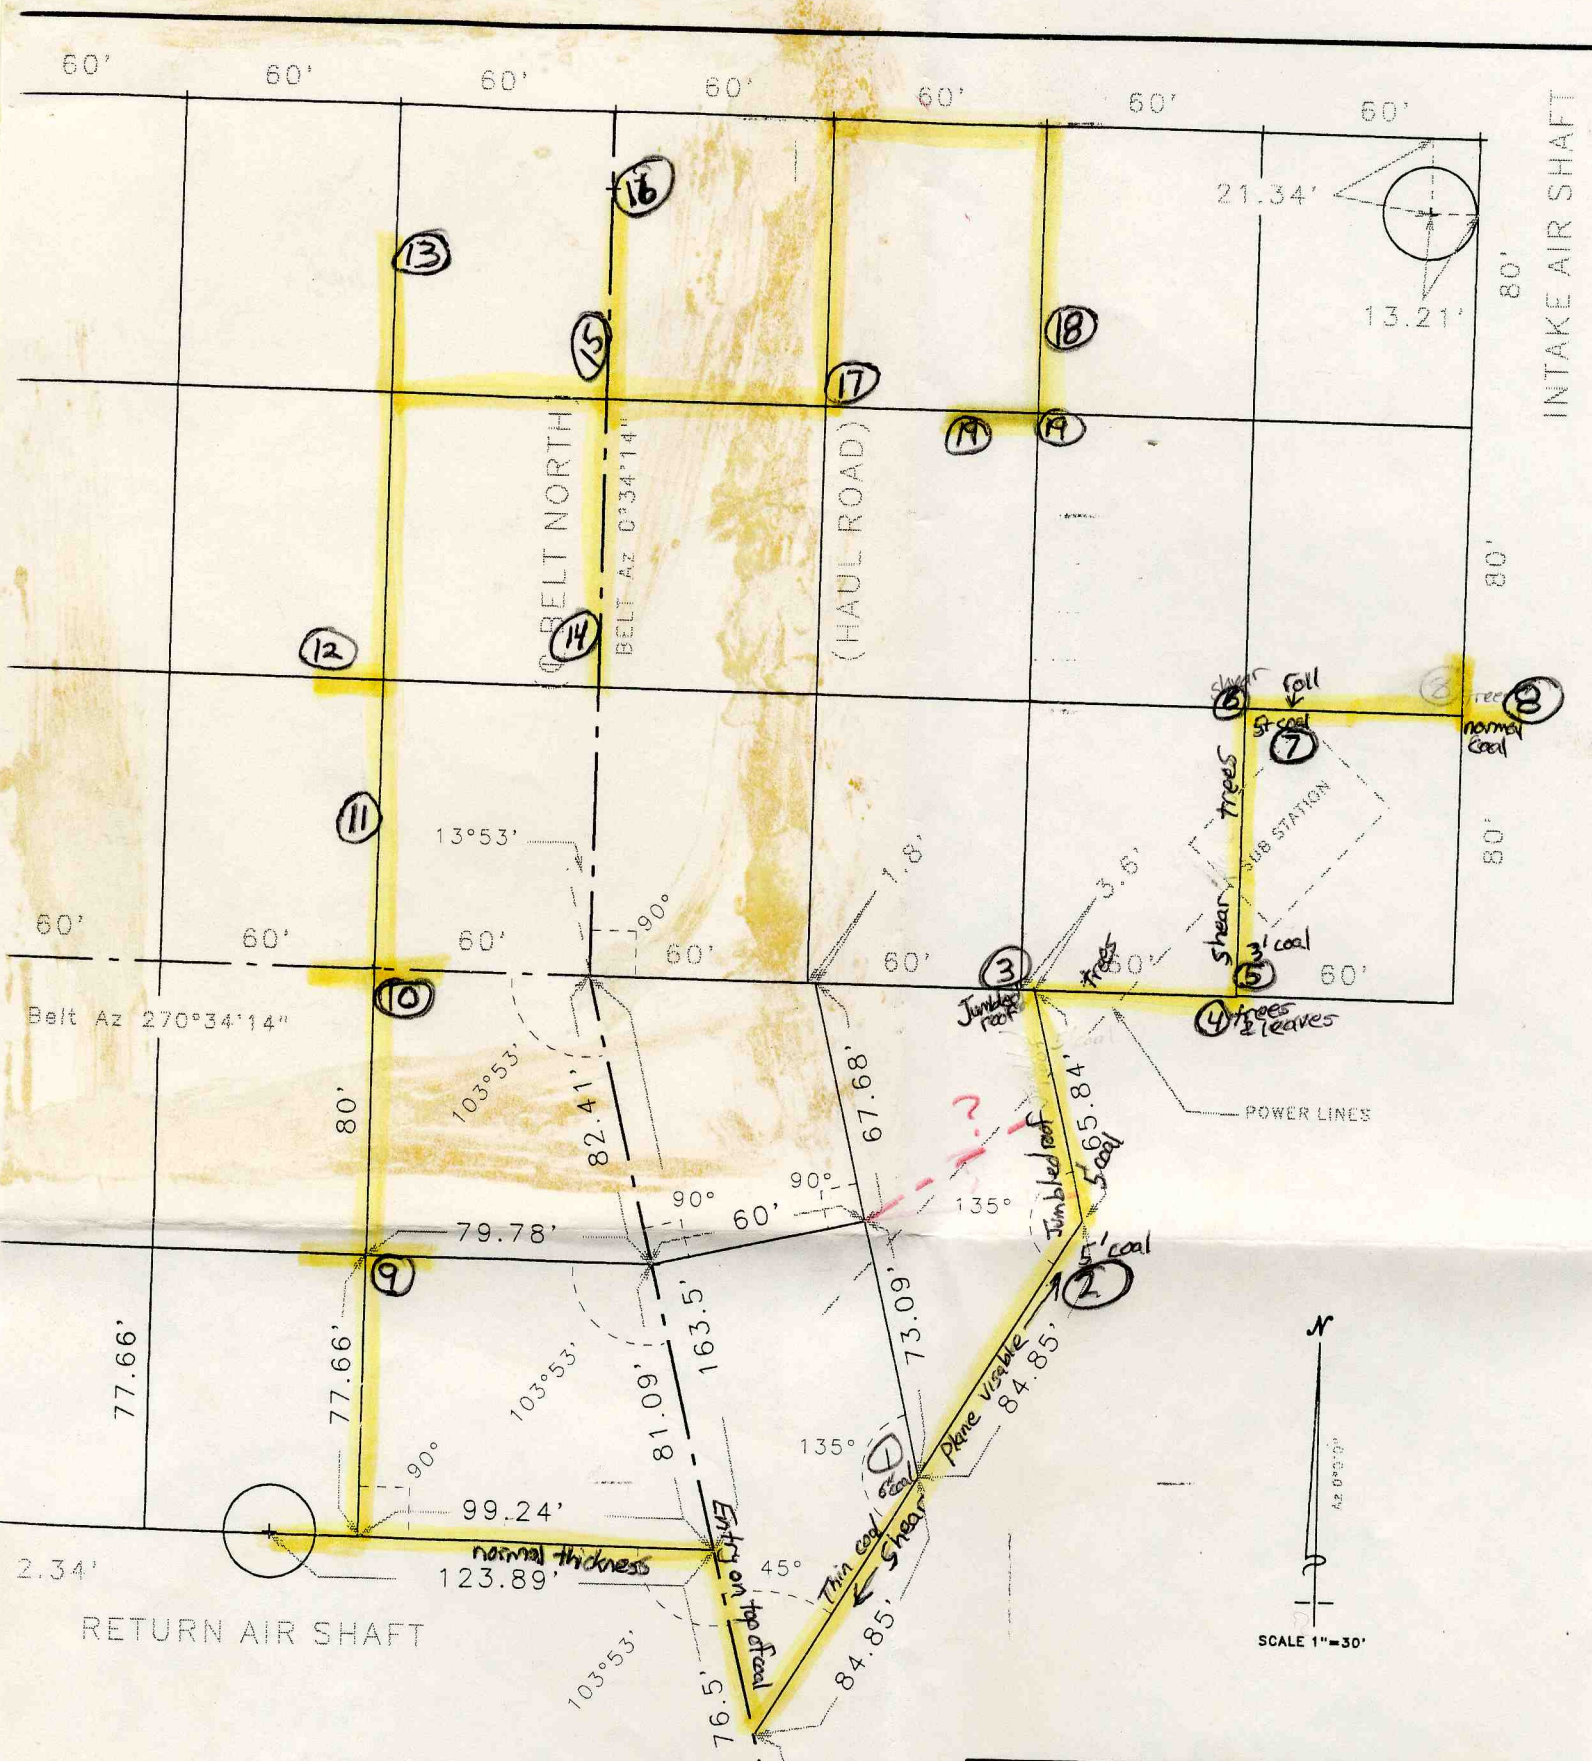
- Entries examined on May 16, 1976

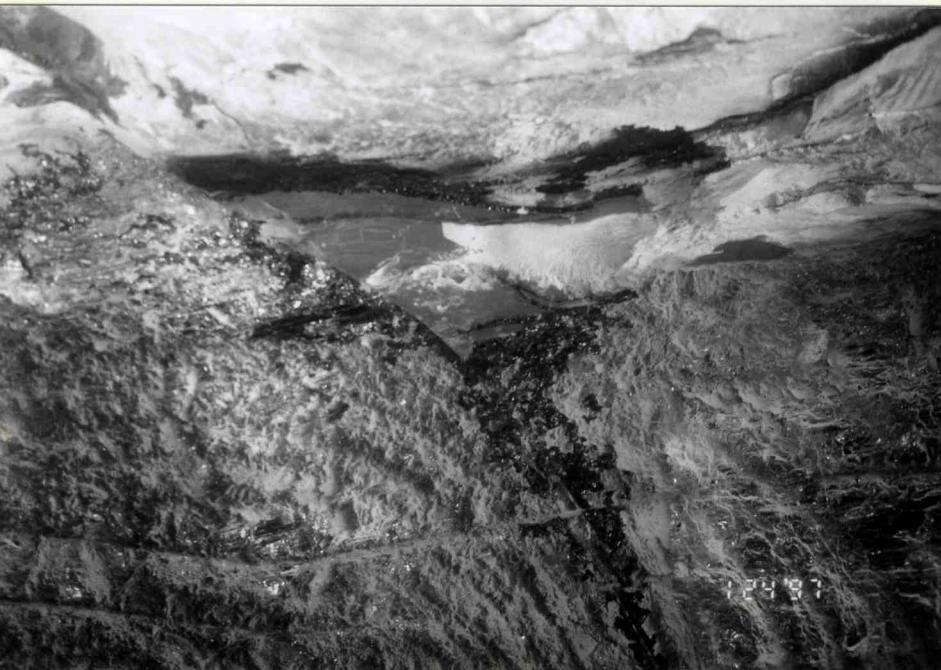
In several places we noticed that sand had been mobilized (including locations 12 and 12); thin irregular veins of fine sand were observed in several places within disturbed roof rock and also within the coal. In one place (location 12) an irregularly shaped body of sandstone up to about ½ ft thick was found about 3 ft below the top of the coal; on one side it ended abruptly, apparently because it was sheared off there. At the same site several small very irregularly shaped sandstone inclusions were observed within the coal seam, apparently brought into the seam along shear zones when the disturbance happened.

Displacement of coal. Location 12, Riola Mine

Displacement of coal into roof rock.  
Location 12                      Riola Mine

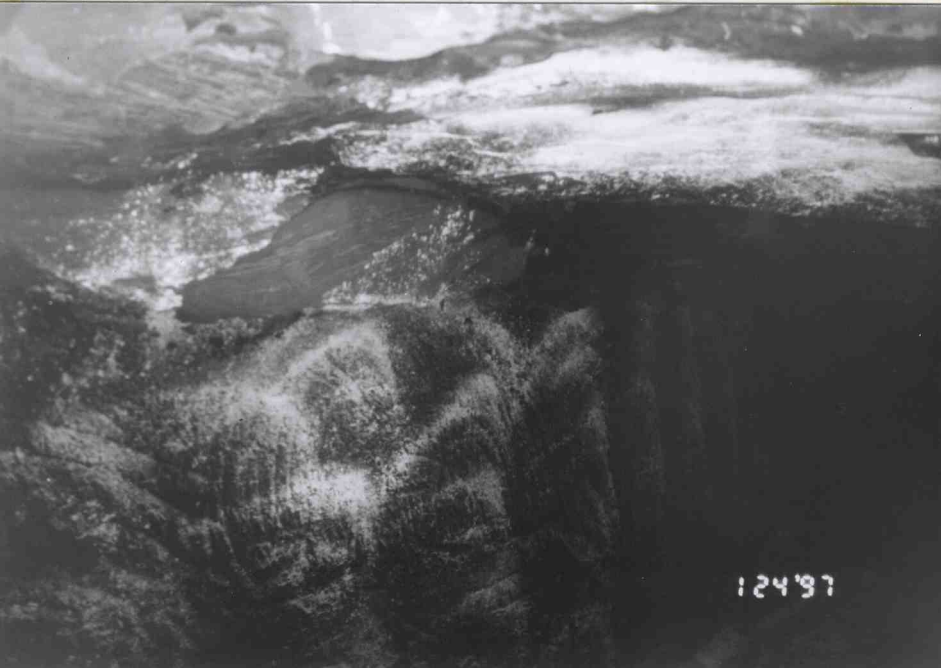
Roll, south rib, location 13

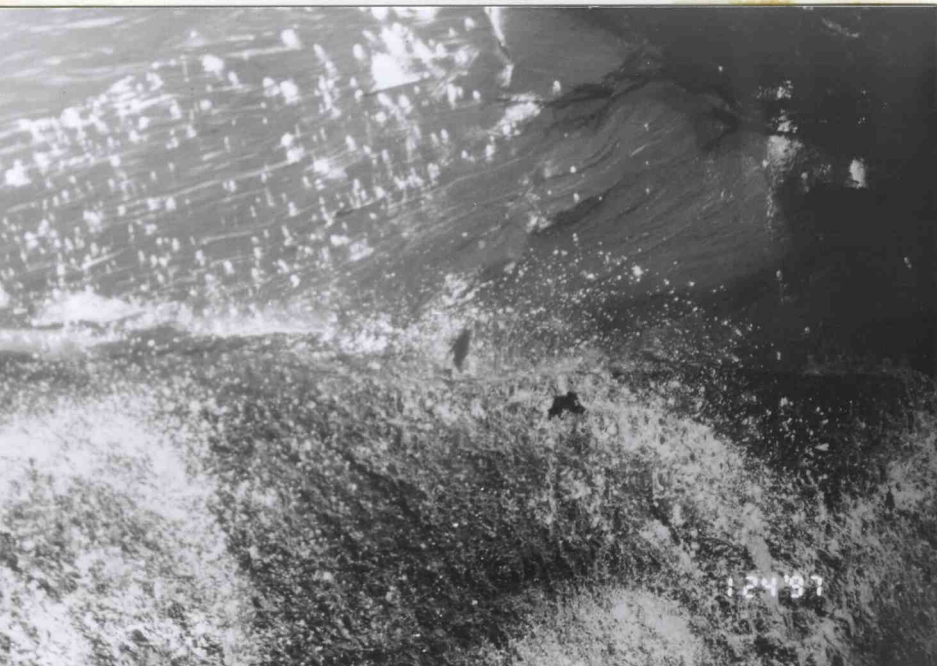
Closeup of roll, south rib, Location 13, Riola Mine

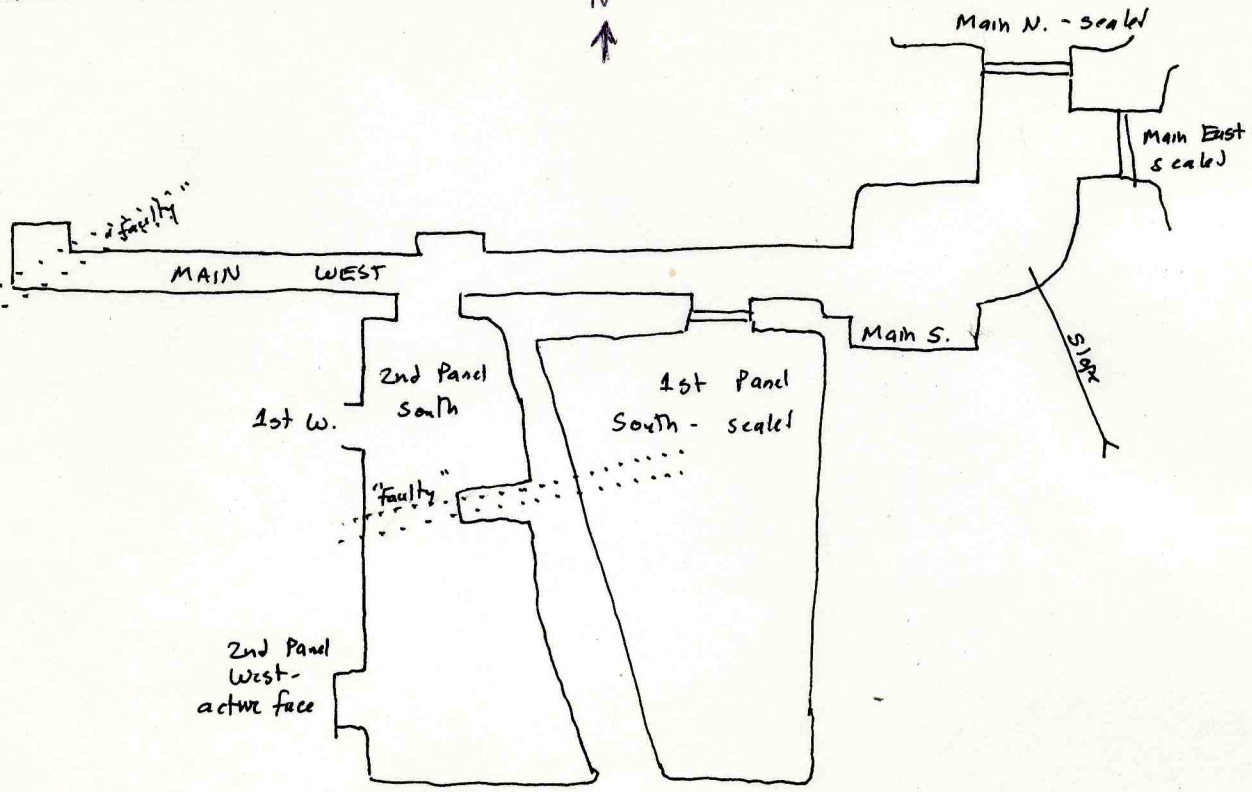
Black Beauty Coal Co. - Riola Mine  
Sketch map by John Nelson

**Summary.** Among mines I have seen having gray shale roof, this one has better than average roof conditions. The biggest problems we saw are associated with the three sets of rolls, which are readily mappable and should be predictable in advance of the working face. I saw no kink zones or other direct indication of in situ stress, although roof falls appear to be more common along north-south entries than east-west ones. Cutters, which form along the ribs and extend several feet upward, develop only in the older works and were not evident in newly mined areas. They seem to be more prevalent in north-south headings, but mapping would be needed to verify their distribution. Conditions at Riola contrasts with those at the nearby Vermilion Grove Mine, where severe kink zones develop immediately after mining and lead to roof falls at the working face. According to Penny, the roof shale at Riola has ten times the compressive strength of that at Vermilion Grove - a factor that readily accounts for the more serious stress-related roof failure at the latter.
