Sahara Coal Co. Mine # 21

SAHARA COAL CO. MINE NO. 21 SALINE COUNTY, ILL.

Notes by John Nelson on visit with Roger Nance and H.-F. Krausse, with Bob Gullic and John Lane of Sahara, on May 27, 1977.

Purpose of visit was to examine faulted areas and select regions for possible future detailed mapping in our study of the Cottage Grove Fault System.

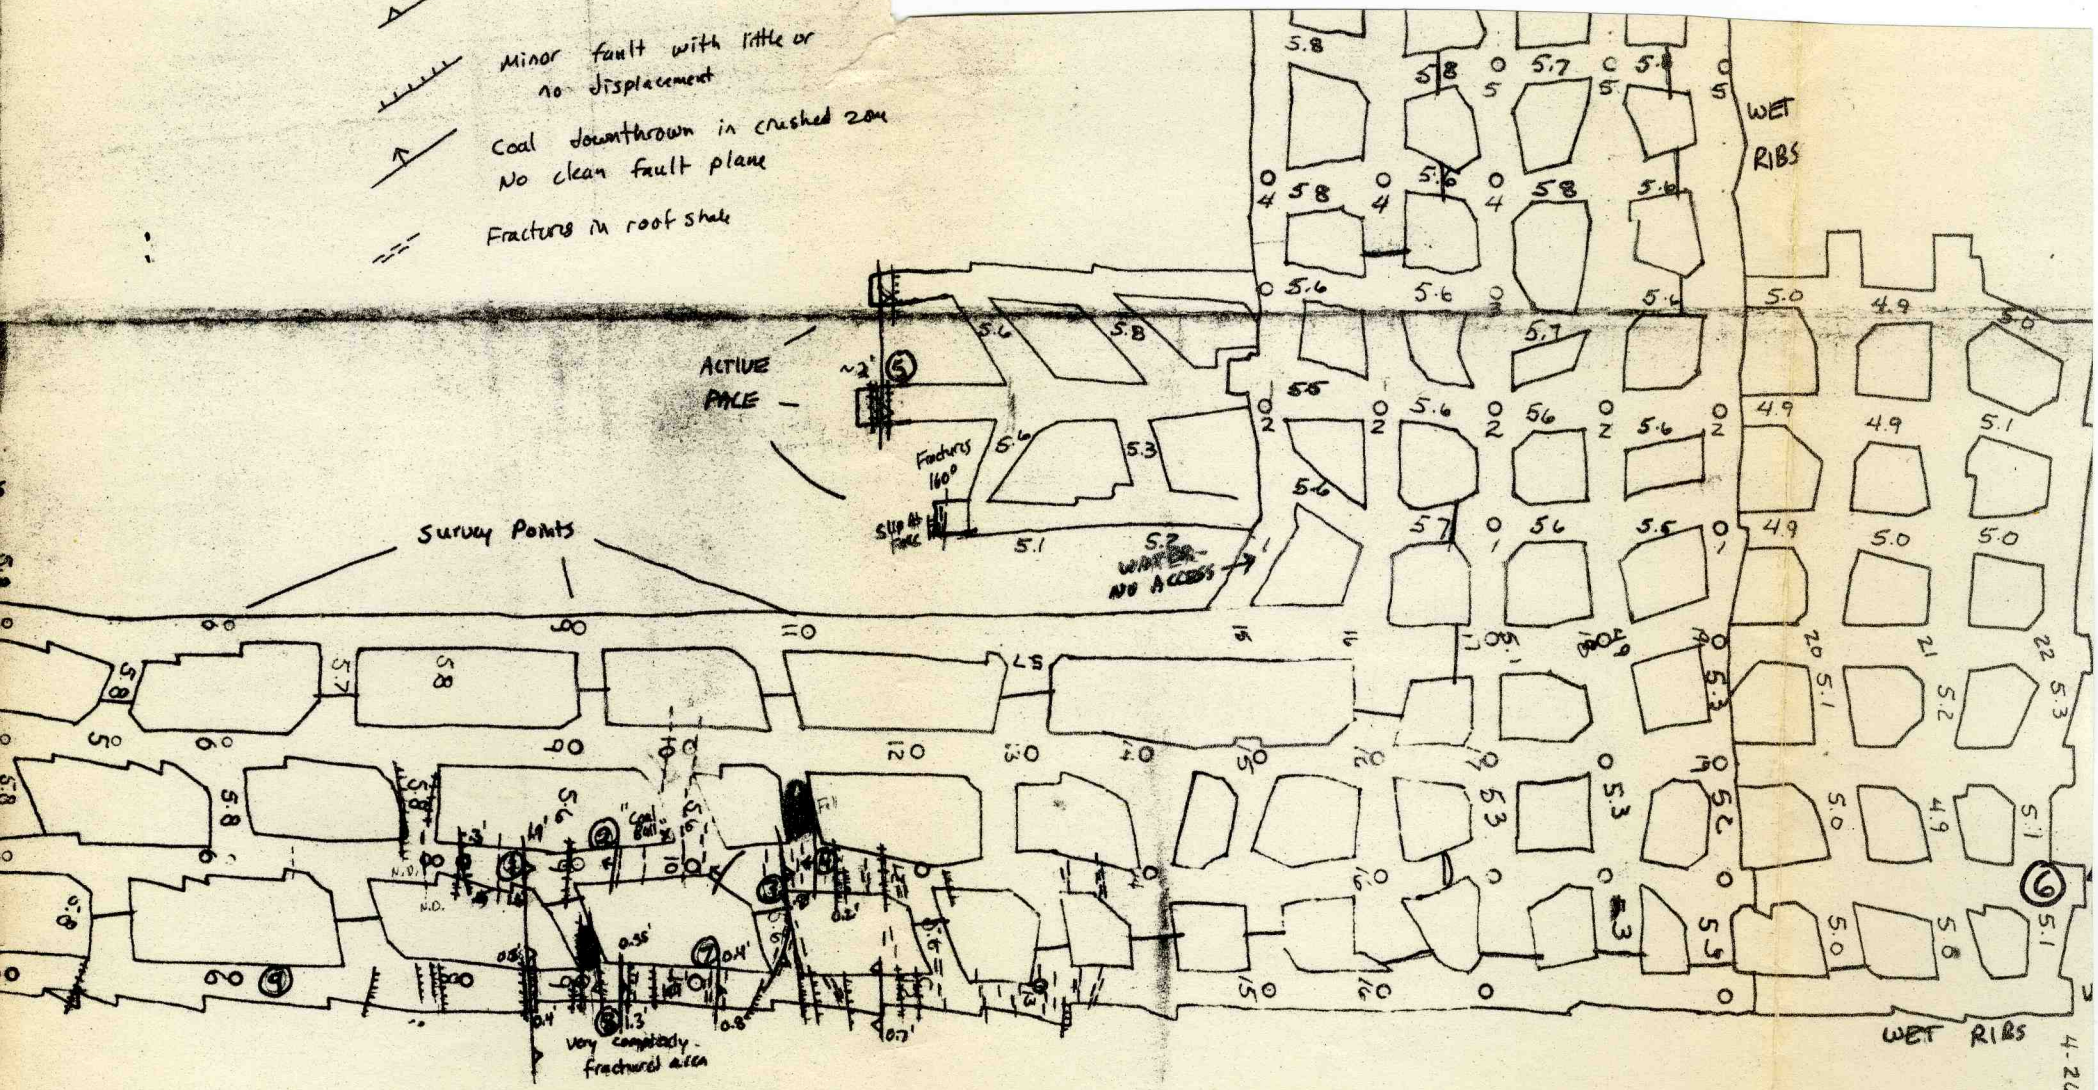
Fractures in roof shale

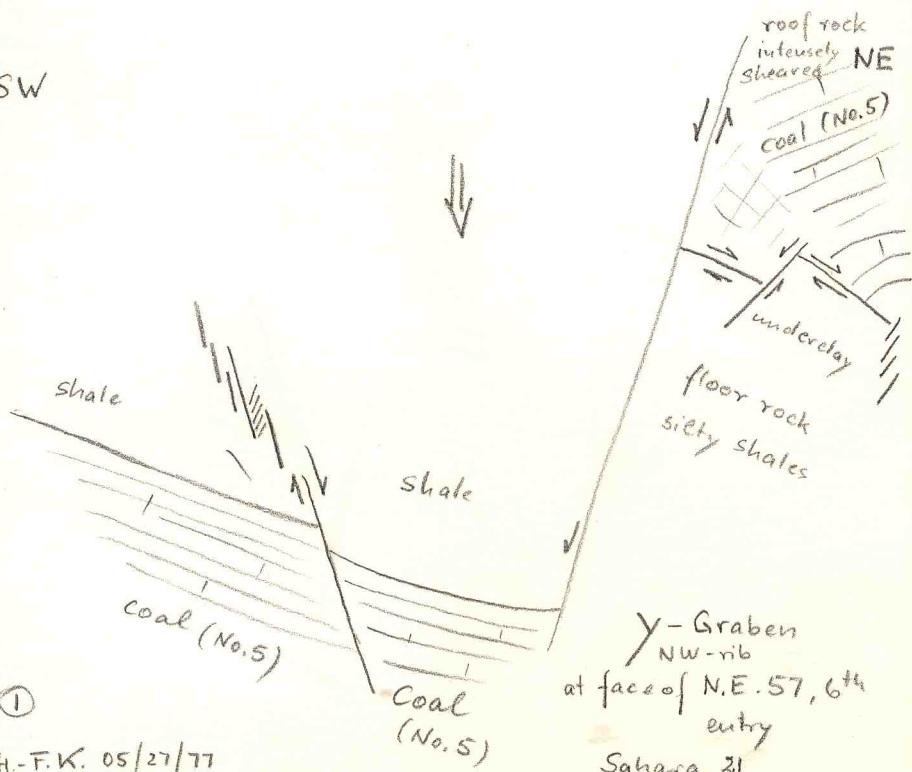
①

Company surveyor had supplied a map showing a small fault near the mouth of the NE 57. No fault was found. The roof contains very few joints. The few fractures present trend about 100° . Minor slabbing of immediate roof (medium gray silty shale with plant/remains).

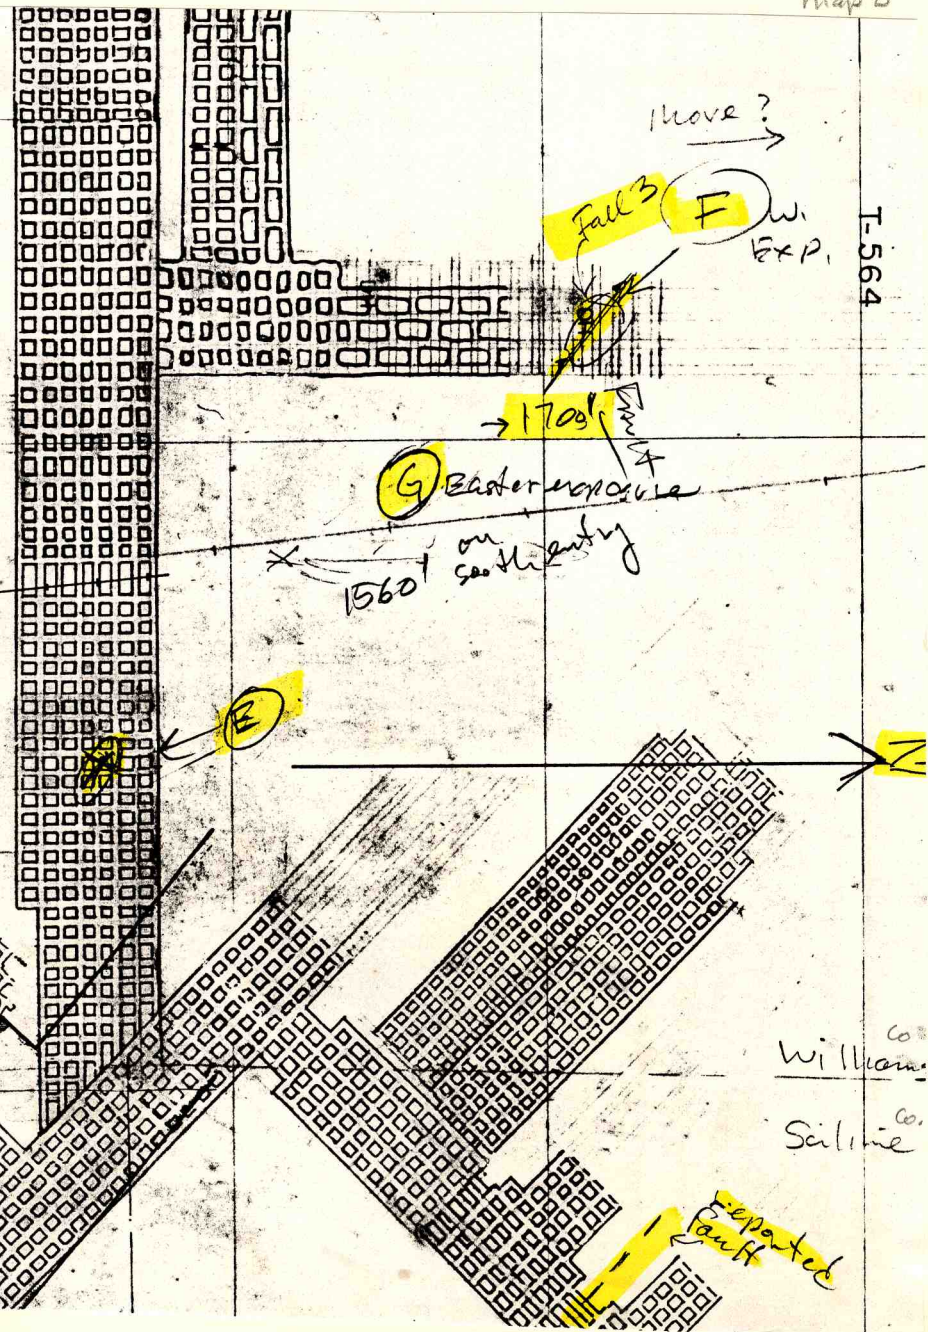
W.T.F. sketch of Wirrib Site F
9/20/90

F. We then went north into Unit 3, which is only ca. 30 c/c in, to look at small fault. Springfield is 4.24' thick on travelway at c/c 14. Area cut with entries on 80' centers + cross-cut at 150' interval (submain layout?): they hit fault 1700' N. of Main's vic 28 c/c. Here at western exposure there is about 5' net throw down to SW on 3 fault plane plus splinter-faults. We are told strike varies from N.30-45° W. across the entries. At one(?) c/c to East we examined a 6' fall at the fault (Fall 3) where entry is 18' wide. 5' and 6' bolts used in top of fall. Wayne made sketch of W. rib exposure and argued some slumping had occurred. E rib shows single fault plane with roughly 50° dip down to SW.
