Truax-Traer Coal Co. Hillsboro Mine

CONSOLIDATION COAL CO.
HILLSBORO MINE

Mine Index No. 871
Coal Report No. S-5

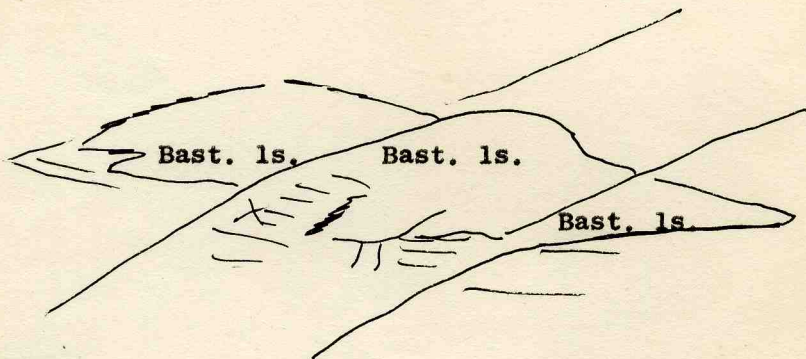
Photos 11 and 12.

- ③ Two clay dikes en echelon, take close-ups!
- ④ Small clay dike confined to top 1/2 of seam.

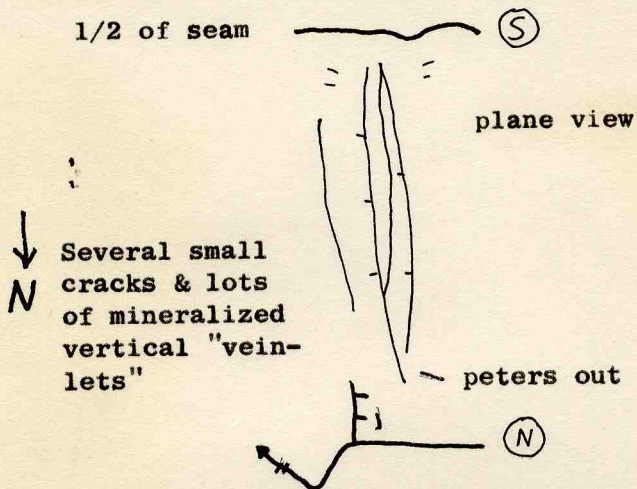
- ⑤ Slip in roof across intersection petering out in coal (top 1/2) as usual.
 - ⑥ Slip down into about 1/2 coal, usual petering out. 120/42-45 S
 - ⑦ Small slip, only in N side of crosscut, peters out in about middle of crosscut, also in usual way down in about 1/2 of coal.
- 40° 135 En echelon off-set in middle to fine streak only in S-side of roof.
- ⑧ Small slip, peters out quickly in coal, with 55-60 115 en echelon continuation also along trend.

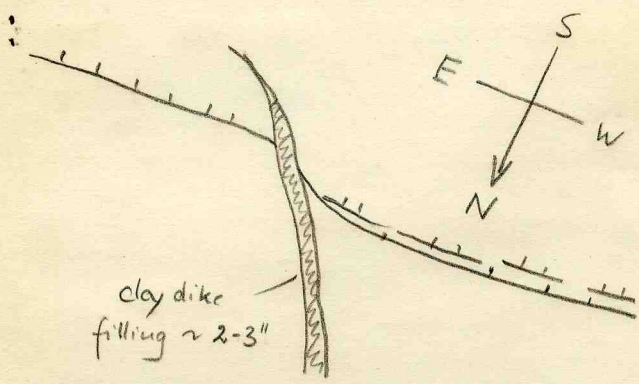
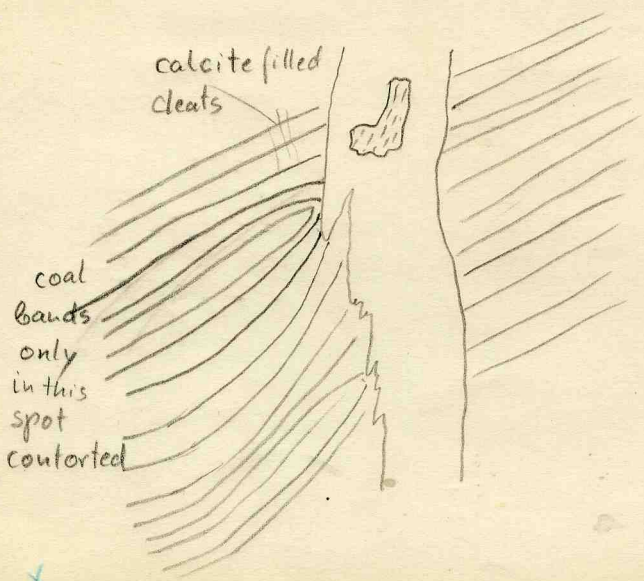
Photo taken
12-04-74

4. Clay dike in roof traceble ¹³⁰ 30/45-55 SW.

(36) 5. Roof is Anna Shale with well developed joints about 60° strike also small clay dike type fault 85/58 South, joints spacing 4 joints/3'.

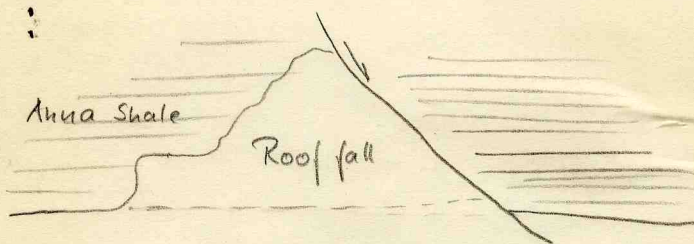
(38) 7. Roof consists of Anna Shale with prominent joints 70/85 SE roof show slabbing and kinks along joint zone.

(38a) 7a. 5' further North clay dike type fault 85/40 SE at east rib is hard to trace west wards similar to #5.

(39) 8. North rib shows clay dike with small fault about 140°/very low angular roof fall area.

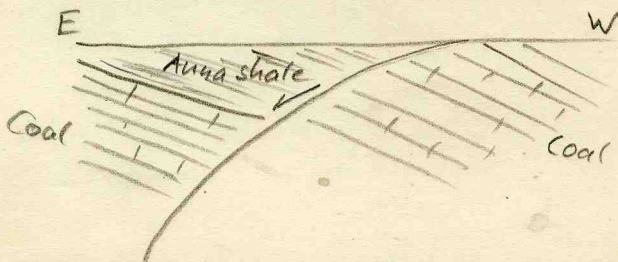
(46)

9. Similar to 8, but not as much fallen (yet) cribs serve as protection.

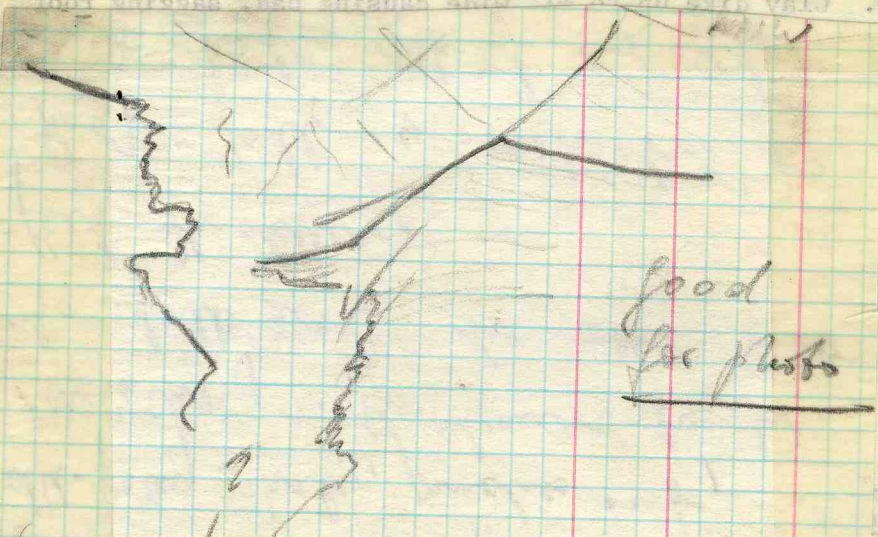
Clay dip up to 11' wide caustic bed, sequence roof

good for photos

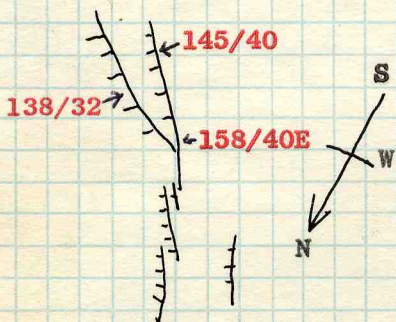
Crosscut 8
Entry 7, 1st S.E.

72. Clay dike, 2-3" filling, about 3' down into coal, rather "explosive" look, runs along edge of fall, slips continuing into roof are visible abt. 120° , in map.
73. Slip in roof with up to 1" clay filling, bifurcates at position indicated into small clay dike to W. and coal mylonite dike to NE, clay dike fades after about 10', coal mylonite dike after 1-2'.
74. Small slips in top coal with thin clay filling.

75. 1.5-2' clay dike—good for photo + vertical, almost down to bottom of seam.
76. Fairly straight small slip in top coal, petering out close to NNW rib like so:

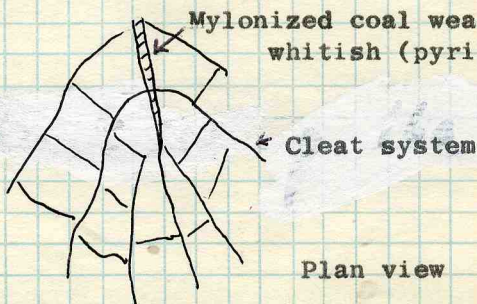
Good
for photo.
