Freeman United Coal Mining Company Orient # 4

Mine Index No. 688
County No. 1671
Coal Report No. S-99

Coal Slope 750' S, 650' W
of NE cor. NE $\frac{1}{4}$ SE $\frac{1}{4}$, Sect. 28

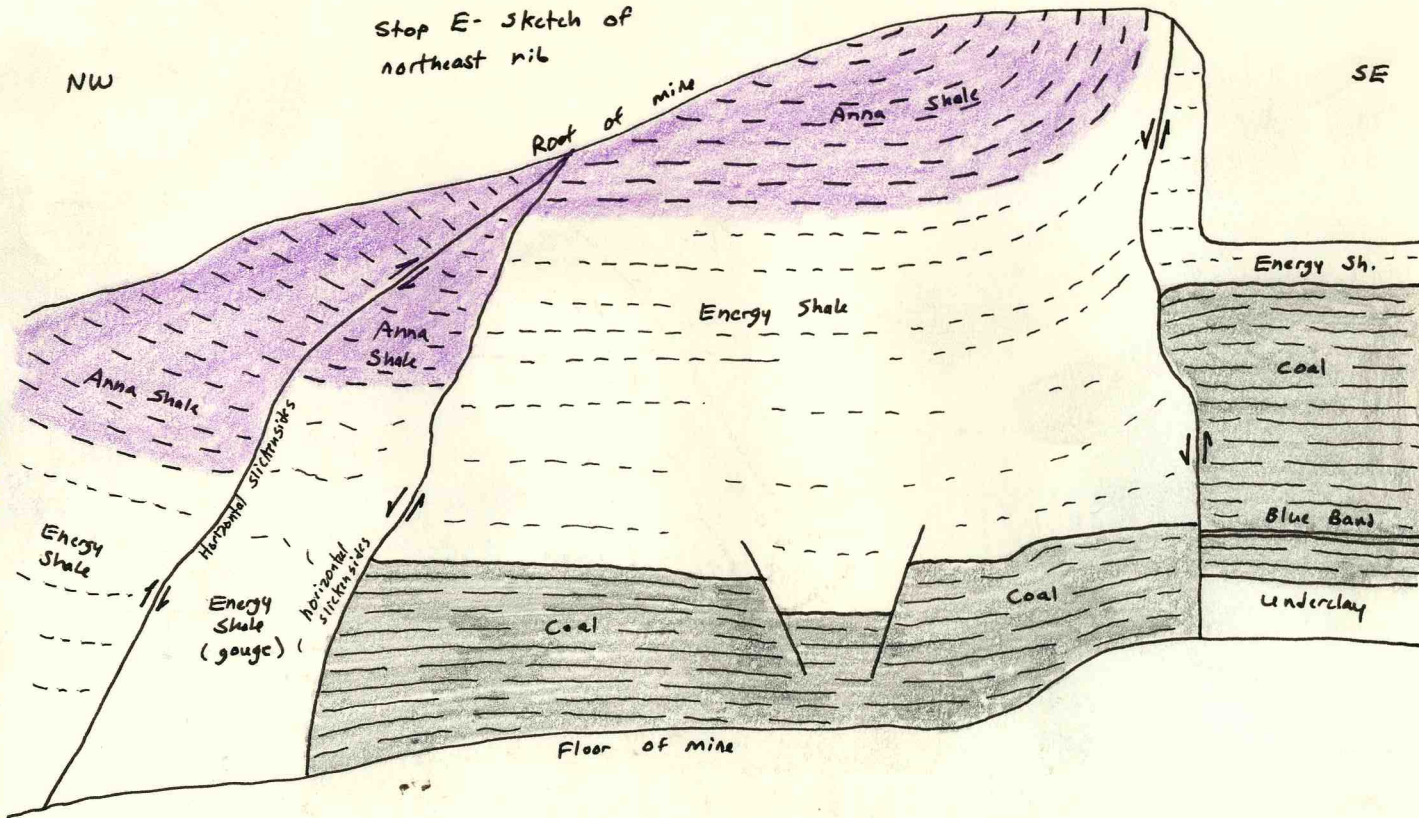
The surfaces of the faults show conspicuous horizontal or obliquely-dipping grooves and striations.

A third large fault trending 105° crosses the entry and appears to join the other two faults near the southwest rib. This fault is nearly vertical although its plane is S-shaped so that near the top of the coal on the northeast rib, it is a reverse fault. Higher up the Energy Shale and Anna Shale are very sharply folded, and the apparent drag indicates a right lateral movement along the fault.

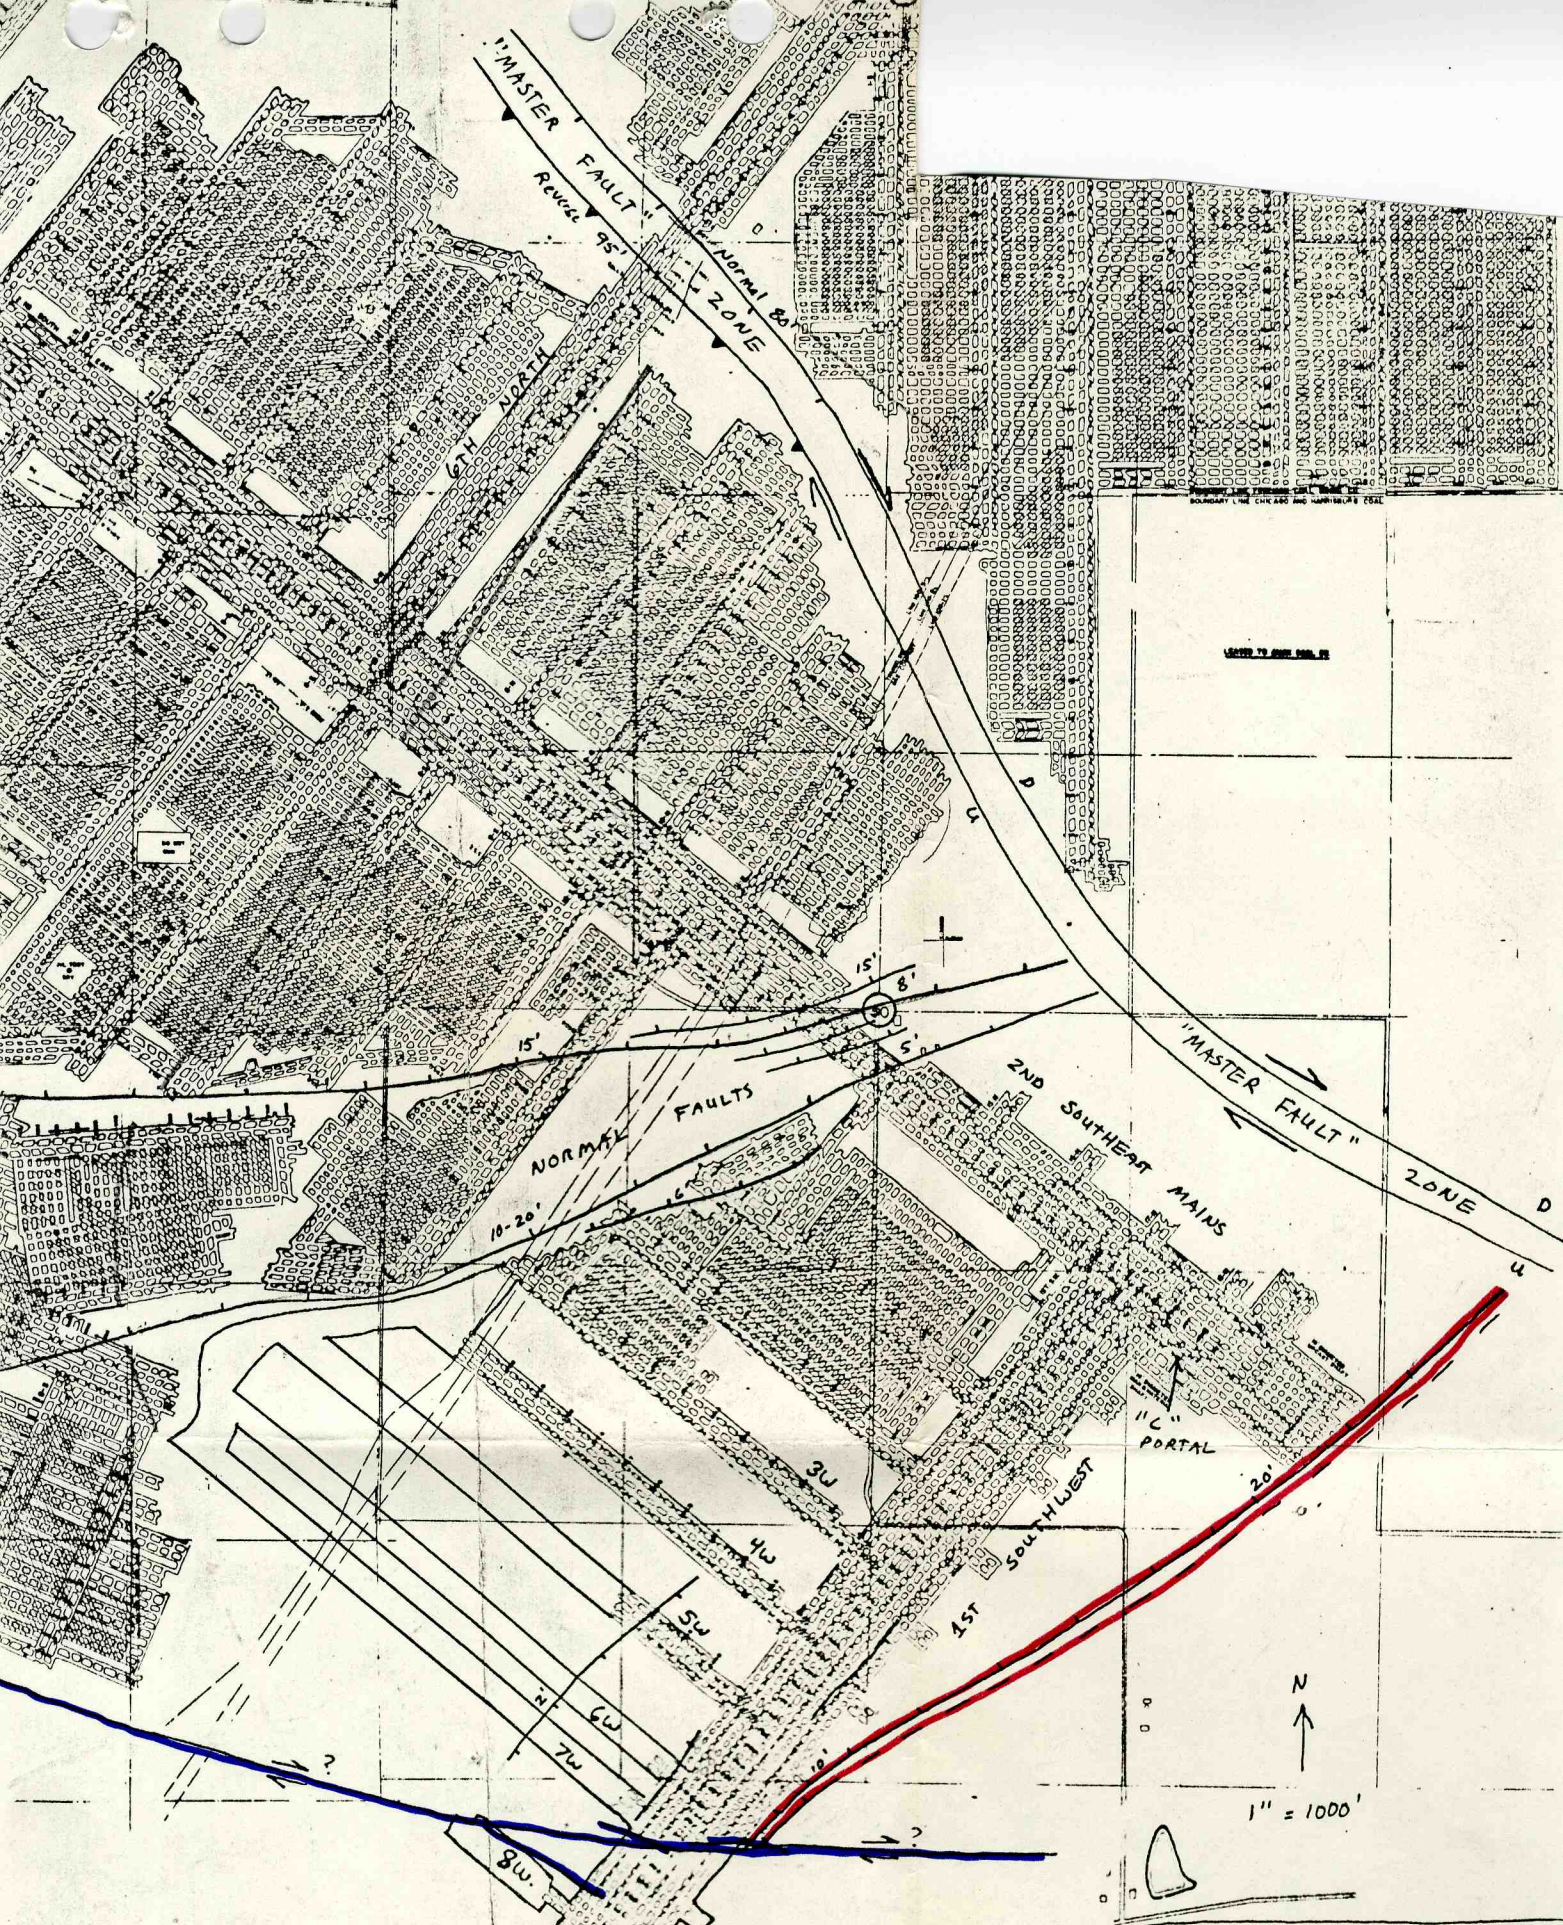
FREEMAN UNITED COAL MNG. CO.
 ORIENT NO. 4 MINE
 FAULTS PLOTTED BY JOHN
 AUSTIN DEC. 5, 1930.

The general structure of the zone, with sharp folds and dominantly high-angle reverse faults, signifies the type of deformation sometimes called "upthrusting". The sketch (over) shows how such upthrusting may occur. I surmise the existence of a large, vertical strike-slip fault at depth below the coal. Movements in the deep fault tended to squeeze blocks or slices of rocks upward. During this upward squeezing action faults tended to propagate upward, becoming more gently dipping with decreasing depth. Most of these faults are reverse faults with a component of strike-slip

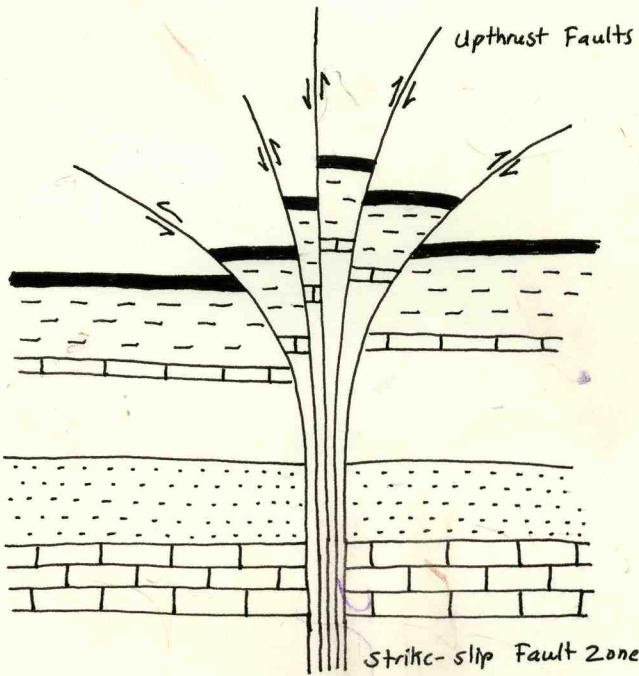
UP THRUST FAULT (CROSS-SECTION)

motion. Some slices in the buried fault zone may slip downward, producing "normal" faults in the surficial strata.

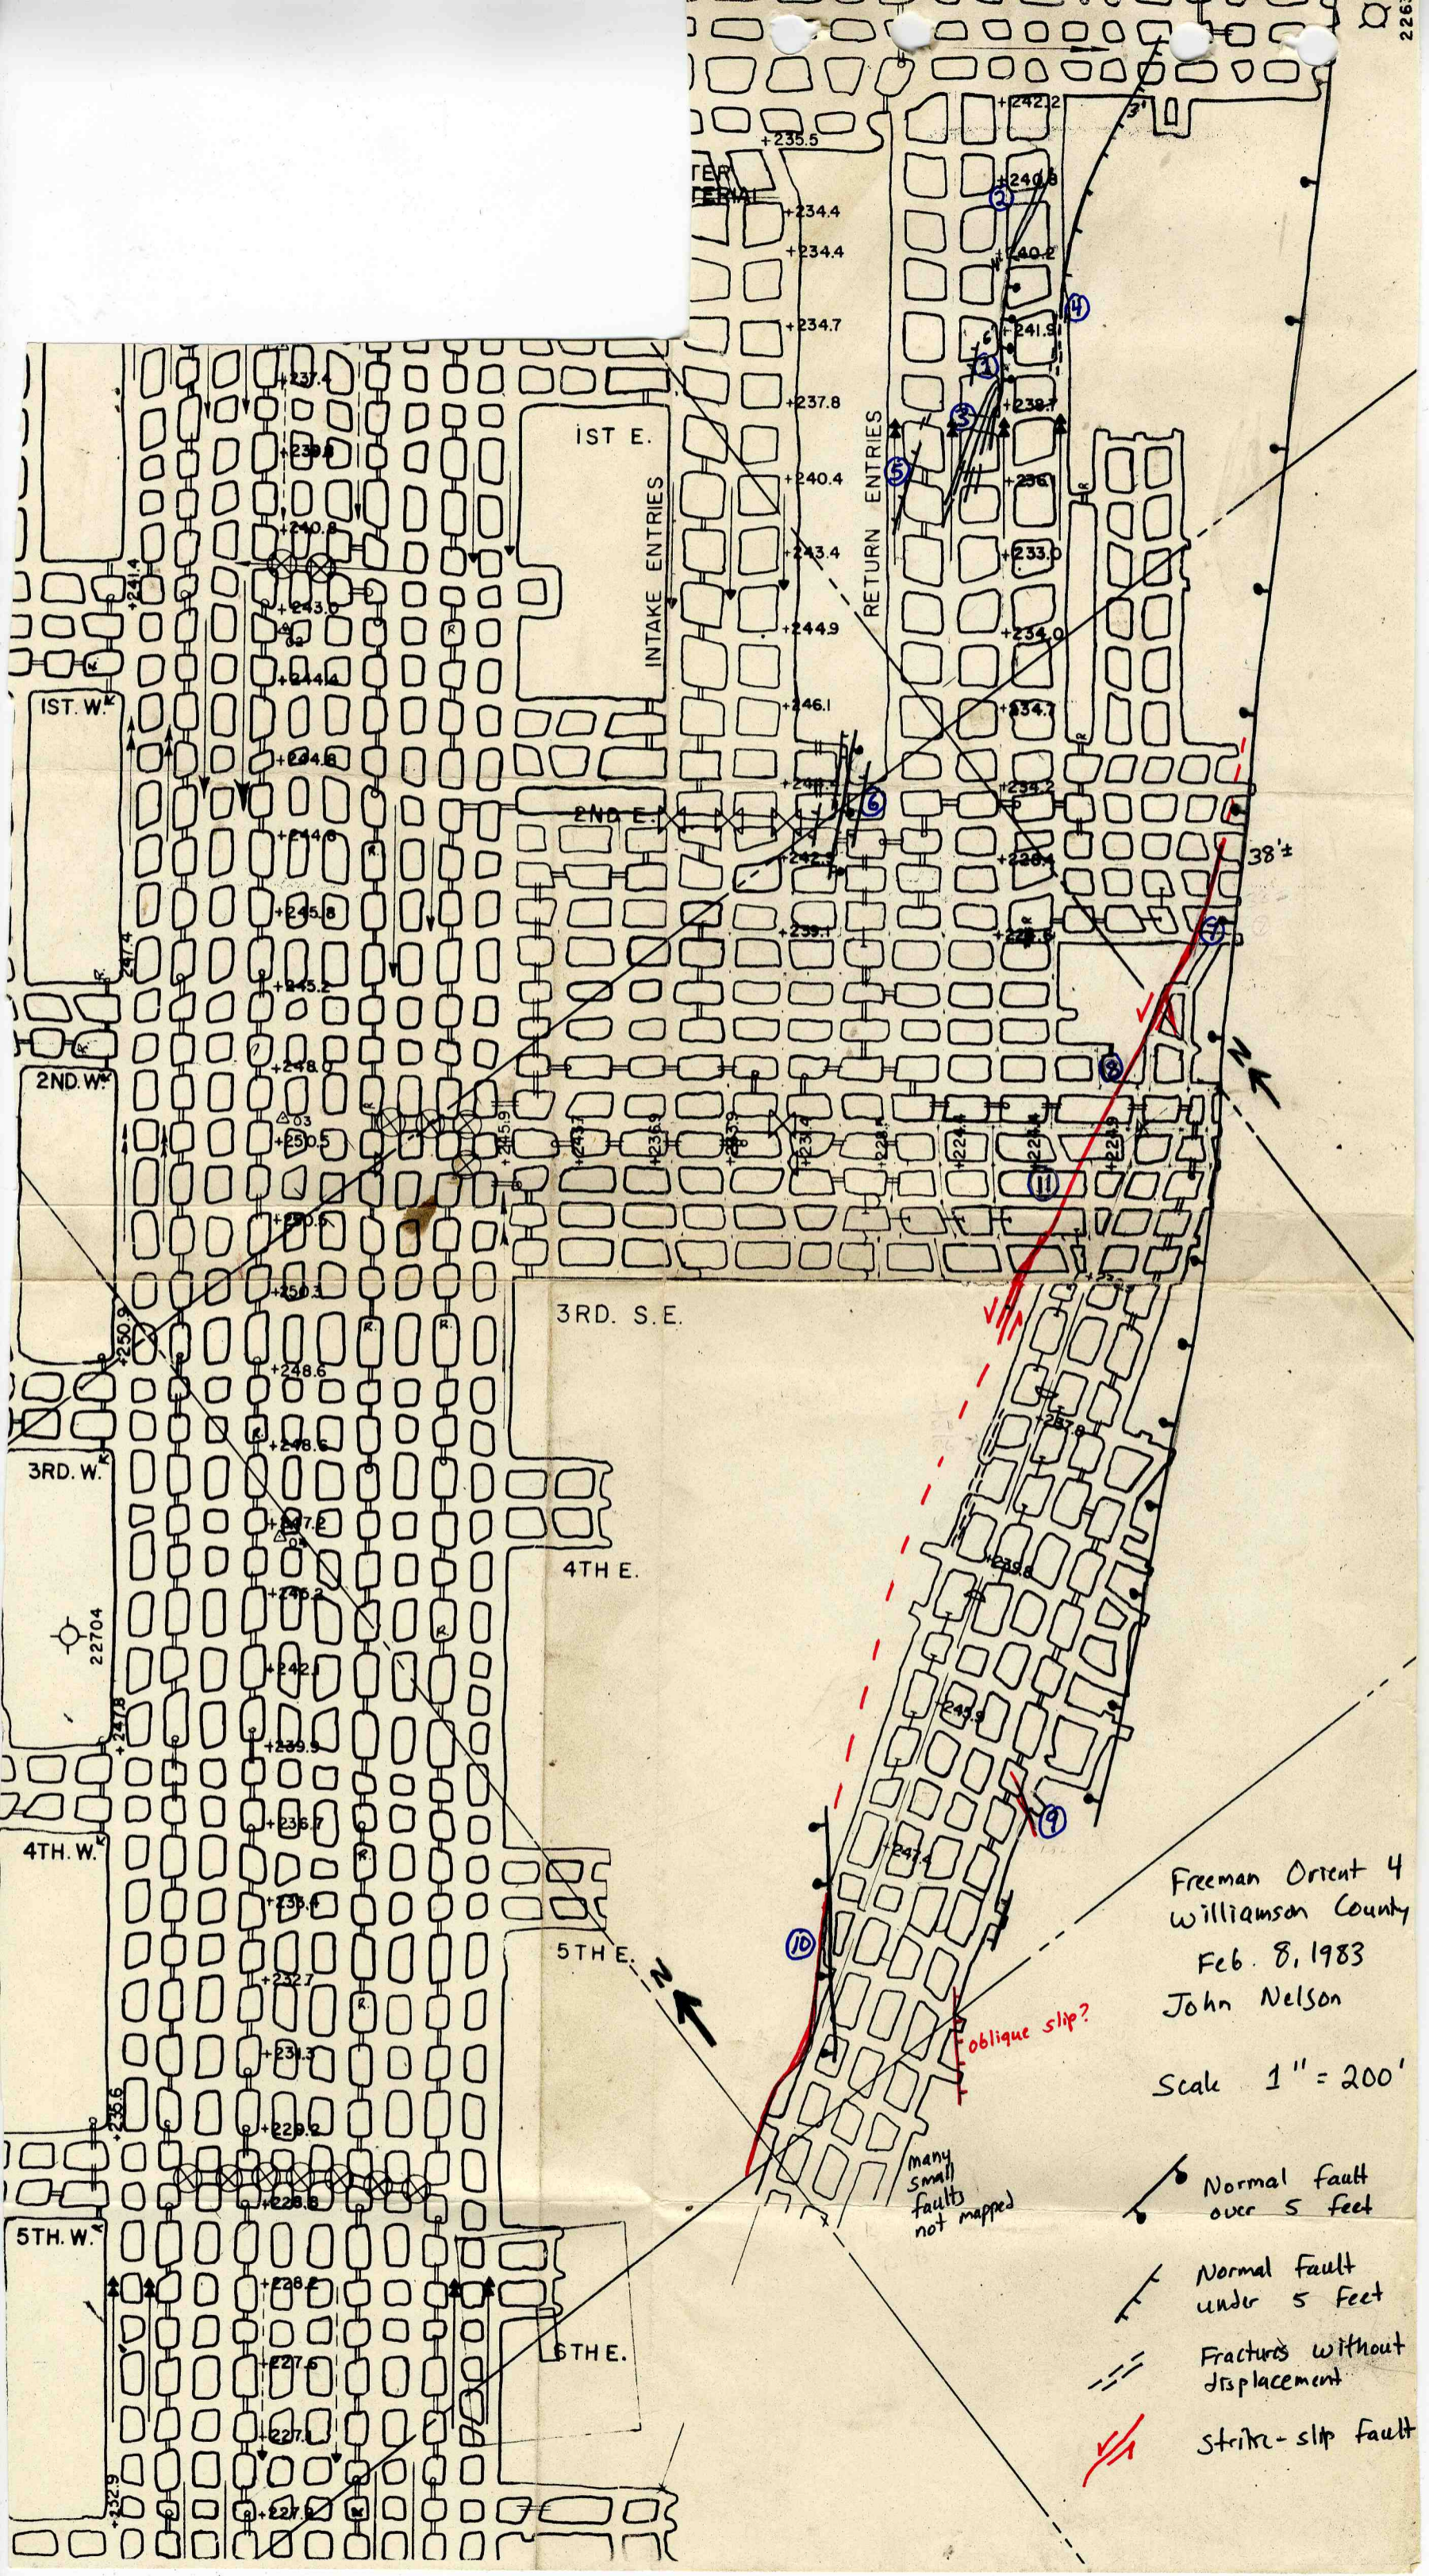
Freeman Orient 4
 Williamson County
 Feb. 8, 1983
 John Nelson
 Scale 1" = 200'

We know that similar problems have been encountered in numerous mines, mostly the deeper mines. The coal is only about 300 feet below the surface in the area where Freeman is encountering the stresses. This is the shallowest working in which I know of such problems. The stresses do not appear to be active north of the strike-slip fault. This suggests that either the stresses are residual stresses related to the Cottage Grove faulting or (more likely I believe) the stresses are modern, active stresses that in some places can relieve themselves by shifting the rocks along pre-existing faults, but elsewhere cannot be relieved until the coal is mined.

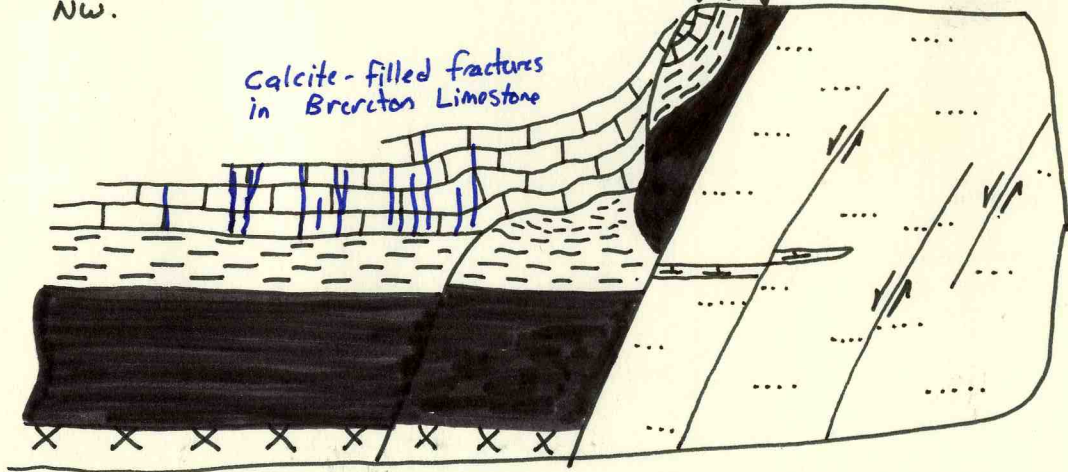
The fault also is exposed in longitudinal section along the northwest rib of the entry between Stop 7 and 8. Several smaller strike-slip or oblique-slip faults branch away from the main fault, assuming a southerly trend. The coal on both sides of the main fault is overlain by Anna Shale. No clear indication yet of the direction and amount of strike-slip motion.

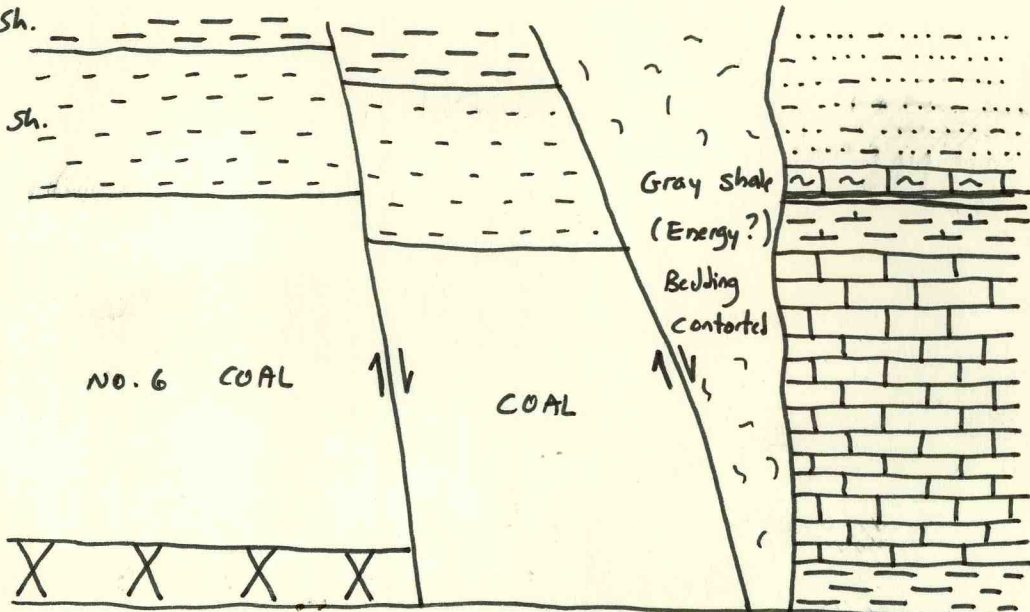
11.) See sketch map (over). Strike-slip fault offsets lateral boundary between Anna Shale in the roof. The offset is roughly 50 feet in a left-lateral direction. Precise measurement is not possible because the changes in thickness of the Energy Shale are very gradual and the edge of the Energy Shale cannot be picked with precision. This is the lower, dark member of the Energy Shale. The difference between Anna and Energy Shales is subtle and may be gradational. Nevertheless there is no doubt about the left-lateral offset.

The main Cottage Grove fault, north of here, is right-lateral and trends roughly N 70 W. Our left-lateral fault, therefore, is a good example of a conjugate or second-order strike-slip fault. It makes about a 65-degree angle with the main fault, about as expected for a conjugate fault.
