HILLSBORO MINE
 (Coffeen)
 1st SE entries

Notes & Map by H. F. Krause. 12/3/74
 Hillsboro Mine (Coffeen), Consolidation Coal Co.
 (Numbers of study sites refer to map of H.-F. K.)
 Location: 1st SE entries, from "parallels" south-
 wards. (in intake air)

Hillsboro Mine (Coffeen) Consolidation Coal Comp.
1st SE Entry at overcast belt entry into E-W parallels
study site # ①

Consolidation Coal Co.
 Hillsboro Mine
 Main East Entries
 Jan. 29-31, 1975
 C. J. N.

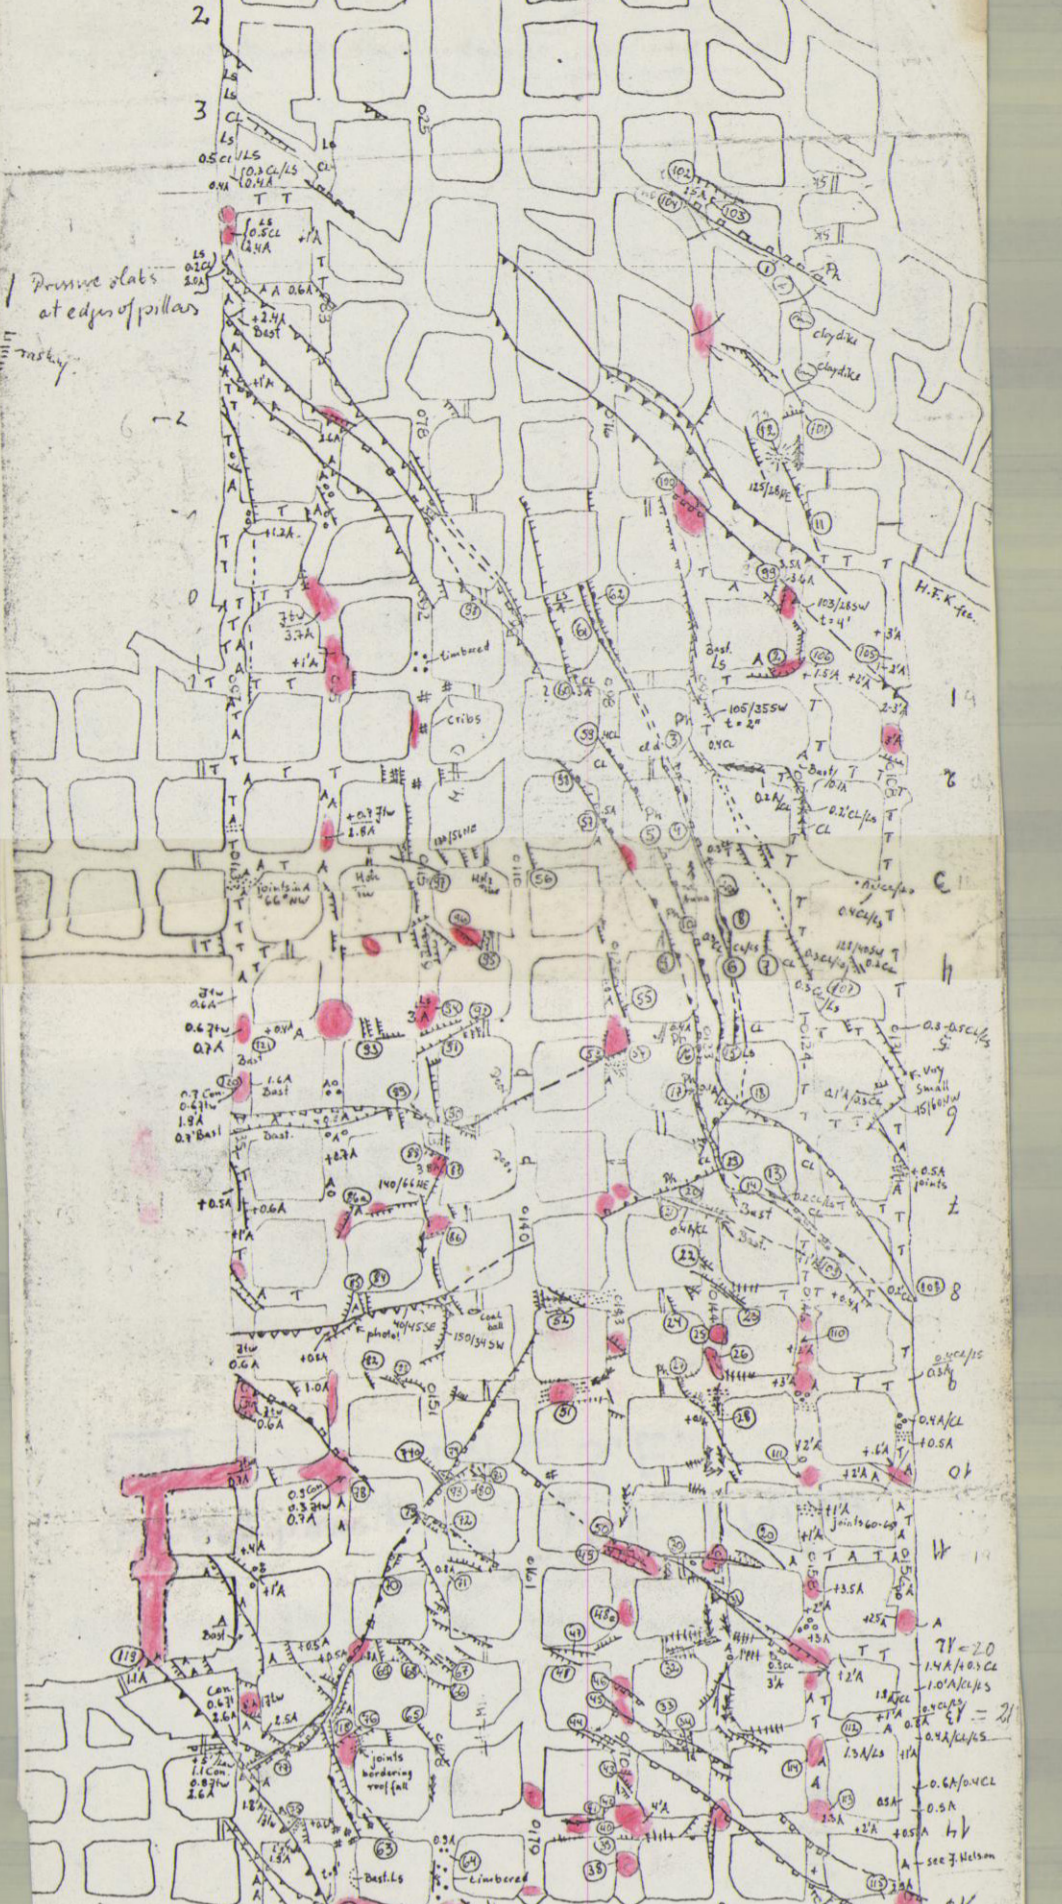
Shale crosses bedding in coal as indicated in sketch; stuff looks like disturbed Anna Shale? Sample taken.

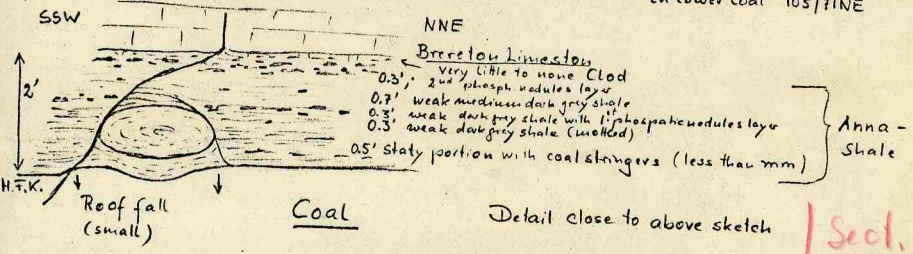
main slip
in Anna shale 107/52 NE
in upper Coal 110/65 NE
in lower Coal 105/71 NE

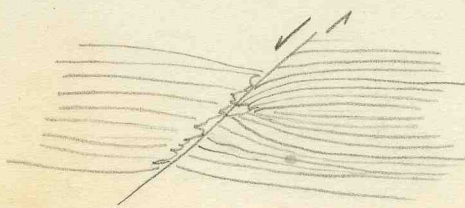
203

3. Two clay dikes with slips 125/45 NE, 127/49 NE. Clay dike slip has very sharp and regular contact to footwall of slipplane but quite irregular and "inter-fingering" in hanging wall. Coal shows usual structural deformations as described by H. H. Damberger

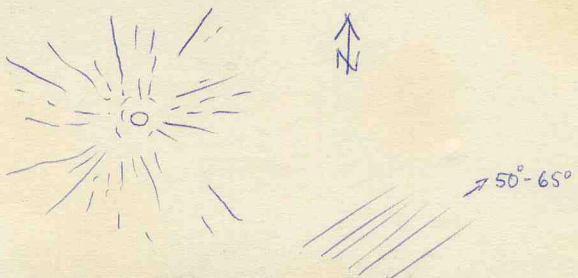
(212)
12. Cleats in "radial" orientation around a center,
cleats are calcite coated, visible in skin coal, probably(?)
caused by a concretion within Anna Shale. Photo should
be taken.

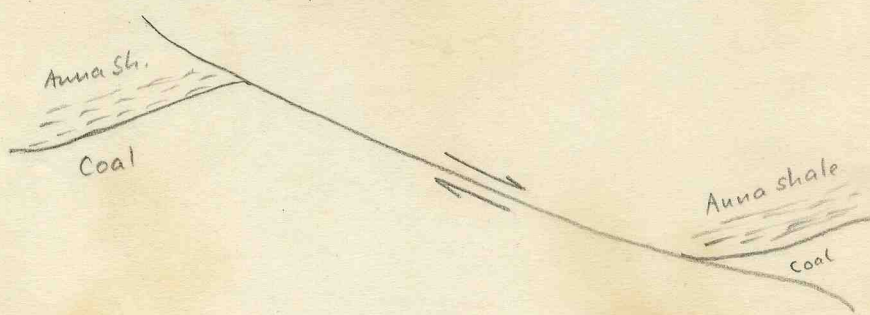
231

31. Very low-angular normal clay dike-type fault, displacement ^{le} and is almost equal to coal thickness (^{etc} ~5'-6'). Roof is Anna Shale, Breton Limestone exists only in few very small lenses.

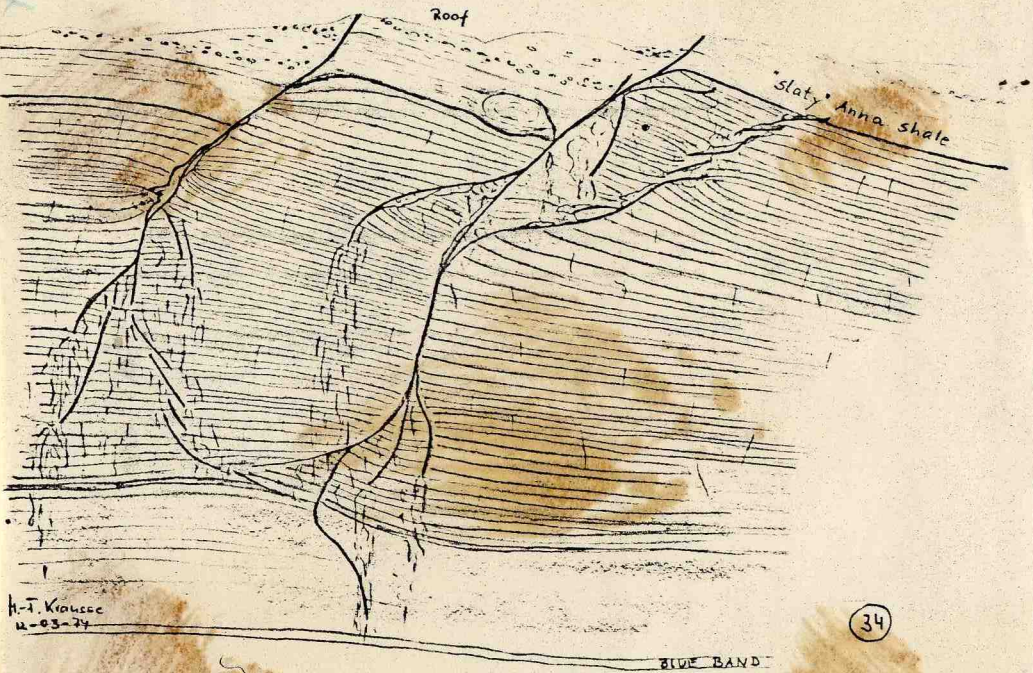
(232) Clay dike faults with filling, "en echelon" position 50/56 NW, 53/51 NW, in crosscut coal faces are rashing high and intensively; roof is Anna Shale.

(233) Long clay dike-type fault 85-90/50-60 South, roof Anna Shale.

(234) Roof Anna Shale, several clay dikes, filling small, but faults complex 145/40-45 SW

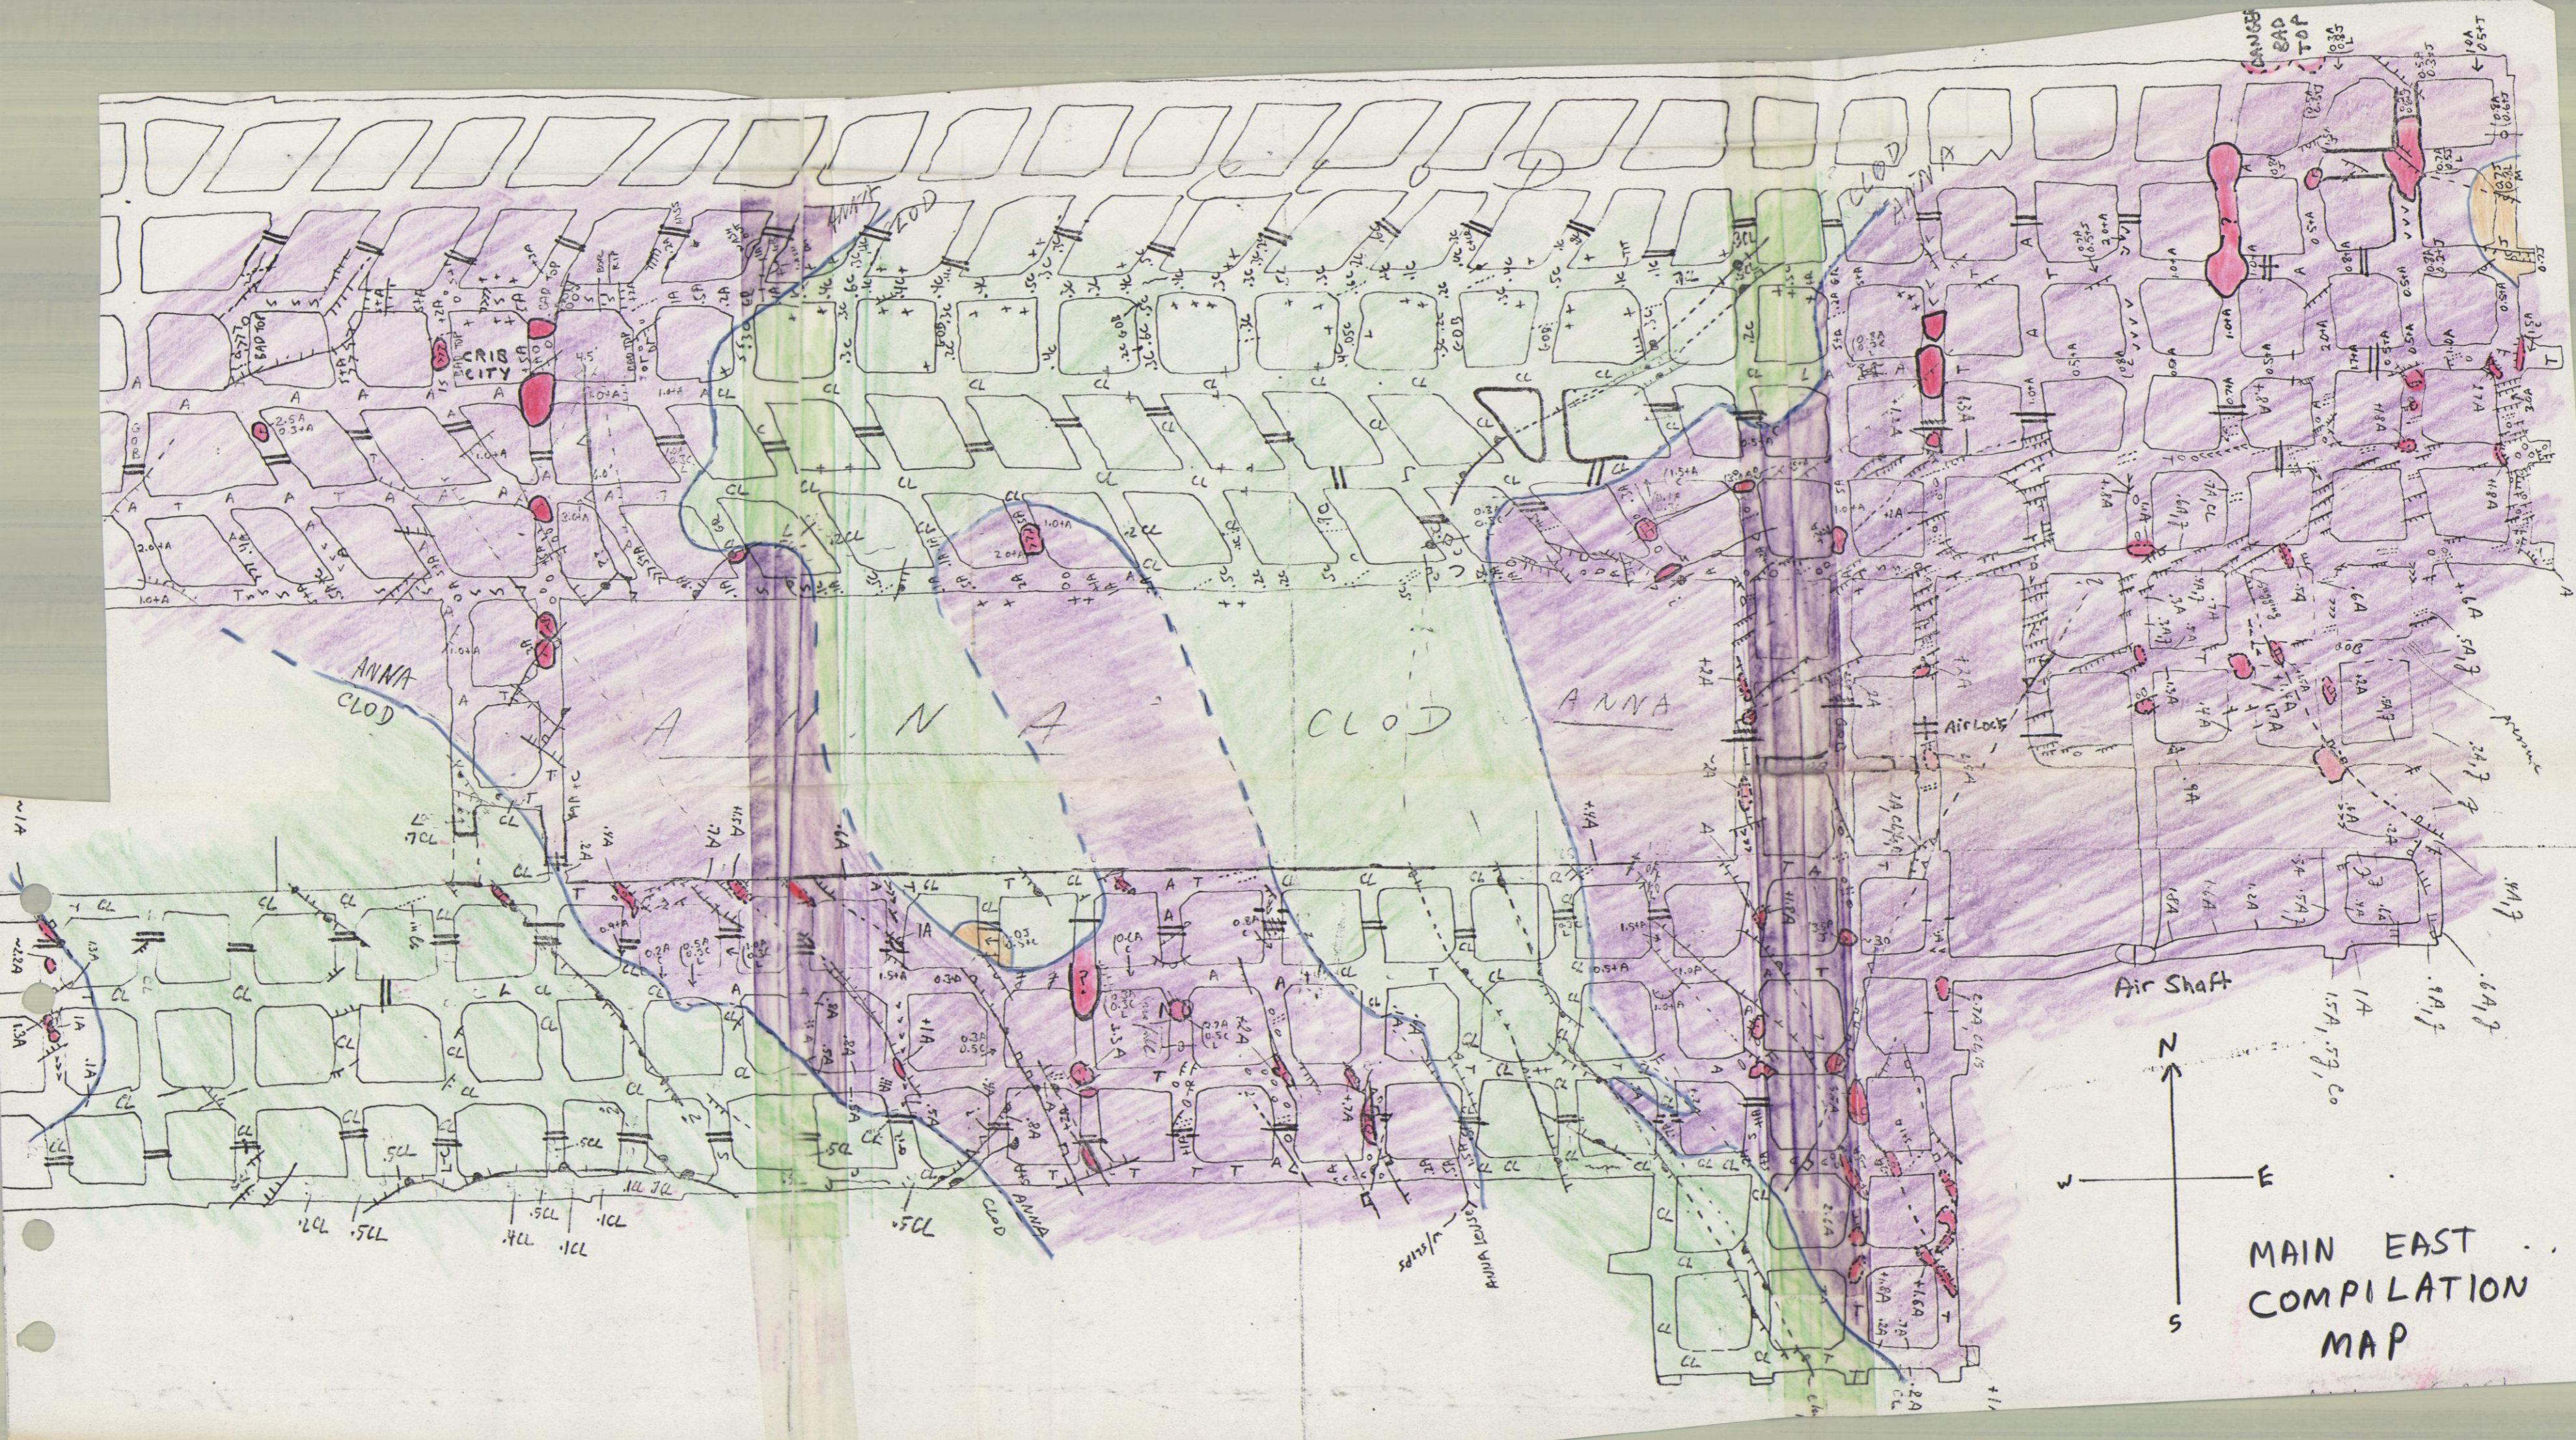
77. Clay dikes with faults 15/45 SE and 10-15/30-45 NW, both with clay filling.

Minor clay dike-type fault (only with ~1" filling) appears to be staggered by former ones (?young?—probably

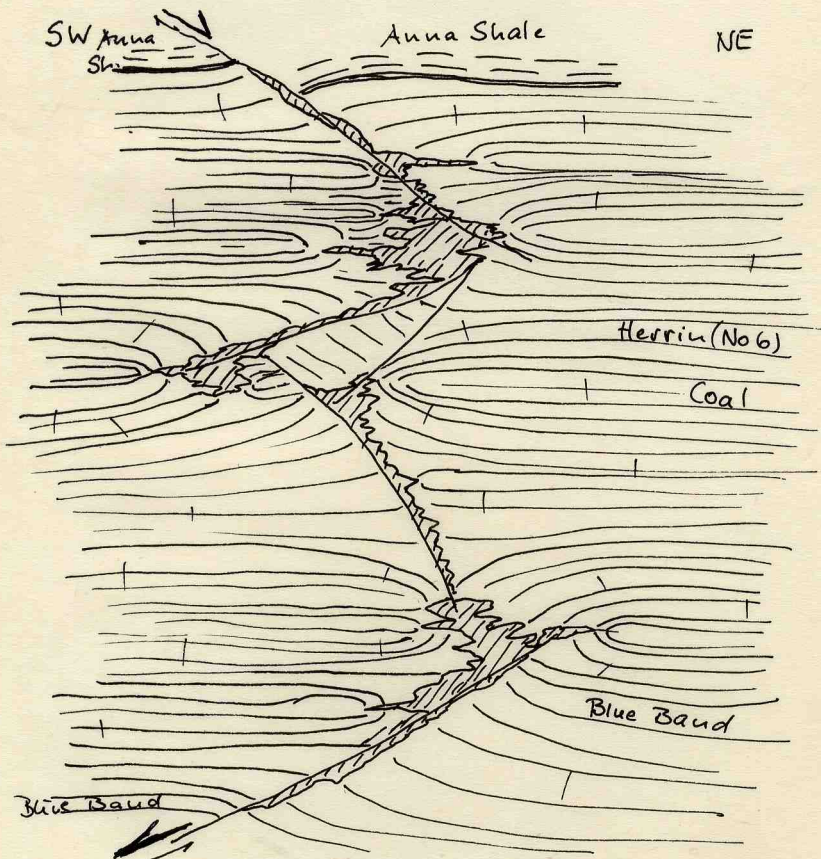
(101) (82) Small clay dike-type fault 96/44 NE.

(102) (83) Clay dike with fault 145/37 NE, compare (80) contains five little faults near floor and higher up in coal.

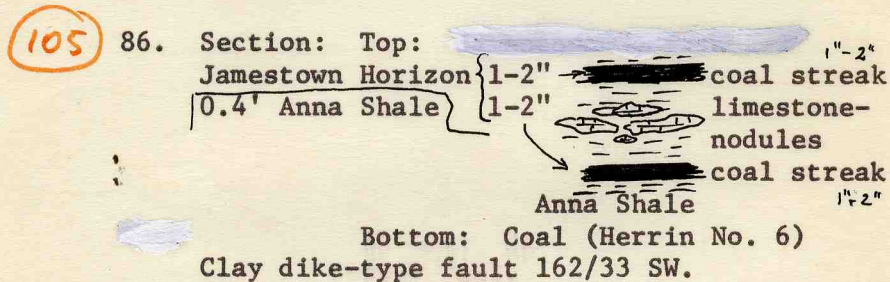
- 103 84. Clay dike, small, with fault 157/59 SW, Anna Shale roof.
- 104 85. and clay dike-type fault 85/33 SE, Anna Shale roof.

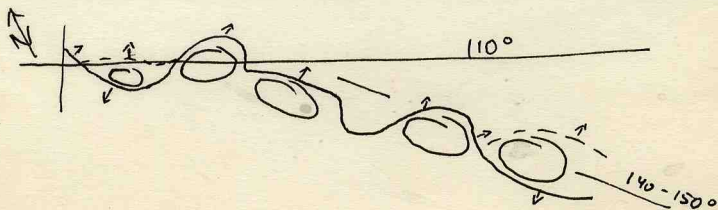
- 117 97. Roof rock is 3.5' or more Anna Shale above Herrin (No. 6) Coal. Larger clay dike-type fault 110/37 NE which peters out with a "goat beard" into top portion of coal. Roof fall is supported by slips and clay dike-type fault of various sizes, which show a very irregular pattern due to frequent Anna concretions.

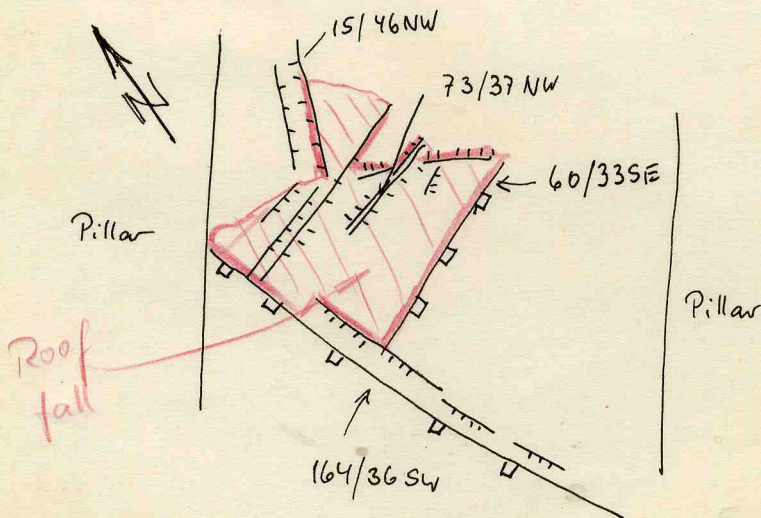
- (118) 98. Clay dike-type faults 127/26 NE and 137/28 SW in coal and roof rock. Roof \div Anna Shale.
- (119) 99. Roof consists of Anna Shale with frequent Anna concretions; well jointed 65/88 SE and clay dike-type faults.
- (120) 100. Clay dike-type fault in roof rock 68/40 SE and 125/~~None~~ 40 NE.
- (121) 101. Roof is Anna Shale with a clay dike-type fault 142/43 SW.
- (122) 102. Several + parallel small clay dike-type faults in Anna Shale and top coal: 148/41 NE; 159/29 NE. (164/42 NE)
- (123) 103. Larger fault 166/32 SW and very small fault 153/46 SW supported roof fall at (103a).
- (124) 103a. Roof fall caused by various intersecting clay dike-type faults. 15/46 NW; 73/37 NW; 60/33 SE; 164/36 SW; 162/40 SW; 81/42 SE.

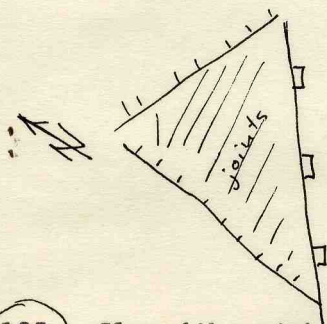
- (125) (104.) Various clay dike-type faults causing small roof fall 48-56/35 SE largest
103/37 NE medium
18/56 SE Smallest
joints in Anna Shale roof contribute to roof fall:
64/87 NW.
