OLD BEN COAL CO.
MINE # 21

Mine Index No. 863 S-23

OLD BEN COAL CO.
MINE NO. 21

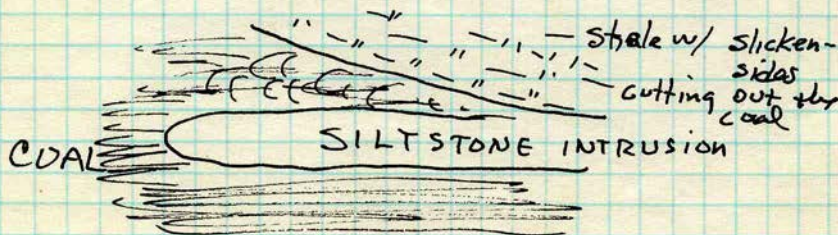
Sketch of South Face

Fairly homogeneous siltstone with much finely disseminated carbonaceous detritus and also several relatively large plant fragments intrudes into coal on south side of entry, this intrusion is up to 2 feet thick and extends back about 20' from west terminus of entry (see picture).

At terminus of entry and on north wall, shale can be seen cutting down into coal removing at least 4' of coal. This appears to be a channel. The contact with the coal is fairly smooth and planar. It dips as high as 31° and obviously cuts out much of the coal. Much slickensides.

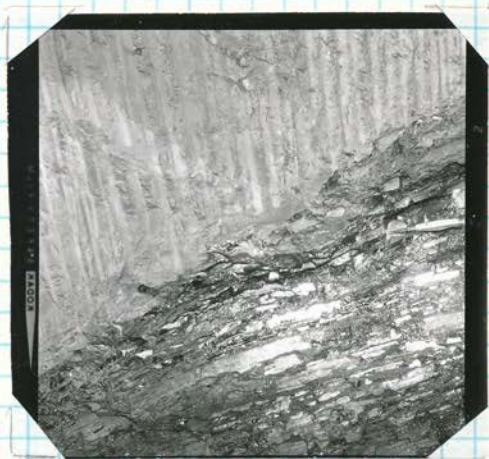
Looking into northeast wall of 45° cross-cut. Shows close-up of margin of cut-out. Note small "barbs" of coal extending into siltstone. Knife at right center for scale.

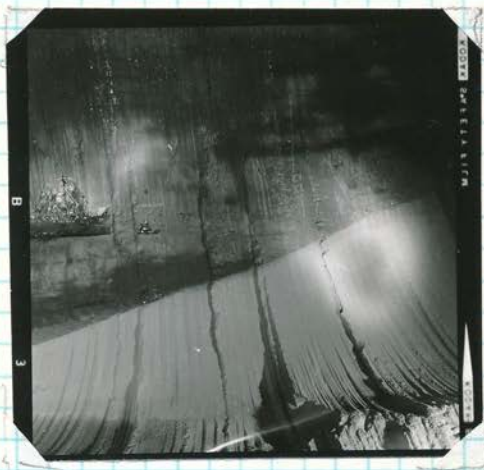
Photo of east wall showing sharp contact of coal and
cut-out material. Pencil at right center gives
scale.

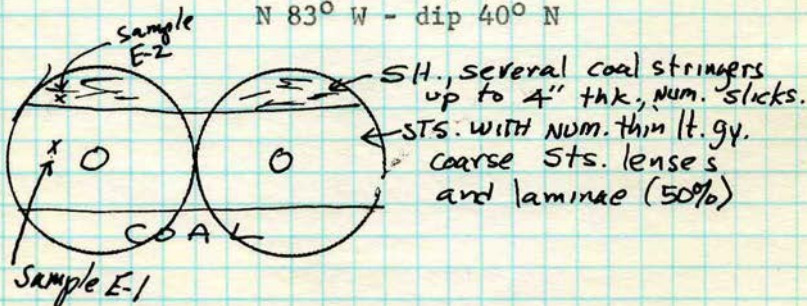
LOOKING N. INTO
END OF ENTRY

Coal is almost completely cut-out and replaced by shale and siltstone, base of channel-fill varies from planar to slightly irregular.

Coal dips north down into cut-out about 15°.

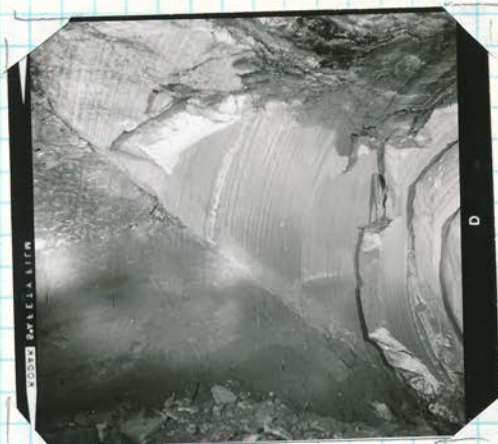
Station E - 81st N. off of 8th W.N. looking NW into end of entry and west wall showing cut-out margin.

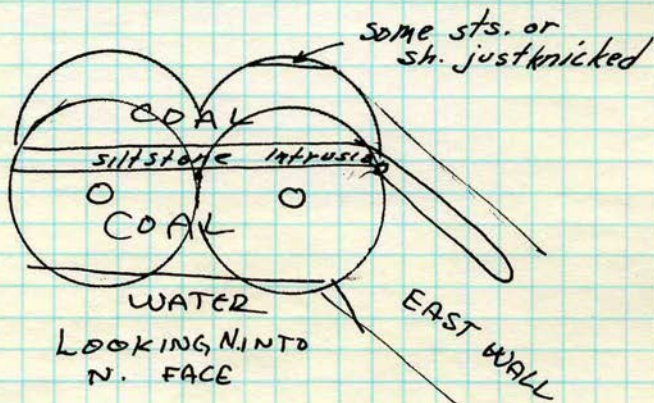
On east wall is siltstone intrusion, relatively blunt
ends about 6' from terminus of entry (picture).

There is no obvious cut-out in this entry but it is
quire probable that the intrusion is some cut-out
material squeezed back a few feet from the cut-out.
Some rock at very top of the end of the entry,
slightly nicked by the machine. This could be the
cut-out.

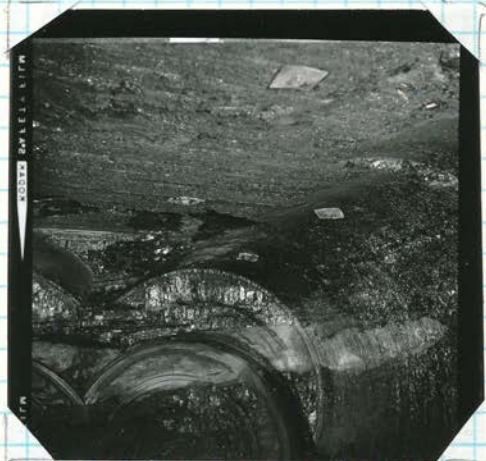
End of 83rd N. off of 8th W.N. Shows terminus of
the siltstone intrusion. *mn-03a-013.tif*

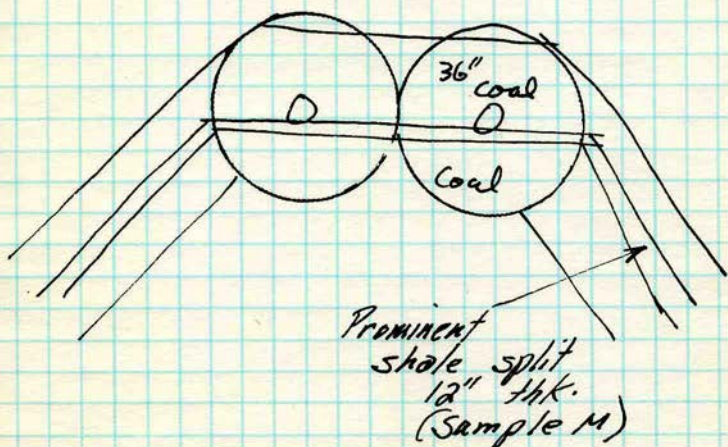
Roof has numerous slip fractures and stringers of coal.

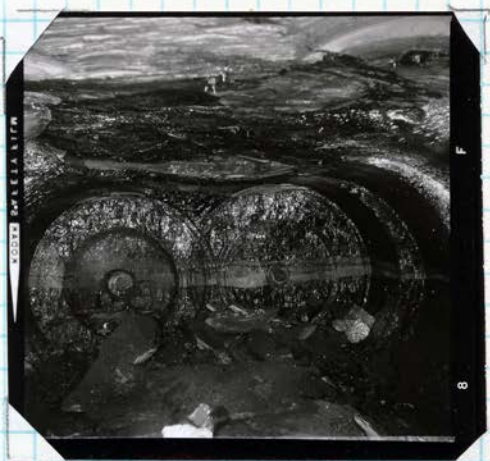
S. end of 75th S. off of 1st W.N. - view of end of
entry showing split in coal.

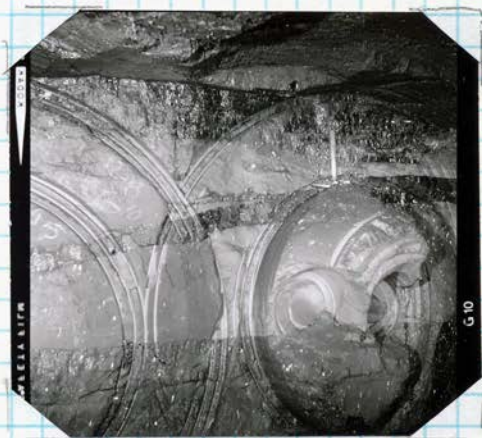
South end of 76th South off of 1st W.N. - split coal
area shows irregular interbedding of shale and coal.

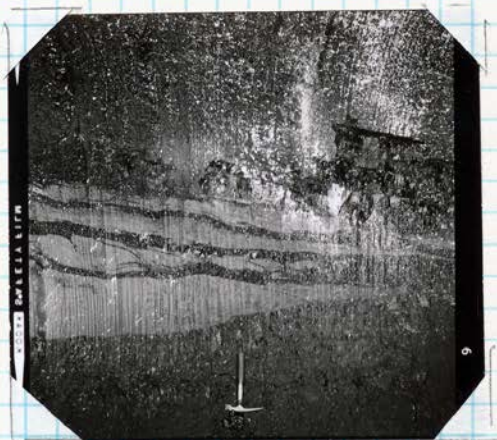
On West wall at South end of 76th South - Shale
splits in coal, shale shows much interior deformation
related to either injection or compaction.

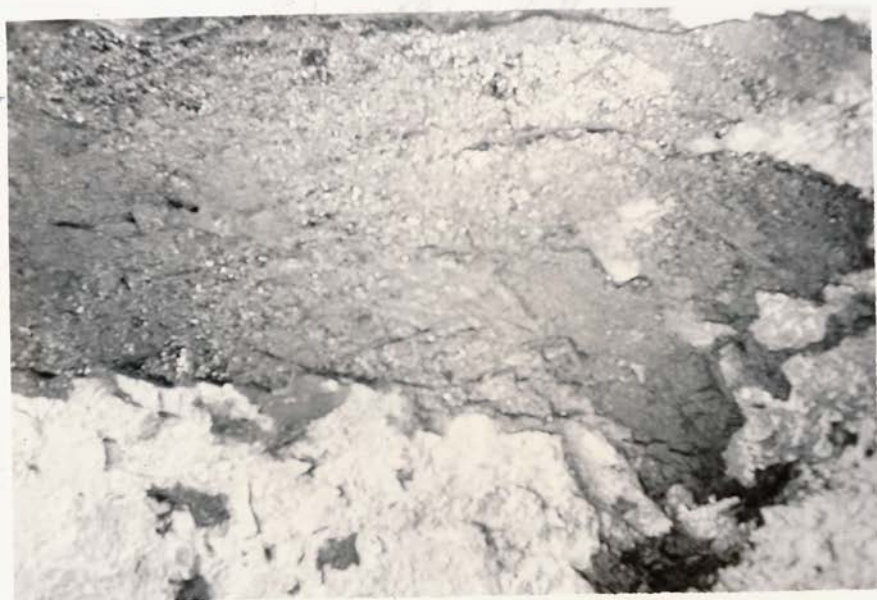
photo 1 ^{mn-039.022} ↑

mn-03A-022
Photo 1 4th North track 45° off 5th Main East off Main
South.

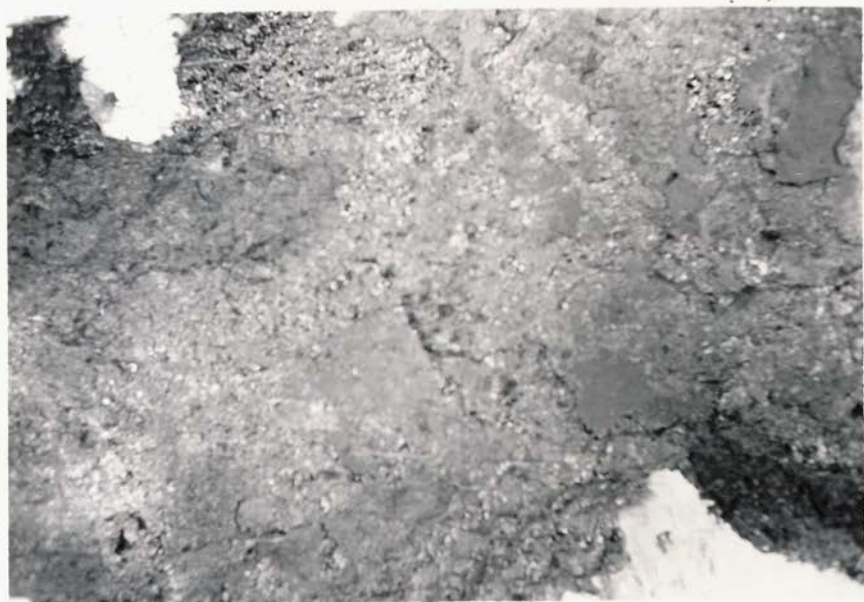
photo 2 ↓ mn-039.023

mn-03A-023
Photo 2 Same location, same stuff, but more irregular
main trend 65-70 (magn.) turning to 25-30 at edge of
photo. 1 and 2 on map. Gray shale wedging out to appr.
N, causing roof problems (slips, riders, etc.)

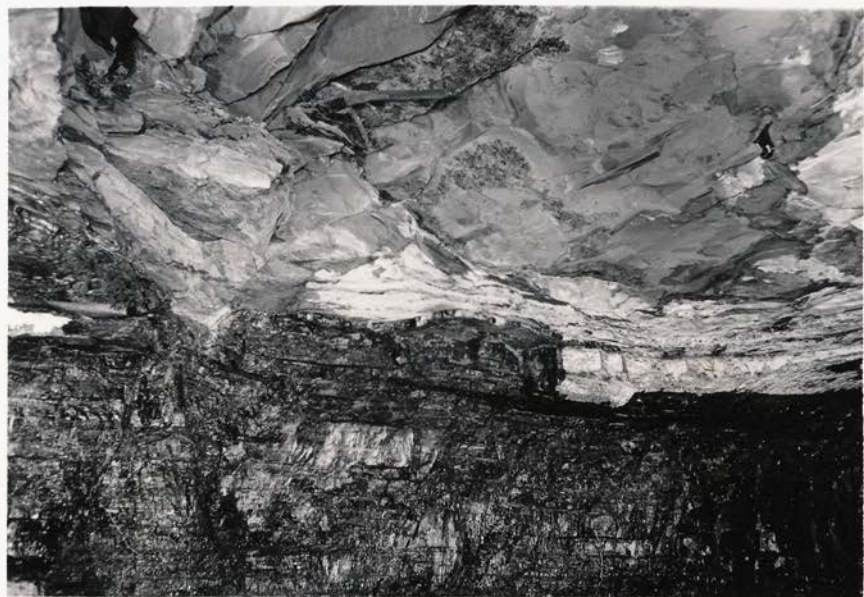
Photo 3 ↑ mn-038-624

mn-03A-024
Photo 3 Roof fall, looking ESE, in 5th Main E. Main slip
90/30 N (to left of photo) other slip 110/62 S (to right
in photo.) Bedding plane with plants: 035/18 SE (kind
of rider taking off top of coal on S (left) side of photo

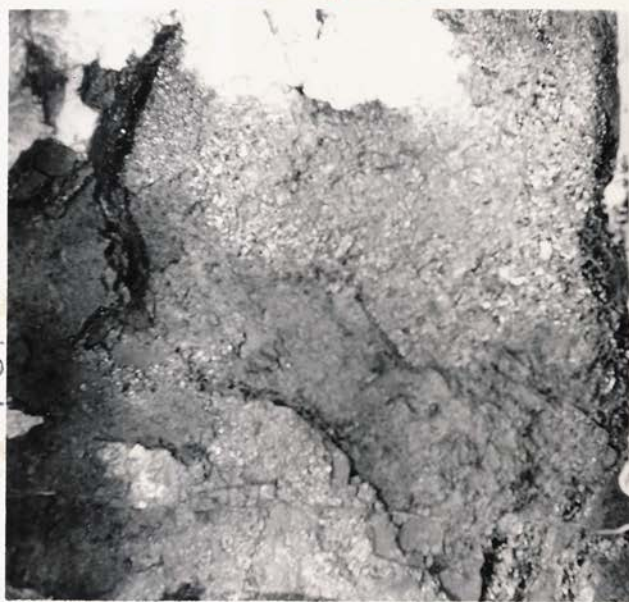
Photo 4 ↓ mn-03A-025

mn-03A-025
Photo 4 Looking up into coal roof: pyrite filled
cleats, main fault 115° bending to 150° (near pipes)
(magn.)

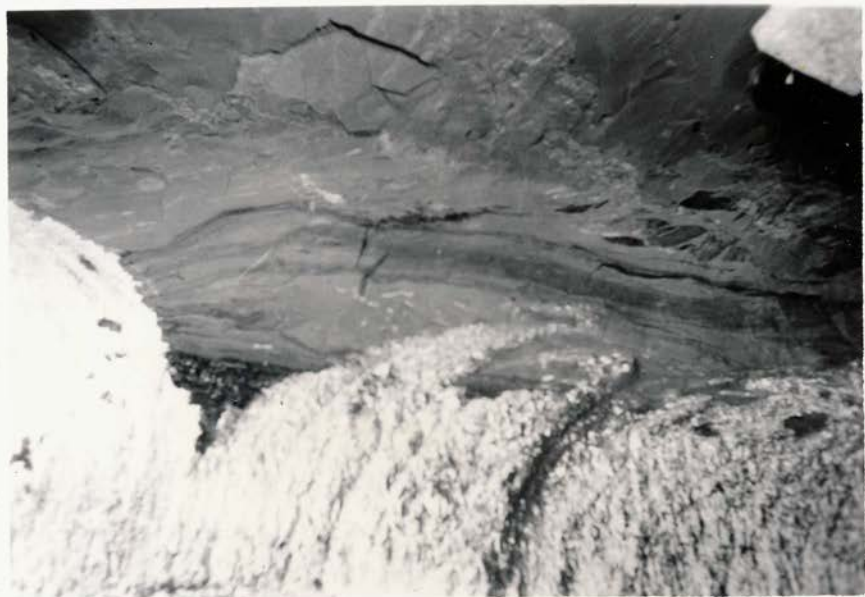
Photo 5 ↑ ^{•m1-031-036}

^{mn-03A-026}
24) Much splitting and riders and slips, bad top again.
Photo 5 wedge of gray shale with coal stringers, internal
slumping indicated by chopped-up sideritic lenses and
distorted bone coal looking west (sic.)

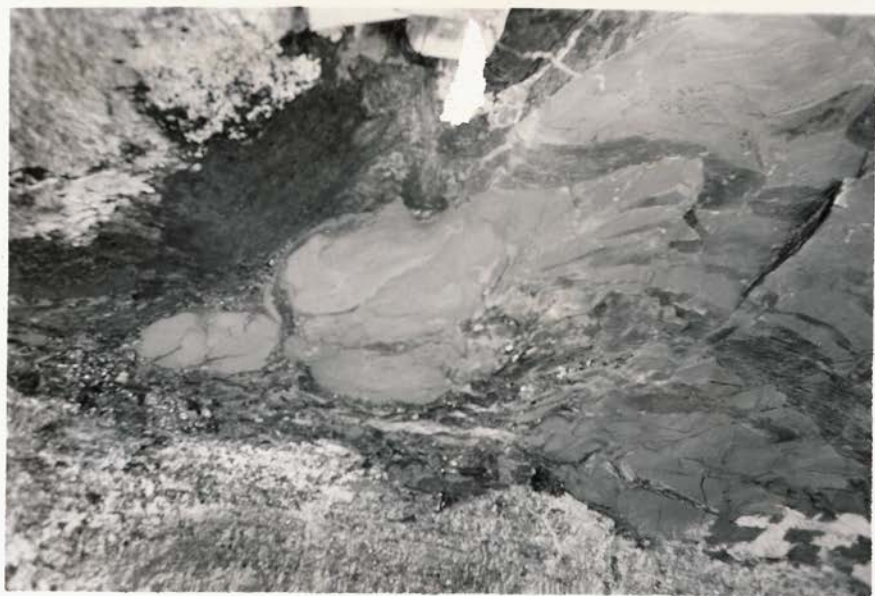
Photo 6 ↓ ^{m1-03A-027}

^{mn-03A-027}
26) Photo 6 Rider, slumped to left (north). Size of oval
in left side about 10" by 4½" good slumping structures in
shale.

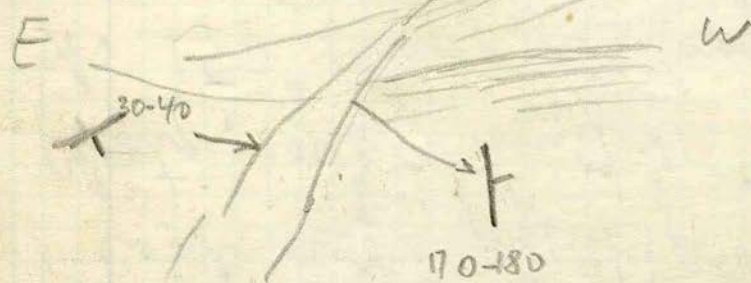
(12) Several major slips cutting across entry, affecting roof and floor, one even predominantly floor

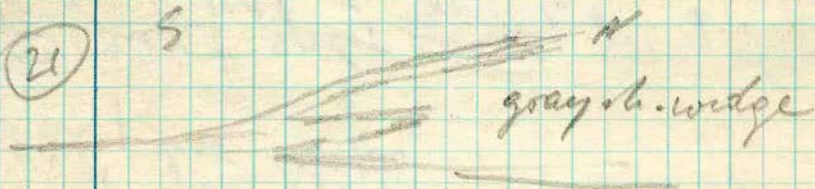
shale taking off coal to about
5' above coal, + irregular
slips & roof falls

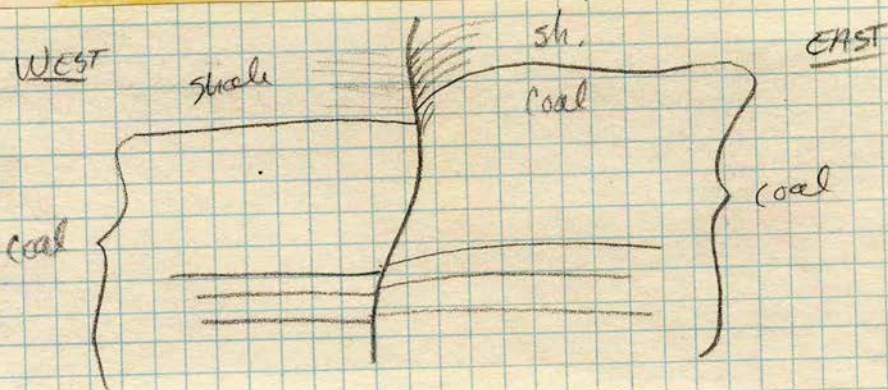
Cross-section looking north:

Fault plane nearly vertical. Normal drag on up side. Shale on upthrown side (east) fragmented near fault (within 10") Drag intensity decreases downward into coal. .5" gouge zone of crushed coal.

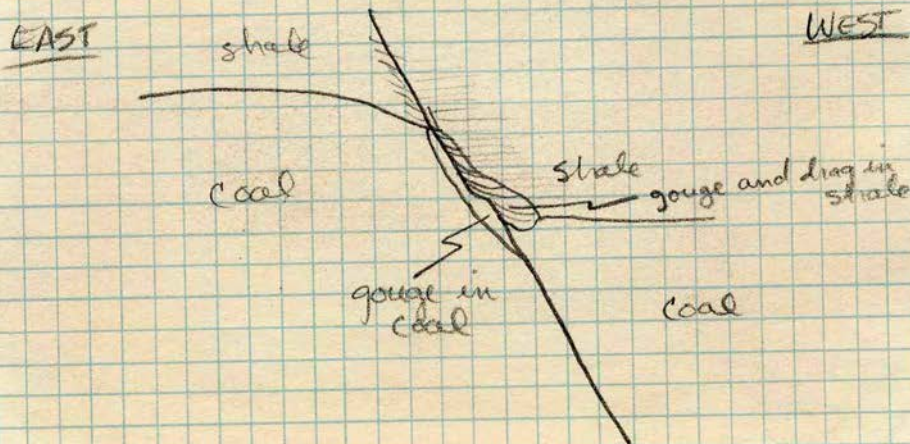
Cross-section looking south:

Dips 64° W. Fault plane is wavy at coal-shale contact. Straighter at coal-coal interface. As above, less drag in coal.

Gouge zone in coal-shale interface on coal side disappears when at coal-coal interface. As above, intensity of drag decreases from shale to coal. Most drag and gouge is in downthrown shale within 4" of fault plane.

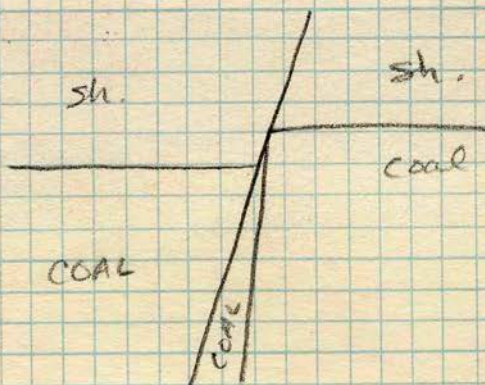
Cross-section looking north:

Apparently fault is dying out to north, or scissoring 1' normal fault, down dropped to west, on north side of entry 4' to west of Fault 12. Cannot be traced across entry, is either a bifurcation of fault just described, or is beginning where first fault died out. Strike 348° , dip 60° W. Fault bifurcates downward when it hits coal seam. Minor normal drag in shale.

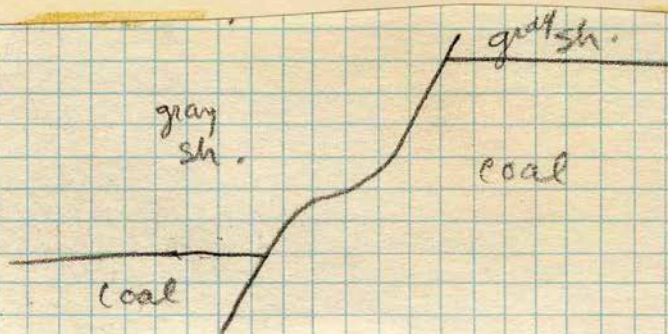
13) 6' normal fault downthrown to west. Strike 348° , dip 85° W. Drag in shale only.

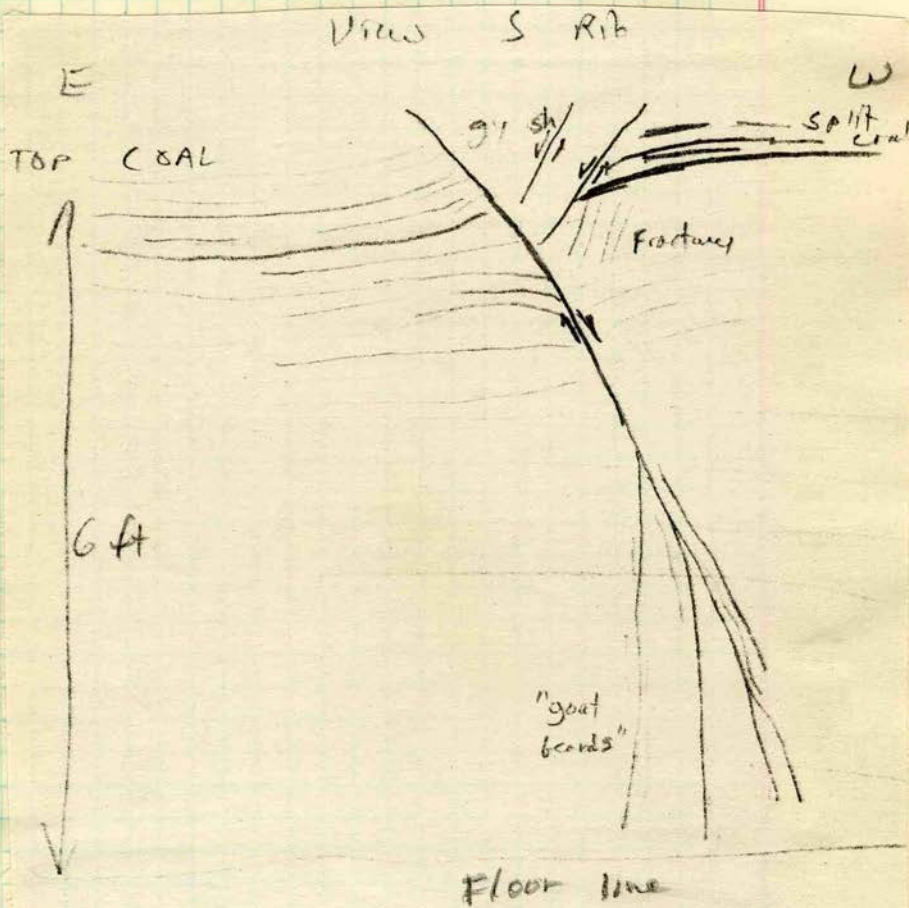
Apparent "reverse drag" in the coal in upper part of seam both sides of main fault. This appears to be another compactional or soft-sediment feature, not a tectonic fault.

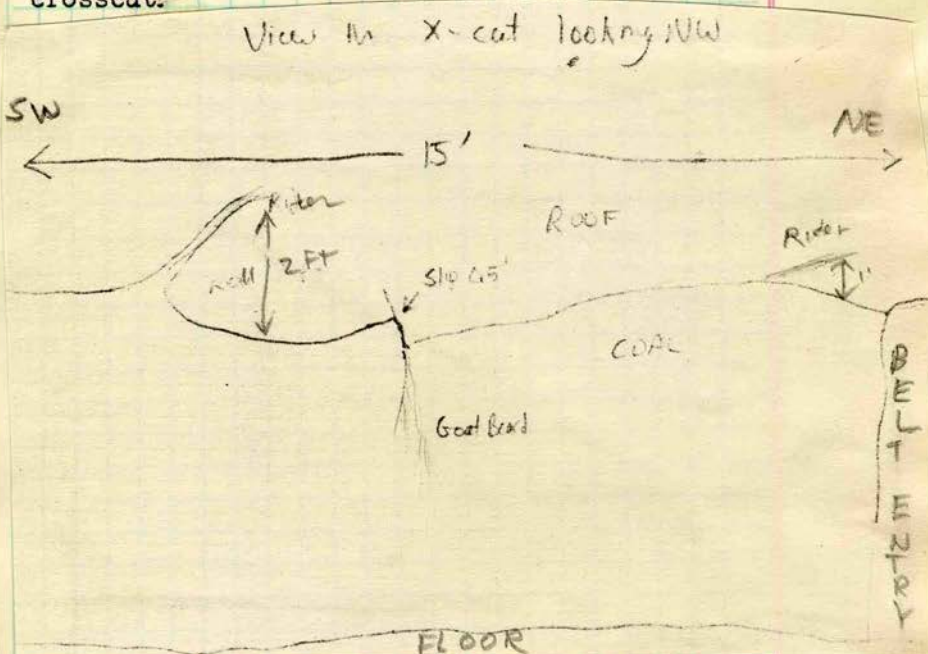
(24) Feature marked as roll on company map is a series of small rolls with associated slip. Very hard to see in belt entry, but visible in crosscut.

Top is irregular in this region, but this is a rather minor irregularity in the coal.

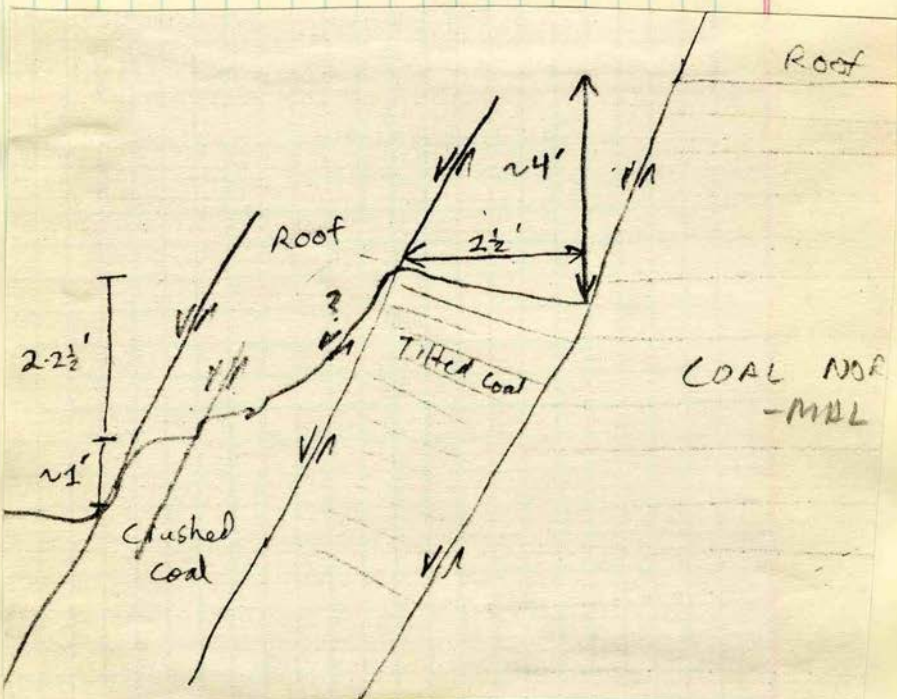
NORTH RIB

Coal is normal and even-bedded east of main fault but heavily crushed, fractured and broken between faults. Strong normal drag is shown on west side of center block of coal.

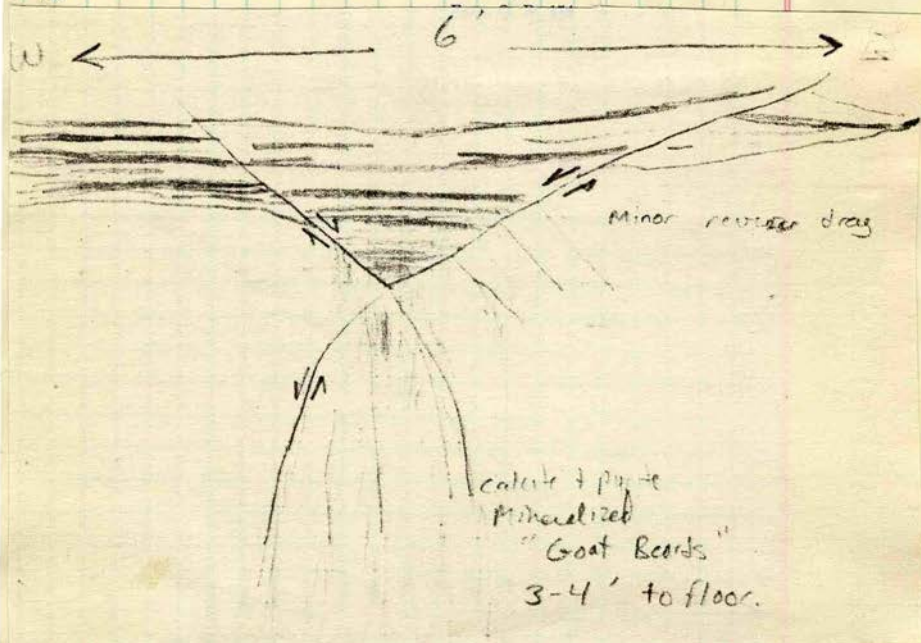
(26) Sketch of feature on north rib mapped by Nick Keyes, his stop (15).

Top foot or so of coal is split; interlayered with grey shale as shown. Complex "goat beard" system reaches to gob on floor. Slips die out in coal and no displacement shown there.

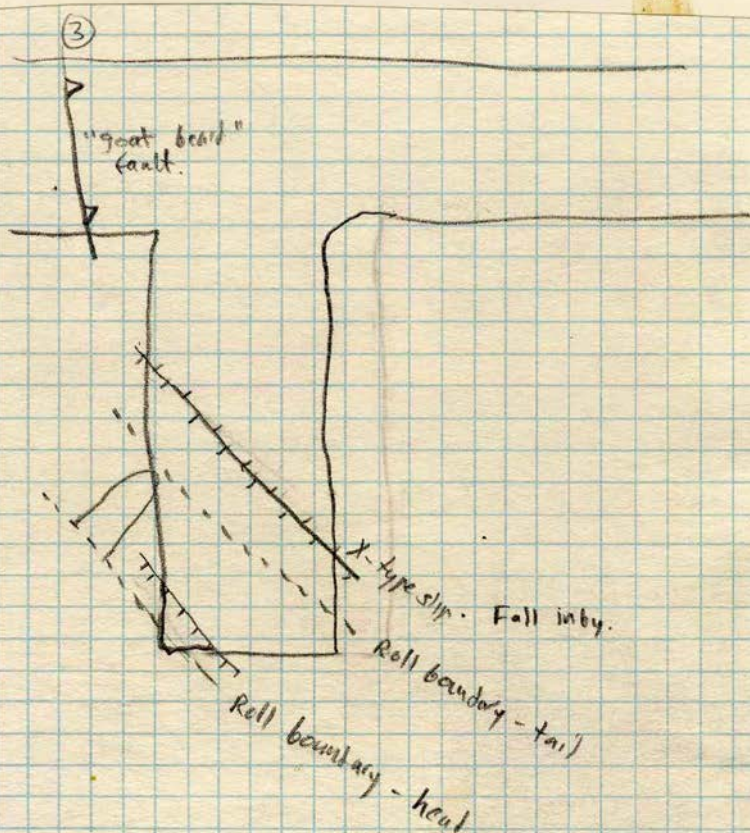
Sketch Map of Area of Stops 3 and 4.

- 2) The 1.5' fault in the entry to the north dies out to the south to become fracture zone with .5' down to west and a .5' fault down to east, forming a small horse about 2' wide. 4' to the west a .2' fault begins north in the 45° crosscut and becomes .5' to west on south side of entry. Roof fall in 45° entry.

Roof fall about 4' high with irregular top. Top of coal is very irregular, "rolly", with thick coal riders angling into the roof shale. Roof shale lamination is inclined, irregular. Main rider appears to "take off" from SW corner of face.

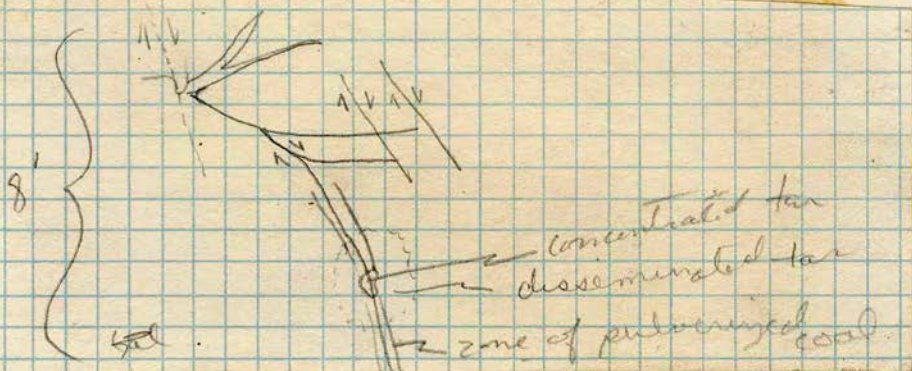
8) Roll with rider taking off from west side. 3' across and 1' deep. Shallow slip on east side 0.3' down to east. 4' below the roll is "asphalt" area; pulverized coal or fusain penetrated by tar-type substance. Area appears related to slip planes coming down from roll. Perhaps related to nearby fault. Cross-section looking north:

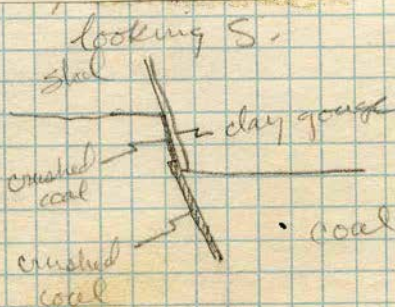
Sketch looking south:

9) Description of fault plane:

Coal-coal interface: pulverized coal (like fusain in texture) but with bits of coal not as much pulverized contained therein. 2-4" thick.

Shale-shale interface: clay gouge only.

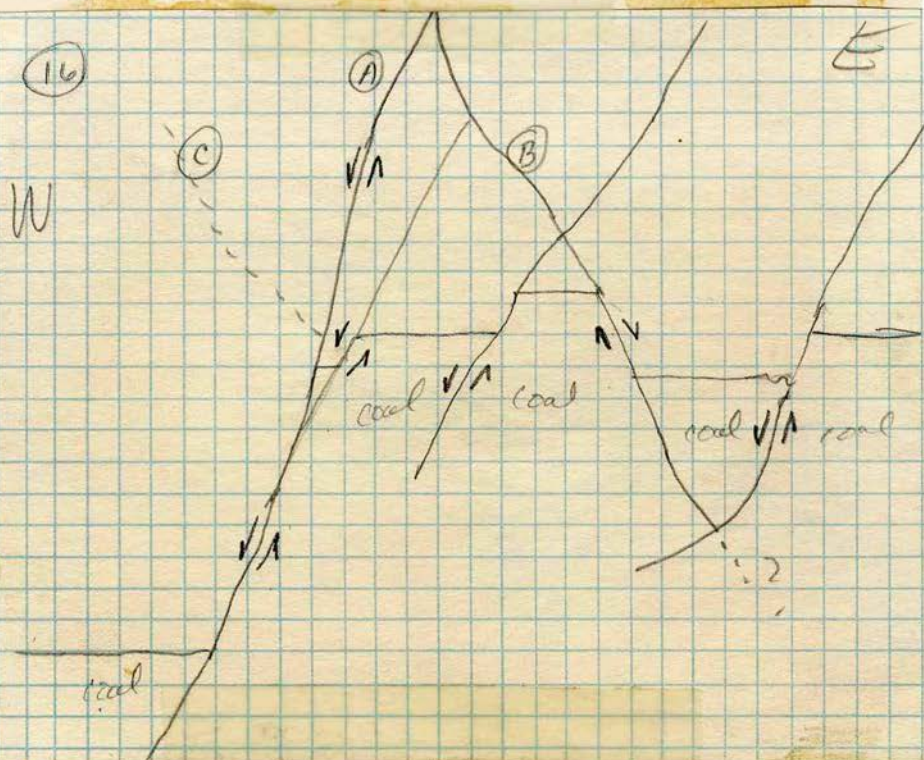
Sketch of Situation at Stop 16.

Floor of coal- $2\frac{1}{2}$ ' of medium-dark gray claystone grading into light buff or cream-colored nodular limestone. Much fractured near fault zone.

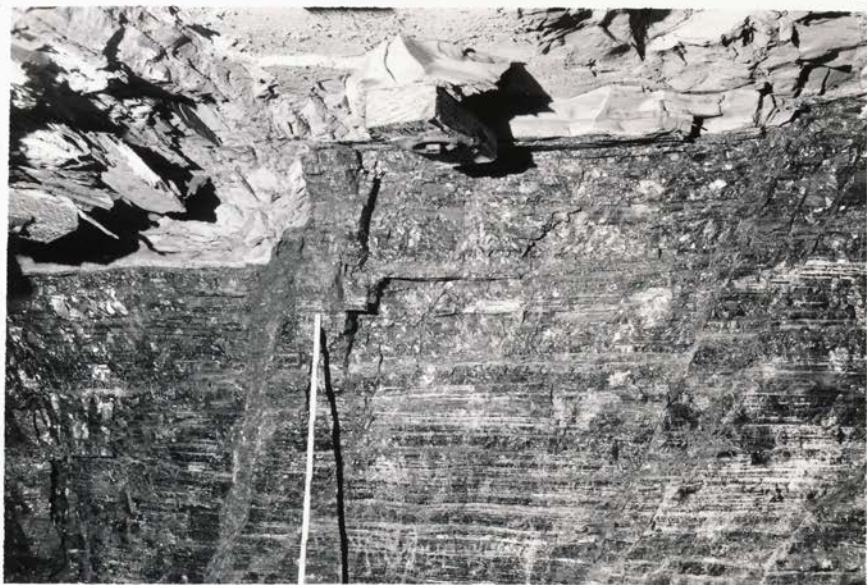
Location: stop 28 from Nelson's notes, 7/28/76.

Photo 8- Krausse. Normal fault in coal, strike 168, throw 1.1 feet down to west. Several smaller normal faults also are visible in coal. Note that main fault does not continue directly upward from coal into gray shale. Rather, the movement was apparently transferred to the left into a series of closely-spaced, low-angle fractures in the shale (upper left).

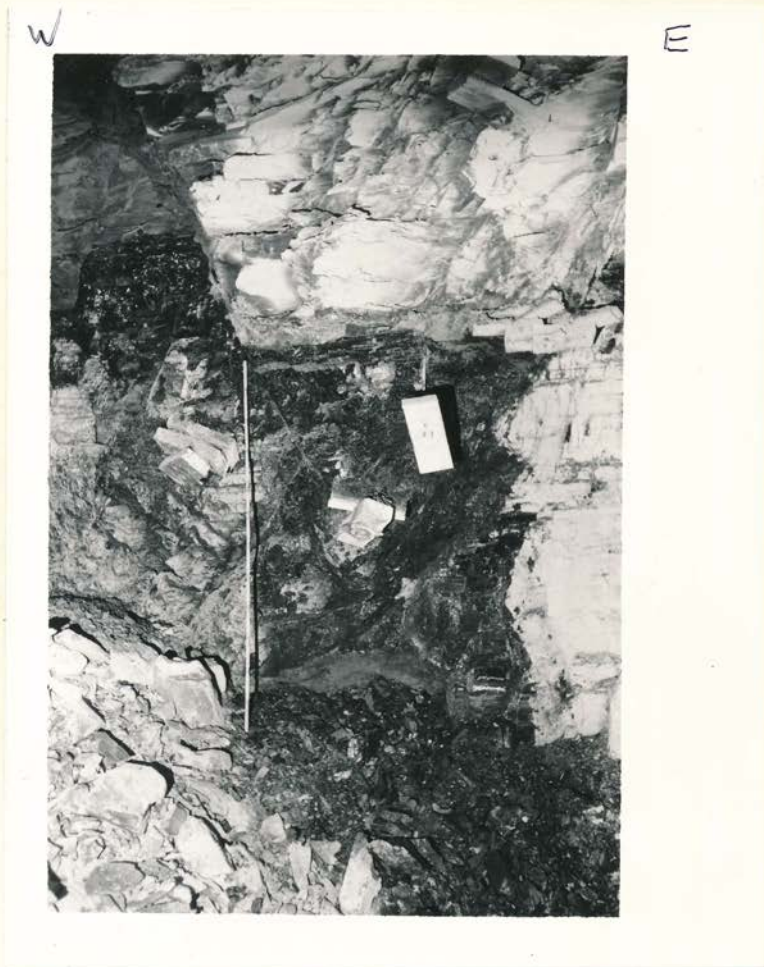
Photo 16- Krausse. Another view of the same, from farther away.

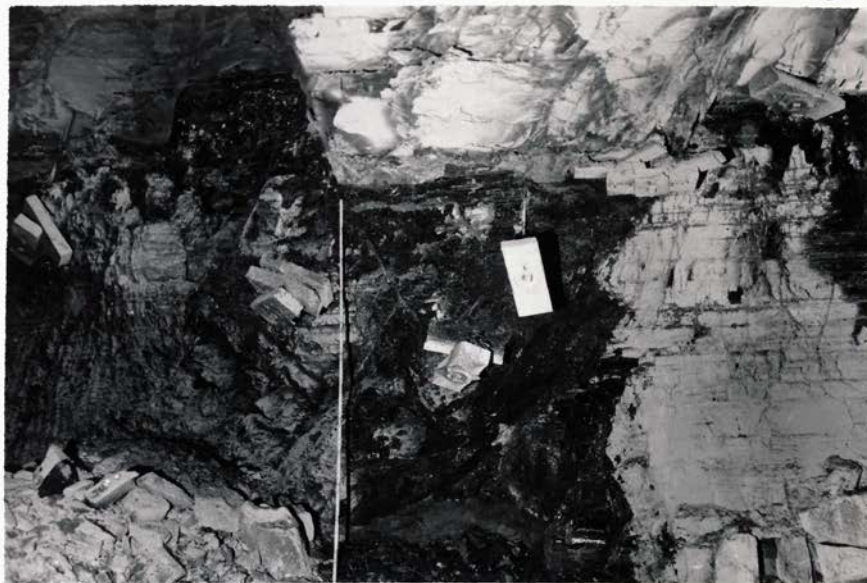
Photo 18- Krausse. Yet another view of the same.
