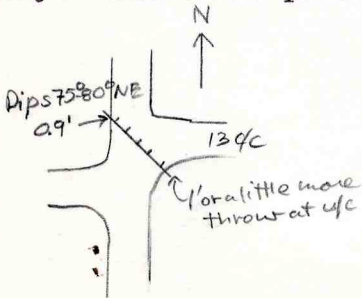
F. We check all possible faults as we went out of the panel. All had vertical movement only. The most prominent one was at the 13th c/c which had weathered out a little & I chipped back further to show Doug. Fault effects full thickness of Herrin; coal and roof both show brittle fracture; mineralized, pulverized coal gouge zone. Mullion structure shows dip-slip movement only. Strike est. at 135-140° - no compass; dip 75-80° NE.

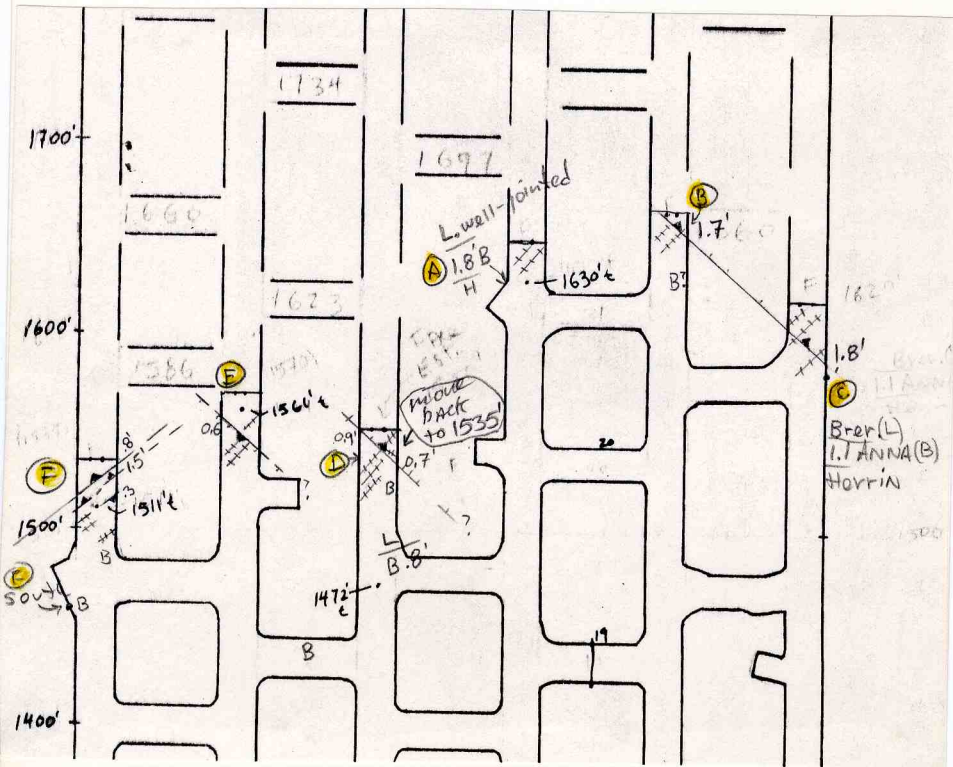
Map A 12/3/84

B. At the face of 2nd entry (about 1670'N.) there is a normal fault striking roughly 305° , down 1.7' to the NE. Clear vertical mullion in Brereton lip and in coal as well. However, the Brereton is highly fractured

C. Same fault as at B. crosses entry here (strike roughly $N35-40^{\circ}W$) with apparent vertical movement. On E. rib the roof sequence is Brereton over 1.1' Anna shale; again the Brereton is well jointed. On W. rib there is 2' of Anna with some injection of light-colored clay into the top--in retrospect this may be deformation associated with channeling (see F.) or with typical soft-sediment deformation of the Brereton. The fault dips $75^{\circ}-80^{\circ}NE$ here, produces a single 1" plane of crushed coal, and has 1.75' of throw. Roof Anna and Brereton jointed NE-SW (primary).

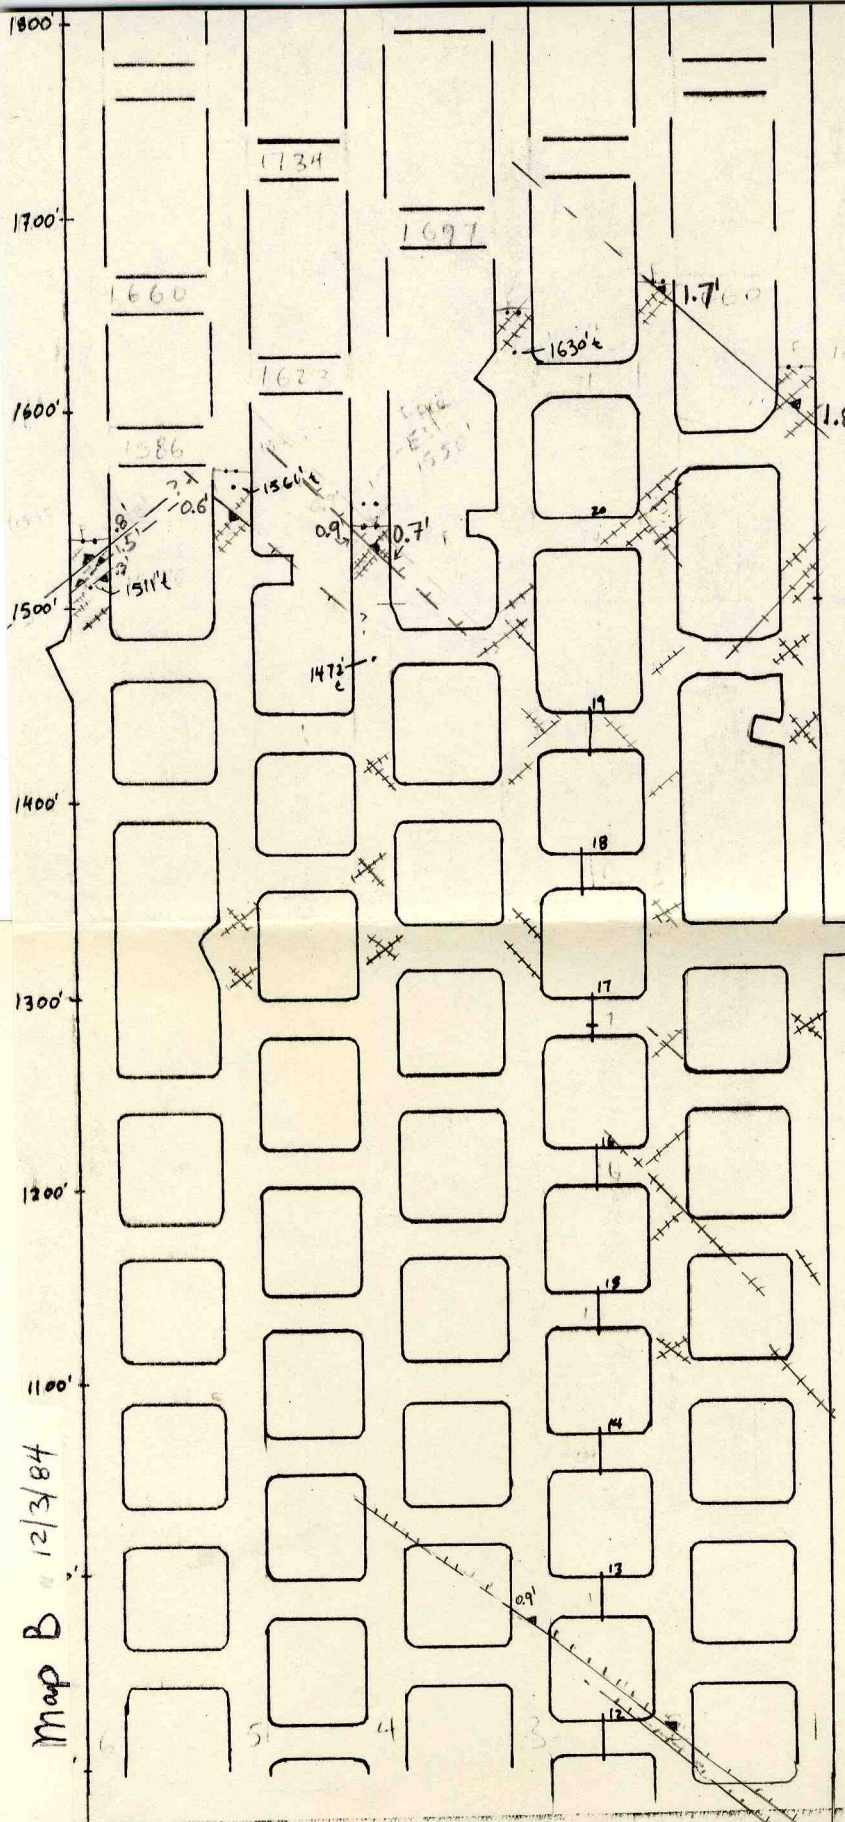
Faults + Fractures

Compiled from 3+ trips
to Dec. 3, '84

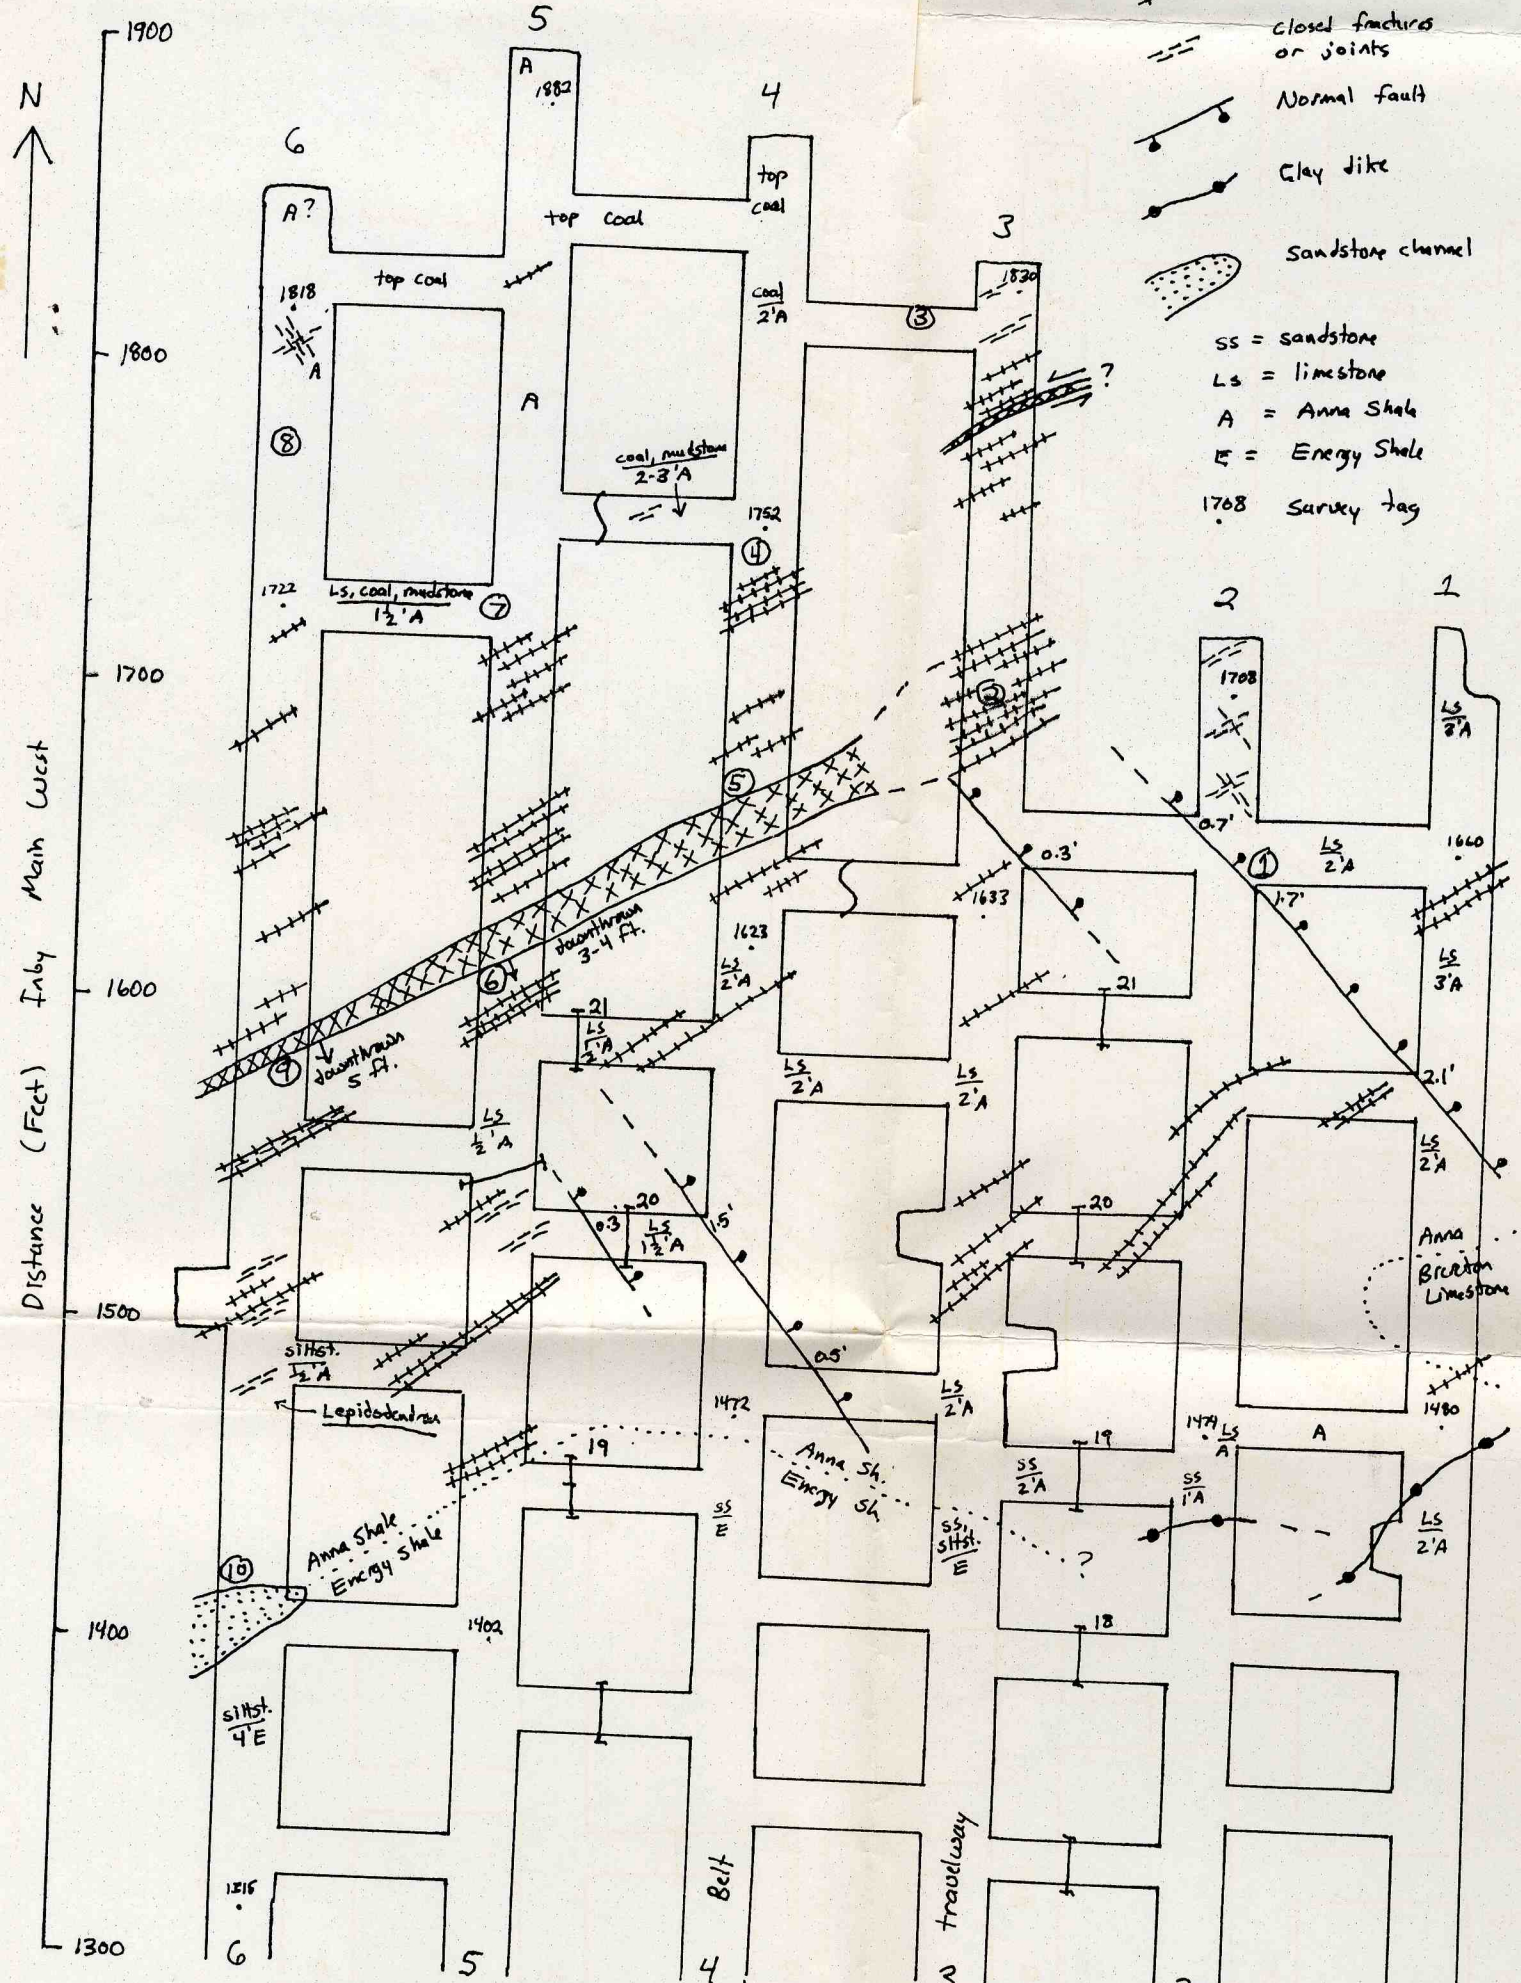
Map redrawn from sketch map made in field, using survey tags for reference - sizes and shapes of pillars were not measured, but merely estimated.

Freeman United Coal Mining Co. - Crown II Mine -
Macoupin County - Notes by John Nelson with Phil
DeMaris - Jose DeLeon from Freeman. January 15, 1986.

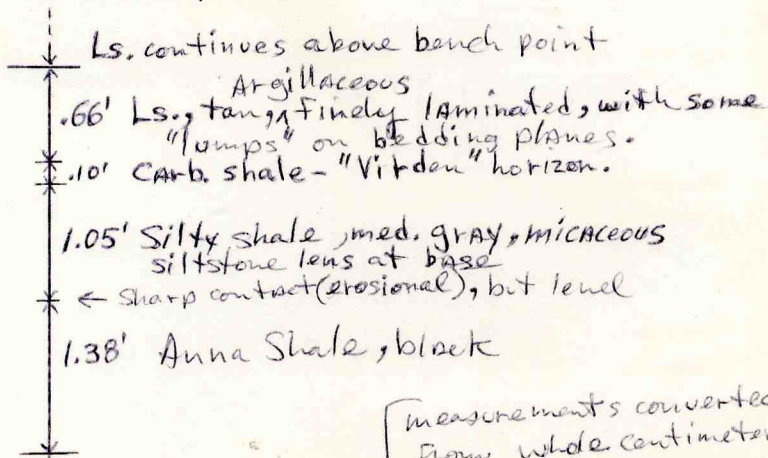
B. We came back south on the 1st N. toward the channel-effected area. Our first confirmed exposure of Anvil Rock channel sediments was in a roof fall at 2385' crosscut between 1st and 2nd. Description on south rib (which matches center of Nelson's sketch, p. 2B):

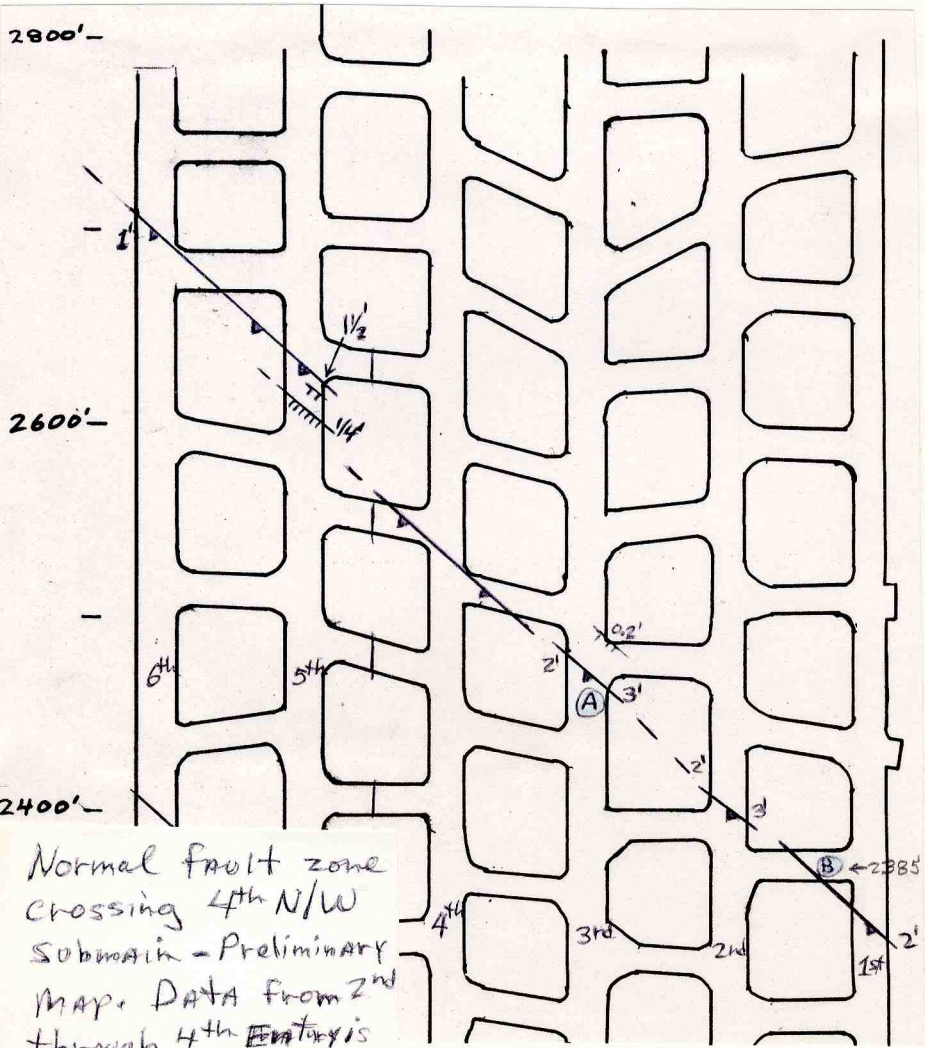
1/15/86 Map A

Normal fault zone
 crossing 4th N/W
 Submain - Preliminary
 Map. DATA from 2nd
 through 4th Entries

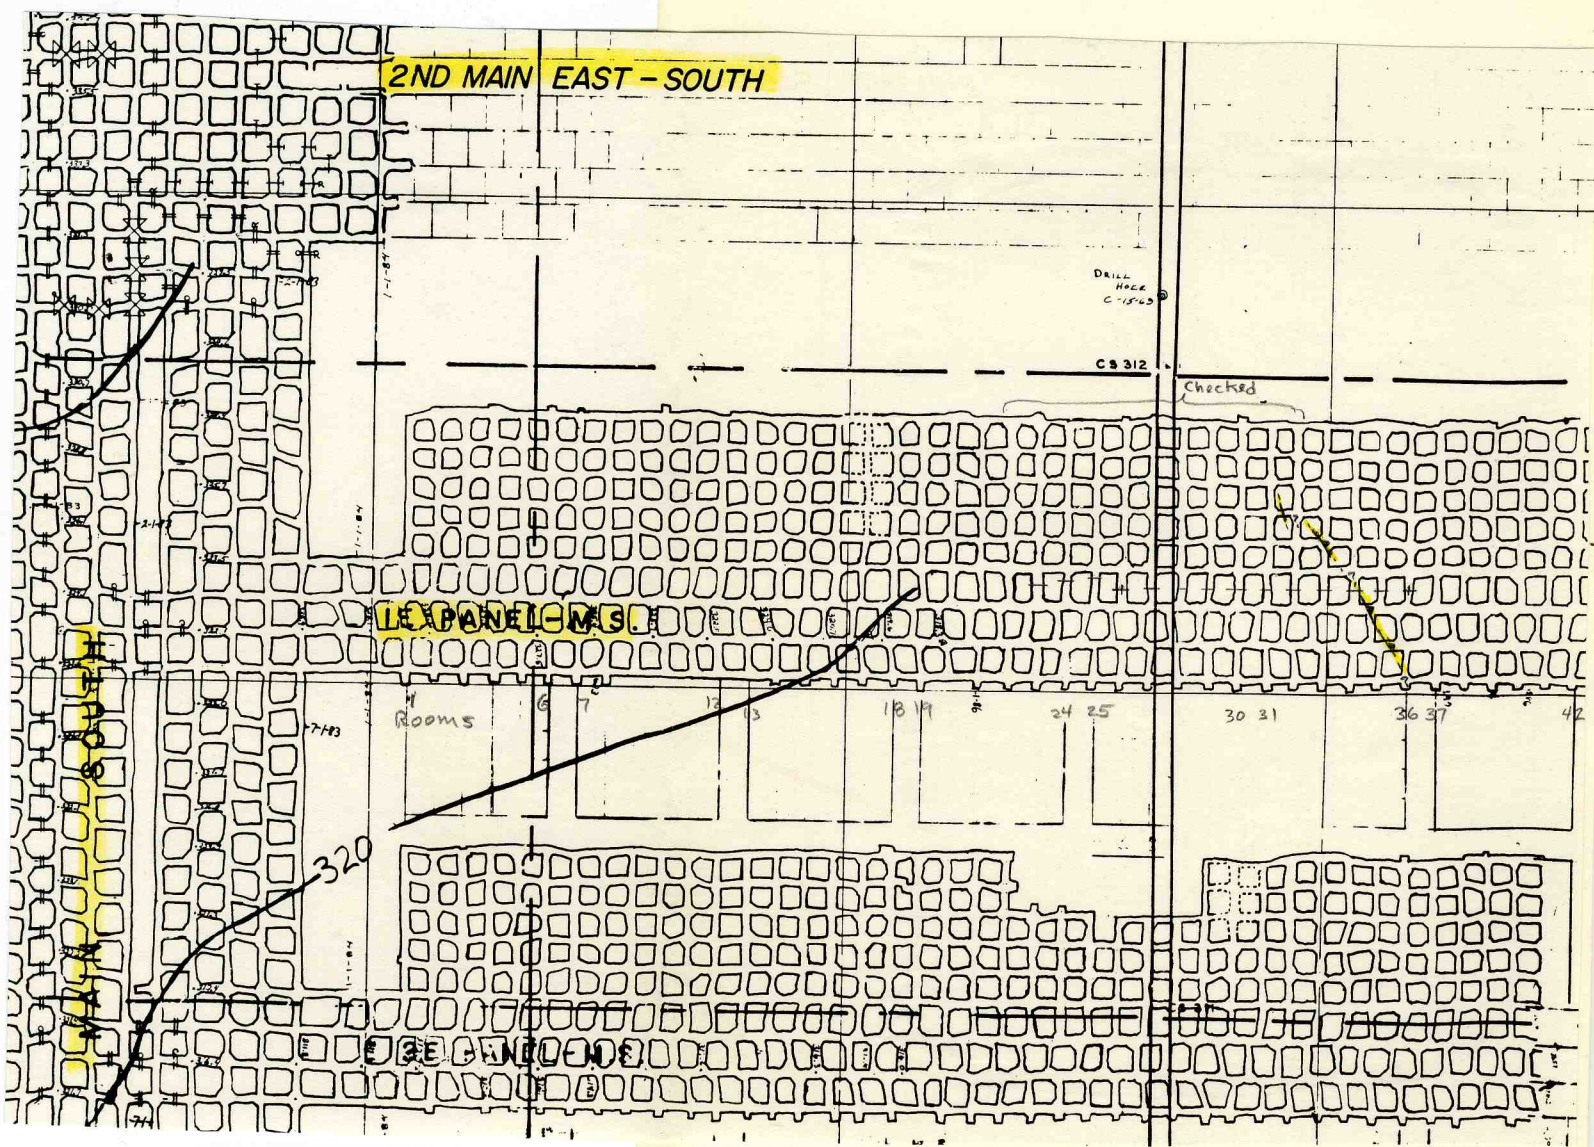
Crown II map A
10/29/86

Map of small (<1/4 throw) fault in 1st E. panel
