Sahara Coal Co. Mine # 20

SAHARA COAL CO.
MINE # 20

ISGS - Mine Index No. 909
Coal Report No. S-56

SALINE COUNTY

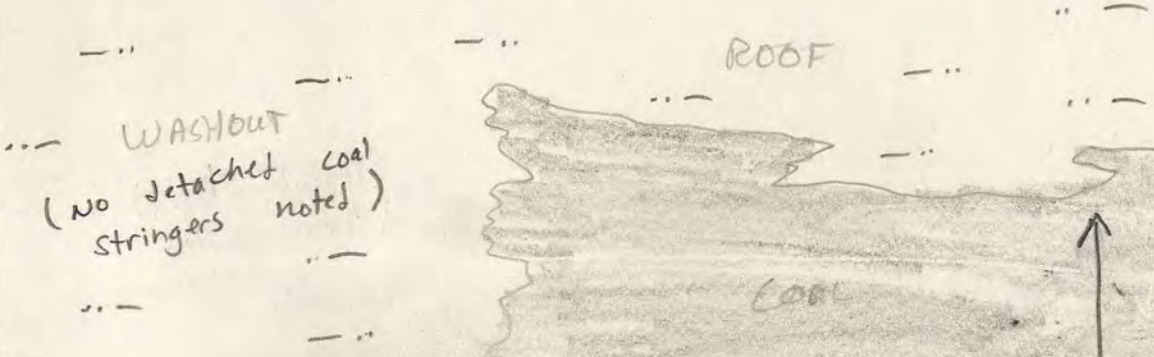
WASHOUT
(no detached coal
stringers noted)

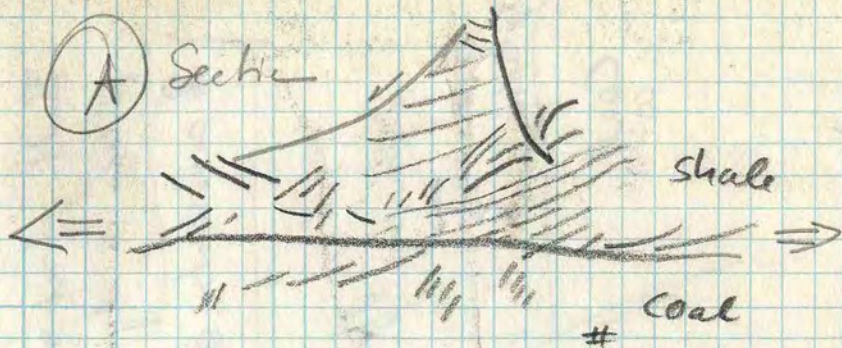
all surfaces
except coal/shale
interface are
shear plane
supporting lateral
movement

Fault offset on bedding plane // shear
plane in Dykesbury Shale

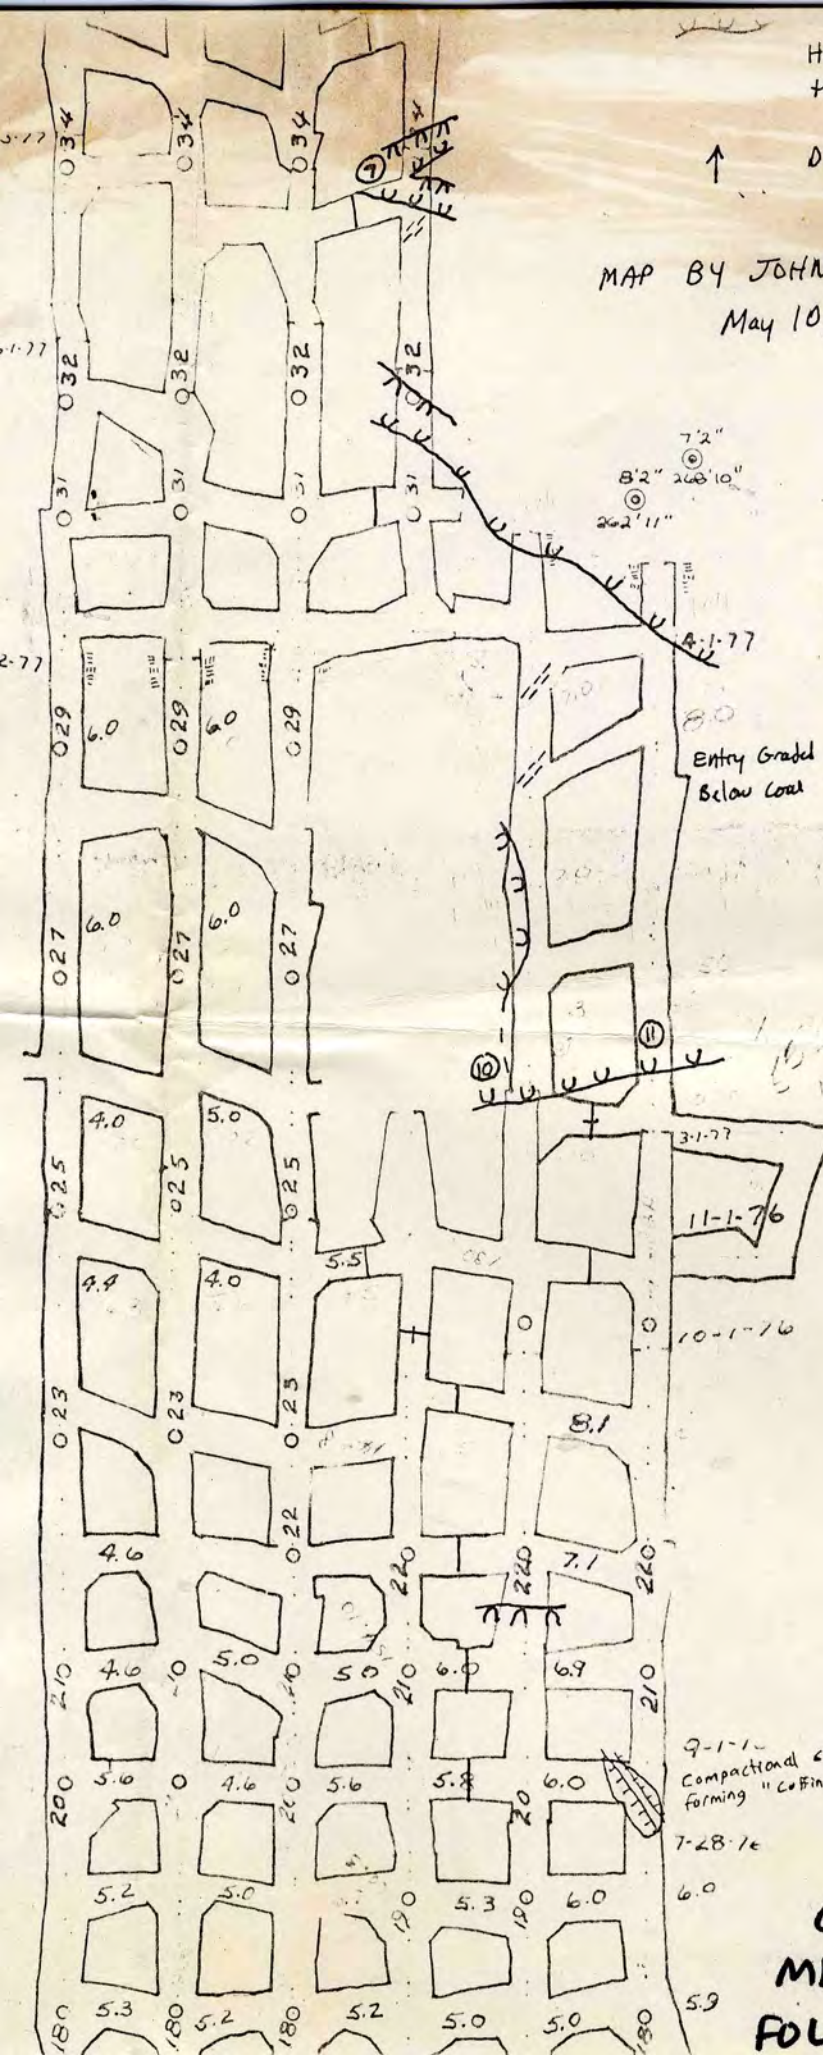
MAP BY JOHN NELSON
May 10, 1978

Abundance of fractures and shear planes has created a large roof fall and very unstable top conditions. There is no water seepage at present.

3. Large roof fall showing faults trending 135/60-65 SW and also roughly *vertical* fractures trending parallel with these. A very prominent system of jointlike fractures in the roof shale trend 050-055/80 NW; roughly perpendicular to main direction of faulting. Spacing averages about one per foot, but locally they are much more closely spaced. Intensity of fracturing increases toward main fault and there is no doubt the fractures are fault related, as the Dykesburg Shale normally is not jointed.

4. Fractures here trending 042/82 NW are partially open with filling of mud. Spacing is in places several to the inch. Fractures parallel to main faults occur in bundles of very intense fracturing.

5. Major fault zone presents very peculiar-picture (sketch, over). The coal seam is more or less continuous through the fault zone, though it is fractured and pulverized. No major displacement of the main seam has taken place.

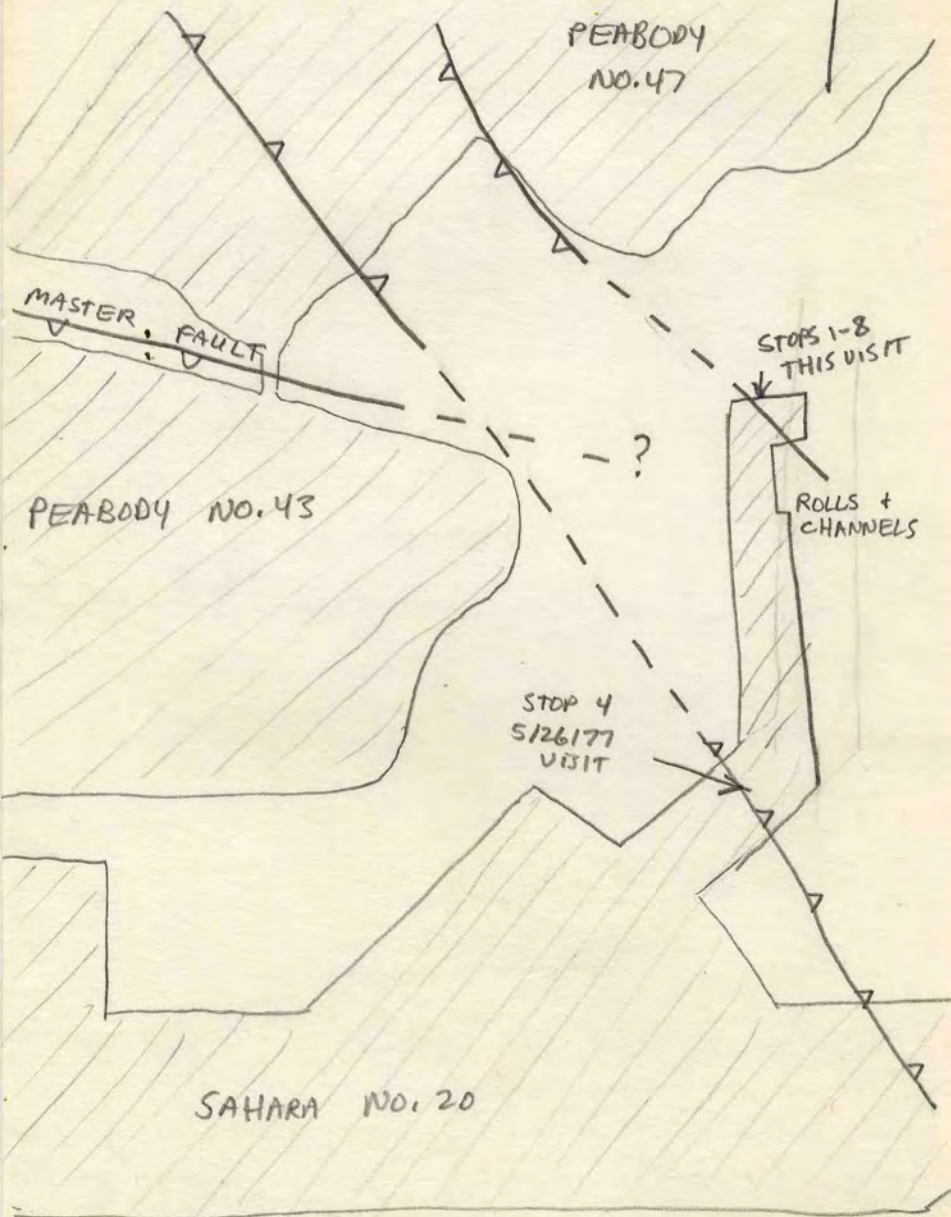
STOP 4
5/26/77
VISIT

In No. 1 (right hand) entry there is a fault about 20' outby the face. It is a normal fault trending $140-145/65-70^{\circ}$ NE with about 0.6 displacement. Several closely-spaced parallel branching fractures are nearby. This is the same set of faults described at Stop 4.

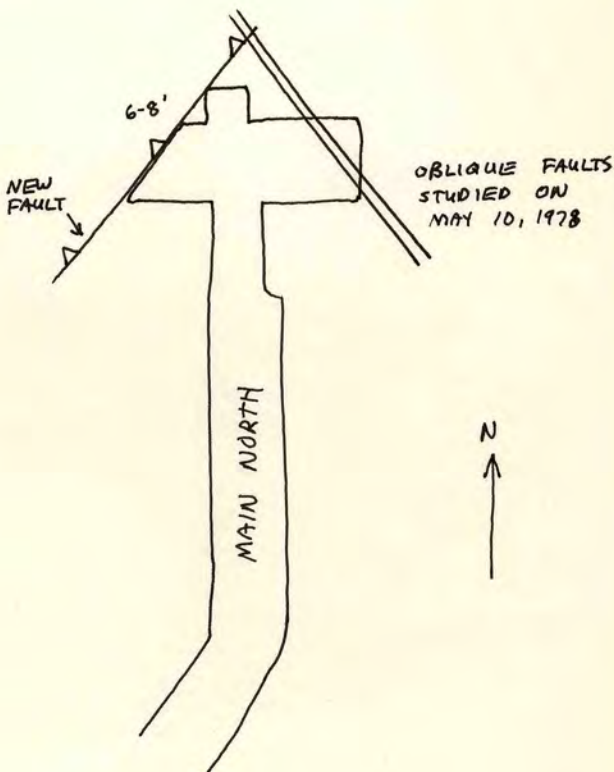
In the office Eric Eggli, chief engineer for Sahara told us that in entries driven west off the Main North they encountered a fault trending NE-SW with 6-8 feet of throw down to the northwest. This fault intersects the NW-SE trending oblique faults studied by us last year (see sketch below). Because of these faults and the large rolls encountered in the same area, Sahara has abandoned the heading.
