Black Beauty Coal Co.  
Vermilion Grove Mine

Black Beauty Coal Company - Vermilion Grove Mine. Underground mine is Herrin (No. 6) Coal, tipples located about one mile north of Vermilion Grove in southern Vermilion County. Notes by John Nelson, January 18, 2002.

## Vermilion Grove Mine, Vermilion County

## **Black Beauty Coal Company - Vermilion Grove Mine - Vermilion County**

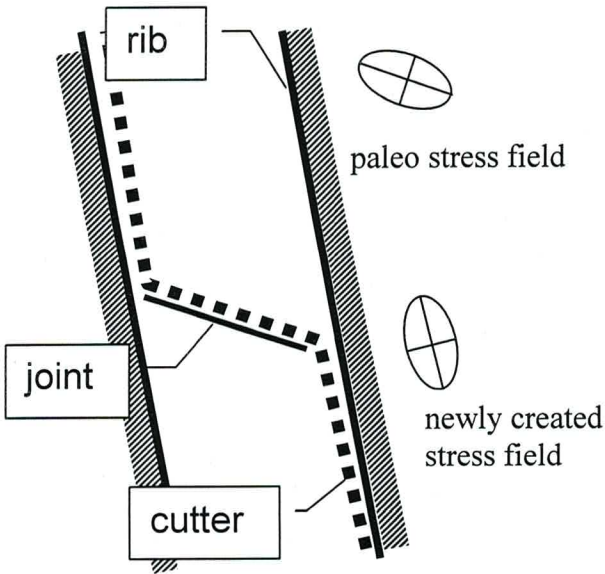
The roof parts very evenly in most of the mine where the laminated "varve" roof is present. This leaves a good, smooth roof that looks almost man-made, resembling a giant flagstone surface. But in many areas, where the middle of the room has this nice smooth roof, there will be a cutter along one or both ribs. In some cases these fractured zones have dropped up to a foot of roof material. These zones will sometimes go around the corner into the crosscuts, following their rib as well. They do not appear to be related to natural fractures, but rather are induced by the

removal of the coal, concentrating the stress at the point where the weight of the unsupported span of the roof is focused at the free-space point just inside of the rib. I suspect the roof is acting like an unsupported beam and is trying to fall, either hinged at one end in some cases where there is a cutter only along one rib, or trying to drop as a block where there are cutter zones along both ribs. In at least one case, Scott and I observed a place where there was a cutter running down one rib up to the point where there was an oblique natural fracture. The bad roof followed the trend of that natural fracture diagonally across the cut, and then went on as a cutter along the opposite rib. This pattern resembles that sometimes seen in naturally faulted areas where there is a weak, pre-existing structural trend that is oblique to younger extension. The extensional faults will try to follow the old trend to a point and then step off in an echelon offset in the orientation of the maximum stress direction, then begin again along the old weak trend.
