SAHARA COAL COMPANY MINE NO. 7

Visit to Sahara #7 Mine

Tuesday, Feb. 5, 1985

Sahara Coal Company - Mine No. 7
Saline County - February 5, 1985

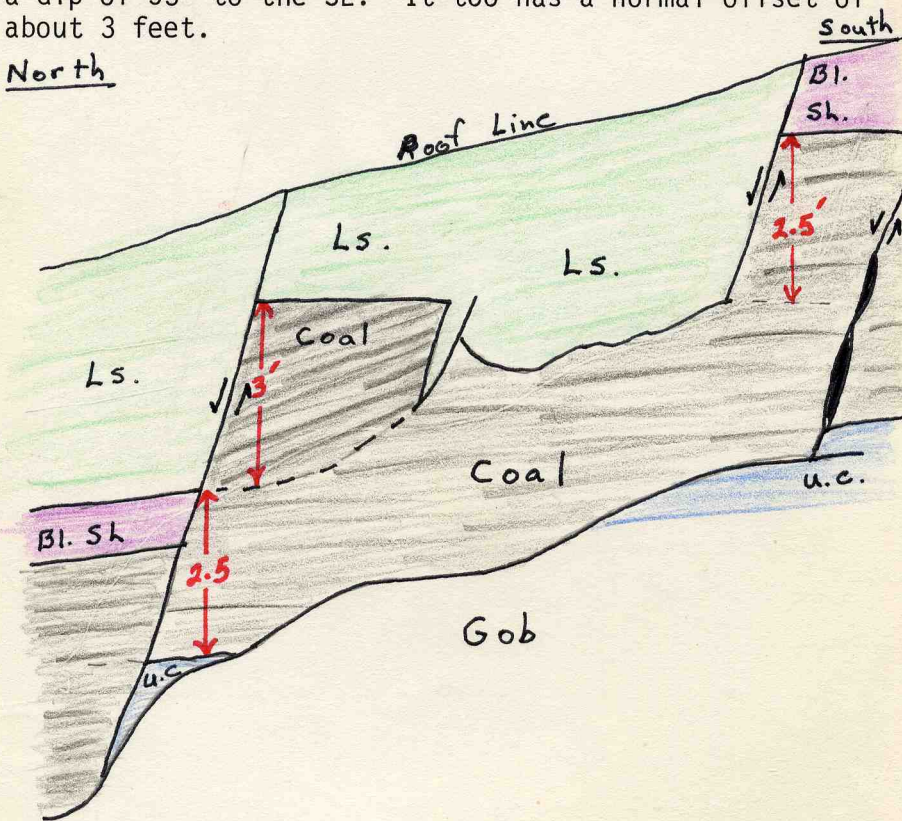
The second fault we encountered on the track entry is much more dramatic in XC #11, about 100' south of the track entry. See Nelson's notes for a sketch of the fault in the west rib of XC #11. The following sketch is of the fault zone where it passes through the east rib of XC #11.

The northernmost fault trends $N15^{\circ}W$, with a dip of 77° to the NE. The NE block is downthrown about 3 feet. The southernmost fault trends about $N40^{\circ}W$, with a dip of 53° to the SE. It too has a normal offset of about 3 feet.

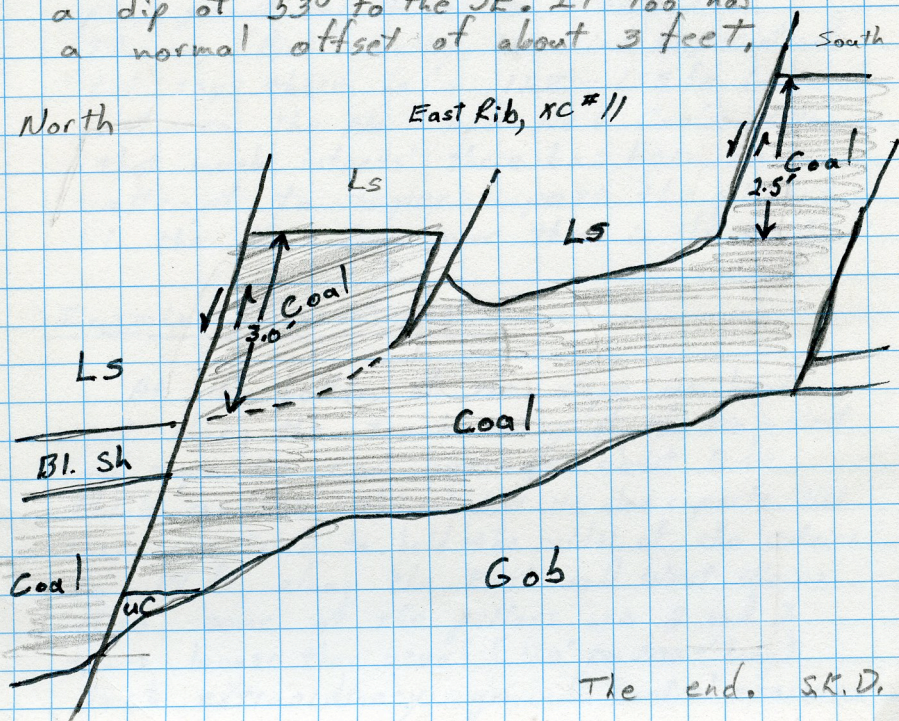
The second fault we encountered on the track entry is much more dramatic in XC# 11, about 100' south of the track entry. See Nelson's notes for a sketch of the fault in the west rib of XC# 11. The following sketch is of the fault zone where it passes through the east rib of XC# 11.

The northernmost fault trends $N 15^{\circ} W$, with a dip of 77° to the NE. The NE block is downthrown about 3 feet. The southernmost fault trends about $N 40^{\circ} W$, with a dip of 53° to the SE. It too has a normal offset of about 3 feet,
