OLD BEN COAL COMPANY
MINE NO. 25

COAL MINE—PRODUCTION

OLD BEN COAL CO., Mine No. 25
Franklin Co.
November 17, 1977

OLD BEN No. 25 MINE - GEOLOGY AND GENERAL CONDITIONS

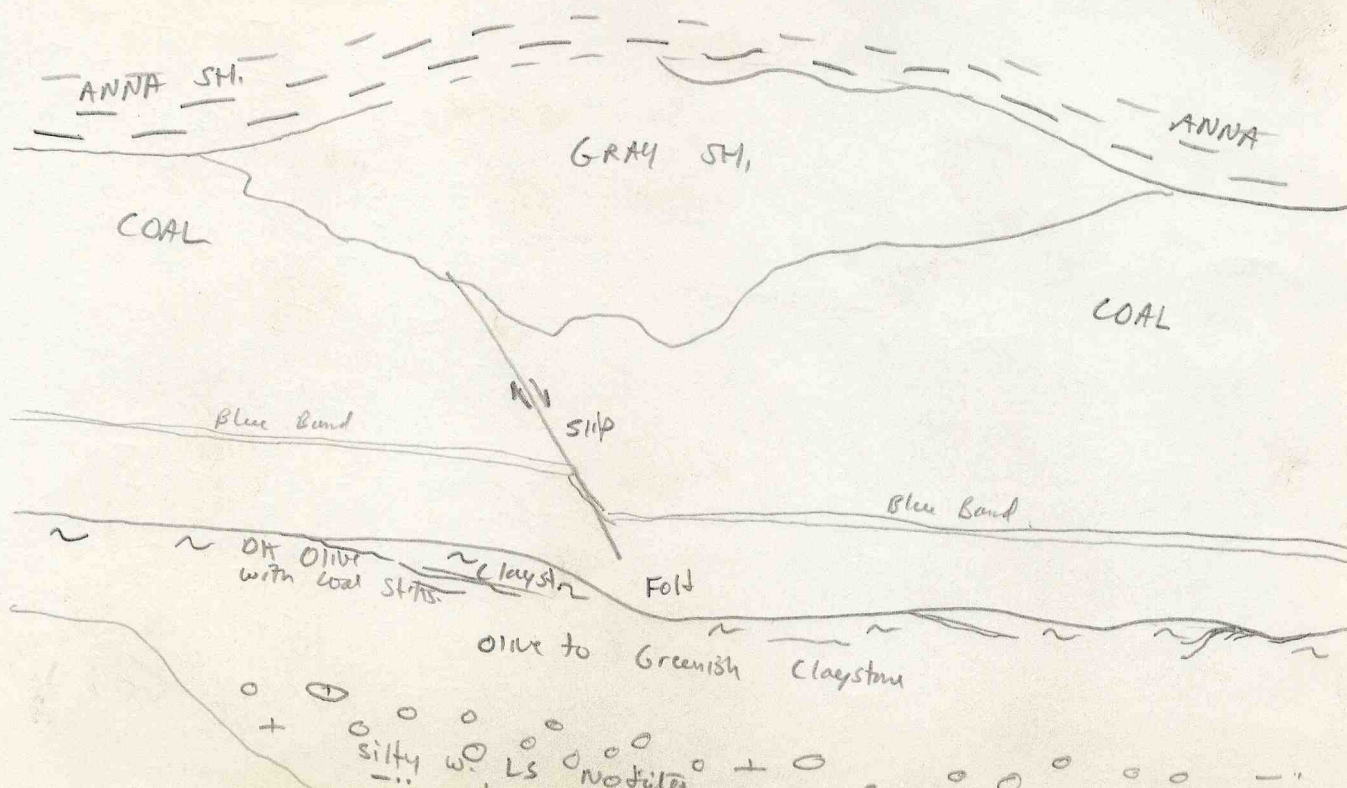
Step 16 - General View w Rib.
Partly Interpretive
50'

16.) 13th M.W. at 130'. Very sharp Anna/Energy contact observed on roof (see bottom only). Here the

Anna is the typical black shale, fissile and finely micaceous, with numerous concretions and pyrite lenses. The Energy Shale is medium gray and poorly bedded, with numerous coalified bark fragments, etc.
